# Magnesia refractory dryout—managing the risk of hydration

by J.D. Steenkamp\*, H. Kotzé†, J.G. Meyer‡, and J. Barnard\*

In 2002 the commissioning of an ilmenite smelter on the North Coast of South Africa was extended by three months due to the failure and subsequent replacement of the magnesia-based refractory lining. The lining failed due to the hydration of magnesia caused by an unexpected source of water. The incident resulted in significant financial losses and a prolonged insurance claim which was settled in 2009. As magnesia-based refractories are used extensively in both ferrous and non-ferrous applications, the authors of the paper want to share the experience gained from this incident with others. The paper reviews the literature available on furnace start-up practices and explains the hydration of magnesia using available sources. The incident is studied in more detail, both technically and economically, and the costs incurred are quantified in terms of the cost of the original lining. The paper concludes with lessons learned and recommendations made for future work. The intention of the paper is to stimulate open debate regarding best practices in preheating of furna

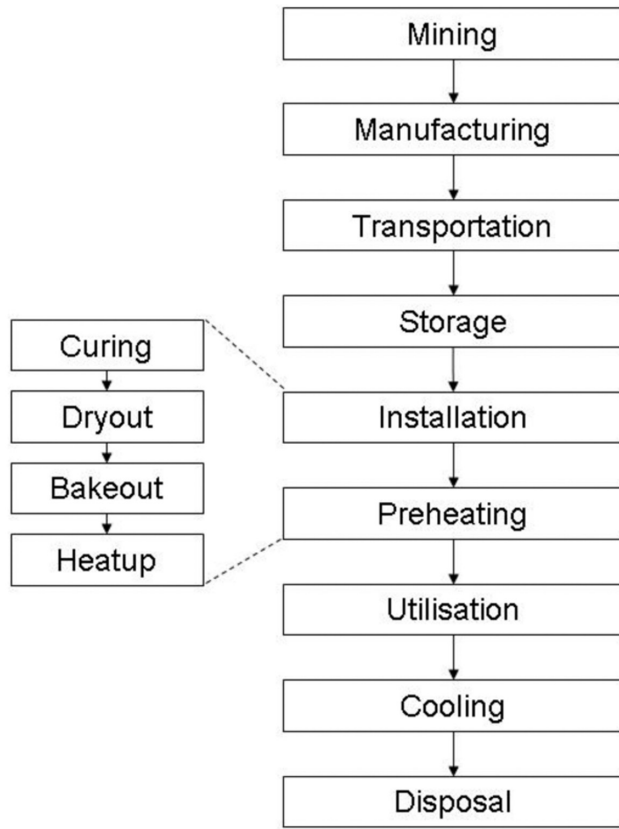
Figure 1—Typical life-cycle of a magnesia refractory brick

Figure 1 depicts the life cycle of a typical magnesia refractory brick. Hydration of the magnesia refractory brick can occur during any of the stages after manufacturing, but the installation and preheating (dryout specifically) stages are high risk stages<sup>4</sup>.

During the installation and preheating stages the brick undergoes several changes<sup>20</sup>. Curing is the formation of hydraulic bonds. Curing follows the placement of the material and is limited to wet installations of magnesia refractory bricks. In wet installations, mortar is utilized as a bonding agent between the bricks. The hydraulic bond forms at ambient temperature within 24 hours of placement i.e. during installation. Dryout is the removal of moisture to render the lining safe to start the process at a later stage. Bakeout is the formation of chemical bonds at elevated temperatures. Heatup is the continuation of the dryout or bakeout stages to the point where the furnace can be put into operation.

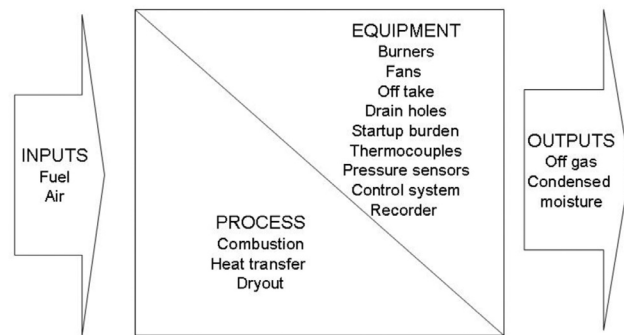
Figure 2—Analysis of the dryout process

Figure 2 summarizes the inputs, process steps, outputs, and equipment involved in a dryout process where measures are put in place to prevent magnesia refractory from hydration by moisture condensing from the off-gas and by moisture condensing against the furnace shell.

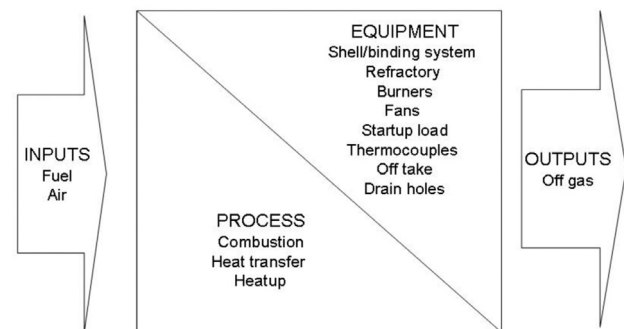
Figure 3—Analysis of the heatup process

The layout and placement of the burners and fans are designed in such a manner that the heat transferred from the hot, dry air to the refractory material is homogenous<sup>9</sup>. If start-up burden is installed prior to preheating, its layout is designed to ensure homogenous heat transfer from the hot, dry air to the refractory lining, but the burden is preferably introduced when the heatup process reached operating temperatures<sup>5</sup> (Figure 3).

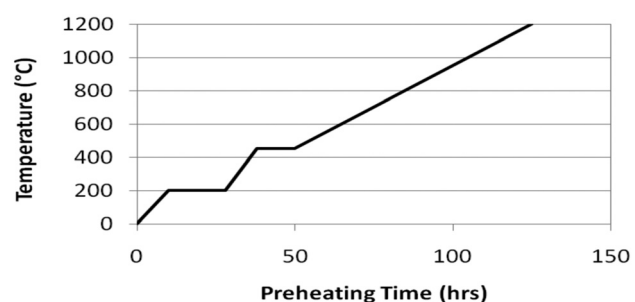
Figure 4—Refractory heatup curve as prescribed by the supplier

- The thermal input into the furnace had to be controlled according to the preheating rate prescribed in Figure 4 to prevent excessive temperature gradients within the bricks

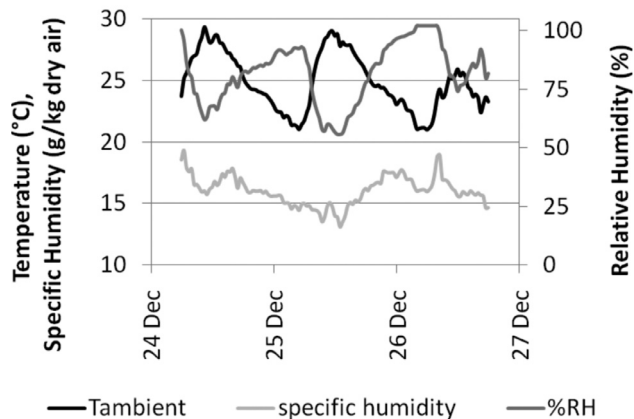
**Figure 5—Ambient temperatures, humidities and dew point inside the furnace during the preheating period. The latter takes into account the increasing volume flow through the furnace with increasing temperature**

Humidity and temperature readings for the days over which preheating were conducted are given in Figure 5. Temperatures ranged in the high twenties, while humidities were close or equal to 100% over the period. This combination results in a humidity load to the internal furnace above 15 g/kg dry air over the last few hours of the hold at 200°C and the subsequent initial increase in internal furnace temperature. At the typical air consumption rates of 10 000–12 000 m<sup>3</sup>/h, this results in 170 200 kg of water per hour. While present as vapour within the heated furnace volume, a major part of this water condensed along the inside of the water-cooled off-gas duct, which was kept cool for the reasons as given above.
