A CONSULTANT'S PERSPECTIVE ON THE USE OF BITUMEN-RUBBER IN ESPECIALLY DOUBLE SEALS

N J J (KLASIE) JOOSTE

KBK Engineers (Pty) Ltd, South Africa, klasiej@kbkengineers.co.za

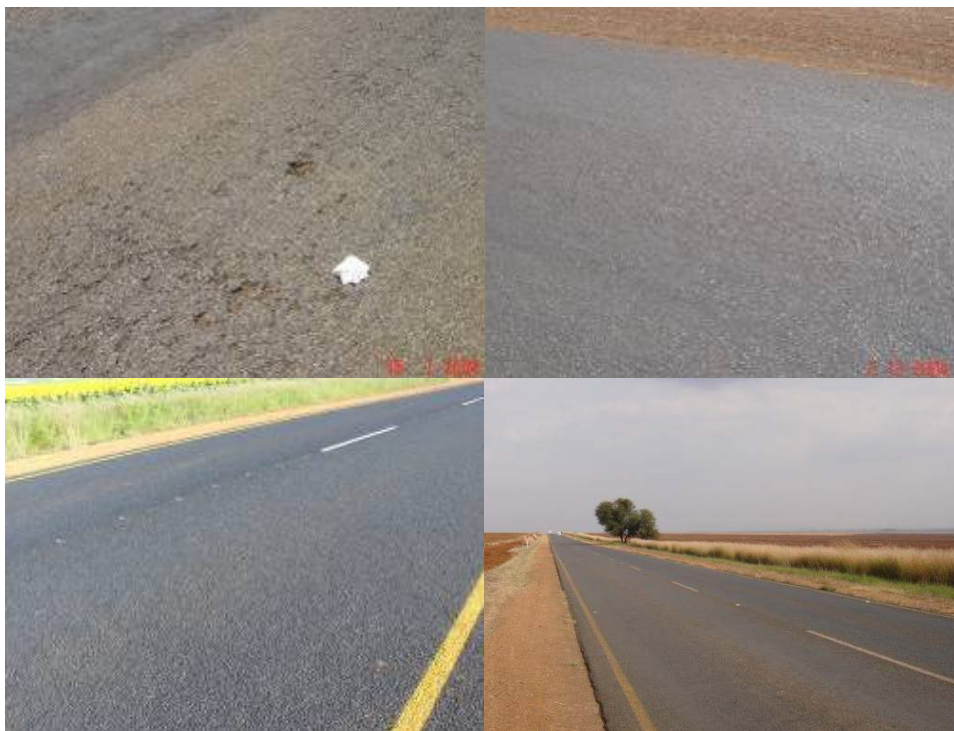
Viewed in sequence, Photograph 1 shows:

- Condition before - Continuous fatigue cracking in wheel tracks
- Condition after slurry texture treatment
- Condition after one year
- Condition now after almost 6 years

Photograph 1: Road K175 near Etwatwa (Daveyton), Gauteng.

The road, especially the surface layer, was in an extremely poor condition exhibiting a very dry, brittle and continuous (fatigue) cracked surface layer with some structural cracking and patches. Due to the varying texture depth a fine slurry texture treatment was applied, prior to the application of 19.0 mm and 9.5 mm bitumen-rubber double seal. In essence the existing road surface layer was long overdue for a reseal, with the pavement structure still in a reasonable condition. FWD deflections were varying with Y_{max} values between 0.3 to 0.7 mm, indicating a distressed pavement. Rutting on average was in the vicinity of 5 to 10mm. The AADT in 2000 on this road was approximately 2600, which has now (2011) escalated to approximately 3500 vehicles per day with approximately 14% heavies. The total binder applied was 5.1 l/m^2 , which was 1.5 l/m^2 higher than the minimum suggested by TRH3 (1997).

Conclusions drawn from observations indicate that the application rate was appropriate to minimise crack reflection while still providing a texture depth in excess of 1 mm after 6 years (Jooste and van Zyl, 2010).

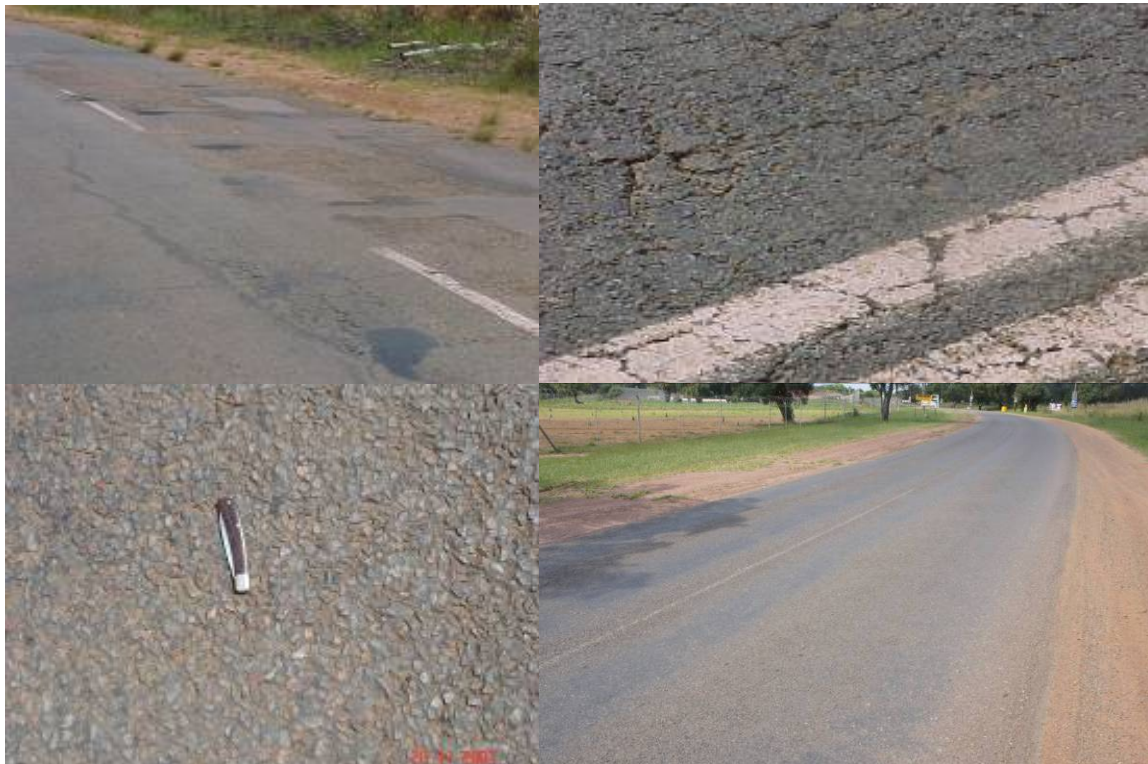
Viewed in sequence, Photograph 2 shows:

- Condition before – Poor riding quality and failed patches
- Condition before - Continuous fatigue cracking in wheel tracks
- Close-up of the condition after 6 years
- General condition now after 9 years

Photograph 2: Road P84-1, first 6 km from Modimole (Nylstroom) towards Vaalwater.

Other than a few large longitudinal cracks reflecting and some isolated small failures after ten years of service, the pavement is still holding without any crocodile cracks and/or pumping visible. The riding quality is still unacceptable, as the double seal could not rectify the shape of the deformed base.

A slight degree of fattiness is visible in the wheel tracks, which is always a good sign in terms of the long term durability, but as always the texture depth is compromised as a result thereof. As a 19/9.5 mm double seal has a relatively high texture depth to start off with, it is rarely found to be substandard when evaluated with TMH 9 (Jooste and van Zyl, 2010).

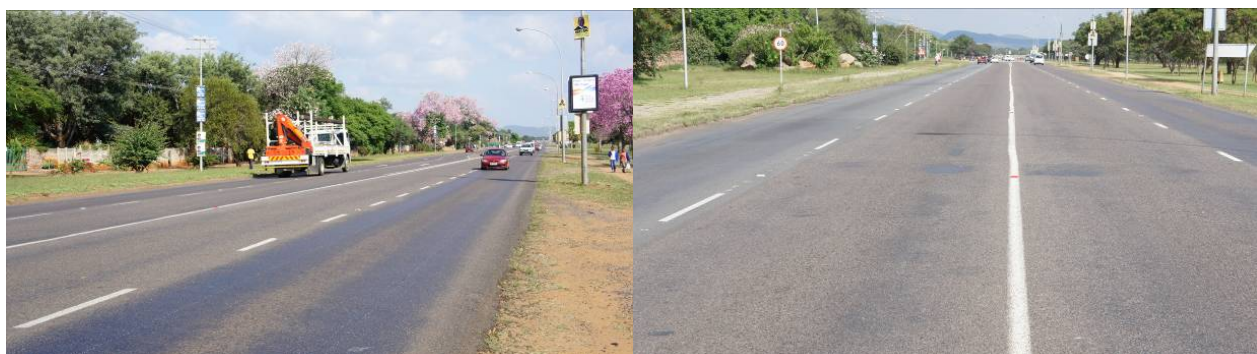
Photograph 3 shows the general condition now, showing fattiness without tackiness or pick-up in the slow lane after 11 years (Jooste and van Zyl, 2010).

Photograph 3: Thabo Mbeki Road (P1-5) through Mokopane (Potgietersrus)

Although embedment occurred in certain areas as a result of not applying the 19 mm stone in the best shoulder to shoulder application rate possible, the a poor base, and patching just prior to reseal, the road is still performing quite well with only a few minor and one large patches in the road that have to be maintained from time to time. The visible bleeding areas, as shown in the second image, are not tacky and no pickup of the binder or seal has occurred to date. Deformation, in terms of rutting increases each year. However, only a few instances of deformation, cracking and/or pumping are visible in these areas after 11 years of service.

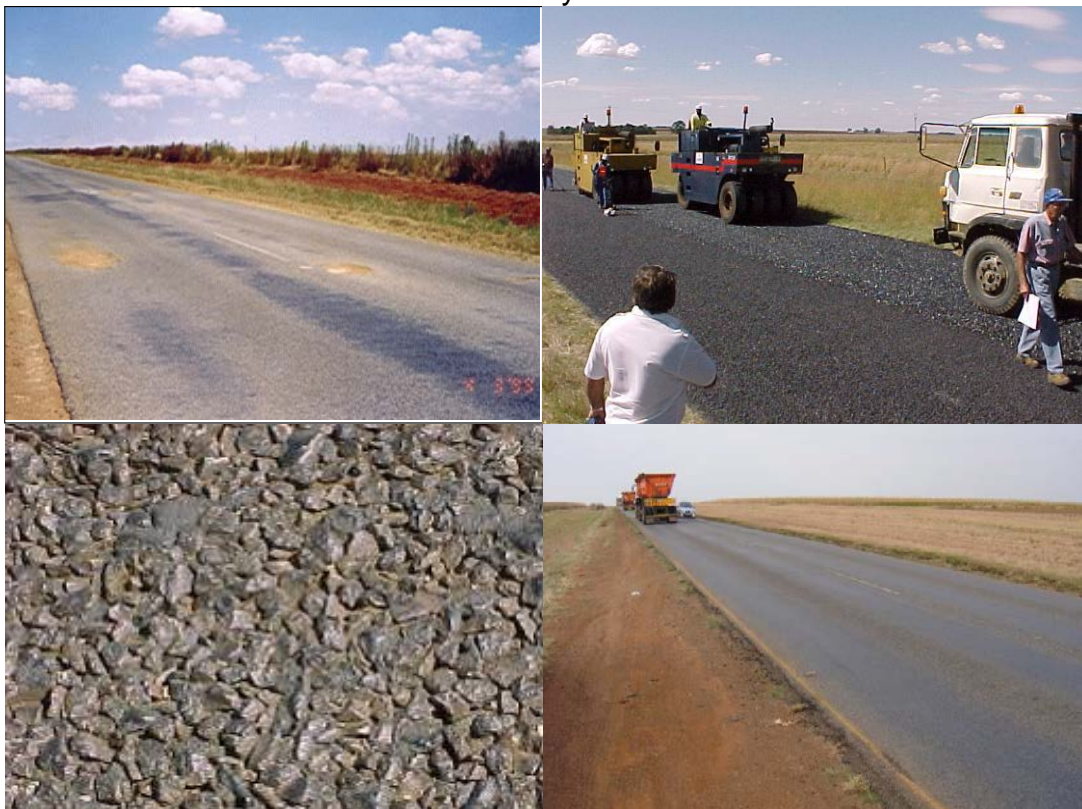
Total binder application rates varied between 4.7 and 5.3 ℓ/m^2 . The double seal in the wheel path has flushed considerably through the years, but it still has a minimum surface texture of approximately 0.4 to 0.5 mm. The general texture, as shown in Photograph 4, is still more than 1 mm. Even though some crocodile cracking was evident before reseal, only isolated occurrence of cracking can be observed and two small structural failures have occurred over the twelve-year period. Viewed in sequence, Photograph 4 shows:

- General condition just before patching and resurfacing in 1999
- During construction. Completed section on left with 19 mm on the right
- Close-up of the seal condition outside the wheelpath after 12 years
- General view and traffic after 12 years

Photograph 4: Road P101-1

Recent photos show the surface in the wheel path to have flushed considerably through the years, but it still has a fair amount of surface texture and has stood up to more than the anticipated traffic extremely well, with only a few small isolated failures now evident. In the beginning the application of the 19 mm stone was not constructed in as tightly as possible shoulder-to-shoulder manner. The result was that in the wheel paths the 9.5 mm stone has been punched into the 19 mm stone by the heavy traffic and has therefore become flushed, whereas the rest of the area almost seems to have received either too little binder or just enough (Jooste and van Zyl, 2010).

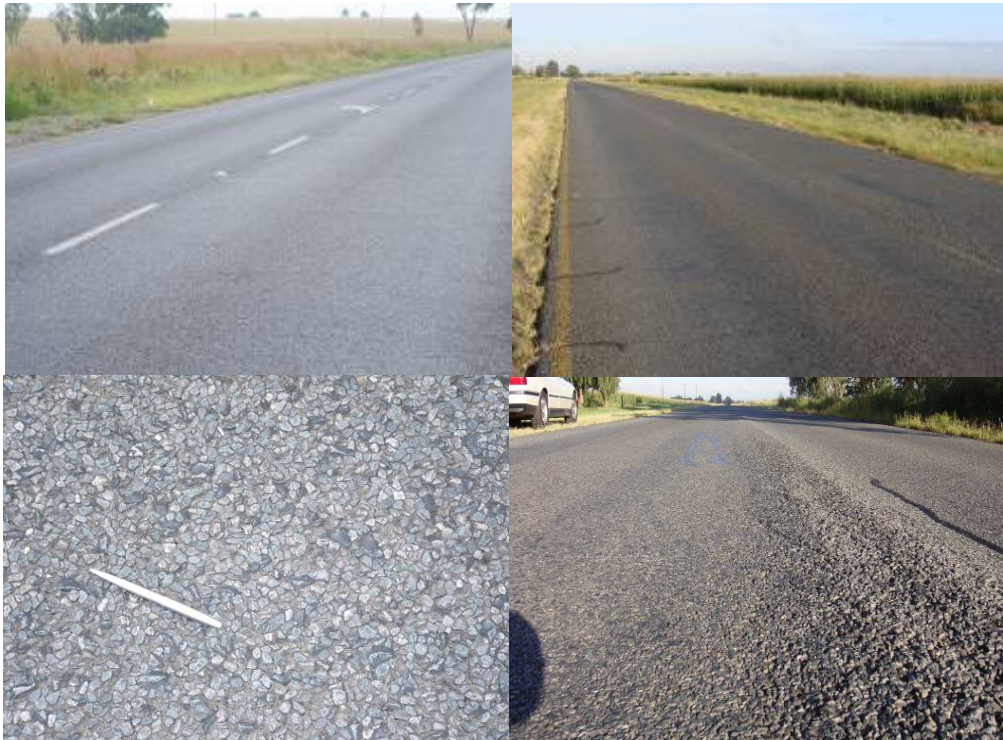
Viewed in sequence, Photograph 5 shows:

- General condition after 5 years showing no defects
- Transverse cracking reflecting through outside of the wheel track after 9 years. Self-healing of the cracks in the wheel track
- Close-up of seal after 9 years
- Structural failure (excessive rutting) but seal still reasonably intact

Photograph 5: Road P5-1 to the east of Springs within Gauteng
