A typology for ‘waenhuis’ in the vernacular farm architecture of the trans-Vaal River region

Mauritz Naudé

Department of Architecture, Tshwane University of Technology, Pretoria

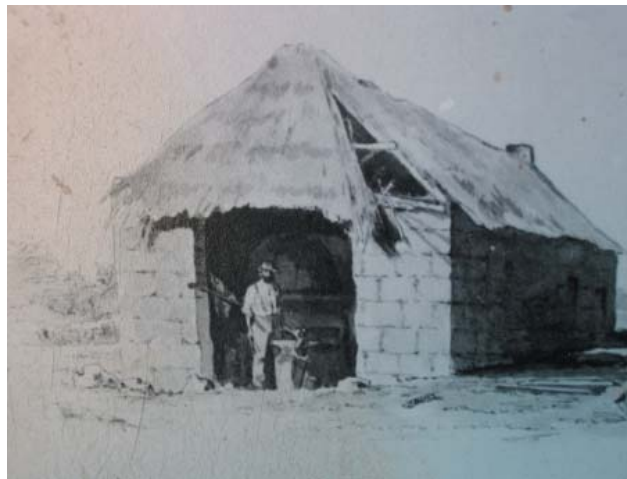
Figure 1

Drawing of a 'waenhuis' (wagon parked inside), made for the Paris exhibition as part of the South African display of a typical Transvaal farmhouse and outbuildings (ca. 1900) (drawing: Ditsong: National Museum of Cultural History, Pretoria).

In 1900 the government of the Zuid-Afrikaansche Republiek (ZAR) was asked to participate in the International Exhibition in Paris. Several drawings were made of what was considered a typical Transvaal farmstead. The drawings included one of a ‘waenhuis’. It was a single space building with a hipped roof at one end and free gable at the other end (figure 1).

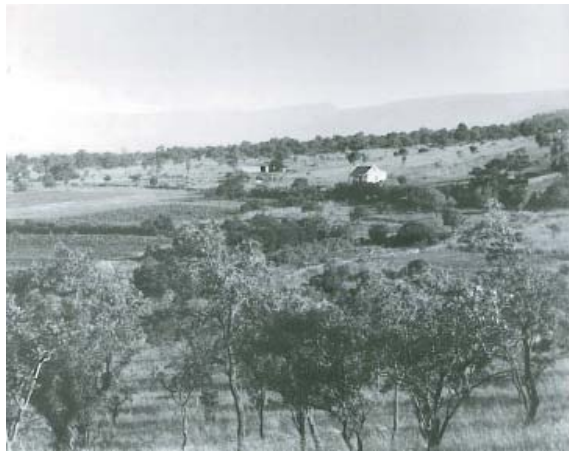
Figure 4
Small farm dwelling with ‘waenhuis’ set at the back and slightly to the side (left) of the dwelling
– Waterberg, ca. 1890 (photograph: Gross Collection, Ditsong: National Museum of Cultural History, Pretoria).

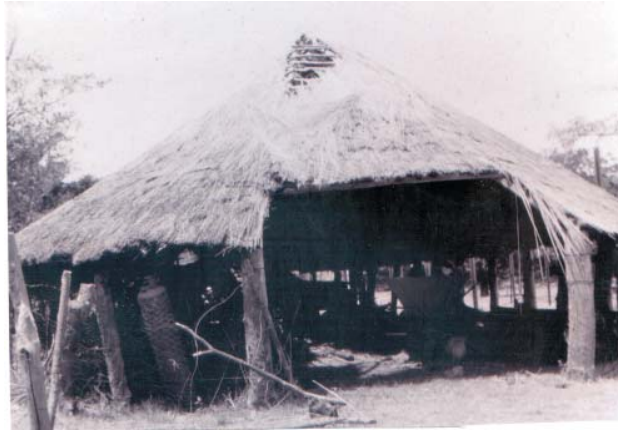
Figure 5

Hipped roof shelter with cut-back roof at the entrance to allow a transport wagon to enter the building - Waterberg region, ca. 1986 (photograph: Ditsong: National Museum of Cultural History, Pretoria)

Research done by the Ditsong: National Museum of Cultural History in the Waterberg (Limpopo Province) during the 1980s²⁰ revealed that although particular vernacular building types (and building techniques) have been exclusively associated with the so called Pioneer period²¹ of the early Transvaal (1848-1880), examples are still found in the Waterberg. ‘Un-refined’ organic materials and construction techniques seem to be still in use and buildings are, to some extent, still built according to the old traditions common in the region. Excellent examples are the single space structures with thatched roofs that have been recorded during the 1980s (figures. 5, 6, 8 and 9).

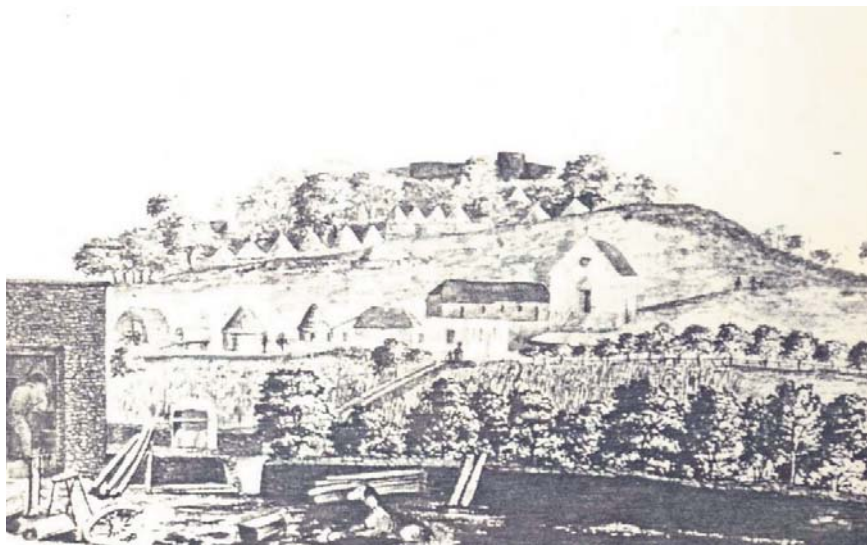
Figure 6

Vaulted timber frame wagon shelter (far left) on the Botshabelo Mission Station, (ca. 1868 - Berlin Mission Society) Middelburg, Mpumalanga Province (photograph of drawing: Restoration report, Hannes Meiring).

A single space ‘waenhuis’ is built to accommodate a wagon and to fulfil other minor storage needs. It consists of one room with no dividing walls or screens. In its simplest form it is just big enough for one wagon. In a drawing (dating back to the early 1860s) of the mission station Botshabelo, near Middelburg (Mpumalanga Province), a structure that seems to be a wagon shelter, appears behind the old parsonage (figure 6). It is located at the same site where a ‘waenhuis’ and stables were later erected. It is a vaulted structure with a timber frame covered

with either grass mats or thatch. It is open at the gable ends. Although it occurs on a mission station of the Berlin Mission Society (1864-1978) and not on a farm, it is worth mentioning as an example of a type. Without generalising, one would like to believe that the example on the drawing is not an isolated case and that similar structures occurred on farmsteads elsewhere in the vicinity or the region.

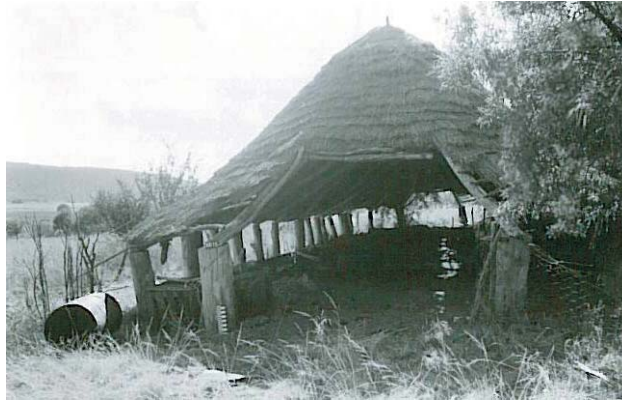
Figure 8

Entrance to a large timber frame shed with entrance cut-back to allow a wagon to enter, Waterberg region, ca. 1986 (photograph: Ditsong National Museum of Cultural History, Pretoria).

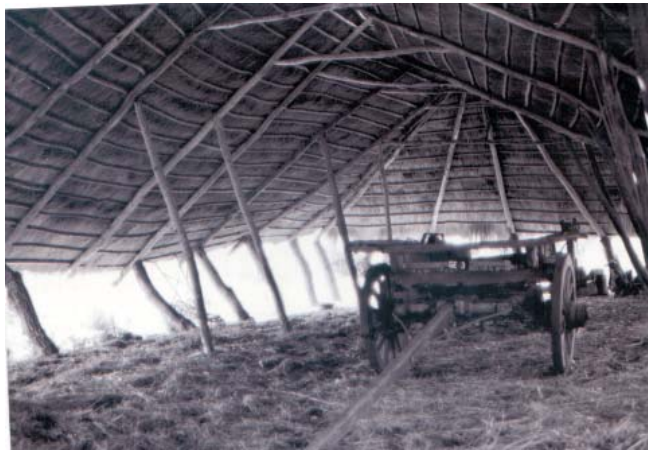
Figure 9

Interior of a large timber frame shed with thatched roof. The timber supports have been pushed outwards due to the lack of horizontal support (tie beams) of the roof structure, ca. 1986 (photograph: Ditsong National Museum of Cultural History, Pretoria).

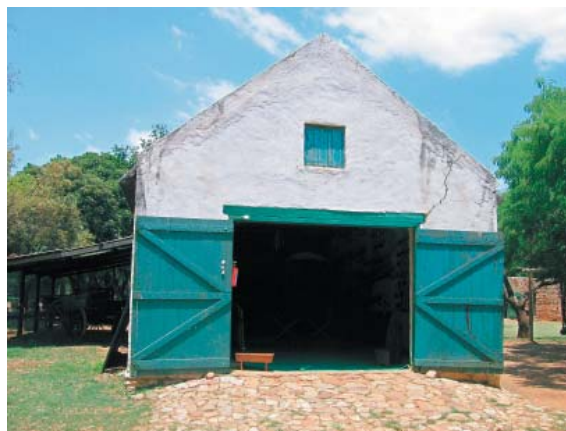
Figure 10

Reconstructed ‘waenhuis’ on historic farmstead on the farm Hartebeestpoort, Pretoria east (photograph: M. Naudé)

One example was the reconstruction of the 'waenhuis' (figure 10) on the farm Hartebeestpoort (Silverton, Pretoria) when (in 1994) it was decided to reconstruct the 'waenhuis'.¹ It is unknown when it was demolished and by whom. The only remains visible on the surface, was a cobblestone floor of about 2,5 m by 2 m. It was assumed that it formed part of the original 'waenhuis'. This cobblestone floor was used as point of departure for an extensive archaeological excavation to expose the foundations of the original 'waenhuis'. When the detail of the excavations were recorded, what remained to be done was to combine the existing published and unpublished information on 'waenhuis' in the Transvaal with the archaeological data to create an academic reconstruction of what the building could have looked like.² It was soon realised how little information existed on the topic. The objective was to design a building that resembled the architectural characteristics of the existing (old) buildings on the site and not to simply replicate another building from a different region and era.

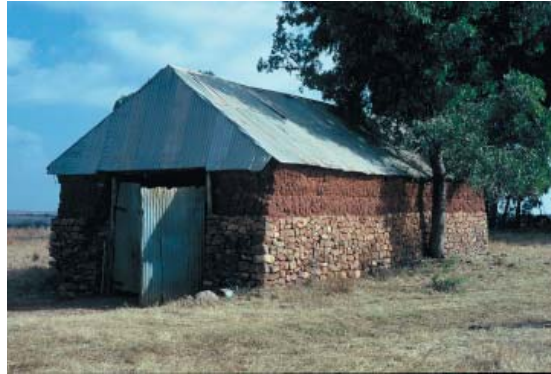
Figure 11

Large 'waenhuis' on the farm Rietvlei in the Potchefstroom district (Northwest Province) with rammed earth walls based on a foundation of dolomite stone (photograph: Ditsong: National Museum of Cultural History, Pretoria).

On the farm Rietvlei in the Potchefstroom district the lower half of the building's walls was constructed of stone and the upper half with moulded clay (figure 11). The stone part of the wall is an extension of the foundation ending in a plinth for the clay walling. The building is still used and is big enough to accommodate about six wagons. According to the owner of the farm, it always had an iron roof, but the date of construction is unknown.²³

On the south-eastern Transvaal Highveld, stone was the building material most often used and many 'waenhuis' were completely built with stone.²⁴ Sandstone, ferricrete ('oukclip') and granite were common. On the farm Bosmansfontein in the Middelburg district, the 'waenhuis' was constructed with blocks of ferricrete ('oukclip') as are most of the other outbuildings on the farmstead. On the farm Rietvlei in the Potchefstroom district, the waenhuis was partially constructed with dolomite masonry (figure 11).

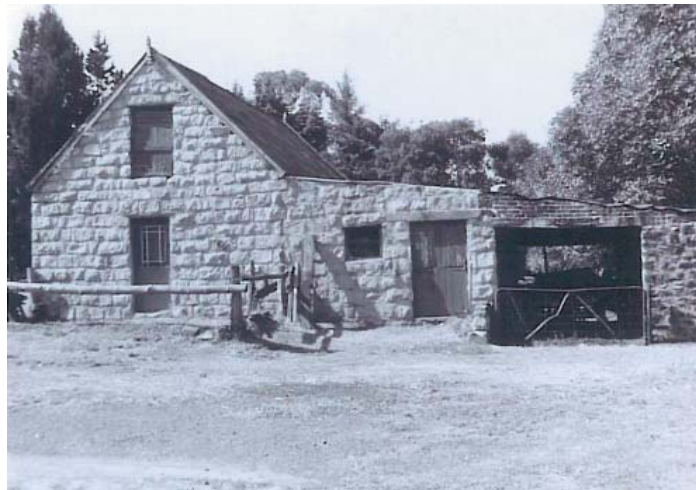
Figure 12

Sandstone 'waenhuis' (main entrance at the back), which later became a farm school on the farm Roodepoort, Middelburg district (Mpumalanga Province) ca. 1990 (photograph: M. Naudé).

On the farm Roodepoort (Middelburg district, Mpumalnga Province), the ‘waenhuis’, which is a fine example of a dressed sandstone building, was first used as a (farm) school and later (1995) housed the owner’s (the original landowner’s son) private collection of old farming implements (figure 12). This had little impact on the building except that an old style two panel door with coloured glass at the top (associated with the front doors of dwellings between 1880 and 910) was installed at the gable end. The ‘school’ cum ‘museum’ eventually became the core building for two lean-tos added to the east. They were used as stables for calves.

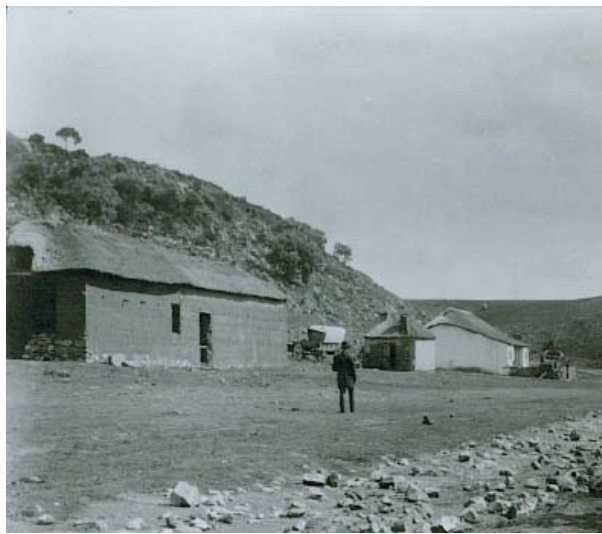
Figure 13

‘Waenhuis’ on the farm Orange Grove with rammed earth walls with dwelling and detached outdoor kitchen in the back, ca. 1890 (photograph: Gross Collection, Ditsong: National Museum of Cultural History, Pretoria).

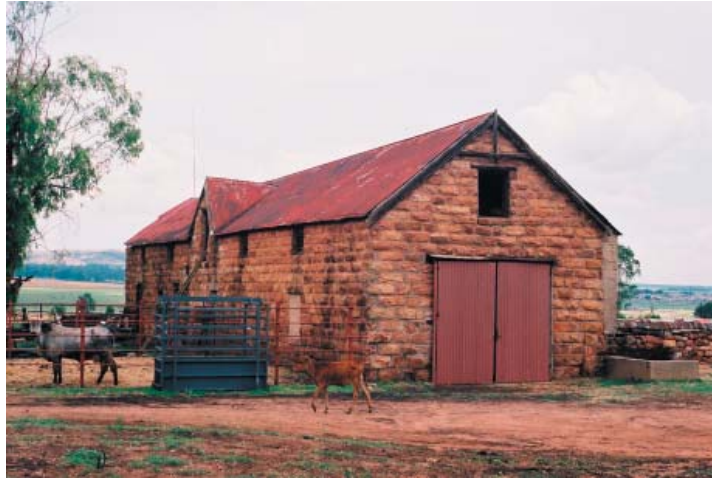
Figure 14
Sandstone ‘waenhuis’ and stables (for horses) on the farm De Rust west of the town of Heidelberg (Gauteng Province) (photograph: M. Naudé).

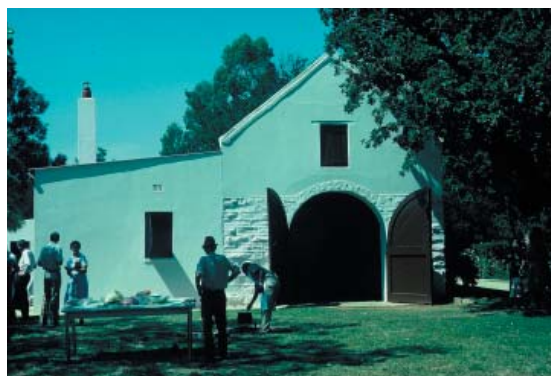
Figure 15
‘Waenhuis’ attached to the 1880 farm dwelling on the farm Kaalfontein - Rayton district (photograph: M. Naudé).

On the farm Kaalfontein (Rayton district), the dwelling was constructed first and the ‘waenhuis’ added later (figure 15). The ‘waenhuis’ has a single entrance and is constructed with stone while the dwelling was constructed with bricks. Although both have lofts they are not connected and the two buildings functioned separately. A separate staircase from inside the ‘waenhuis’ leads to the loft. The entrance (for the wagon) is located at the gable end of the ‘waenhuis’ section of the building and opens onto the farmyard leaving the front yard (Afrikaans: ‘voorplaas’ - to the south) and the backyard (Afrikaans: ‘agterplaas’ - to the north) accessible for other household activities. The original farmyard was entered from the west exposing the side elevation of the dwelling and the entrance to the ‘waenhuis’ to the principal (historic) entrance onto the farmyard. On the farm Kafferskraal, also in the Rayton district, the ‘waenhuis’ and farmhouse share the same roof. The position of the ‘waenhuis’ is not easily recognisable from outside as both are built with plastered bricks.

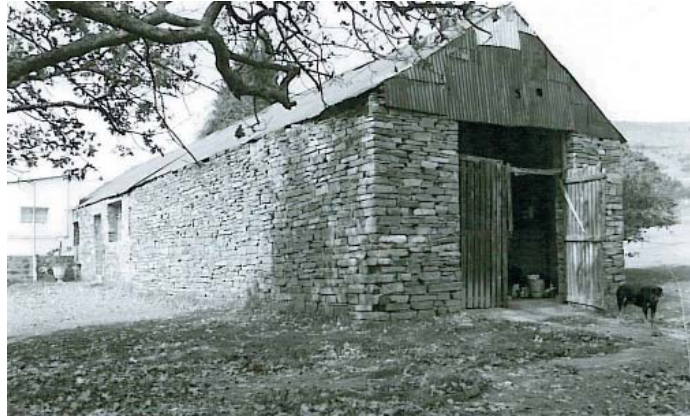
Figure 16

The ‘waenhuis’ on the farm Doornhoek is attached to the farm dwelling, Pilgrims Rest district - Mpumalanga Province (photograph: Ditsong: National Museum of Cultural History, Pretoria).

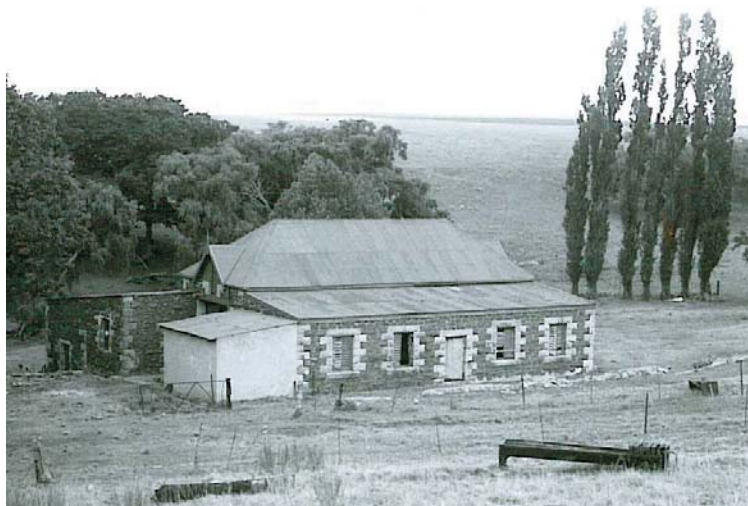
Figure 17

Granite and sandstone dwelling with ‘waenhuis’ located in the centre, on the farm Uitkomst in the Ermelo district – Mpumalanga Province (photograph: Ditsong: National Museum of Cultural History, Pretoria).

On the farm Uitkomst in the Ermelo district, the ‘waenhuis’ is located in the centre with rooms along its sides. The ‘waenhuis’ and the adjacent rooms were built at the same time and no rooms were added later. The building was constructed with granite with sandstone quoining. The ‘waenhuis’ section has a hipped roof with a dormer-like loft door directly above the ‘waenhuis’ entrance. The roofs on the adjacent rooms are almost flat resembling those of a typical lean-to.²⁷

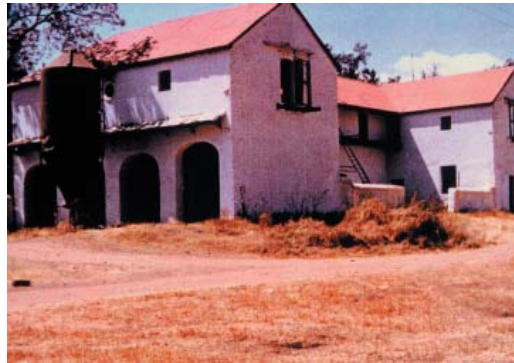
Figure 18
Horse stables and cart shed on the farm Zwartkoppies (Pretoria) erected ca. 1886 (photograph: M. Naudé).

The cart shed on the farm Zwartkoppies³⁰ (east of Pretoria) has no resemblance to the ‘waenhuis’ associated with Boer families. The building is located about 100m from the main house, opposite the cow byres. It is a double storey building and the carts shared the same roof with the horse stables. It does resemble the form, scale and space utilisation patterns of those in Great Britain. The Zwartkoppies example was erected in the period 1899 to 1895 and contains several spaces designed for carts but these spaces are smaller than those for ‘waenhuis’. All the entrances are arched.
