**CHAPTER 1****INTRODUCTION**

### 1.1 BACKGROUND TO THE PROBLEM

### 1.1.2 Slope failures in complex geotechnical conditions

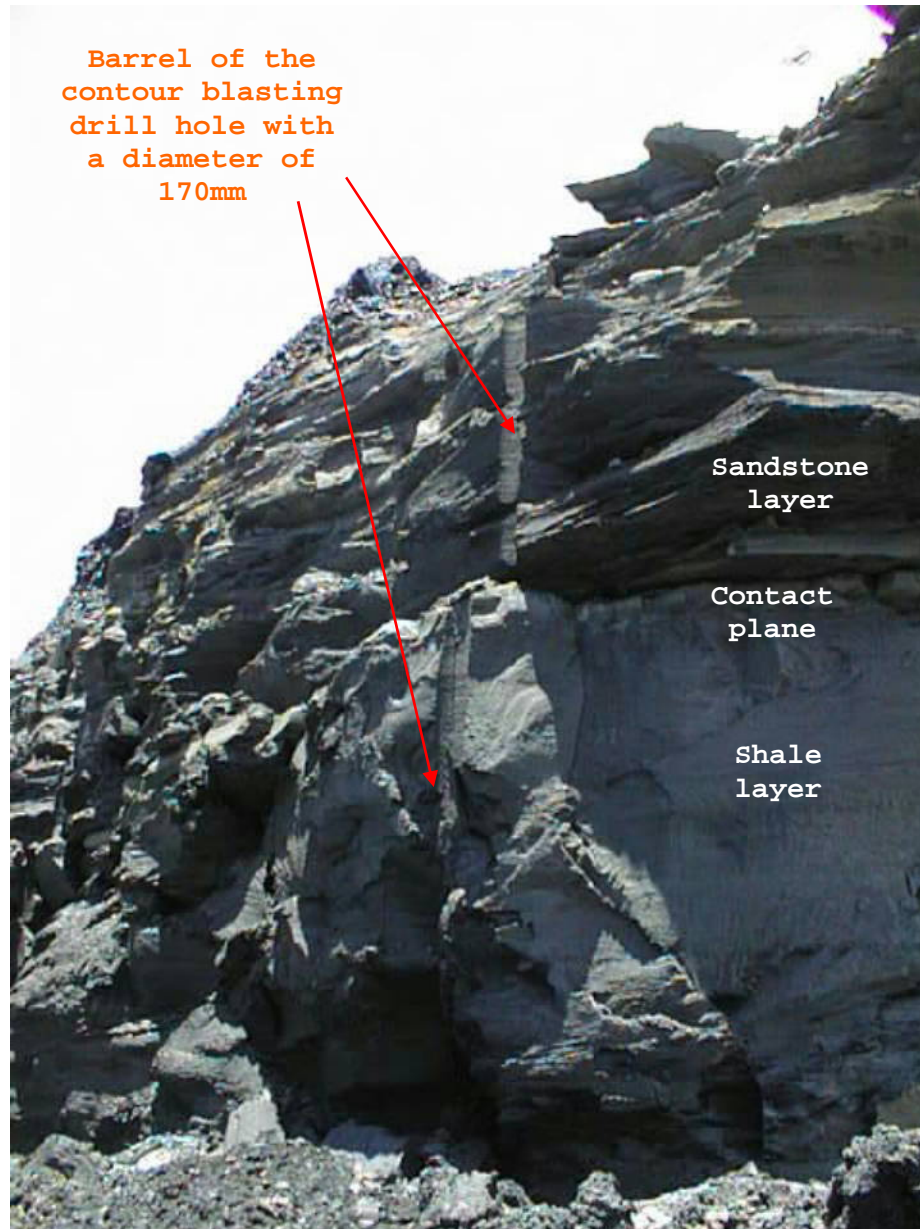
Picture 1.1

Shale swelling exposed at the toe of slope in gently inclined strata (strata inclined at  $5^{\circ}$ )

The author has experience with slope failures that have taken place in South African coalfields. Some coal mines exploit uneven seams in undulated strata, where slope failures exhibit the passive wedge mode as shown on Figure 1.1. The author's observations were that the most common effect of faulting in such a situation was the provision of a rear release plane, frequently with associated adversely dipping strata. In almost all of the cases, a relatively weaker layer was embedded in the profile and exposed at the toe of the slope. In almost all of the cases the weaker layer was shale. In the areas with almost flat strata it is usual to have swelling in such a shale layer, as can be seen on Picture 1.1.

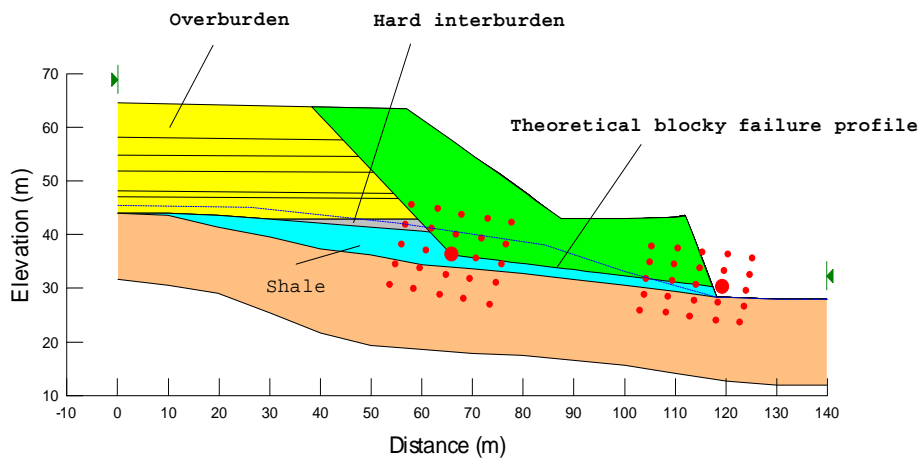
Figure 1.6

POSSIBLE BLOCKY TYPE OF FAILURE BEFORE MAJOR COLLAPSE

Theoretical failure profiles for final major slope collapse after the initial failure had been cleared- Pit A-1 (note lower slope angle in sandy overburden)

The major collapse followed the cleaning operations that took place after the initial failure, when the slope profile had a lower slope angle than it had prior to failure (compare Figures 1.5 and 1.6). The major failure indicates a multi-planar or blocky type of failure, but the applied block-specified technique used for the FOS calculation was not successful, because the calculated FOS value was higher than unity. SLOPE/W outputs are shown in Figure 1.6. Mine plans did not show any underground mining activities in the area underneath the failure.

to approach the toe of the slope (see Figures 1.6b and 1.8b).

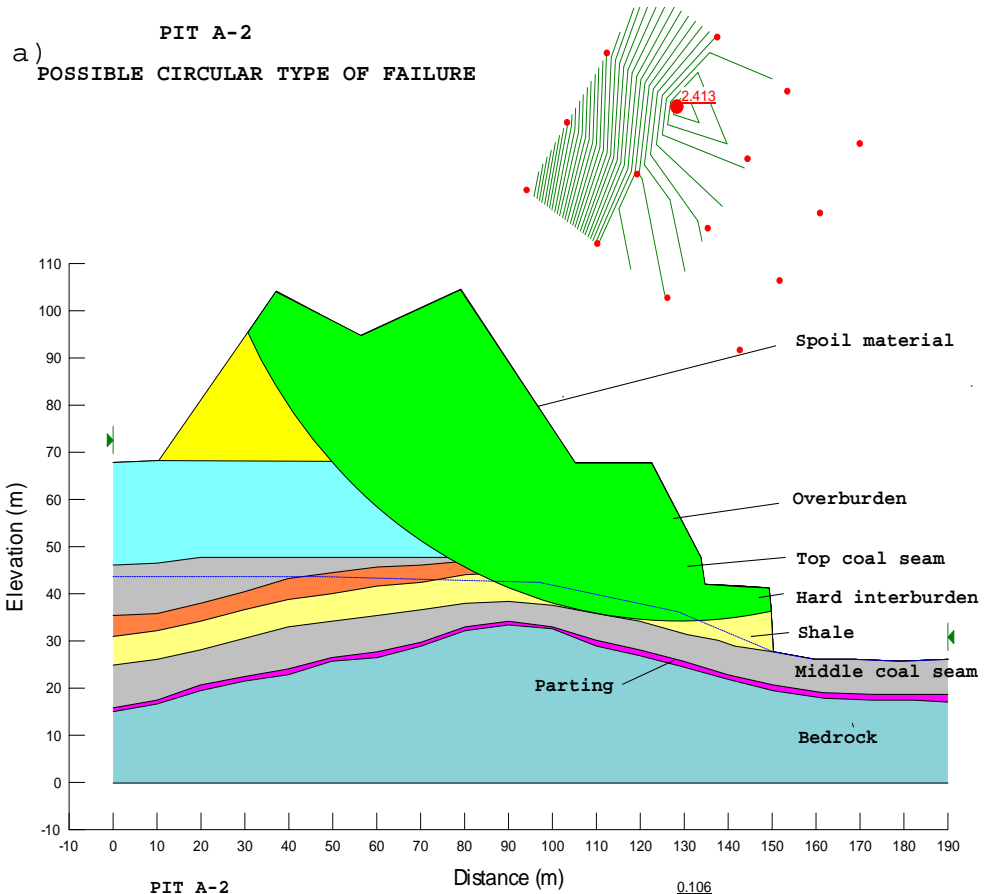
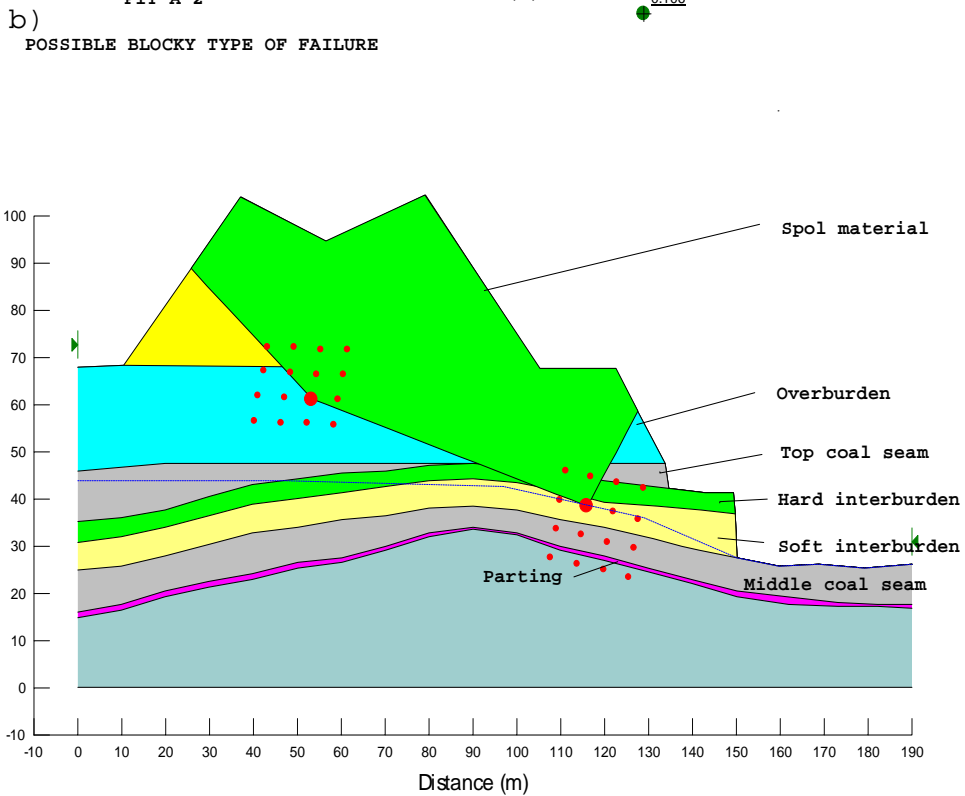
Possible circular (a) and blocky (b) type of failure at Pit-A2

The second slope failure took place in Pit "A-2" of the same colliery. Figure 1.7 presents the slope profile before and after the failure, while Figure 1.8 shows possible failure mechanisms. Spoils with heights of 20m to 25m were dumped at a distance of approximately 20m behind the slope crest. Any joints that might have triggered wedge failure were not observed in the area.

After the cleaning operations, the failure surface was clearly observed on the contact between the soft interburden and the middle coal seam (Figure 1.9) which had an average dip angle of  $16^{\circ}$  towards the pit. The estimated FOS for the circular type of failure (Figure 1.8a) was between 2.4 and 2.6 depending on the method of calculation (Ordinary, Bishop, Janbu, Spencer or Morgenstern-Price).

The blocky type of failure (Figure 1.8b) had a lower FOS for the profile, varying between 0.2 and 1.2. From these results and the derivative profile of the failure mass the author concludes that the failure must have been of a "blocky" type. As with the previous slope failure example in Pit A-1, there are problems with the application of the "Block Specify" in SLOPE/W because of the complexity of the slope profile. For instance, one of the most reliable calculating techniques, namely the Morgenstern-Price method, for blocky failure calculations, gives a very low safety factor value (FOS=0.11 to 0.14). The other methods, such as the Janbu and Bishop indicated slightly higher safety factors around FOS=0.15, while the Ordinary method

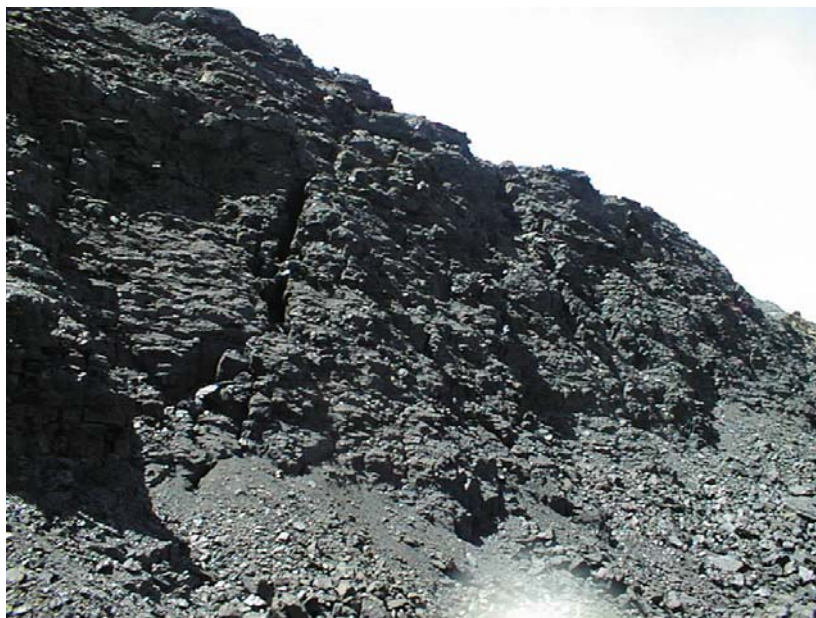
Face of the failed slope profile in Pit A-2, which does not indicate any significant structural damage to the shale

Picture 1.2 shows the front side of the failed blocks for the second slope failure. There is no significant structural damage, despite the fact that the material is shale, which had been thrust forward some 20m. The location of the picture is shown in Figure 1.7. If there were any joint sets which might have triggered wedge failure, and which were missed by the author, then the downward movement of the spoil material and almost horizontal movements of the other points in the slope profile are kinematically impossible for the wedge failure mode. Furthermore, wedge failure cannot

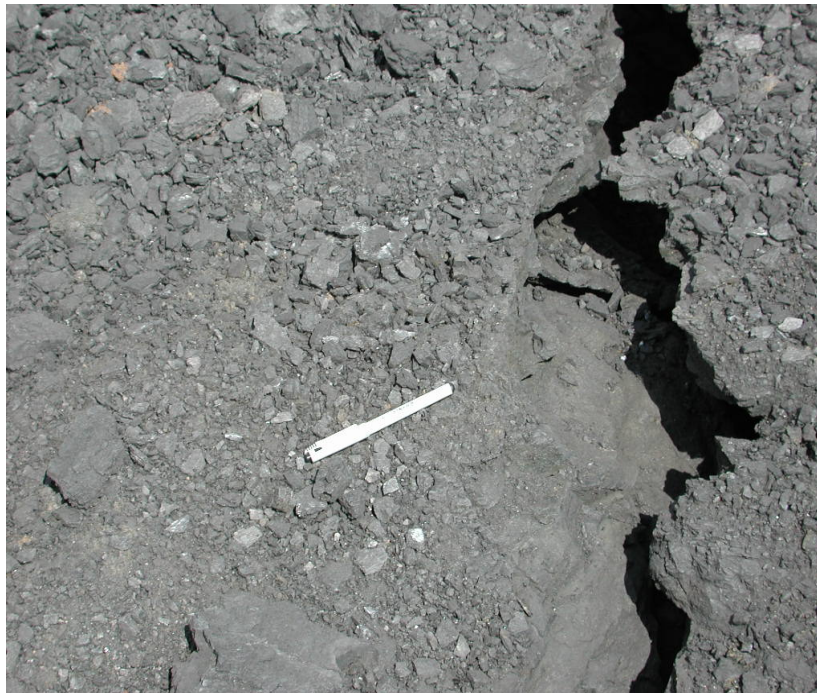
Picture 1.4

Open tension crack in the coal seam on the sheared block side (closer to the slope crest)

The failure indicated only horizontal movement toward the pit along the contact between 0.6m thick clay layer the coal seam. When the failed overburden was removed, two fracture zones could be seen in the coal seam (Picture 1.3) - a shear zone and a tensile zone. Pictures 1.4 and 1.5 are detailed pictures taken at the shear and tensile zones respectively. Measurements of the slope profile before and after the failure were not made available to the author, so no further analysis of this failure is possible in the thesis.

The fourth feature common to the failures is the presence of almost vertical tensile fractures (indicating tensile failure) above the crest of the undulated strata formations. These fractures are often difficult to see because they are usually covered by debris but, whenever access is available, for example after cleaning operations (as in Picture 1.3), they can be seen. In this case, it appears that tensile fractures may have persisted from surface behind the slope crest, into the middle coal seam.

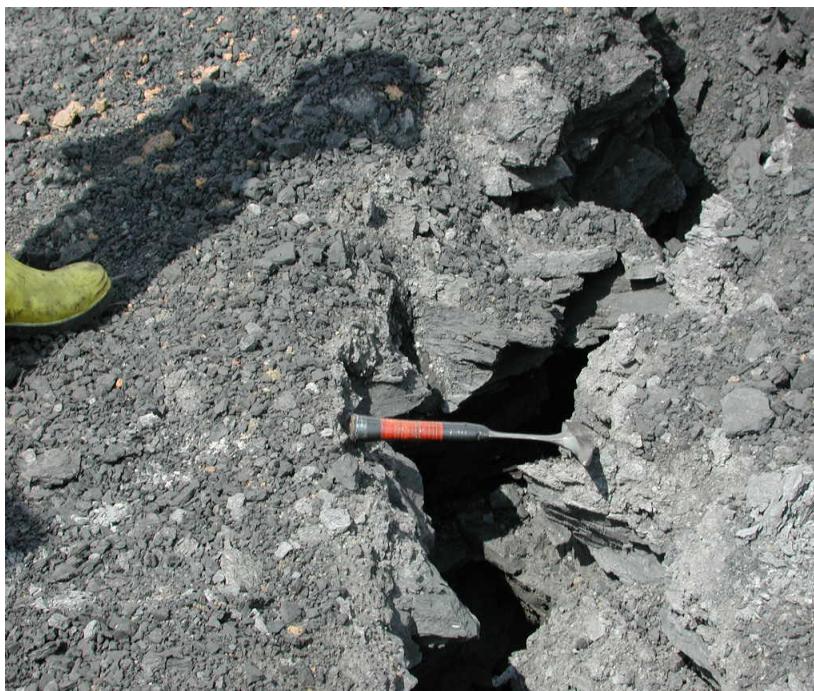
Picture 1.5

Tensile type of failure at the coal seam on the sheared block side, further from the formation crest
