CHAPTER 7

HEAVY VEHICLE SIMULATOR TESTS ON CEMENT-TREATED BASES

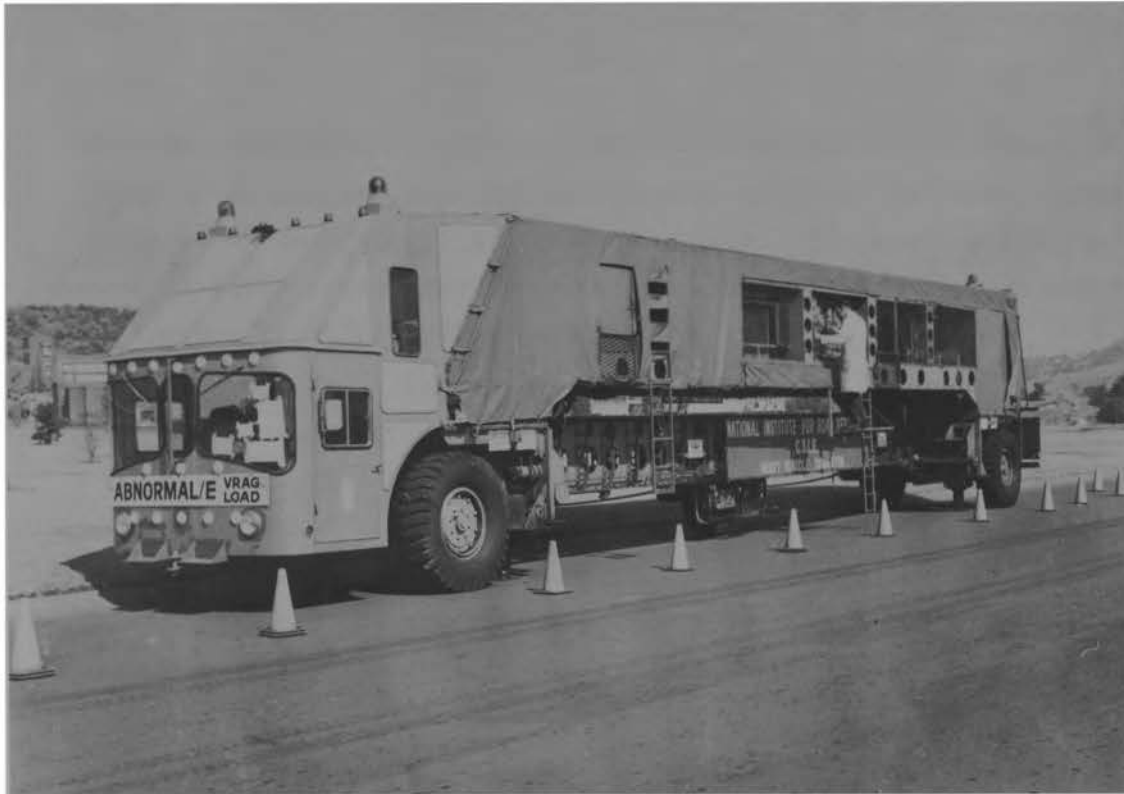
FIGURE 7.1
The heavy vehicle simulator.

Overall view

Chain drive on test wheel

The first Heavy Vehicle Simulator (HVS) (Van Vuuren, 1972a and 1973) (Figure 7.1) was commissioned during early 1971. Since then it has been used to simulate the action of heavy vehicles on various types of pavement, which included untreated crusher-run bases, upside-down designs and cement-treated bases. To date no HVS tests have been performed on cement-treated natural gravel bases or on any lime-treated materials. A total of 24 HVS tests was completed in the 5 years between March 1971 and March 1976.

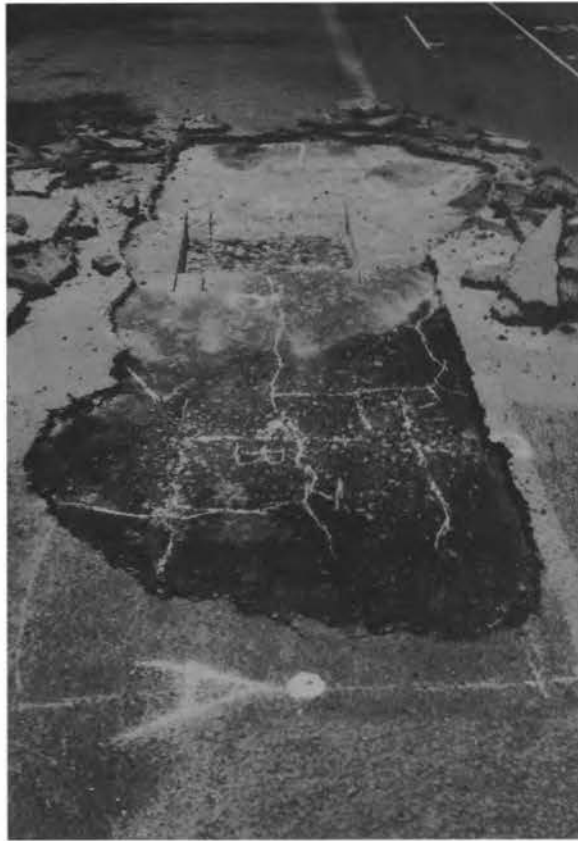
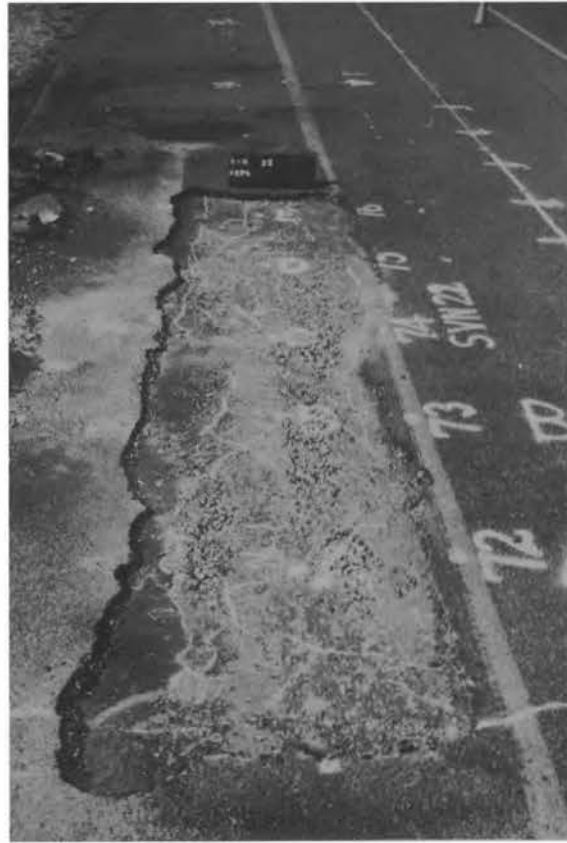
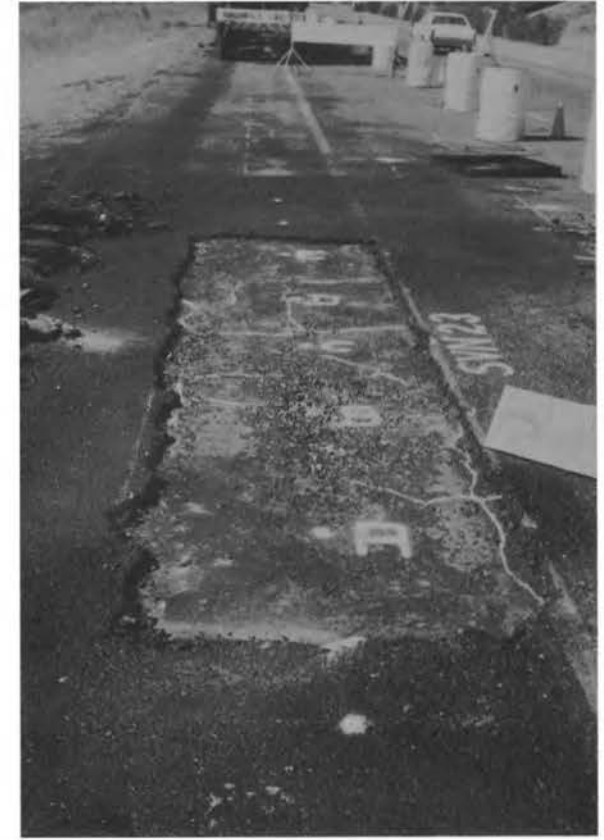
FIGURE 7.5

Site 1

Site 2

Site 3

Condition of test sites after asphalt surfacings were removed. Cracks in base were marked with white chalk lines.

Cracking: There were only a few visible cracks on the surface after the completion of trafficking on the three sites. This may be because of the concentrated traffic and some oil and diesel fuel spillage resulted in them being closed. The 25 mm surfacing was removed and the visible cracks in the base were marked with white chalk lines. There were several cracks in the base and these can be seen in Figure 7.5. On site 1 point A was crack-free, the area around point B was cracked into 100 mm square blocks and another major crack occurred between points D and E. Severe pumping occurred during the test, and the circle on the right-hand side of the picture, at point E, shows an area that pumped extensively. All the test points on site 2 had a fair amount of cracking and loose stones were found on the surface of the cement-treated crusher-run base. This could have been caused by the trafficking or they could be rough areas which came about during construction when the stones on the surface of the base were not properly compacted and cemented. Site 3 had a rough area with loose stones around point B, some cracking at points C and D but very little visible cracking at points A and E.

Test site 2 had a fair amount of cracking and these cracks appeared to be very well distributed over the site (Figure 7.5). Figures 7.8 and 7.9 seem to confirm the assumption of relative homogeneity for this site since the plots of recorded deflection and radius of curvature at the 5 test points are very much the same. The elastic modulus of the cement-treated layer (E_2) was reduced to below 1 000 MPa and this was confirmed when three 600 x 600 mm block samples were sawn from the pavement after completion of the test. The samples were removed at test points C, D and E and schematic drawings of the cracking patterns at the bottom of the cement-treated crusher-run base can be seen in Figure 7.10. These drawings confirm that the cement-treated layer was in fact cracked into little pieces, especially at test points D and E, and that its elastic modulus would be of the order of about 1 000 MPa.

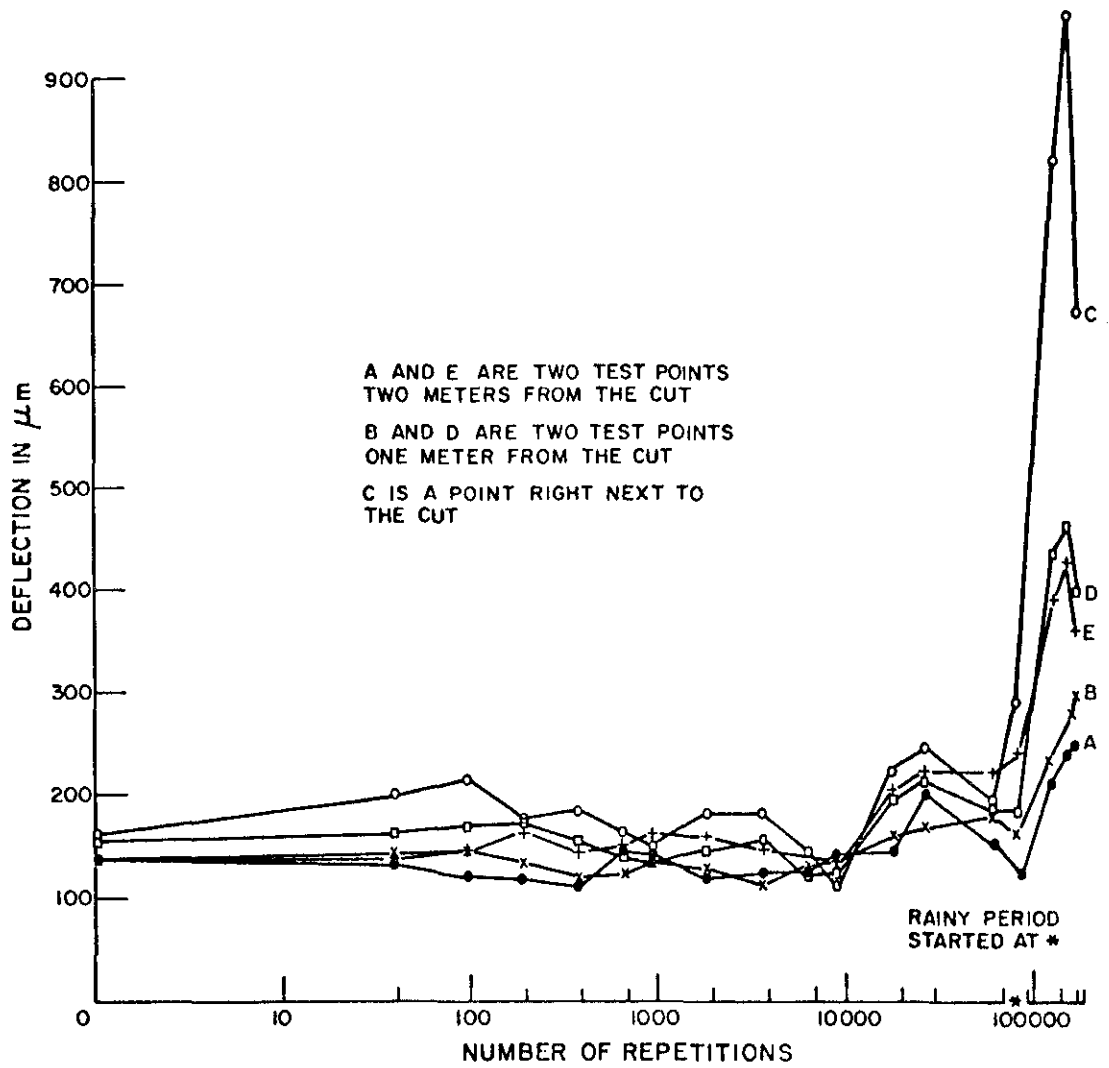
The surface deflection versus number of repetitions are reproduced in Figure 7.14. During the first 93 000 repetitions of the 55 kN wheel load the deflection at the saw-cut (point C) increased at the same rate as at the other four points. During the following 82 000 repetitions (from 6 October 1975 to about 25 November 1975) 142 mm rain fell and the deflection at point C increased rapidly to about 960 μm . From this figure it

FIGURE 7-14
EFFECT OF RAIN ON SURFACE DEFLECTION
NEXT TO A SAW CUT

appears that a wide saw-joint, and for that matter any crack, would have very little effect on the surface deflection of this road, provided the water could be kept out of the pavement. As soon as rain fell water could easily penetrate through the 5 mm cut, it apparently softened the lower layers (mainly the crusher-run), the elastic modulus was reduced and the deflection increased rapidly.
