CHAPTER 4

4. INVESTIGATING THE EARLY THERMAL BEHAVIOUR OF ROLLER COMPACTED CONCRETE IN LARGE DAMS

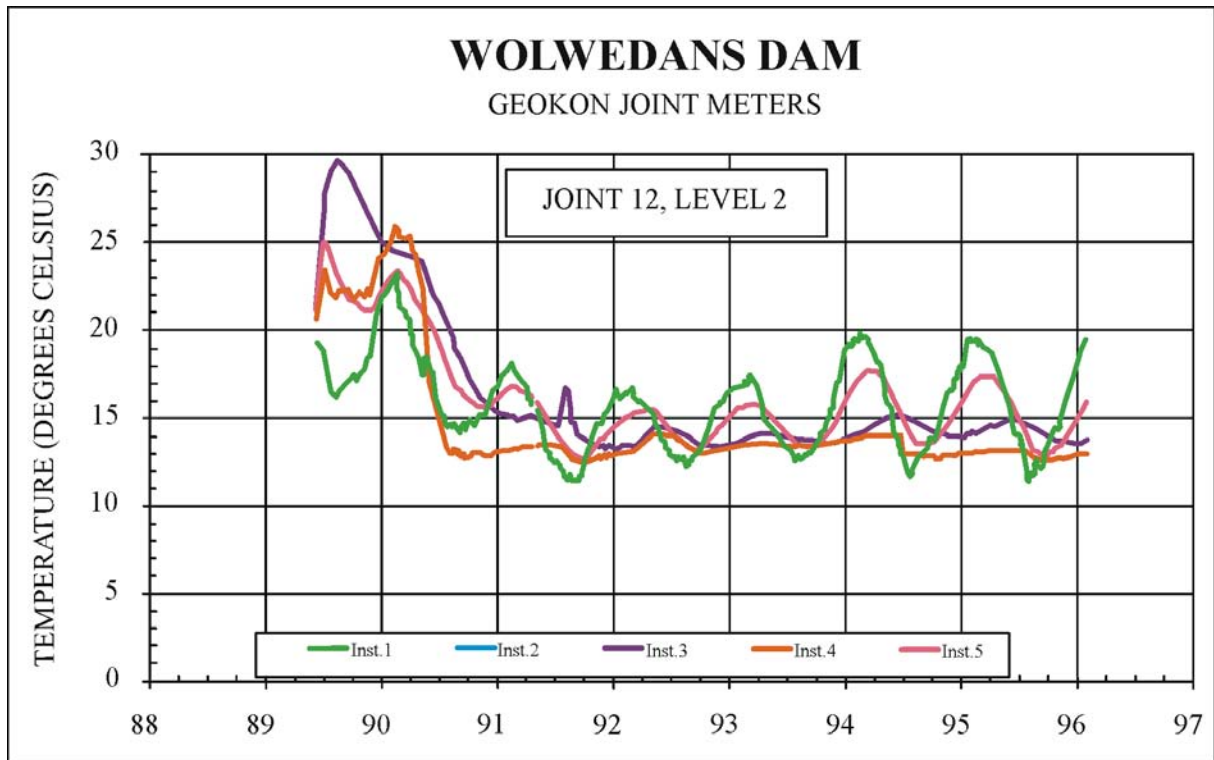
Figure 4.2: Temperatures on LBSGTMs at RL 52.25 m^(1 & 2)

In July 1993, the temperature in the core of the dam at RL 52.25 m was fractionally below 14°C, approximately 7°C below the placement temperature, or 16°C below the peak hydration temperature. The total joint opening translates into approximately 40 microstrain, suggesting that some closure of the induced joints must have occurred as a result of the water loading, whether, or not any creep of the RCC had occurred.

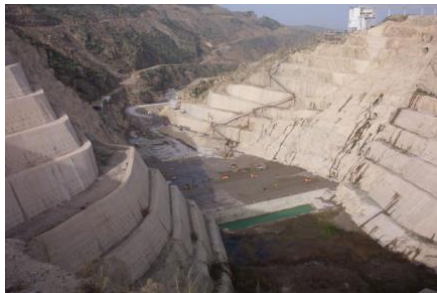
**Plate 4.1: January 2005 –
El 147.50 mASL**

Instruments were installed at three elevations; 147.50 mASL in October 2005, 184.25 mASL in November 2007 and 208.50 mASL in November 2008 respectively. A final set of instruments was installed at elevation 232 mASL in November 2009⁽⁵⁾.

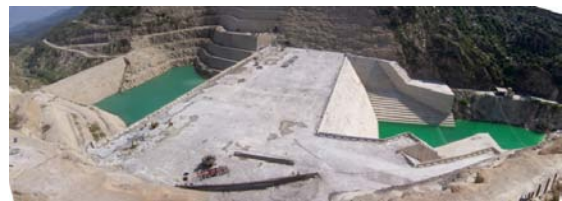
Plate 4.2: April 2007 – El 187 mASL

A comprehensive thermal analysis was completed for Çine Dam, with the initial 2005 exercise being supplemented with an evaluation of a possible continuous placement of the top 55 m of the structure in 2008. The placement of the RCC for Çine Dam will be completed during 2010 and the dam has been constructed in a series of 6 winter-season placements, which started in 2004/2005.

With placement initiated in October/November each year, a total of approximately 300 000 m³ was placed by the following March/April. Thereafter, the structure was left exposed until the following winter placement season. The

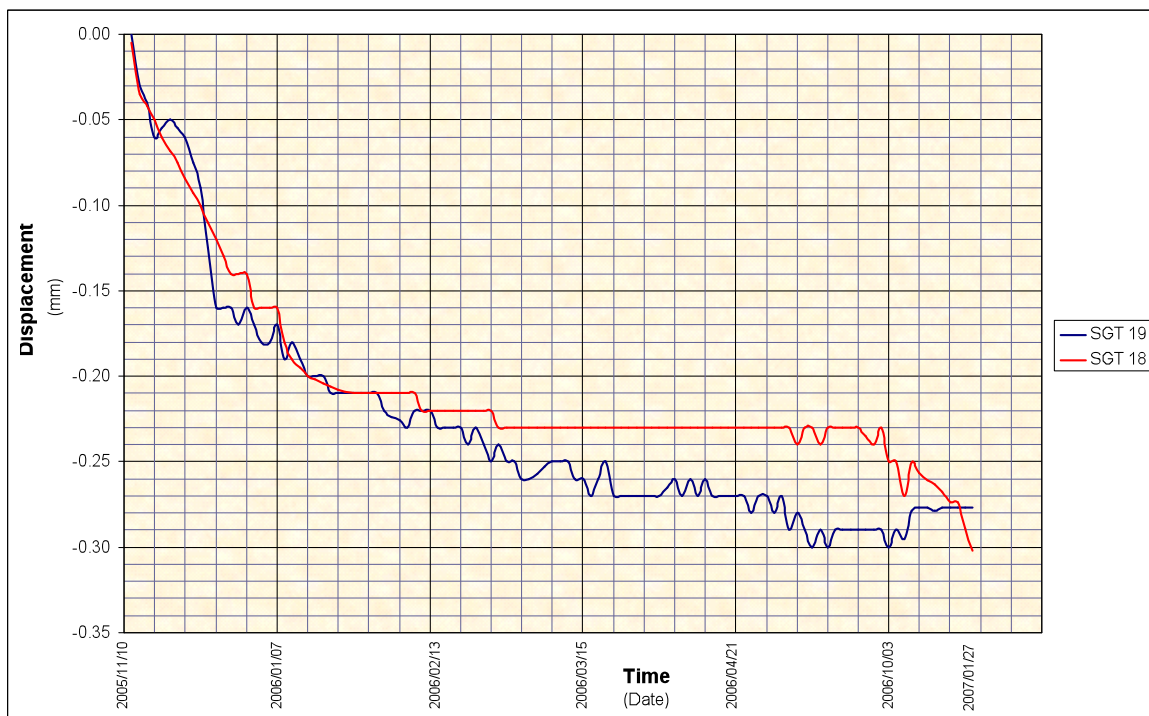
Figure 4.17: Typical Joint Deformation History for SGT Instruments⁽⁵⁾

In relation to strain, the SGT gauges demonstrate compression displacements (**Figure 4.17**) that increase linearly over the first two months after installation followed by an additional 2 months of displacement increasing at a reduced rate. Thereafter, the displacements remain essentially constant. The displacement behaviour of the RCC measured on the gauges can accordingly be seen to follow directly the hydration temperature development. Typical maximum compression displacements vary between 0.11 and 0.50 mm, with an average of approximately 0.28 mm, which translates to 280 microstrain over a gauge length of 1000 mm.

It was initially considered anomalous that compression strains of 250 to 280 microstrain should be indicated on the SGT gauges for a typical hydration temperature rise of 14°C. While lower strains could be anticipated in the direction of the dam axis, as the body of the wall is restrained within the foundation, expansion, as opposed to contraction would be anticipated, corresponding with the expanded materials volume associated with increased temperature.

The evident contraction across the LBSGTMs can, however, be explained by the fact that the meters are located on the induced joint, immediately above a crack director (which are installed in every 4th layer). The method of construction of these induced joints effectively causes them to act, to a minor extent, as compressible expansion joints, as discussed in Chapter 2. While the process of roller compaction results in the development of horizontal restraining stress within the RCC, this stress is broken as the induced joint faces are opened to facilitate the insertion of the de-bonding plate. On completion of the induced joint construction, some capacity to absorb expansion of the adjacent RCC is developed. This is also considered to be the reason for the scatter of the applicable compression strain values evident on the SGT gauges, when compared with the strains indicated on the SGA gauges.

As the temperature in the dam rises during the process of hydration, the resultant restrained expansion will cause compression across the dam wall structure between abutments. With more ability to accommodate contraction across the induced joint than in the remainder of the RCC, a disproportionate part of the thermal expansion of the RCC will be taken up in contraction across the induced joint, while the balance will be experienced as compression in the RCC. Ignoring autogenous shrinkage, a 14°C temperature increase would give rise to a strain of approximately 120 microstrain, as indicated on the SGA gauges. At 1.5 to 2 months age, the long-term RCC deformation modulus might be 10 to 12 GPa, suggesting a restrained compression stress of a little over 1 MPa.

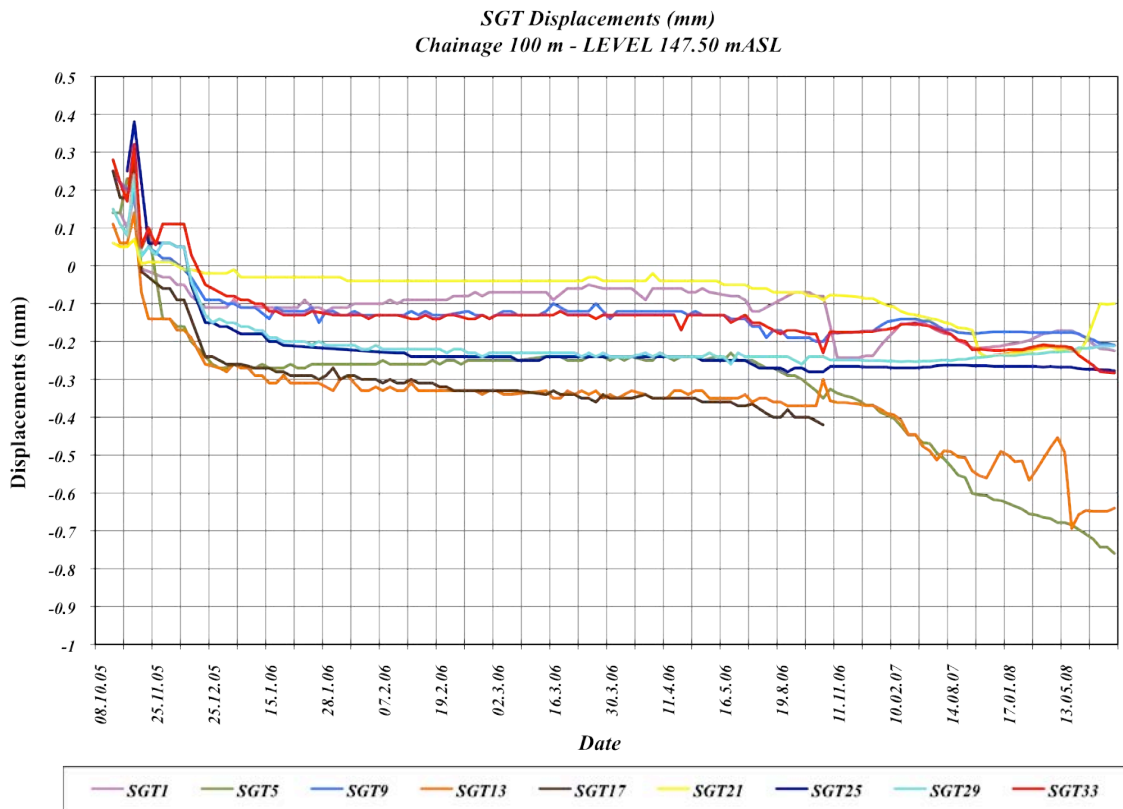
Figure 4.22: Displacements on LBSGTMs (SGT) at El 147.5 m - Ch 100 m⁽⁵⁾

At El 147.50 mASL, the joint closure measured across the LBSGTMs apparently generally peaked at 0.40 mm at maximum hydration temperature. Over an instrument length of 1 m, this represents a strain of 400 microstrain. For a hydration temperature rise of 11°C, this would translate directly into a thermal expansion coefficient of approximately $36 \times 10^{-6}/^{\circ}\text{C}$, which is obviously rather improbable. Furthermore, while the effects of the increase in temperature during 2008 are evident, the problem with the instrumentation readout unit cloud any real quantitative analysis. However, the fact that a 1°C temperature rise might result in compression across the induced joints of the typical order of 0.02 to 0.04 mm again suggests relatively linear-elastic behaviour.

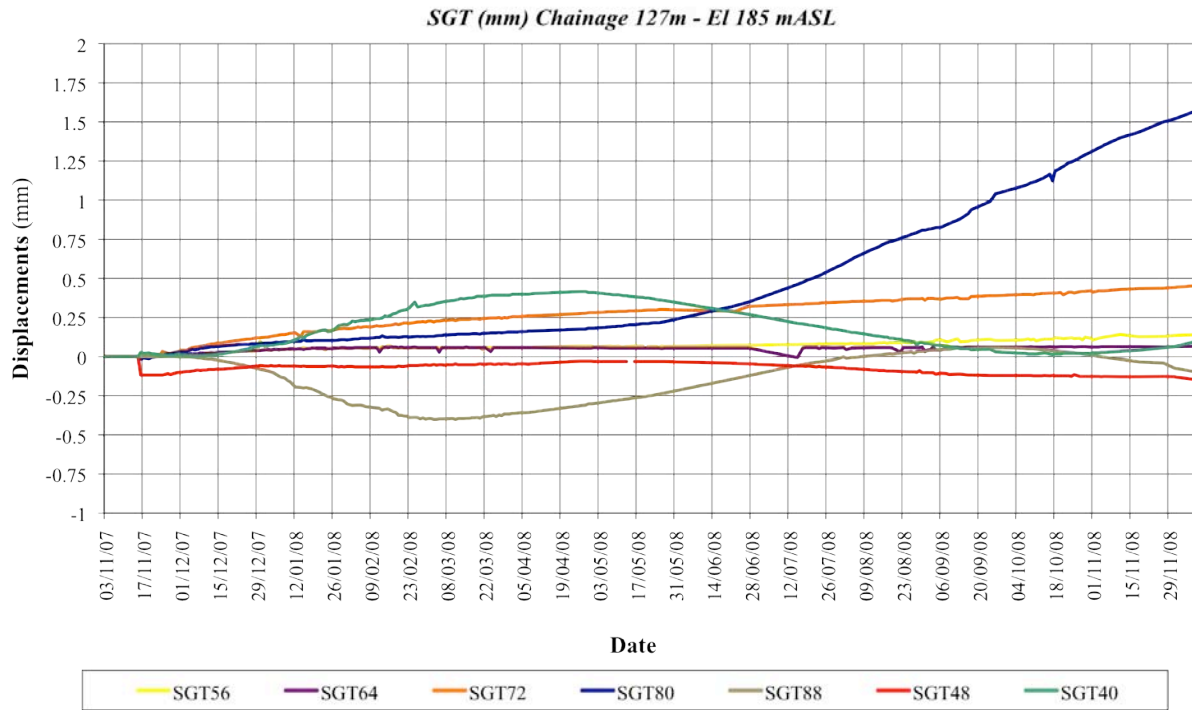
Figure 4.27: Displacements on LBSGTMs (SGT) at El 185 m – Ch 127 m⁽⁵⁾

The SGT gauges at Chainage 127 m indicate some strange behaviour. SGTs 72 and 80 suggest that a significant crack is developing towards the downstream of the

section, but SGT 88 (closest to the downstream face) indicates exactly the opposite. SGT 40 (closest to the upstream face) indicates a crack of 0.4 mm width that opens with dropping temperature, while SGT 88 indicates a joint closure of the same order, while experiencing a greater temperature drop. It is accordingly considered that a sufficient level of confidence cannot be placed in this data and that any attempt at interpretation would consequently not be of any value.

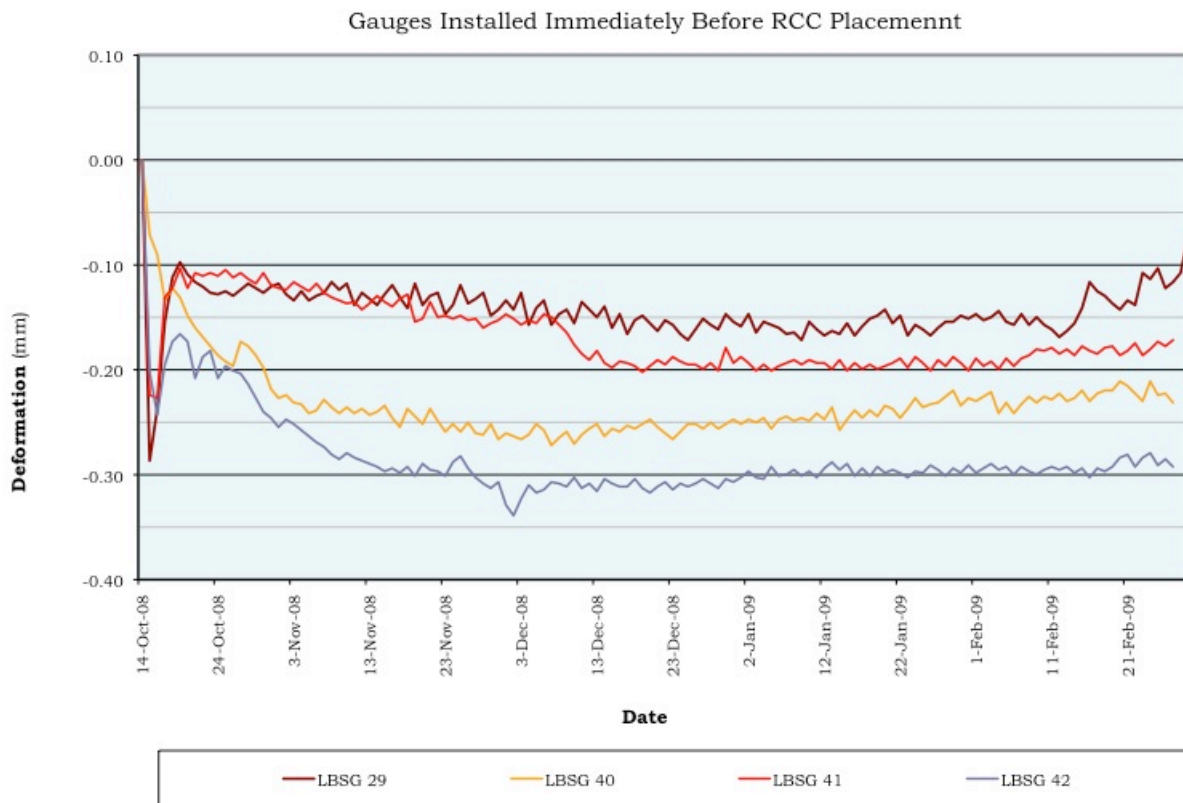
Figure 4.50: Deformations on LBSGTMs Installed Shortly Before New RCC⁽¹²⁾

The LBGTMs at El 150 mASL indicate a pattern of compression where close to the abutments and expansion away from the abutment rockmass. Similarly to the gauges at El 135 mASL, a pattern of greater compression/joint closure is evident on the gauges on the left abutment (LBSG 40, 41 & 42 on Figure 4.48), while a greater tendency towards expansion/joint opening can be discerned on the right abutment (LBSG 20 & 21 on Figure 4.48). While this situation might seem difficult to understand, it is important to take note that although the majority of the gauges, and the top of the previous RCC layer, were exposed to severe solar radiation for a period of 5 to 6 days before the cooler RCC was placed on top, four gauges at El 150 mASL were in fact installed immediately before new RCC placement. **Figure 4.50** illustrates the deformation histories for these gauges.
