CHAPTER 5

5. SIMULATING PROTOTYPE MATERIALS BEHAVIOUR THROUGH FINITE ELEMENT MODELLING FOR WOLWEDANS DAM

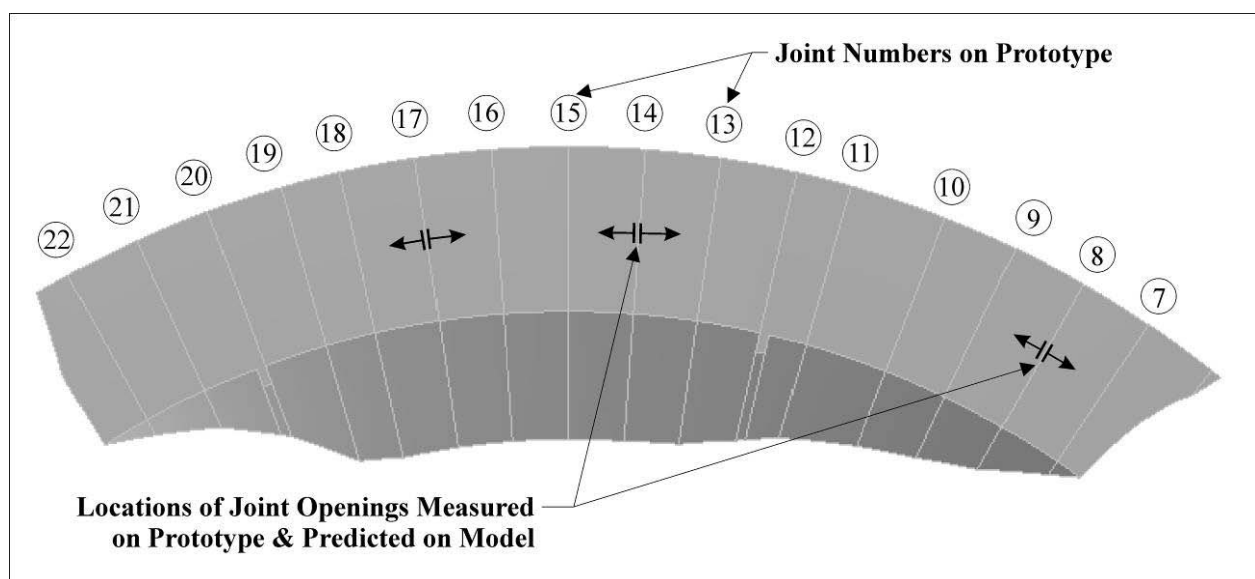
Figure 5.6: Horizontal Section through FE Model Illustrating Location of Joint Opening Reference Points

For each analysis, the opening of each induced joint was evaluated at elevation RL 66.25 m, on a local co-ordinate system, on the centreline of the dam, as illustrated on **Figure 5.6**. In addition, the level of residual stress in a direction parallel to the dam axis was reviewed in the centre of the blocks between open induced joints and in the flank zones of the structure, where no joint openings were observed.

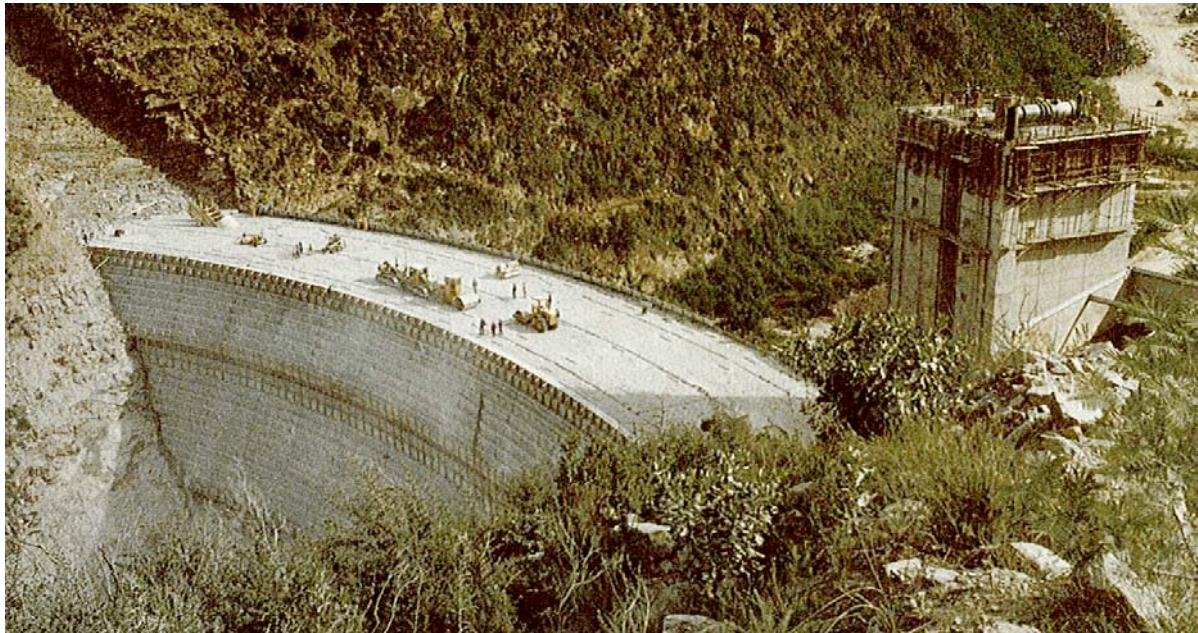
Plate 5.1: Wolwedans Dam Instrumentation Installation at RL 66.25 m

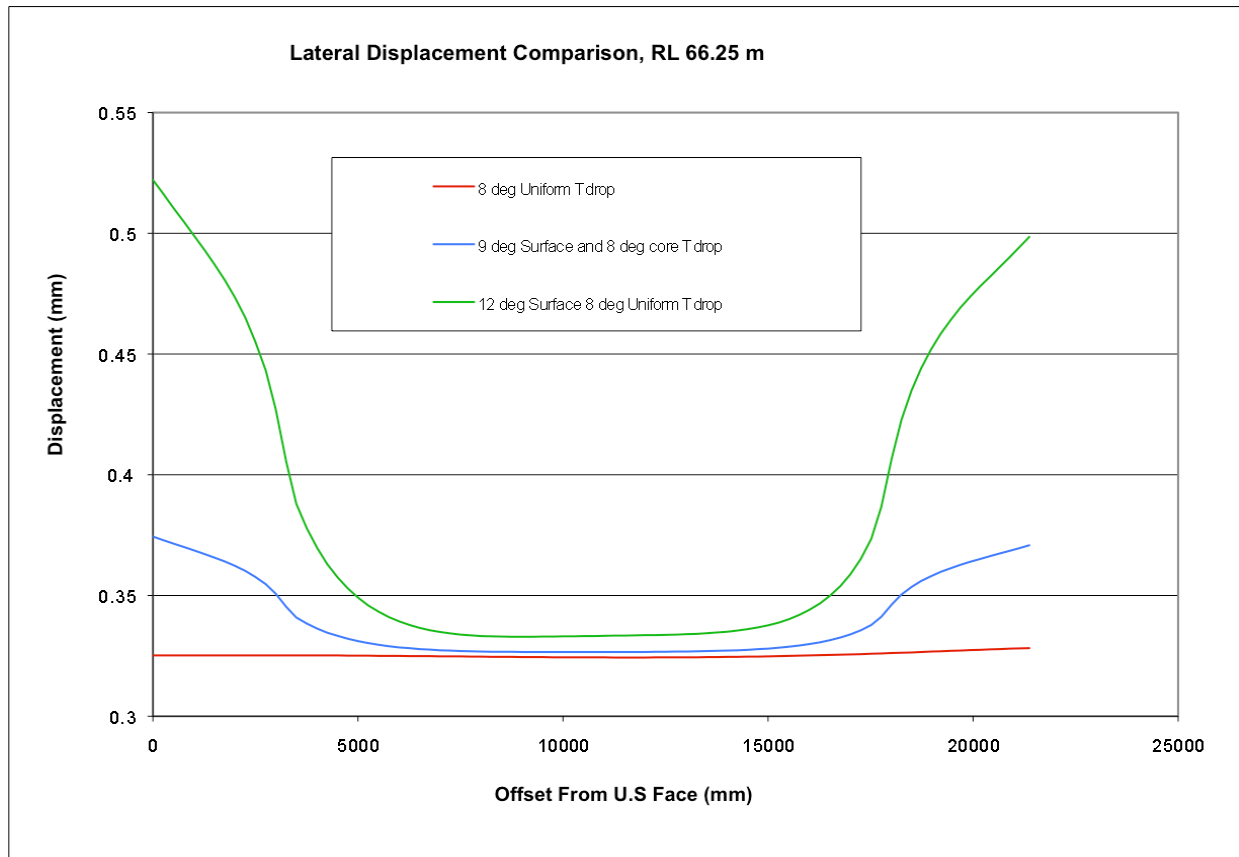
Figure 5.11: Displacement Profile for Differing Differential Temperatures

The results of this analysis, as presented in **Figure 5.11**, indicated a lateral shrinkage of approximately 0.32 mm for the 8°C temperature drop, which was locally increased to 0.37 mm with an external surface temperature drop of 9°C and 0.50 mm with an external surface temperature drop of 12°C. The 12°C temperature drop accordingly indicated an increased external zone joint opening of approximately 0.36 mm ($2 \times (0.50 - 0.32)$), suggesting that the external zone effectively experiences a larger effective temperature drop than the core zone of between 3 and 4°C. For a thermal expansivity of $10 \times 10^{-6}/^{\circ}\text{C}$, the effective temperature drop differential would probably be 3°C.

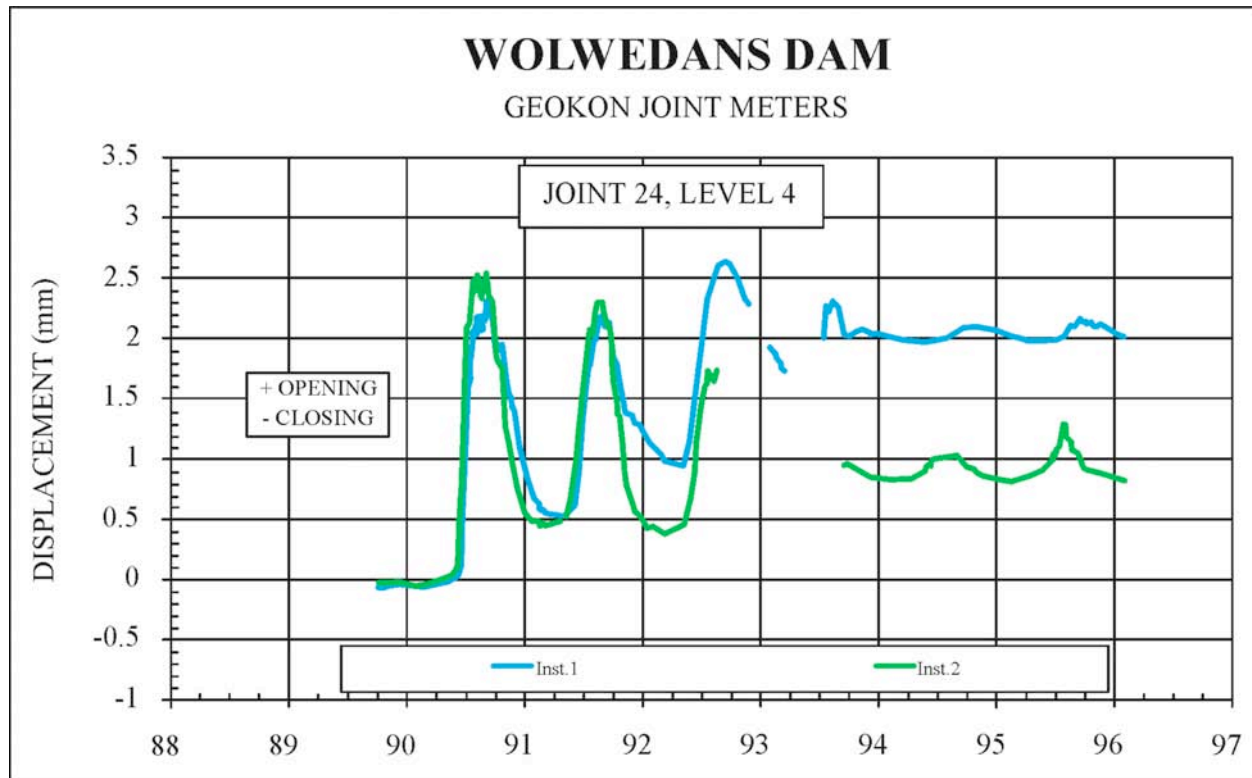
Figure 5.19: Displacement History for Joint No 24 at RL 84.25 m⁽⁷⁾

- A net upstream movement of the dam crest of approximately 2.5 mm was recorded in February 1994, compared to February 1993, despite a 2 m higher impounded water level. This suggests that the grouting caused an upstream movement of the crest towards the centre of the dam of approximately 3 mm.
- Of the 58 instrumentation sections, across four levels, the impact of the joint grouting is only really discernable at three (as indicated on **Figures 5.17, 5.18 and 5.19**) in the form of reduced seasonal joint movement.
- At the time of grouting, the only induced joint to have opened above RL 84.25 m was Joint No 24 (at the far end of the right flank).
- The only joint at which a distinct and definitive impact of the grouting was apparent was Joint No. 24, which demonstrated significantly reduced movement after grouting (see **Figure 5.19**).

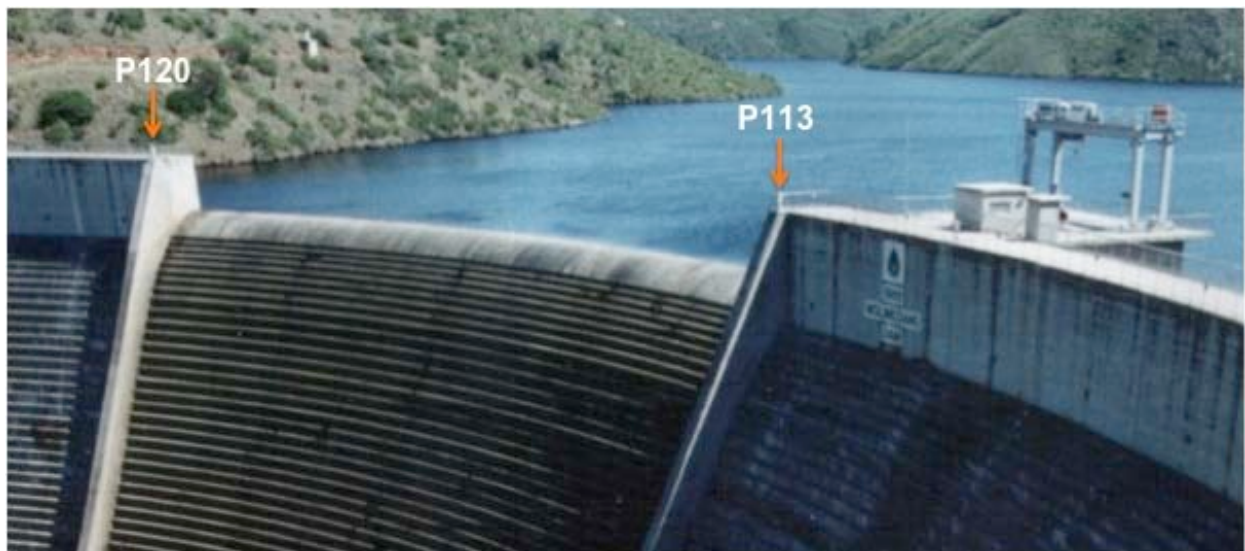
Plate 5.2: Wolwedans Dam – Illustrating Crest Beacons P113 & P120

Measurement points P113 and P120 are located at the beacons on the NOC immediately to the left and right sides of the spillway at Wolwedans Dam, respectively. The total horizontal, downstream crest displacement measured at these beacons in July 1993 was recorded as 14.5 and 11.7 mm respectively, compared to a base reference of January 1990. Equivalent seasonal displacement variations at these two points are approximately 10.9 and 12.8 mm respectively. While the data from the reference point P113 appears consistent with expectations, the seasonal variations and the total displacements indicated for point P120 are substantially higher than anticipated.

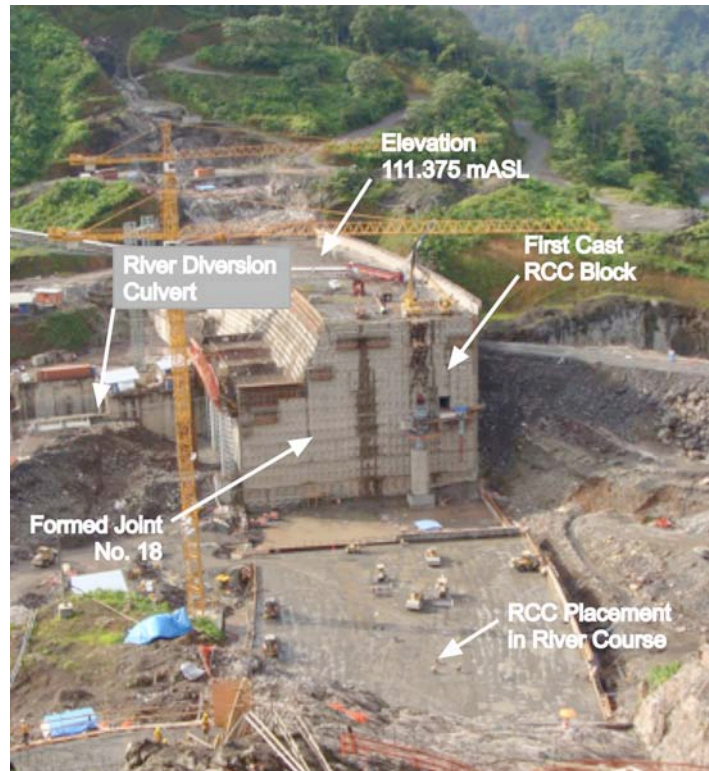
Plate 5.5: RCC Placement at Changuinola 1

From approximately 40 m height, Changuinola 1 Dam will be constructed in a conventional manner, placing RCC continuously between abutments. Up to that level, however, in order to accommodate seasonal river flow and to maximise the RCC placement period, placement was split into two components. While excavation and foundation preparation was underway in the main river course, RCC placement was initiated around the river diversion culvert, comprising two 9 x 9 m culverts, on the right flank. On completion of consolidation grouting and the placement of dental concrete on the foundation in the original river course, the location of the RCC delivery system was re-routed and RCC placement was initiated on the left flank, as illustrated on **Plate 5.5**.
