**BEHAVIOUR OF
CEMENTITIOUS SUBBASE
LAYERS IN BITUMEN BASE
ROAD STRUCTURES**

Presented as partial fulfillment of the requirements for the degree M(Eng)
in the Faculty of Engineering, University of Pretoria

PRETORIA, NOVEMBER 1985

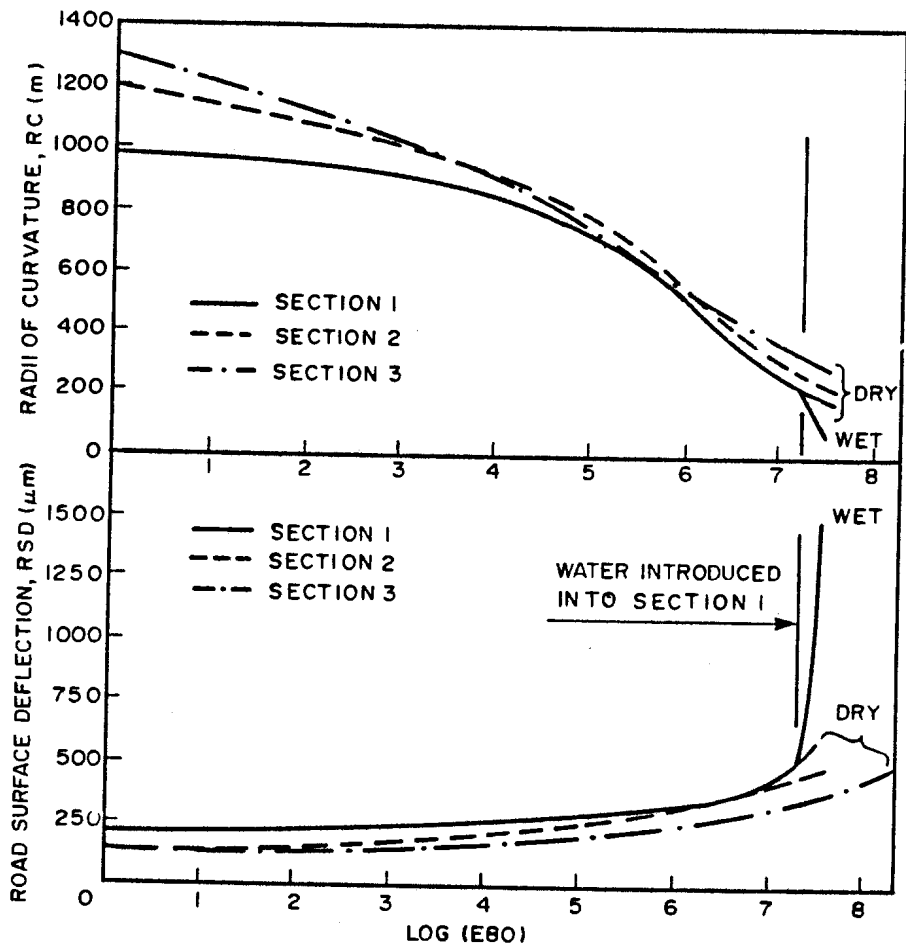
FIGURE 3.10
COMPARISON OF THE AVERAGE RADII OF CURVA-
TURE AND ROAD SURFACE DEFLECTION
MEASURED ON THE THREE TEST SECTIONS AT
MARIANHILL, N3/1

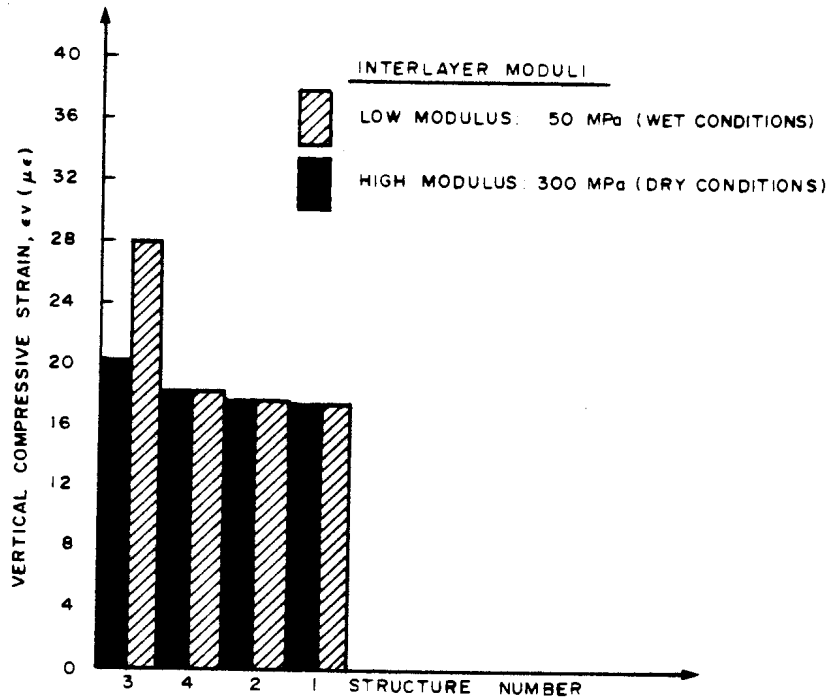
FIGURE 5.6
VERTICAL COMPRESSIVE STRAIN AT THE BOTTOM OF
THE UPPER SUBBASE LAYER

The vertical compressive strains at the bottom of the upper subbase are illustrated in Figure 5.6. Maximum strains were obtained on the interlayer of Structure 3. Similar strains were obtained for the remaining structures. But here again it is virtually only the wet condition which is significantly higher than the rest.

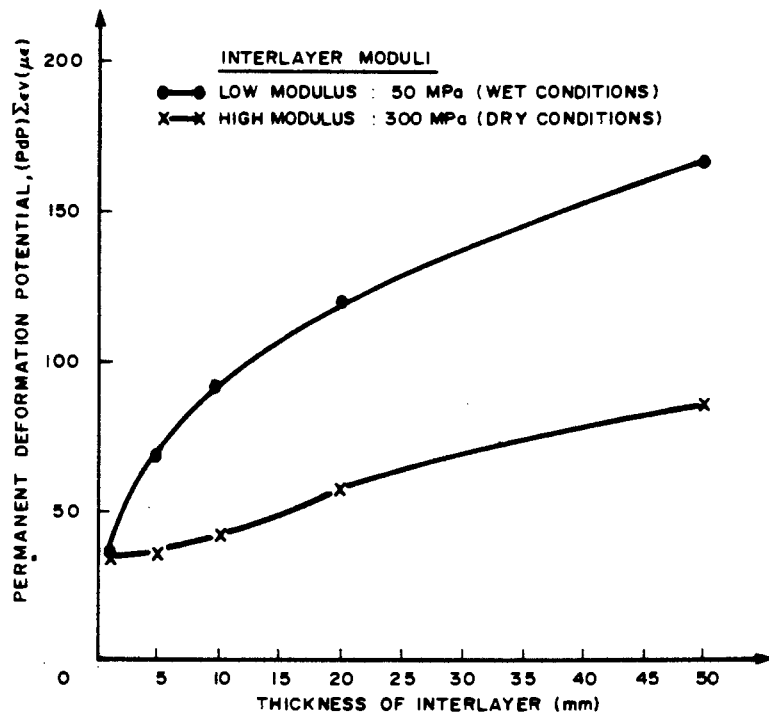
FIGURE 5.13
RELATIONSHIPS BETWEEN THE PERMANENT DEFORMATION STRAIN POTENTIAL AND THE THICKNESS OF THE INTERLAYER

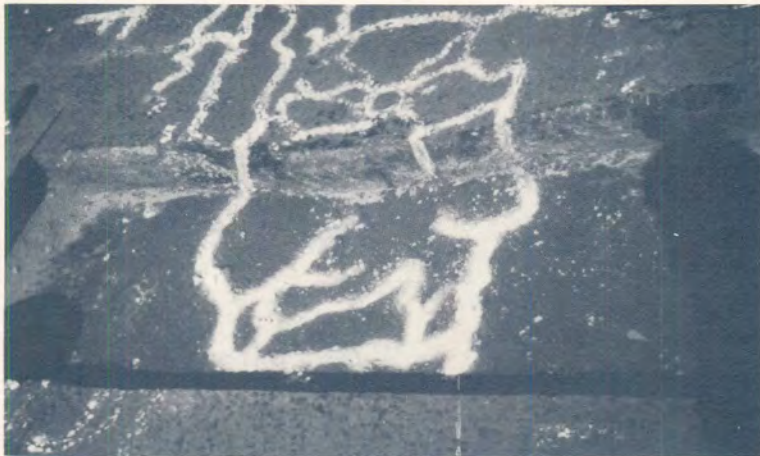
(b) Visible cracks on top of the upper stabilized subbase layer after the removal of the asphalt in (a).
