Chapter 4

RESULTS

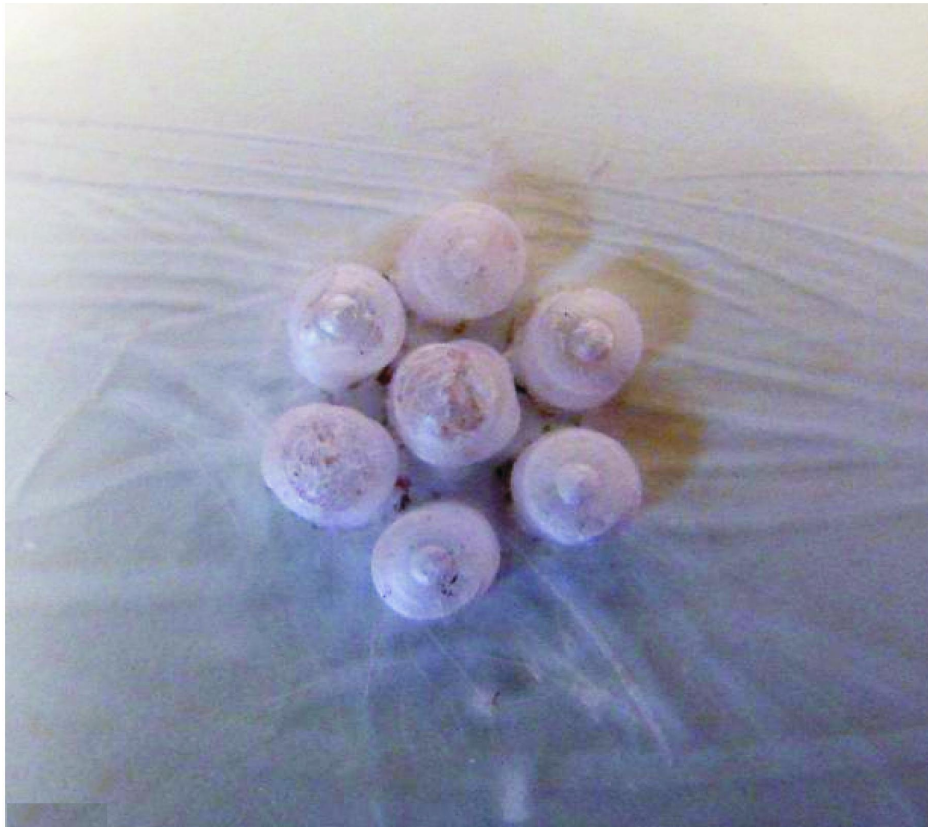
Figure 4.1: Clear polycarbonate cover sheet shown from the outside, showing holes ending blindly.

Seven holes with a diameter of 2.5 mm each were drilled in close proximity to each other (Figure 4.1). These holes do not go completely through the polycarbonate sheet, but end blindly 0.3 mm before the outer edge. This was done to maintain a smooth watertight surface on the outside of the cover.

The microphone is mounted on the inside of the polycarbonate sheet directly beneath the holes. It is fixed to the cover panel with watertight Pratley putty. The remaining thick parts of the sheet between the holes provide strength in the area above the microphone.

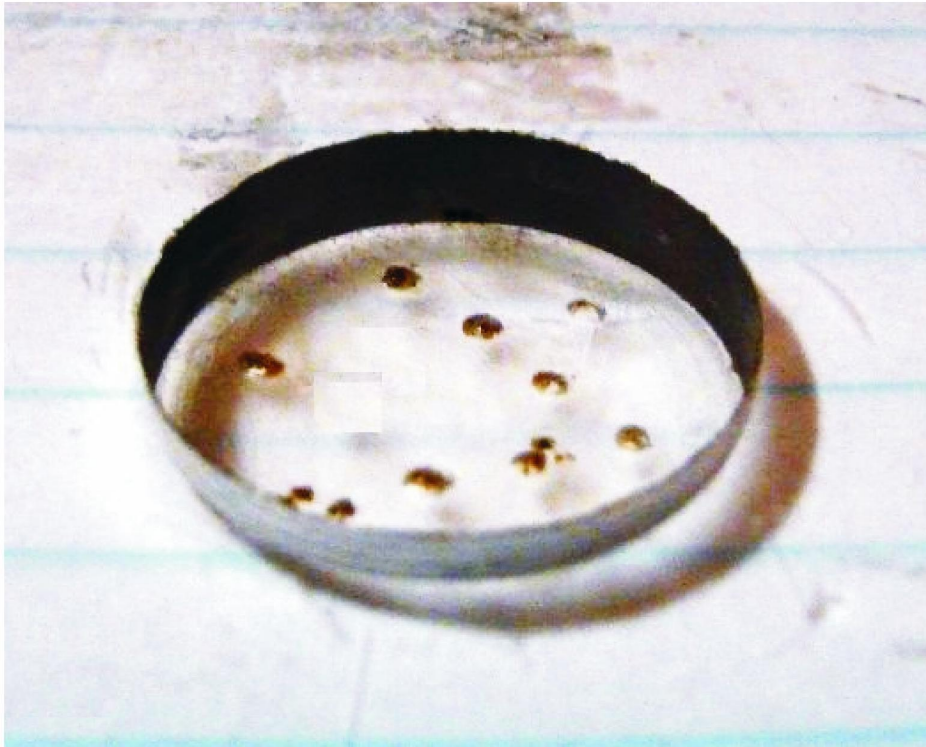
Figure 4.2: This figure shows the microphone-diameter blind hole. The smaller holes at the bottom of the larger hole were drilled for method 5, but were not present in method 3.

A single large hole with a diameter of 24 mm (so that the microphone can fit into it) was drilled into the polycarbonate sheet. Once again this hole does not go through, but ends blindly, leaving 0.3 mm of material on the outside of the sheet. The microphone is mounted inside this hole. See Figure 4.2.

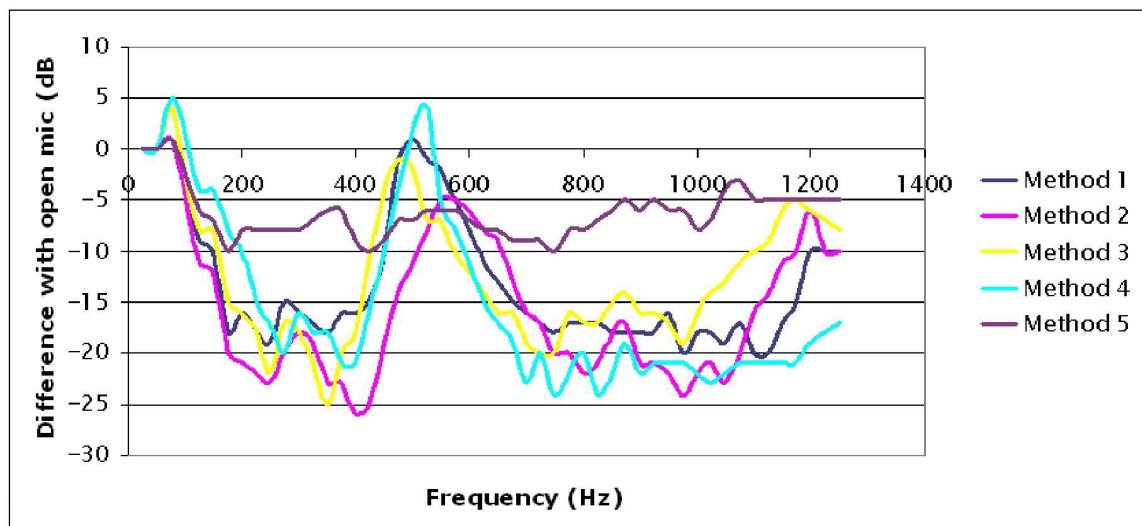
Figure 4.6: Transfer functions obtained from each of the five mounting methods described in the text, along with the reference (“open mic”, i.e. unobstructed microphone).

Figure 4.6 shows the results of the experiments. The first test was performed without a cover screwed onto the electronics enclosure, so that the transmission path to the

microphone was unobstructed. This result was used as a reference for the various mounting methods tested.

The objective was to find a microphone mounting method that would provide good audio signal transmission, while providing adequate protection for the microphone. It is clear from Figure 4.6 that microphone placement methods 1 to 4 resulted in suppression of spectral components and appeared not to be appropriate choices. Mostly frequency components around 500 Hz conducted well through the thin layer of polycarbonate, but the frequencies lower and higher than 500 Hz were suppressed.

Method 5 resulted in a flatter transfer function throughout the part of the frequency spectrum tested and appeared to be the better choice among these methods. Note also (although this result is not shown) that without the latex sheet covering the microphone in method 5, there was almost no attenuation. Thus, with holes in the

cover panel carefully aligned with the microphone casing holes, the primary source of attenuation became the latex sheet used to provide a watertight seal.

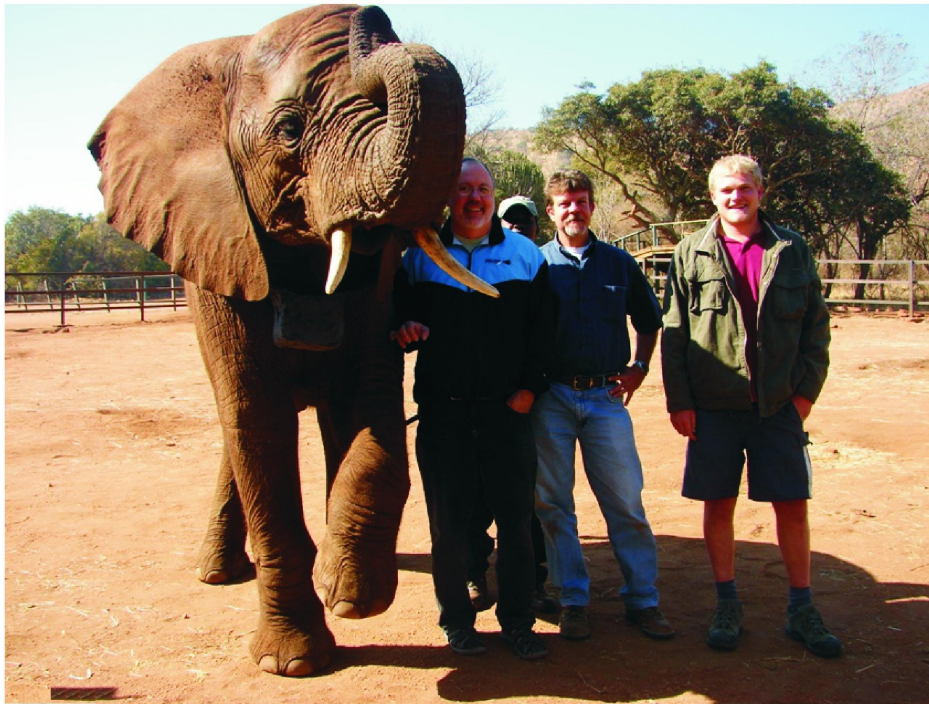
A 4 GB micro hard drive with a CompactFlash interface (from now on called the microdrive) as well as a 256MB CompactFlash card were used as data storage media. The cards were inserted into two of the available CompactFlash sockets housed in the collar. The device was activated approximately 15 minutes before the collar was mounted on the elephant. Figure 4.10 shows the collar fitted onto the elephant.

Figure 4.10: The elephant after the collar have been successfully mounted.
