## **CHAPTER 9**

### **QUANTIFICATION OF PAVEMENT FUNCTIONAL PERFORMANCE**

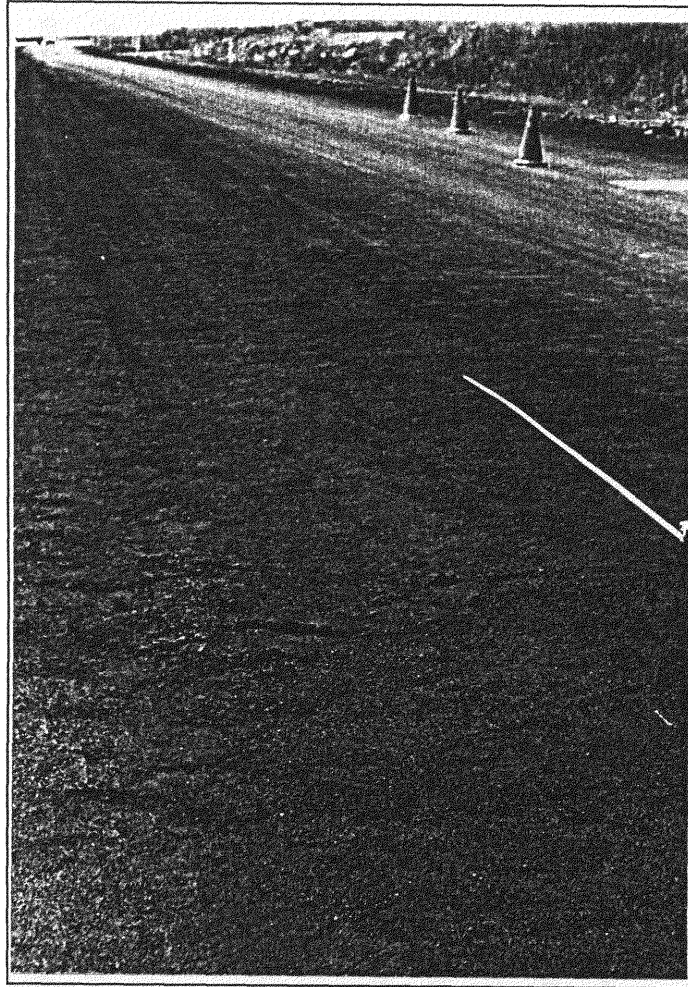
**Figure 9.7** General View of Kriel Colliery Site 1, showing rutting and damage to wearing course.

Figure 9.7 shows a general view of site 1 with the laden side of the road on the RHS. Although the site offered both level and grade (3,6%) sections, no significant difference in functional performance was noted except for slightly worse rutting on the laden side and crocodile cracking on the unladen grade section, probably due to the deceleration of the mine haul trucks coupled with a relatively plastic material. No excessive erosion of the wearing course was noted (along or across the road). Cracking of the wearing course material is shown in Figure 9.8 together with the presence of stones in the wearing course. During maintenance these stones lead to ridges being bladed into the road or, when removed, small

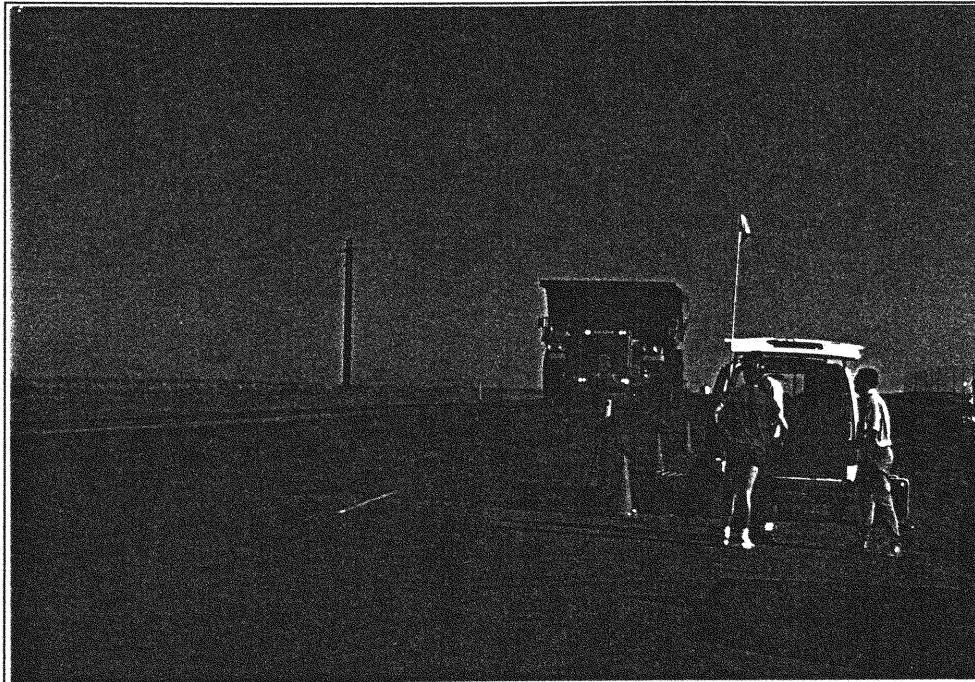
**Figure 9.14** General View of Kriel Colliery site 3.

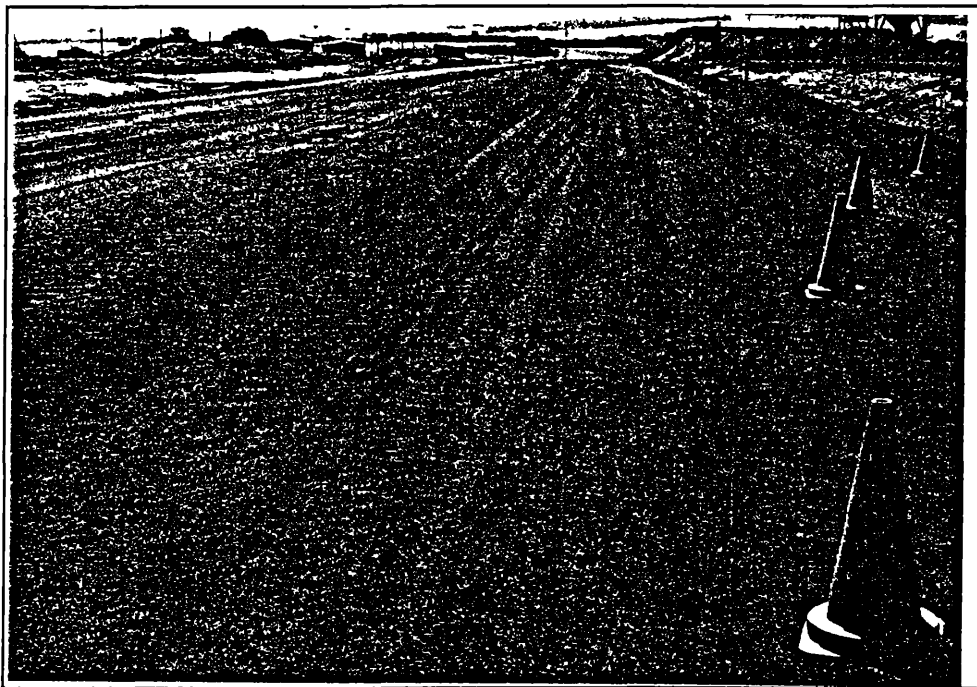
**Figure 9.19** General View of SACE Kromdraai Colliery Site 1

Figure 9.19 shows a general view of site 1 with the loaded side of the road on the LHS. Although the site is slightly on grade (1,7%), no significant erosion of the wearing course

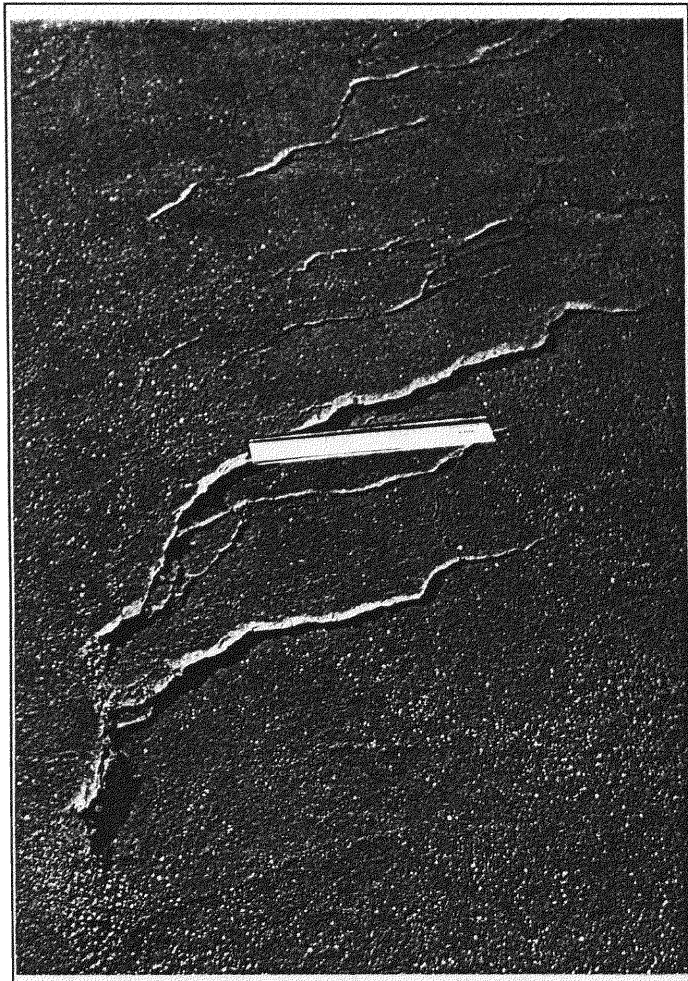
**Figure 9.20** Cracking and pushing out of wearing course in centre of road, Kromdraai Colliery Site 1.

was noted (along or across the road). In addition, no major differences in functional performance were noted between laden and unladen sides of the road. Figure 9.20 illustrates cracking in the centre of the road due to local failure and movement of the wearing course to a depth of 30-40mm. This may be explained by the braking action of the loaded haulers developing shear forces and tensile forces in the pavement, together with the layering that takes place on the road due to successively blading wearing course off and on the road in wet weather and the formation of a "blad". This type of functional defect may be associated with the high plasticity index (PI) evident from the material classification (Table 3.10) and the gradual reduction in binder material that can be anticipated as the wearing course is repeatedly bladed off the road during the wet season (Paige-Green, 1989). Inadequate scarifying prior to the replacement of the wearing course will lead to the development of layers, especially if coal fines are also present on the road surface. Figure 9.21 shows the typical location of this defect on the right hand track of the laden side of the road, shown in the photograph on the far side of the road.

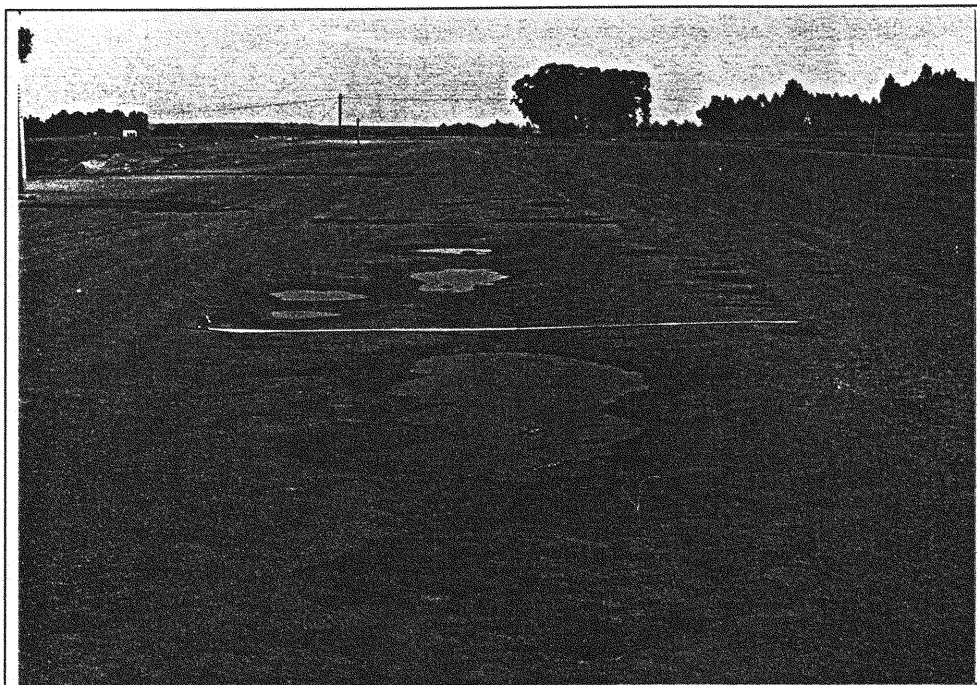
**Figure 9.28** Potholing as a result of localised soft spot in newly constructed and trafficked site 3 road at SACE Kromdraai Colliery.

Since the road is relatively new and traffic has increased steadily from Feb 1994 onwards, some local deformation may be expected. This is seen in Figure 9.28 where slip cracks at the side of the road and potholes in the centre of the road are seen. The pothole defect appears to increase with the increasing cumulative traffic up to November 1994 from whence it remains constant, eventually being reduced by blading after rain in January. No further excessive pothole defect scores were recorded after this initial compaction of soft spots in the road. Both effects were noted on both laden and unladen sides of the road with only a slight increase in shearing damage seen on road bends.

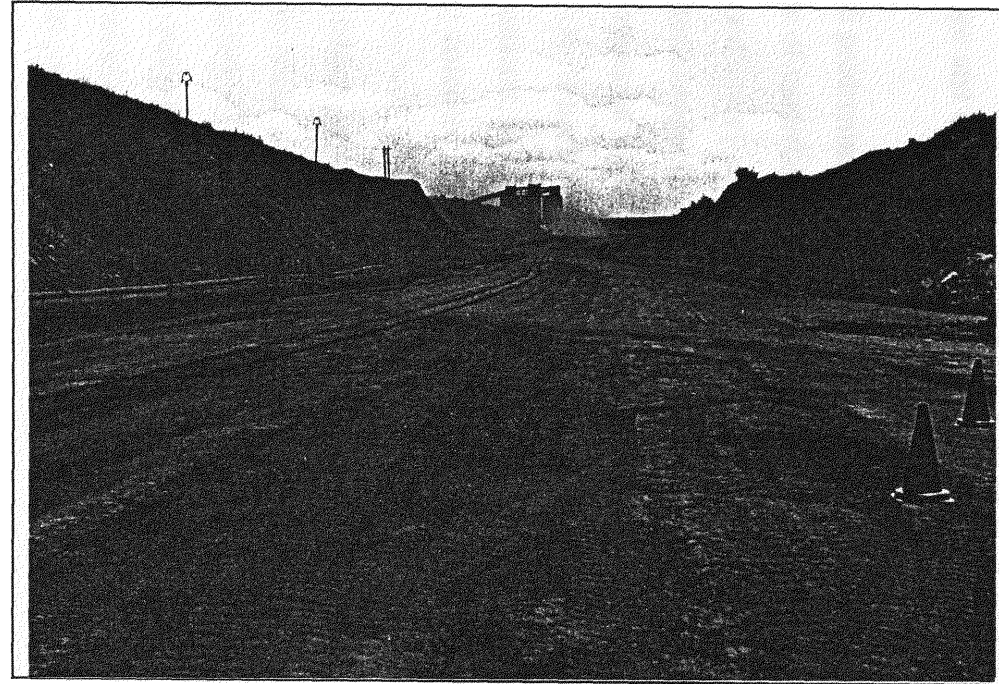
**Figure 9.55** Condition of wearing course after blading, Kleinkopje Colliery Site 2.

Only level straight and level curved sections were available at this test site for assessment and no major differences were seen apart from a tendency of the wearing course to shear failure on the curved section of the road when wet. Little difference was observed between laden and unladen sides of the road apart from the character of the dust (associated with fine coal spillage) and a greater extent of smaller potholes or depressions on the unladen side (possibly due to material whip-out). Figure 9.54 illustrates the difference between laden and unladen carriageways (laden LHS) due to fine coal spillage (water recently applied) whilst Figure 9.55 illustrates the condition of the road after recent blading. Loose material on top of a well compacted and cemented "blad" is apparent, together with loose uncompacted material in depressions and shallow wide potholes. Cementing of the wearing course through natural chemical processes has been observed at other mine sites where ferricrete forms the wearing course material and, without scarifying, may cause layering of wearing course material that is bladed on and off the road when wet.
