2 TESTWORK

**DETERMINATION OF FACTORS INFLUENCING THE DEGREE OF REDUCTION DISINTEGRATION IN NORTHERN CAPE LUMP ORE
AND THE ROLE OF GANGUE MINERALS IN THE PROPAGATION OF CRACKS**

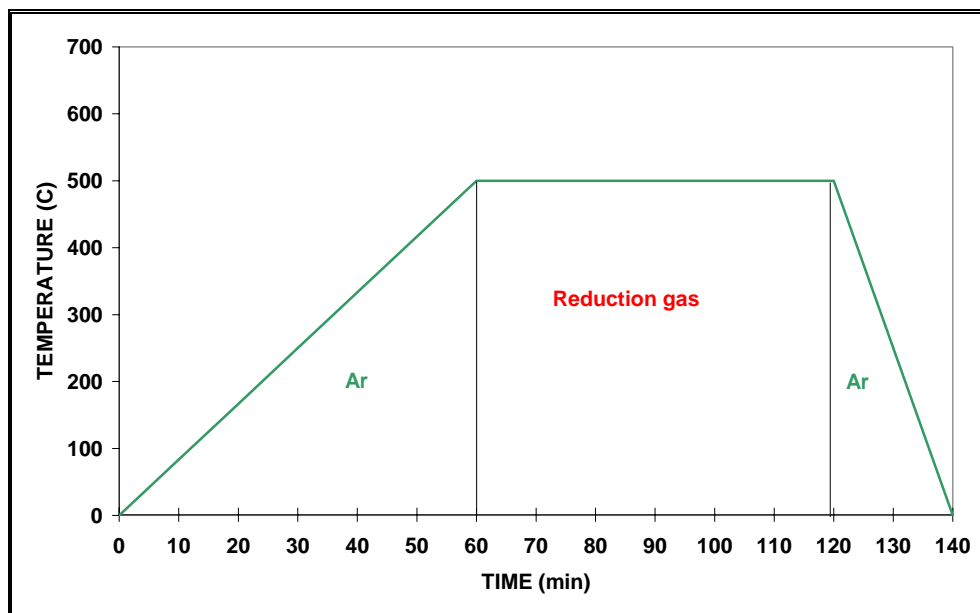
Due to non-uniform heating of the sample (under inert conditions), the heating rate was decreased so that the samples were heated from 0-500°C in one hour. **Figure 34** is an illustration of the test conditions used in the high temperature microscope. During the tests, a video recording was made of the entire test. Emphasis was placed on crack formation and propagation. A magnification of 10 times (objective) was used.

Figure 34: Illustration of test conditions used in the high temperature microscope.

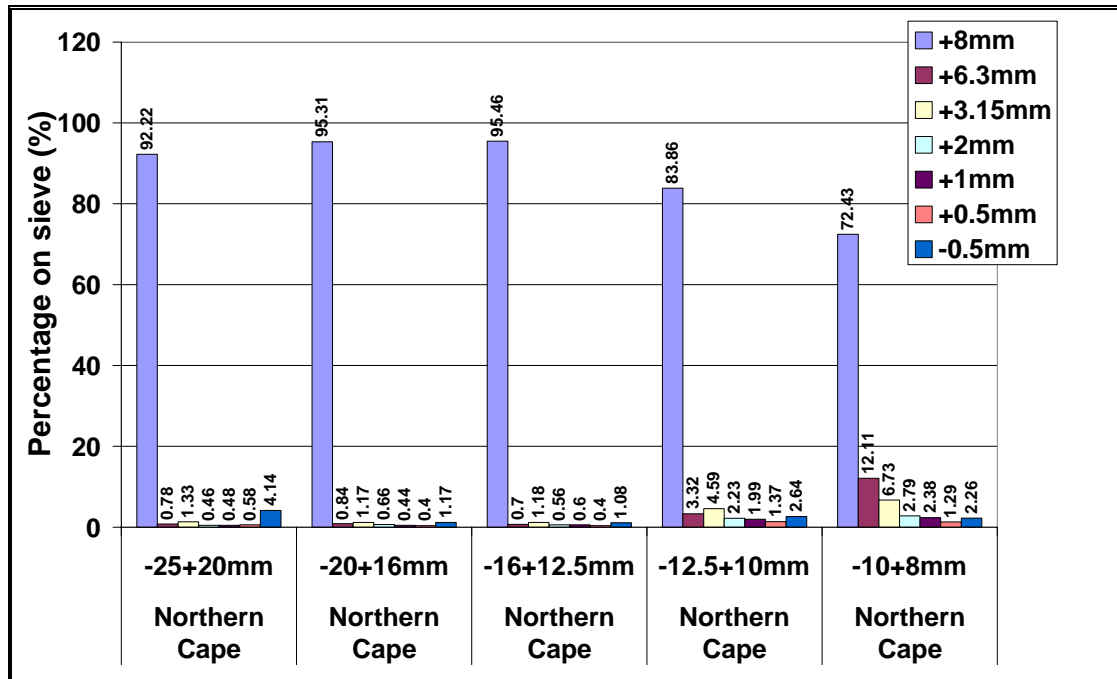
Figure 35 indicates the effect of burden size on the degree of reduction disintegration on Northern Cape STD. From the graphs it is clear that the degree of reduction disintegration is very similar despite differences in the burden size. It is only for the burden size -10+8mm that a significant increase in the percentage fine material is noted. This is mainly due to the fact that the burden material size fraction is merely +8mm, hence only a small degree of size degradation is required to produce a significant amount of -8mm material.

Figure 35: Effect of burden size on the degree of reduction disintegration on Northern Cape STD.

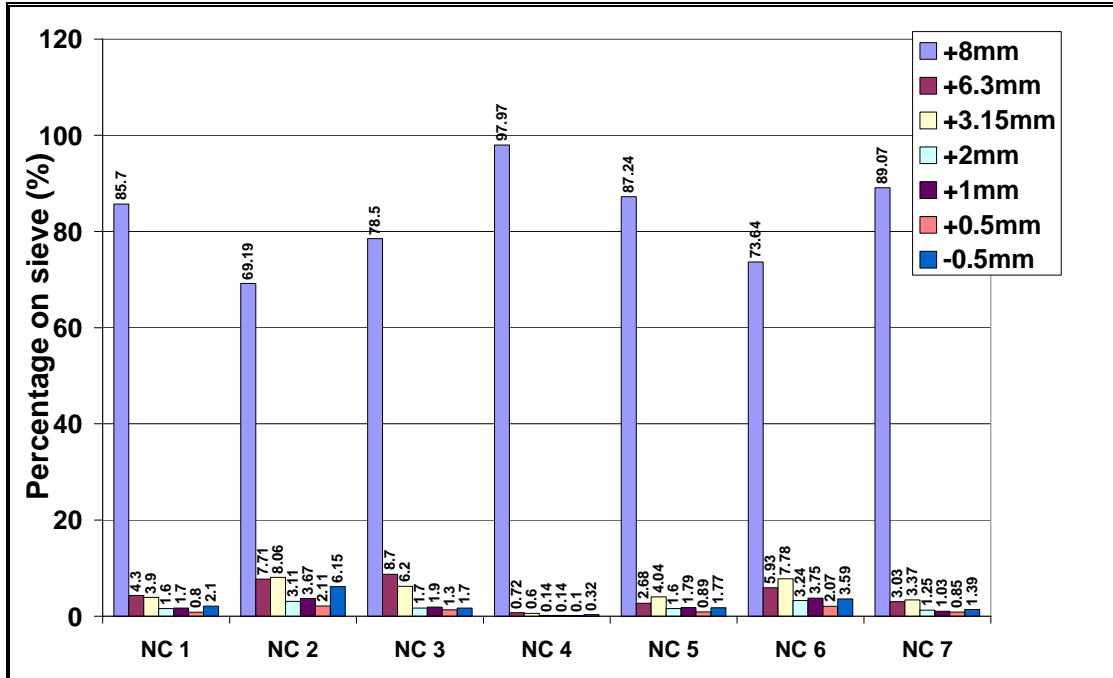
Figure 36 indicates the effect of ore composition and microstructure on the degree of reduction disintegration. The results indicate that Northern Cape OT 4 is very stable with 98 percent of the material greater than 8mm. This correlates with the low degree of reduction that was recorded for this ore type. In contrast, Northern Cape OT 7, that performed second best with regards to the degree of reduction disintegration, recorded the highest average degree of reduction of 5.2%. On the other hand for Northern Cape OT 2 and Northern Cape OT 6 only 70-75 percent of the material is greater than 8mm. Although the general thinking is that the disintegration is mainly due to the reduction process, the average degree of reduction for Northern Cape OT 2 is 1.7 percent while that of Northern Cape OT 6 is 3.8 percent (**Figure 37**).

Figure 36: Degree of reduction disintegration for the different Northern Cape Ore types.

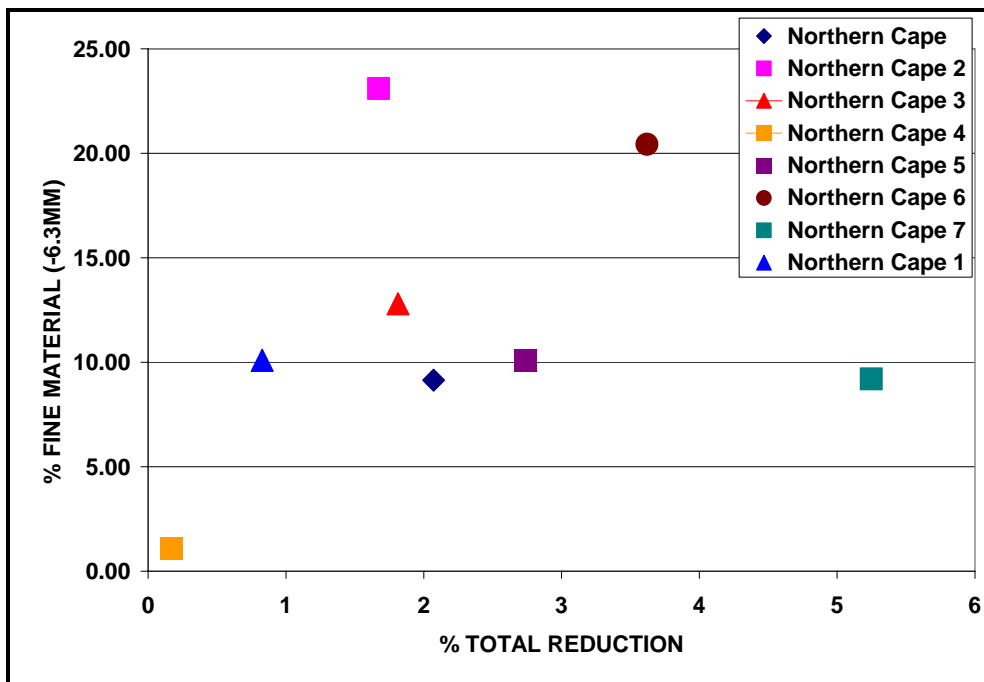
Figure 37 These results suggest that the degree of breakdown depends both on the reduction process as well as the microstructure of the ore.

Figure 37: Percentage reduction after reduction disintegration tests for Northern Cape STD and the various ore types plotted against the % fine material (-6.3mm) generated during the test.

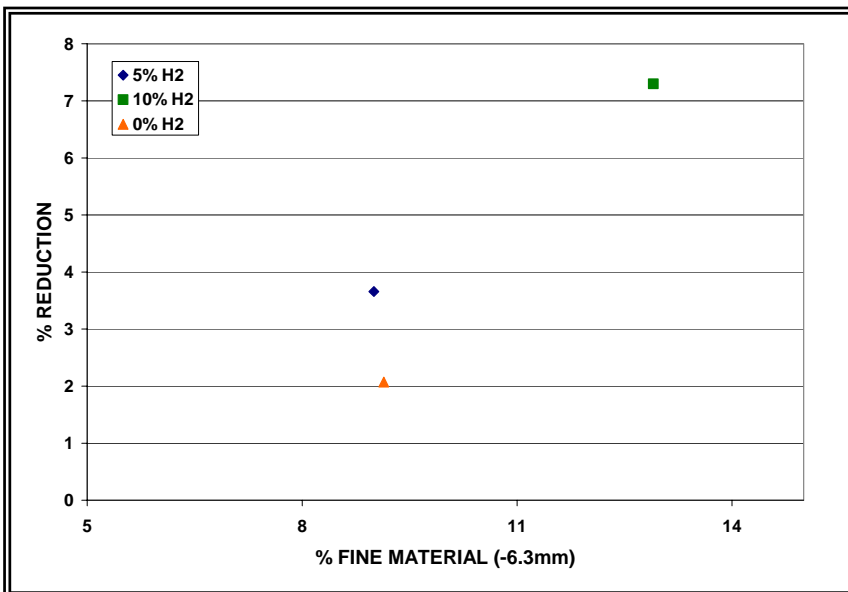
Figure 38: Effect of gas composition on the degree of reduction and the percentage fine material generated.

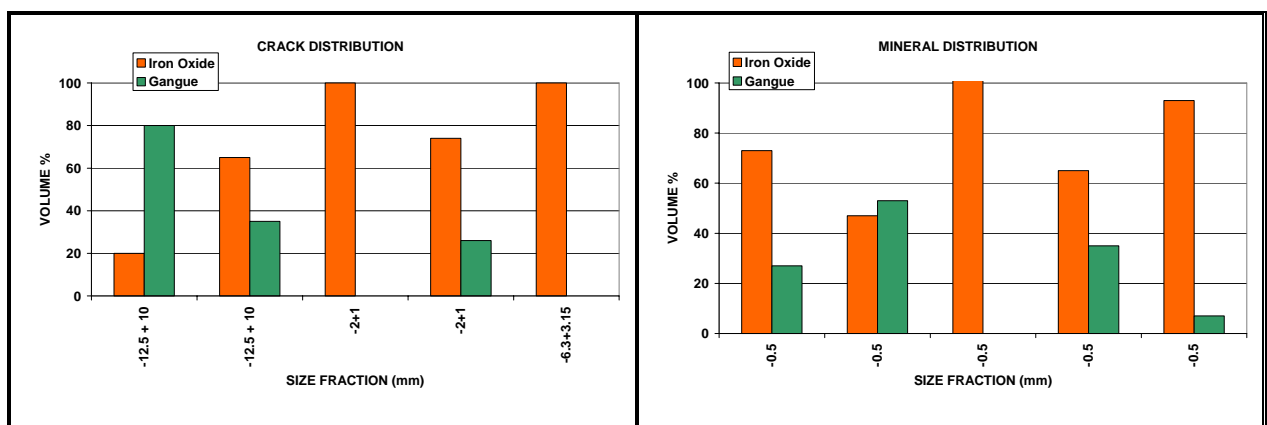
Figure 62: Graphical representation of the crack association in the different size fractions of Northern Cape OT 4.
