CHAPTER 7

FATE OF THE ORGANIC COMPONENTS OF WINERY EFFLUENTS IN SOILS

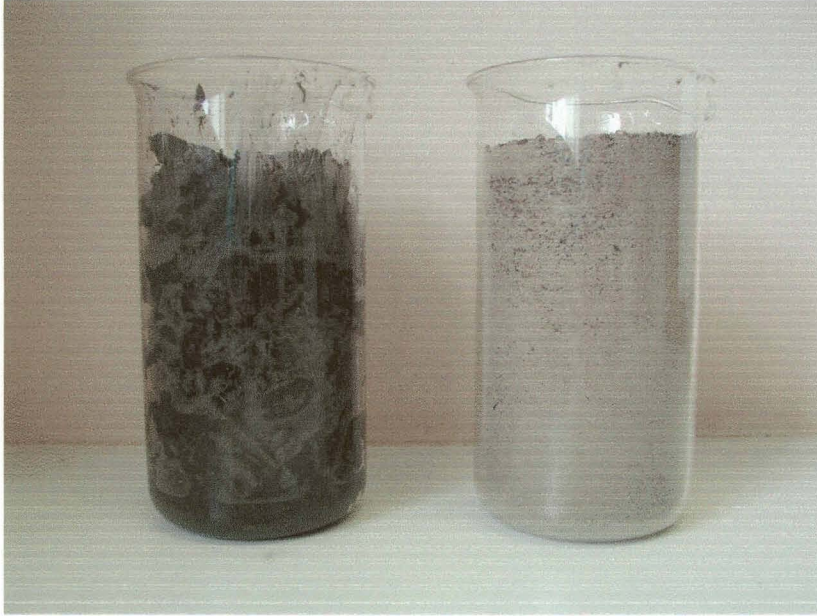
Plate 7.1: Samples of black soil from the water table at Robertson 1 winery (left) and white sand remaining after washing of a similar sample with water (right)

During November 2000, i.e. long after the end of the vintage season and shortly before the beginning of the next season, the thickness of this black layer in the soil of the disposal site of the Robertson 1 winery was determined. It was found to stretch from 1,2 m below the surface to 1,8 m below the surface, i.e. it was 60 cm thick. A sample of this black soil was washed in the laboratory by adding water, stirring it and decanting the supernatant liquid. After repeated washing the result was white sand, identical to the soil above the water table, and a black liquid (Plate 7.1)

This clearly indicate that the black substances is water-soluble organic matter from the effluent. Investigations in a drainage ditch at the bottom end of the area on which the effluent is disposed, revealed large amounts of black gel-like organic coagulates in the ditch (Plate 7.2). This indicates removal of the organic matter from the disposal site by lateral subsurface leaching. Since the ditch empties into a nearby stream, this poses a real organic matter pollution hazard to the stream.
