**ENVIRONMENTAL IMPACT OF WINERY EFFLUENT IN THE WESTERN
AND NORTHERN CAPE PROVINCES**

Mini – dissertation presented in partial fulfilment of the requirements for the degree

Magister Institutionis Agriculturae in Land Use Planning

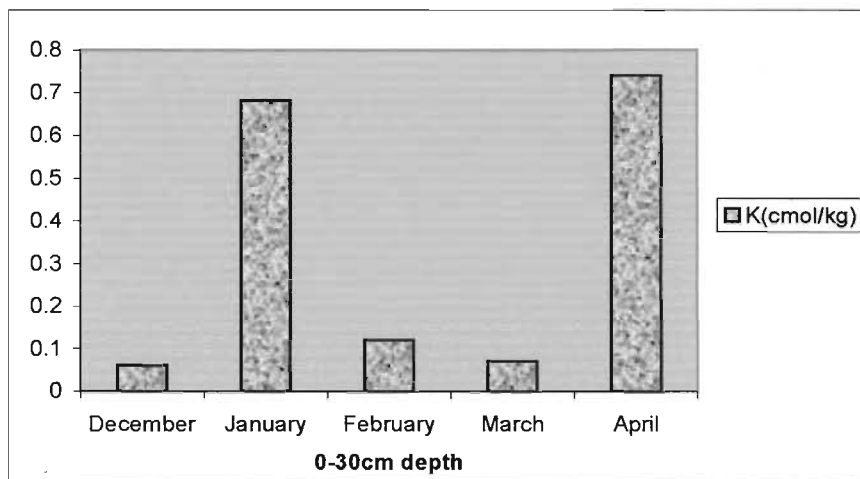
Figure 6.1b: Potassium trend of topsoil (0-30 cm) at Orange river winery

These effects are clearly illustrated for K and Na at the Orange River winery (Figures 6.1 and 6.2). For both elements there are sharp increases in their levels in the soil at all depths in April, following their sharply increased levels in the March effluent. Conversely their levels in the soil decreased sharply in February, following their high levels in the soil in January, in response to their low levels in the January effluent. Unfortunately no analyses are available for the December effluent, so that it can only be speculated that the high levels of these elements in the soil in January were due to high levels in the December effluent.

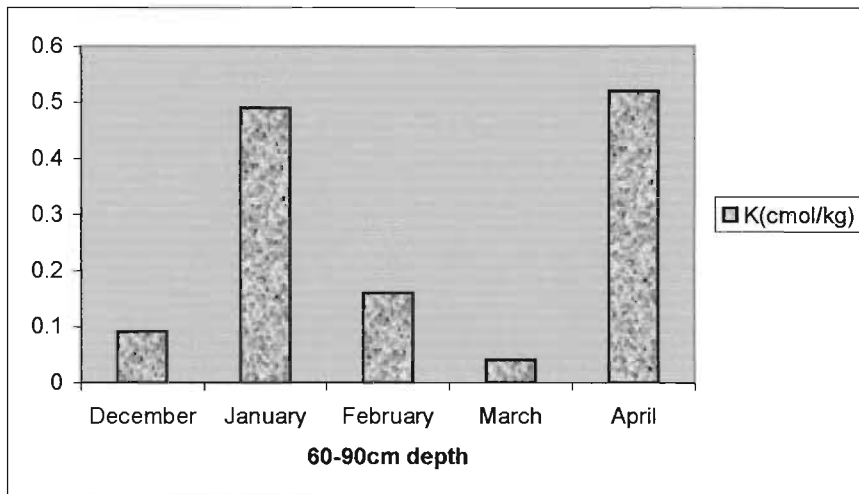
Figure 6.1d: Potassium trend of subsoil (60-90cm) at Orange river winery

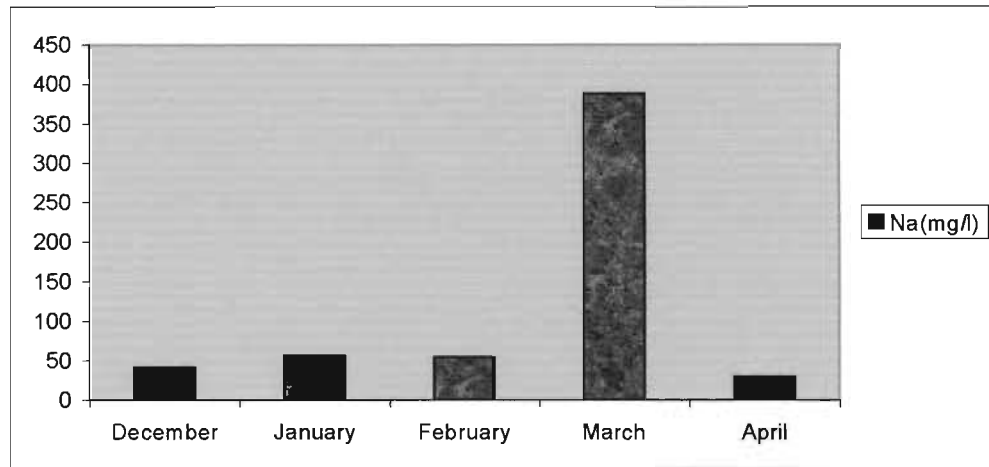
Figure 6.2a: Sodium trend of effluent at Orange river winery

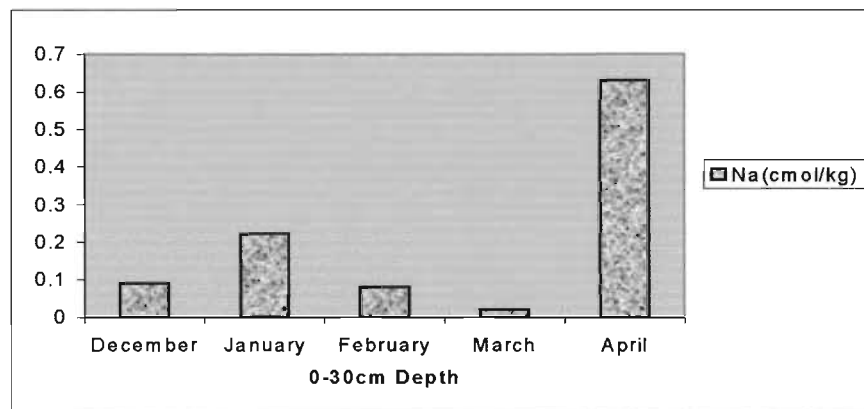
Figure 6.2b: Sodium trend of topsoil (0-30cm) at Orange river winery

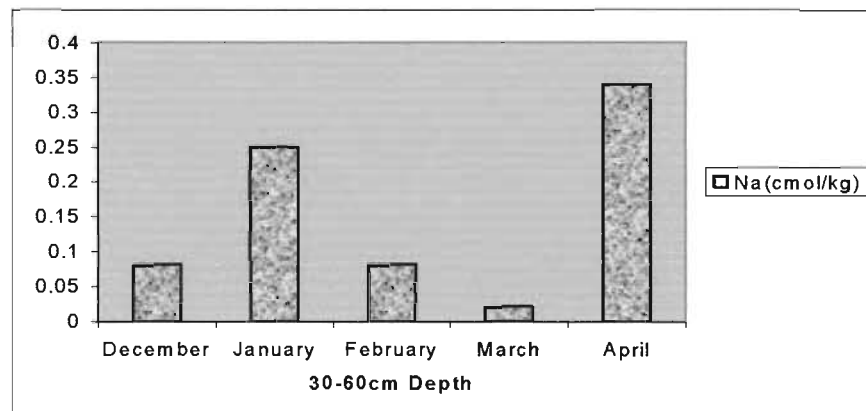
Figure 6.2c: Sodium trend of subsoil (30-60cm) at Orange river winery

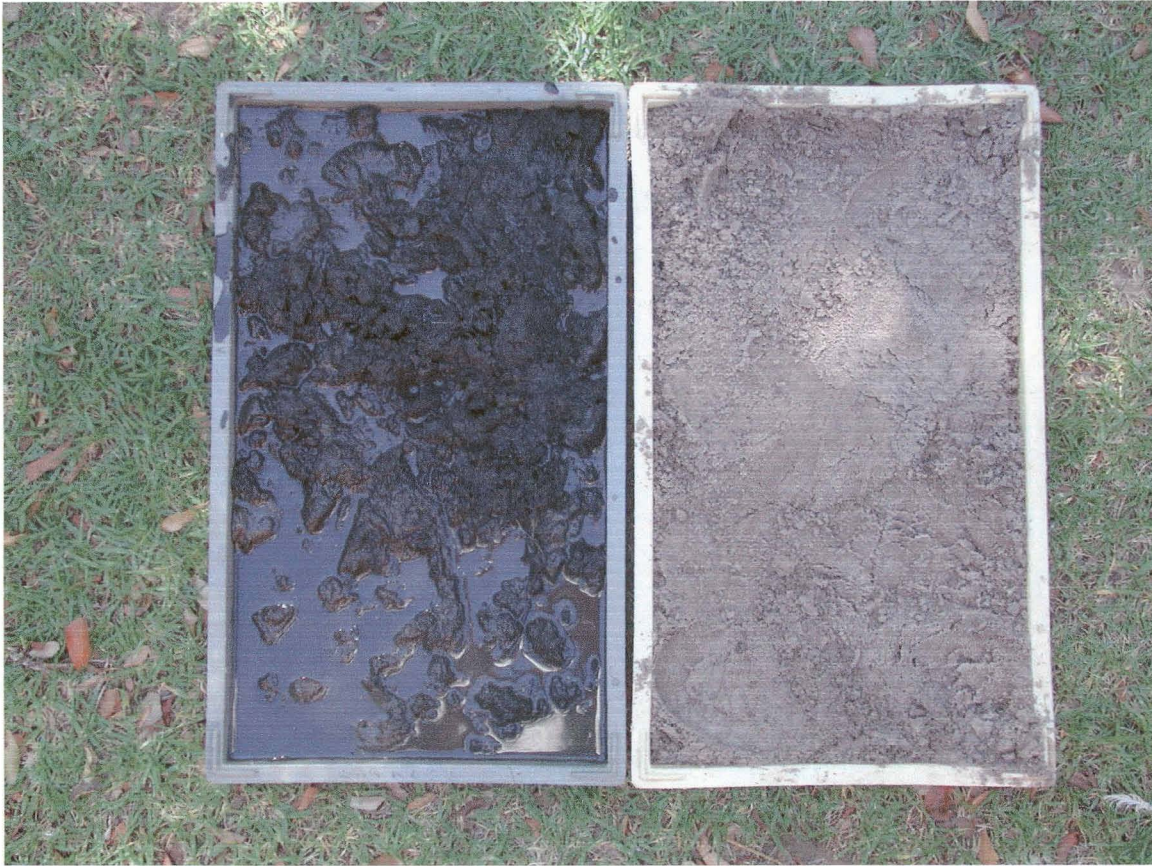
Plate 7.2: Samples of black material from the drainage ditch at the disposal site at Robertson 1 winery (left) and normal white soil from the disposal site (right)

This clearly indicate that the black substances is water-soluble organic matter from the effluent. Investigations in a drainage ditch at the bottom end of the area on which the effluent is disposed, revealed large amounts of black gel-like organic coagulates in the ditch (Plate 7.2). This indicates removal of the organic matter from the disposal site by lateral subsurface leaching. Since the ditch empties into a nearby stream, this poses a real organic matter pollution hazard to the stream.
