CONTEXT
PLATFORM

CONTEXT

Project Overview

Site Analysis

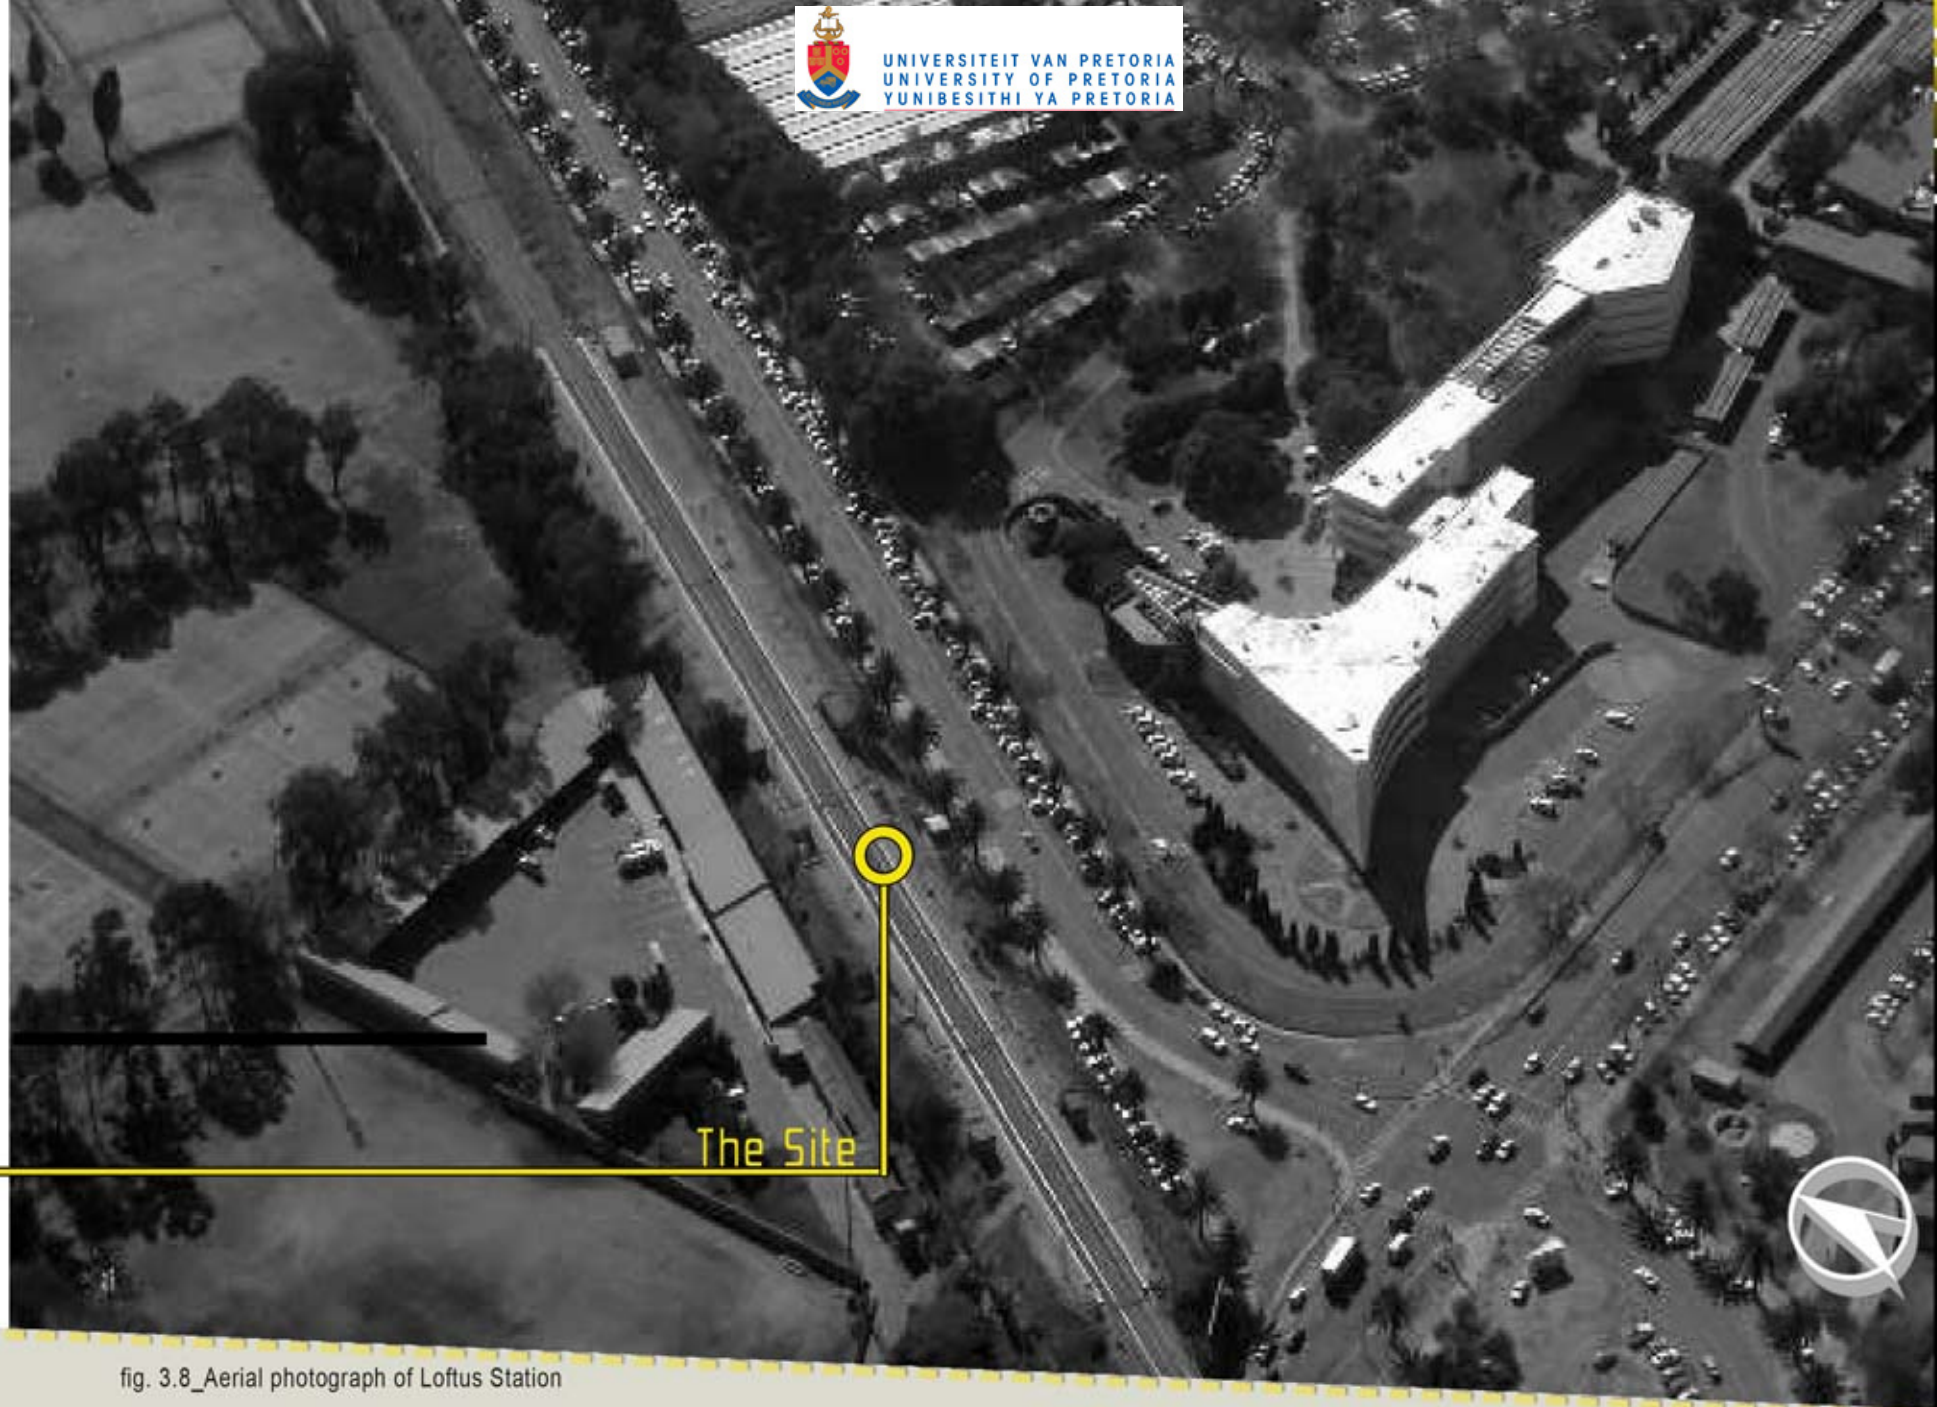
fig. 3.8_Aerial photograph of Loftus Station

The site is at the centre of the rapidly developing Hatfield precinct, covering an area of 3.25 hectares.

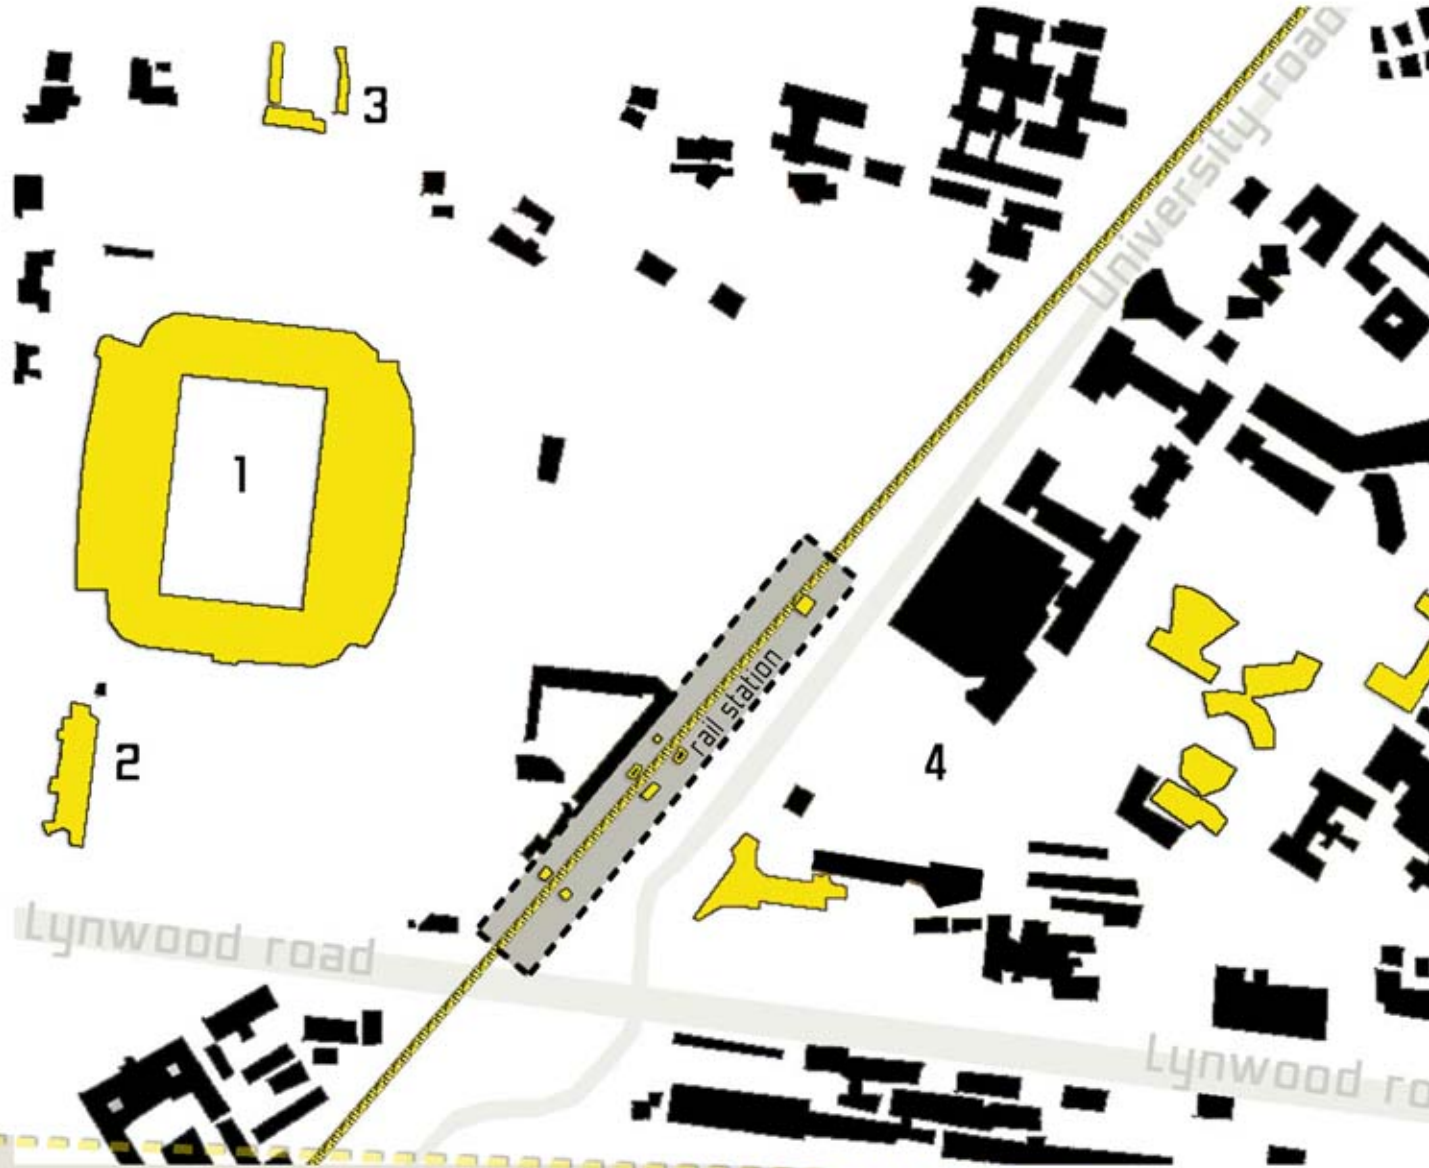
Public & Private

- public
- private
- proposed site

- 1 Loftus Versfeld
- 2 Mixed-use
- 3 Restaurant
- 4 University of Pretoria

There are very little public facilities within the study area. These facilities are mono functional and are restricted to time constraints. Such as Loftus Versfeld stadium - only occupied during match times on weekends. It is apparent that the study area lacks diversity.

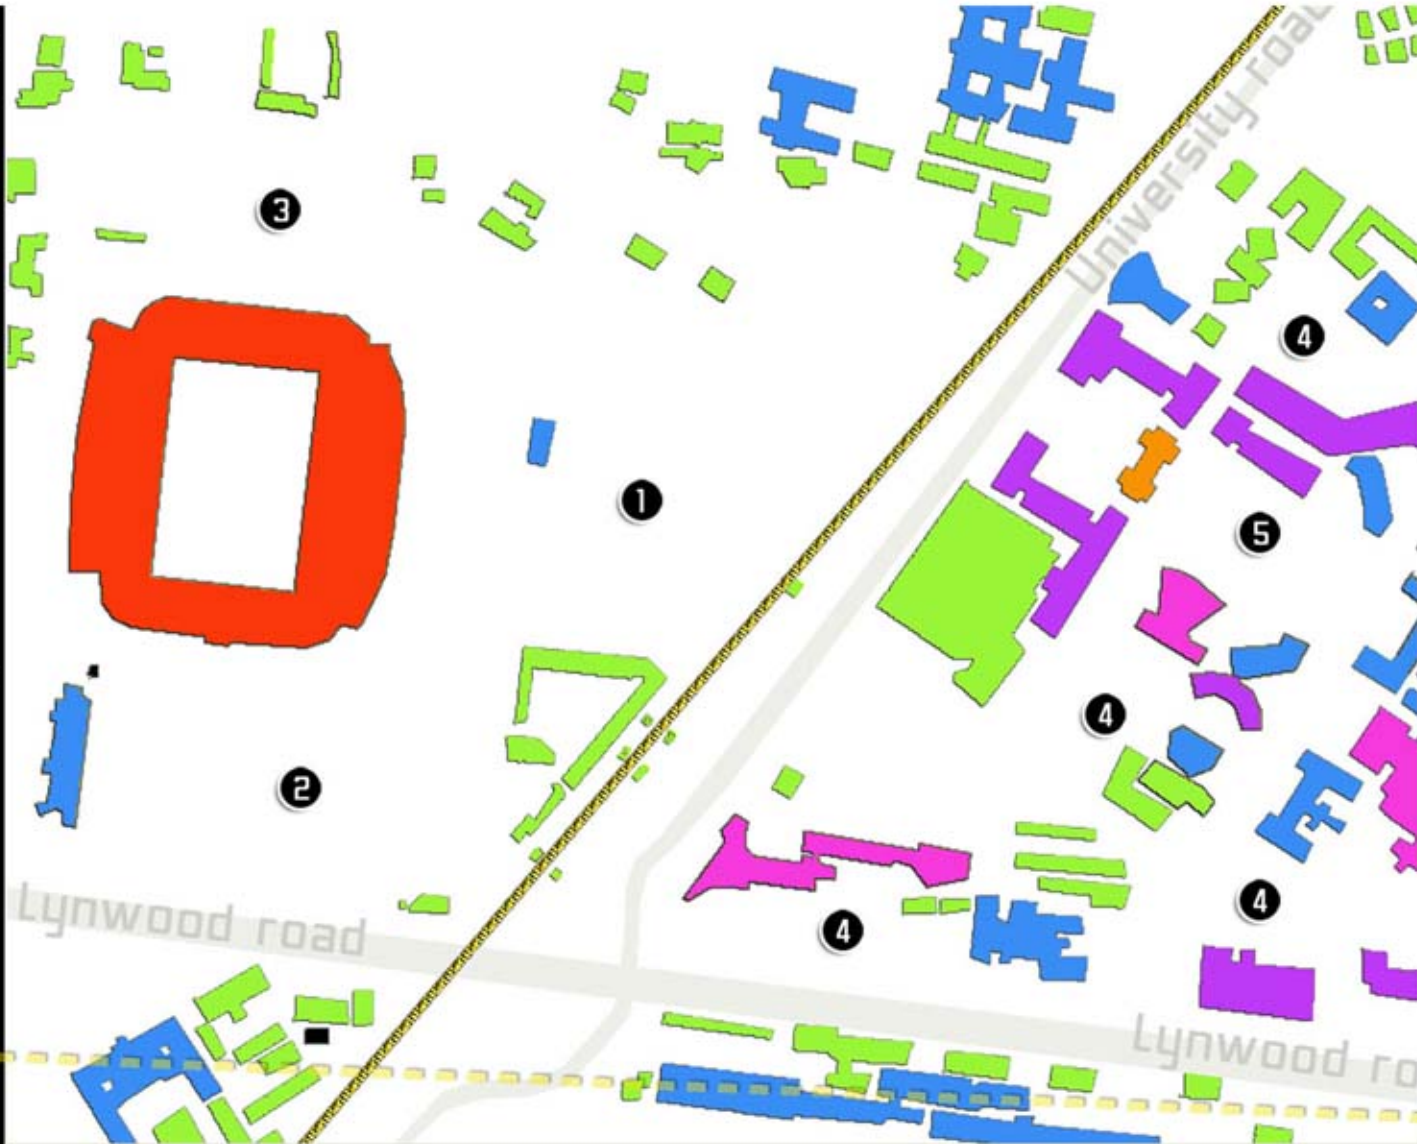
Building Heights

- one level
- two levels
- three levels
- four - six levels
- seven - ten levels
- eleven - fifteen levels

Open Areas

- ① Girls High - Sport Fields
- ② Loftus Rugby Fields
- ③ Loftus additional parking
- ④ University Staff Parking
- ⑤ University Green Space

The street perimeter lacks continuity that building heights and placements offer. There are too many under utilized open spaces inaccessible to the public. These open spaces need to be defined by the placement of walls, landscaping or buildings (4-6 levels). Ground floor edge treatment to relate to a pedestrian scale through facade design.

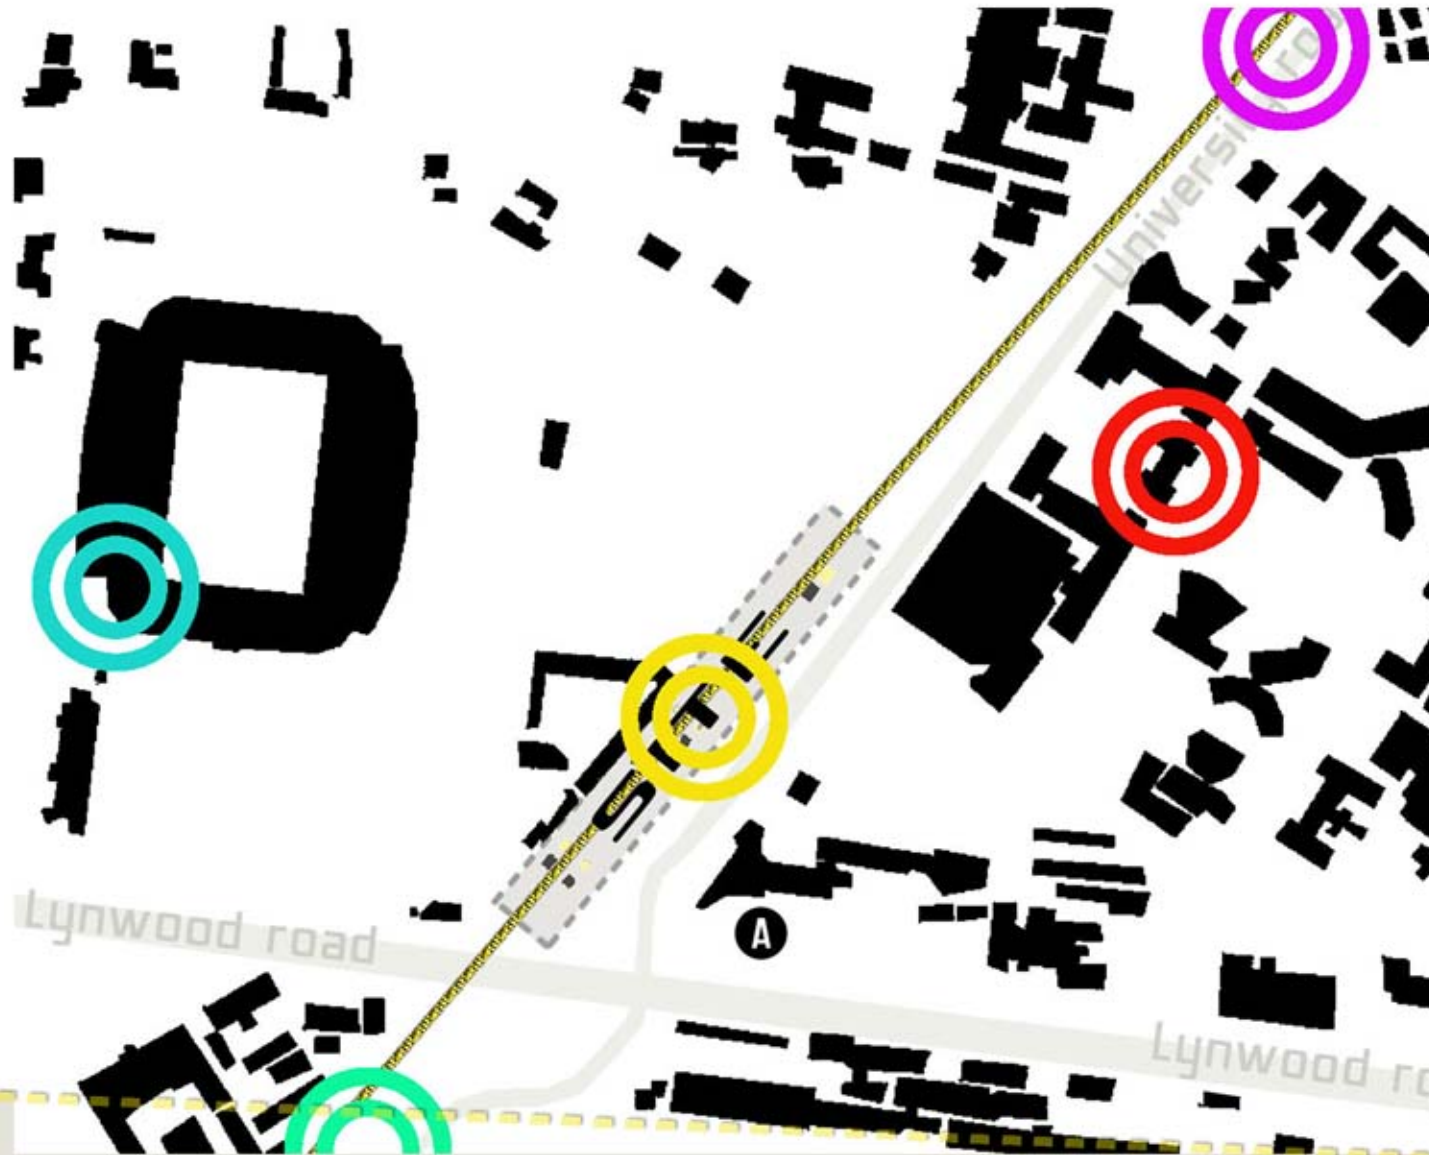
Paths

According to Lynch:
"channels along which the observer
customarily, occasionally or potentially
moves."
(Lynch, 1960:47)

Main Pedestrian route

Main Vehicular route

The path of the user is determined by the layout of the city grid. Pedestrians are forced to walk around large city blocks - no through fare exists. Vehicles dominate roads, sidewalks are inadequate and the walking distance radius is large.

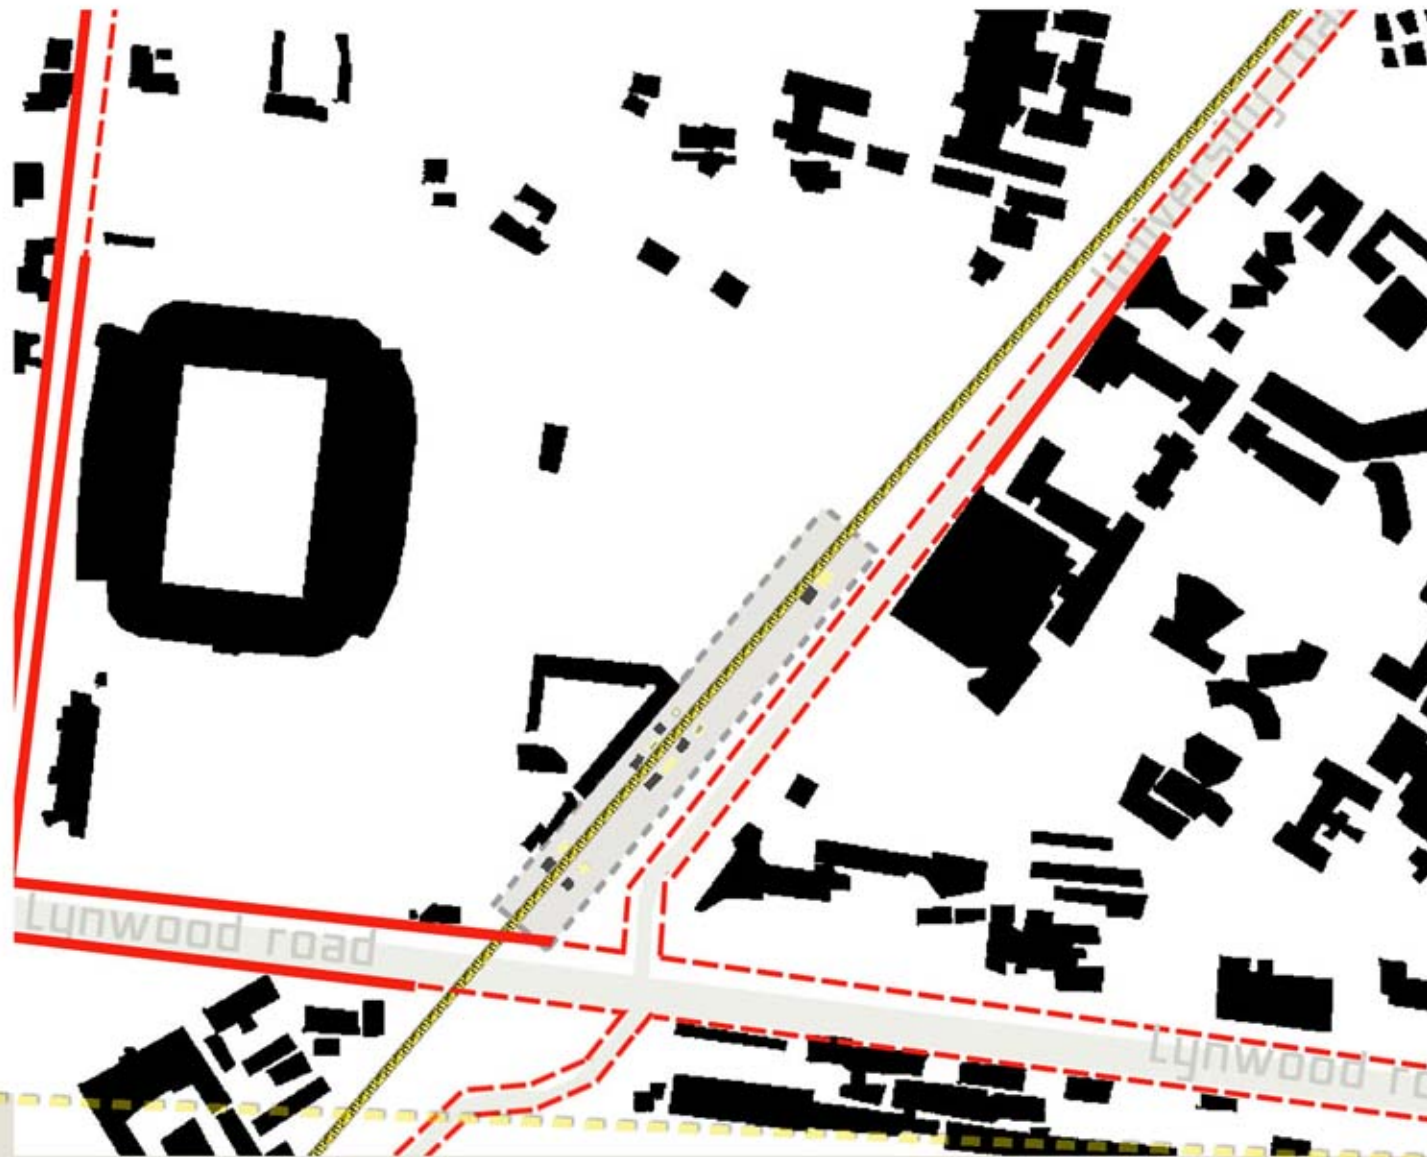
Edges

Buildings are set back too far from the street. No continuous edge exists, resulting in a poor street interface and passive surveillance.

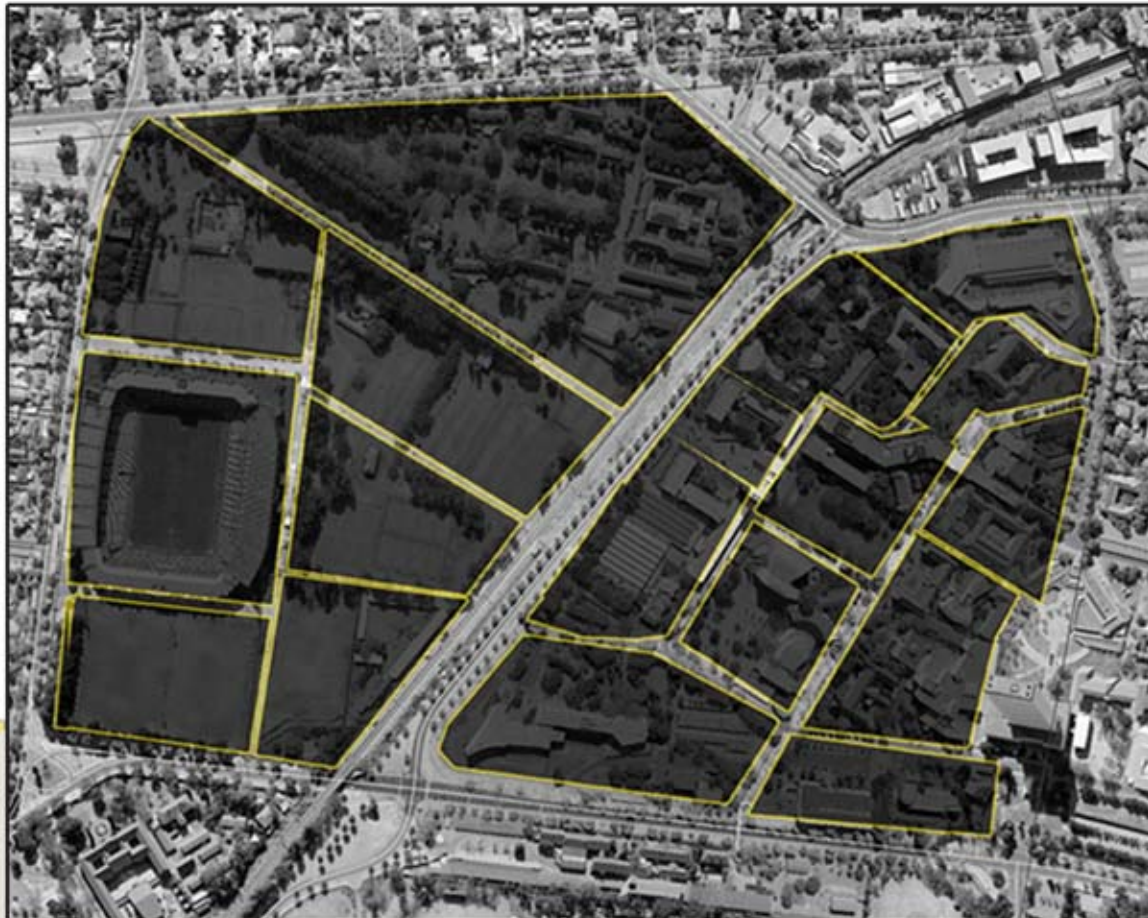
fig. 3.27_Diagram illustrating proposed division of city grid

From the analysis of the project area, one can clearly see that one of the main problems with the site is the large scale of the city block. The city block is too large and results in inadequate pedestrian movement around a vacant area which is inaccessible and detrimental to the proposed train station. Therefore the proposed site will be divided into typical size city blocks (fig. 3.27) with defined edges, activating and reinforcing existing pedestrian routes in the area.

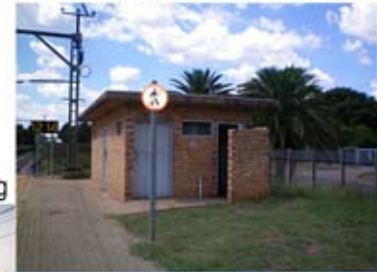
fig. 3.41_Ablution facilities

There are no ticket, control or security offices at this point (fig. 3.33). The provided synthetic lighting is out of order and the ablutions are vandalized and not fit for use (fig. 3.40).
