APPENDICES

121 - LOCAL PRECEDENT TYPOLOGY STUDY

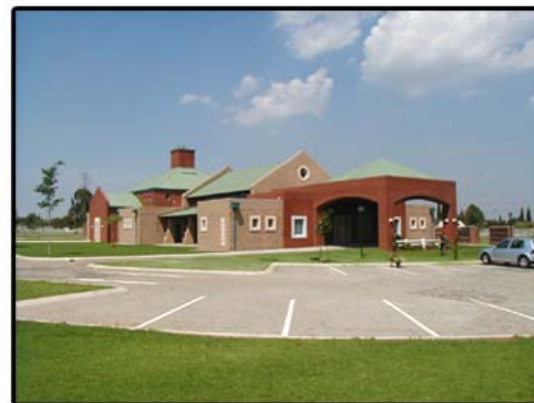
Figure 131: Benoni Crematorium

Description : Face-brick, pitched tiled roof with steel pipe chimneys
 Planning : Rectangular
 Entrance Viewing Room : Yes
 Chapel Location : In front of the cremation room
 Chapel Layout : Christian bench row seating
 Cremator Lobby Type : Lobby hatch
 Mortuary : Yes, 2 bodies
 Stores : 3
 Offices : 2
 Urns Placement : Face-brick remembrance walls

Cremator Manufacturer : American
 Cremator Energy Source : Gas – 4500L tank
 Quantity of Cremators : 2
 Maximum Cremators : 4
 Total Cremations / day : Expected 12

Utilized to Full Potential : No, building standing empty due to Council red-tape
 Meets Health Standards : Designed to latest requirements
 Meets Air Pollution Stds. : Designed to latest requirements

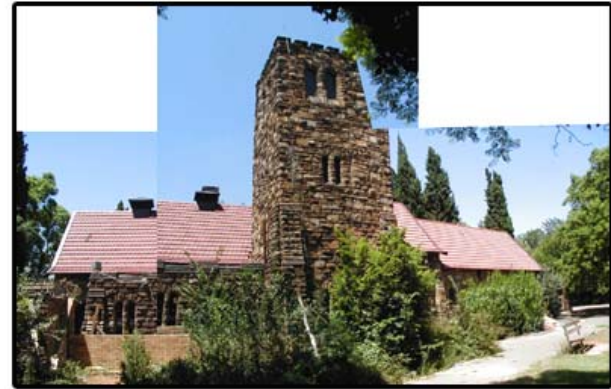
Figure 133: Braamfontein Crematorium

Description : Stone walls, pitched tiled roof with church bell tower, steel chimneys
 Planning : Rectangular
 Entrance Viewing Room : Yes
 Chapel Location : Between Viewing room and the cremation room
 Chapel Layout : Christian bench type row seating
 Cremator Lobby Type : Lobby hatch
 Mortuary : None
 Stores : 1
 Offices : 1
 Urns Placement : Face-brick remembrance walls & basement Mausoleum

Cremator Manufacturer : American
 Cremator Energy Source : Gas – piped by municipality
 Quantity of Cremators : 4
 Maximum Cremators : 4
 Total Cremations / day : 24

Utilized to Full Potential : No, currently under renovation, re-opening April 2003
 Meets Health Standards : Unknown, currently under renovation
 Meets Air Pollution Stds. : Unknown, currently under renovation

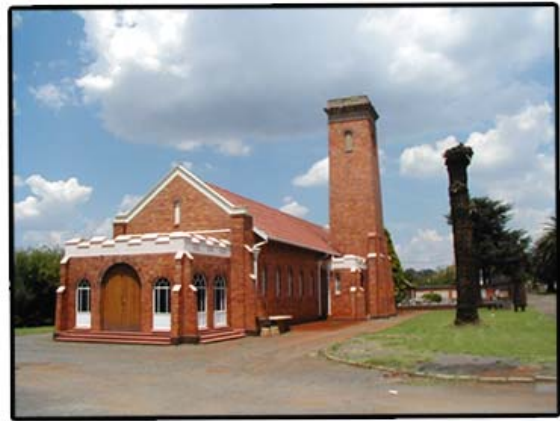
Figure 135: Brakpan Crematorium

Description : Face-brick, pitched tiled roof with church bell tower type chimney
 Planning : Rectangular
 Entrance Viewing Room : No
 Chapel Location : In front of the cremation room
 Chapel Layout : Christian bench row seating
 Cremator Lobby Type : Lobby hatch
 Mortuary : None
 Stores : 1
 Offices : None
 Urns Placement : Face-brick remembrance walls

Cremator Manufacturer : American
 Cremator Energy Source : Gas – 2500L tank
 Quantity of Cremators : 1
 Maximum Cremators : 1
 Total Cremations / day : 4

Utilized to Full Potential : No, chapel never used
 Meets Health Standards : No, cremation room dirty, with ash on the floor
 Meets Air Pollution Stds. : No, smoke visible from chimney

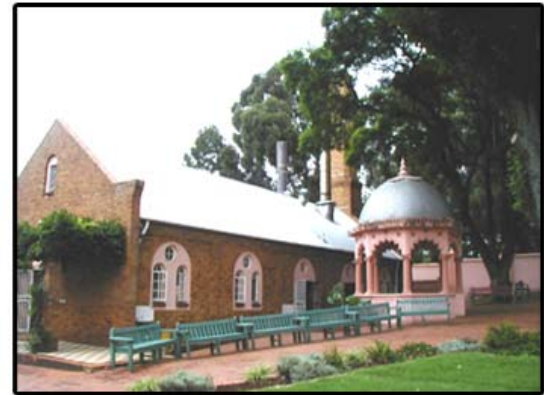
Figure 137: Brixton Crematorium

Description : Face-brick, pitched steel roof with brick bell tower type chimney
 Planning : Rectangular
 Entrance Viewing Room : No
 Chapel Location : In front of the cremation room
 Chapel Layout : Perimeter seating
 Cremator Lobby Type : Lobby hatch
 Mortuary : None
 Stores : 2
 Offices : 2
 Urns Placement : None

Cremator Manufacturer : American
 Cremator Energy Source : Gas – cylinder tanks
 Quantity of Cremators : 2
 Maximum Cremators : 2
 Total Cremations / day : 12

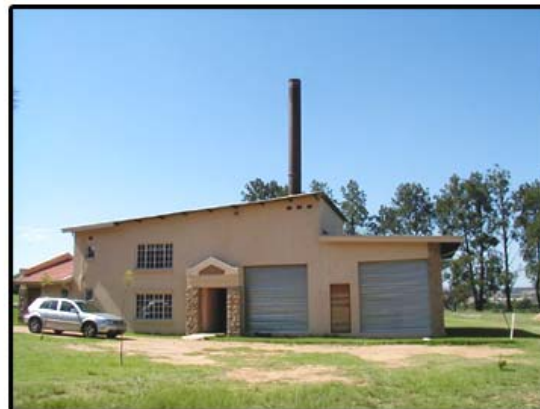
Figure 139: Fourways Crematorium

Description : plaster and paint steel roof with a single steel chimney
Planning : Rectangular
Entrance Viewing Room : Yes
Chapel Location : No chapel
Chapel Layout : None
Cremator Lobby Type : No hatch, access through door way
Mortuary : None
Stores : 2
Offices : 2
Urns Placement : Memorial gardens

Cremator Manufacturer : South African
Cremator Energy Source : Diesel – 2000L tank
Quantity of Cremators : 1
Maximum Cremators : 2
Total Cremations / day : 6

Utilized to Full Potential : Yes
Meets Health Standards : 50%, ash on floor
Meets Air Pollution Stds. : Unknown

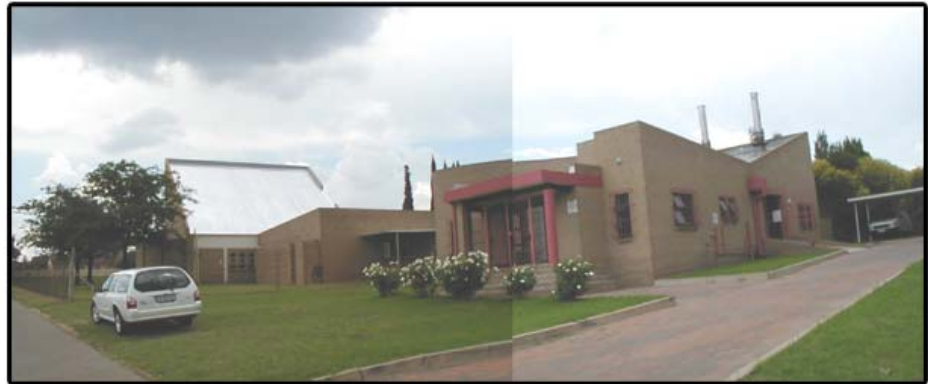
Figure 141: Kempton Park Crematorium

Description : Face-brick, mono pitched steel roof with steel pipe chimneys
 Planning : Rectangular
 Entrance Viewing Room : Yes
 Chapel Location : In separate building adjacent to crematorium
 Chapel Layout : Christian bench row seating
 Cremator Lobby Type : Lobby hatch
 Mortuary : Yes, 15 bodies
 Stores : 3
 Offices : 2
 Urns Placement : Face-brick remembrance walls

Cremator Manufacturer : American
 Cremator Energy Source : Gas – 4500L tank
 Quantity of Cremators : 2
 Maximum Cremators : 2
 Total Cremations / day : Expected 16

Utilized to Full Potential : Yes
 Meets Health Standards : 50%, reasonably clean with ash on floor, strong smell in the air
 Meets Air Pollution Stds. : No, smoke visible from chimney

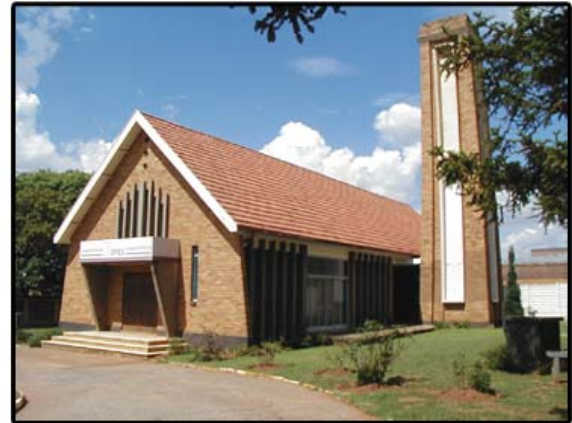
Figure 143: Krugersdorp Crematorium

Description : Face-brick, pitched tiled roof with church bell tower type chimney
 Planning : Rectangular
 Entrance Viewing Room : No
 Chapel Location : In front of the cremation room
 Chapel Layout : Christian bench row seating
 Cremator Lobby Type : Lobby hatch
 Mortuary : None
 Stores : 1
 Offices : None
 Urns Placement : Face-brick remembrance walls

Cremator Manufacturer : American
 Cremator Energy Source : Gas – 4500L tank
 Quantity of Cremators : 1
 Maximum Cremators : 1
 Total Cremations / day : 6

Utilized to Full Potential : No, chapel never used
 Meets Health Standards : No, cremation room dirty, with ash on the floor
 Meets Air Pollution Stds. : No, smoke visible from chimney

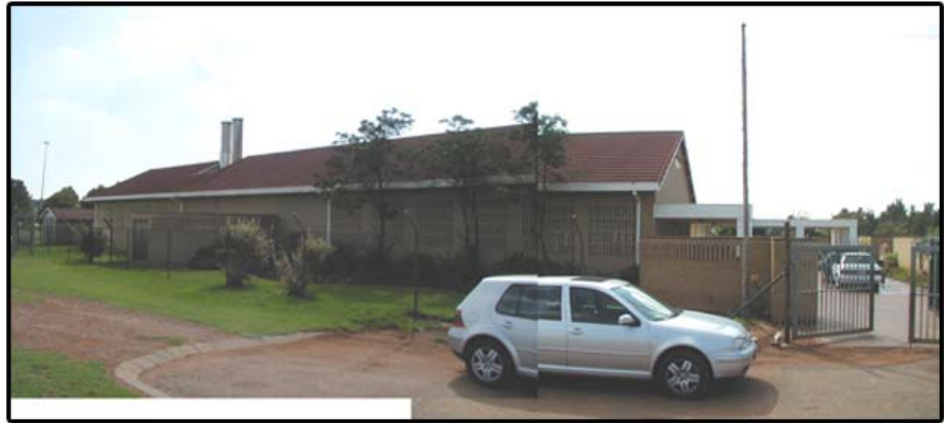
Figure 145: Lenasia Crematorium

Description : Face-brick walls, pitched tiled roof with steel chimneys
 Planning : Rectangular
 Entrance Viewing Room : No, to side of chapel
 Chapel Location : In front of the cremation room
 Chapel Layout : Benches to perimeter of chapel
 Cremator Lobby Type : Lobby hatch
 Mortuary : None
 Stores : 1
 Offices : 1
 Urns Placement : Face-brick remembrance walls

Cremator Manufacturer : American
 Cremator Energy Source : Gas – 4500L tank
 Quantity of Cremators : 3
 Maximum Cremators : 4
 Total Cremations / day : 15

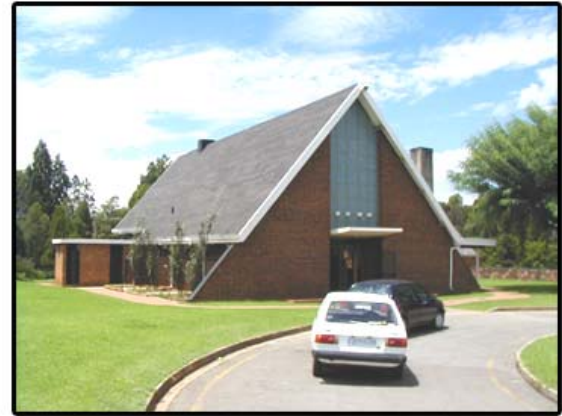
Figure 147: Pretoria Crematorium

Description : Face-brick walls, pitched roof tiles, concrete chimney
 Planning : Rectangular
 Entrance Viewing Room : No
 Chapel Location : In front of cremation room
 Chapel Layout : Christian bench type row seating
 Cremator Lobby Type : Drop type hatch
 Mortuary : None
 Stores : 1
 Offices : 2
 Urns Placement : Brick and stone remembrance walls

Cremator Manufacturer : American
 Cremator Energy Source : Gas – 4500L tank
 Quantity of Cremators : 4
 Maximum Cremators : 4
 Total Cremations / day : 24

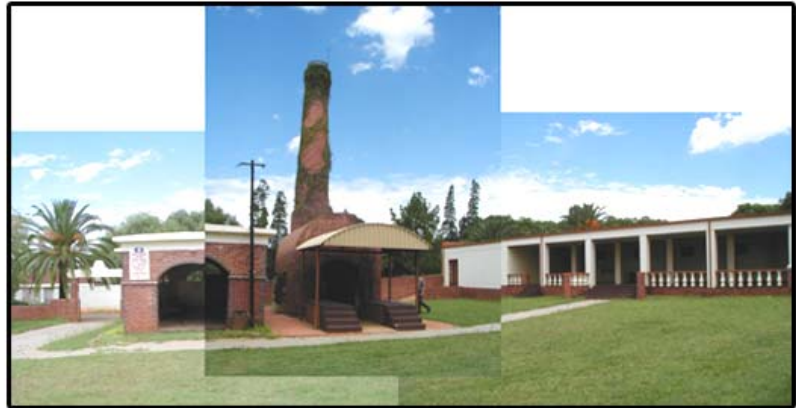
Figure 149: Pretoria Hindu Crematorium

Description : Face-brick walls, brick dome roof, brick chimney
 Planning : Rectangular
 Entrance Viewing Room : No
 Chapel Location : None, covered area adjacent to cremator
 Chapel Layout : None
 Cremator Lobby Type : None, open to the air
 Mortuary : None
 Stores : 1
 Offices : 1
 Urns Placement : None

Cremator Manufacturer : Unknown
 Cremator Energy Source : Wood furnace, 400kg per cremation
 Quantity of Cremators : 1
 Maximum Cremators : 1
 Total Cremations / day : 2
