## **CHAPTER 3**

### **CREEP ANALYSIS FOR UHMWPE**

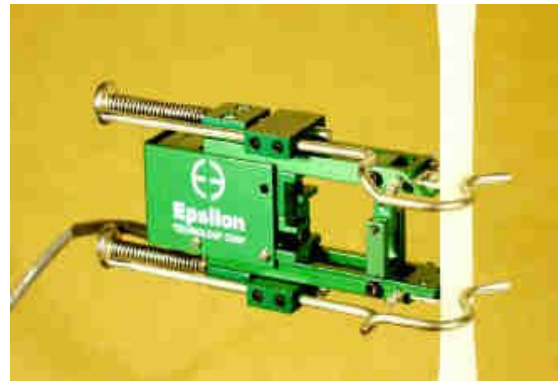
The test pieces were placed, individually, in a Schenk testing machine (100 kN) and loaded to the equivalent of 8 MPa in compression. (See Figure 3.4 for the test configuration in the Schenk Hydro-pulse testing machine.) With this machine, it is possible to load a test piece in tensile and compression under computerised control. The load applied to the test piece was determined as follows: the most common size femoral head that is used is 28 mm in diameter. The maximum projected area in the

The displacement was measured by making use of a calibrated clip-on extensometer, while the load was measured with a calibrated 500 kg load cell. According to the ASTM standard (ASTM D2990, 1990), the load was applied within three seconds and kept on the test piece for one hour. The displacement data was recorded and plotted. The data was sampled at a rate of 50 Hz resulting in  $1.8 \times 10^5$  data points over a one-hour period.

Figure 3.4a: Test set-up in Schenk testing machine

Figure 3.4b: Clip-on extensometer

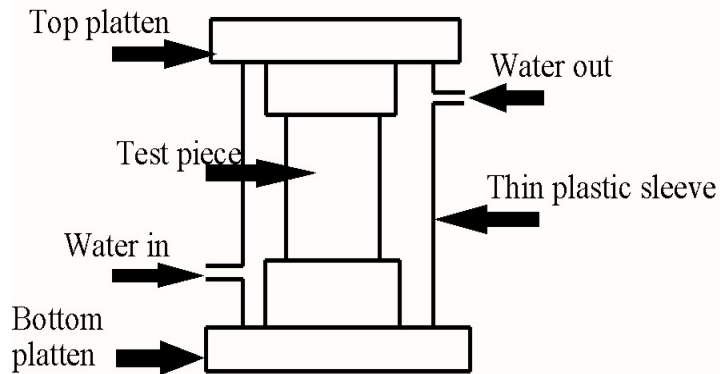
Figure 3.10: Test set-up for tests at elevated temperatures

The temperature was monitored by placing a thermocouple down the centre of the test piece, measuring the core temperature of the test piece. This was done to ensure that the complete test piece was at the specified temperature and not only the outside. The test piece was heated up by circulating hot water around the test piece until the core had reached the desired temperature. The test set-up is shown in Figure 3.10. The rest of the test procedure remains as described earlier.

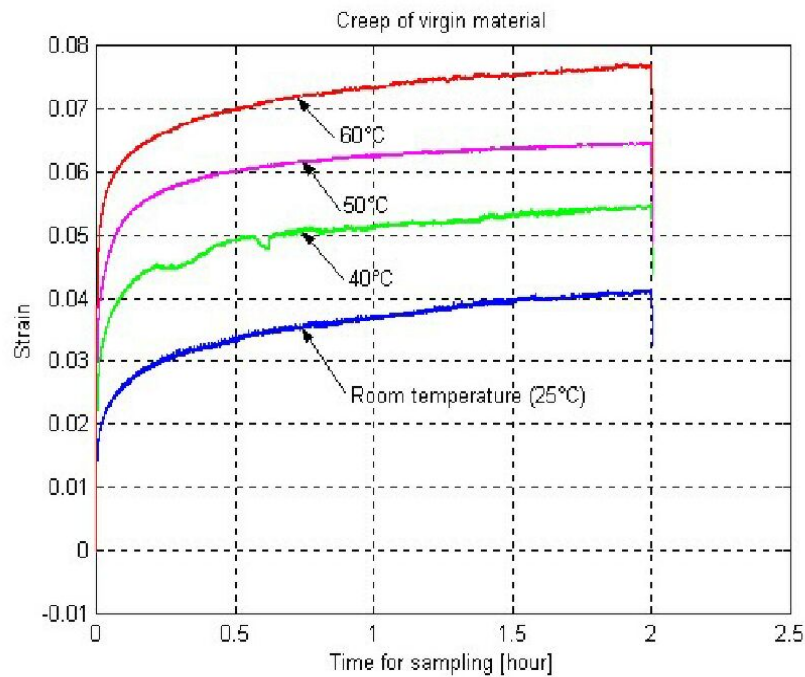
Figure 3.11: Summary of creep results at elevated temperatures

The summary of the results of the tests at elevated temperatures are shown in Figure 3.11

From the data as presented in Figure 3.11 and Table 3.2, it can be seen that there is a substantial difference in the creep properties of UHMWPE at room temperature and at 60°C. The difference in the creep values done at room temperature and at 60°C is 87% or 0.716 mm as measured over a two-hour period. The total amount of creep, at 60°C, after two hours was 1.5 mm.

The test data as presented above correlates with the data presented by Meng Deng and Latour (1998). Although Meng Deng and Latour (1998) do not present actual data values they report an increase in the creep values of 80% if the temperature is taken from 37°C to 62°C. The creep test data illustrates that at elevated temperature the material softens to such an extent that extrusion of material in the local hot spot areas will be possible.

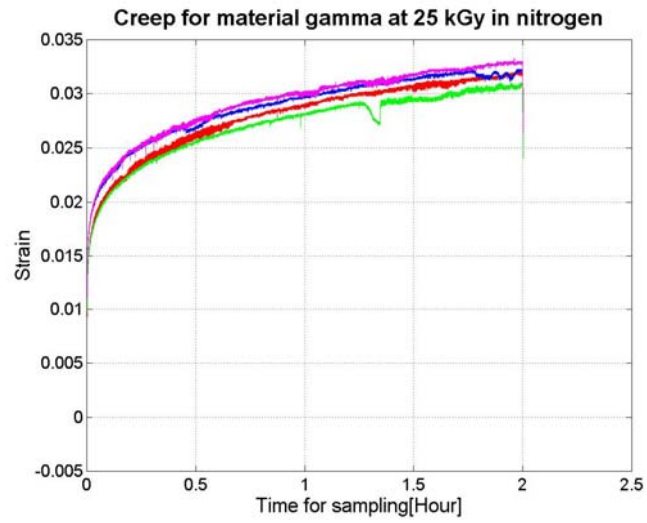
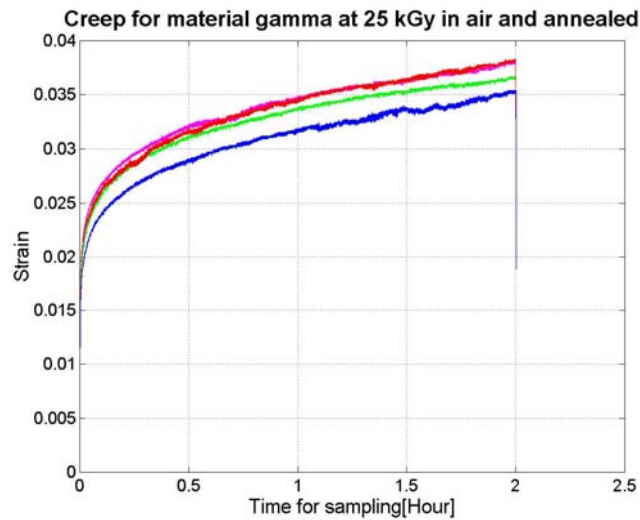
The test results to determine the effect of gamma irradiation are shown in Figure 3.12 (irradiation in air), Figure 3.13 (irradiation in nitrogen) and Figure 3.14 (irradiation in air and heat-treated to achieve annealing).

Figure 3.12: Creep properties of material irradiated in air

Figure 3.13: Creep properties of material irradiated in nitrogen atmosphere

Figure 3.14: Creep properties of material radiated in air and heat-treated at 80°C and tested at room temperature

If the data as presented in Figures 3.12 to 3.14 is compared to the creep property data in the literature (Lee & Pienkowski, 1998; Meng Deng & Latour, 1998) and taking the data from paragraphs 3.2 and 3.4 into account, it can be seen that there is a slight decrease in the creep values for UHMWPE. However, the annealed material showed a substantial increase in the amount of creep (see Table 3.3).

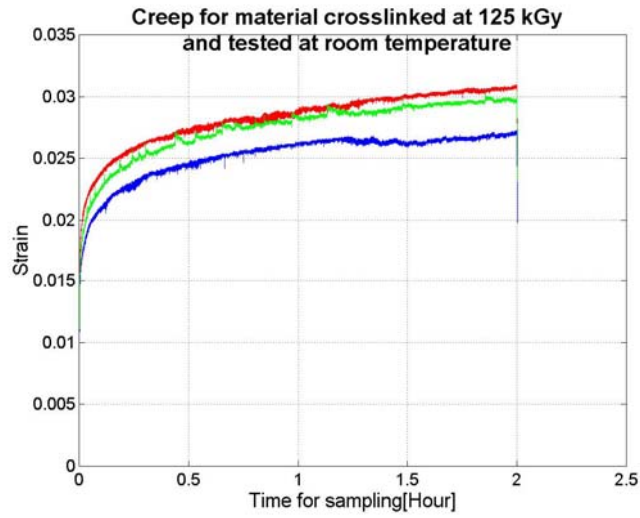
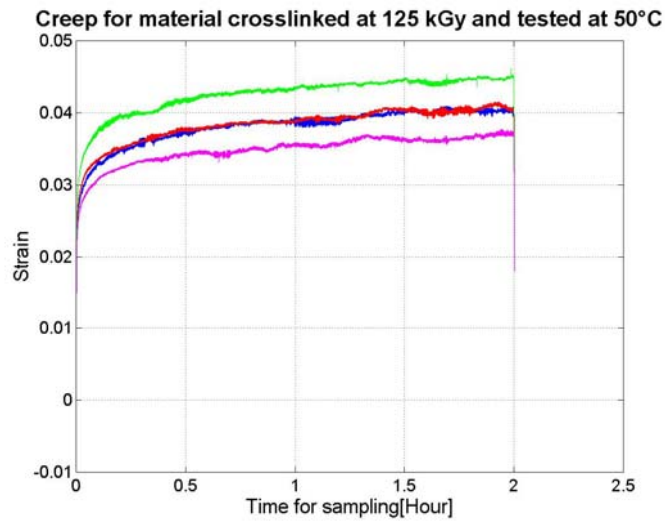
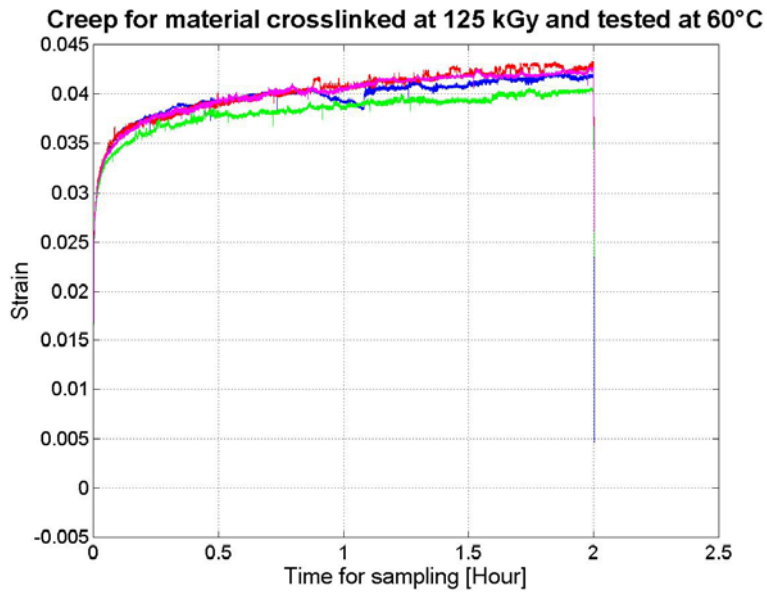
The test results of the gamma crosslinked test pieces are shown in Figure 3.15 (room temperature), Figure 3.16 (creep at 50°C) and Figure 3.17 (creep at 60°C).

Figure 3.15: Creep properties of crosslinked UHMWPE at room temperature

Figure 3.16: Creep properties of crosslinked UHMWPE tested at 50°C

Figure 3.17: Creep properties of crosslinked UHMWPE tested at 60°C

The summary of the test data compared to the data of virgin material can be seen in Table 3.4. The creep data is average values.

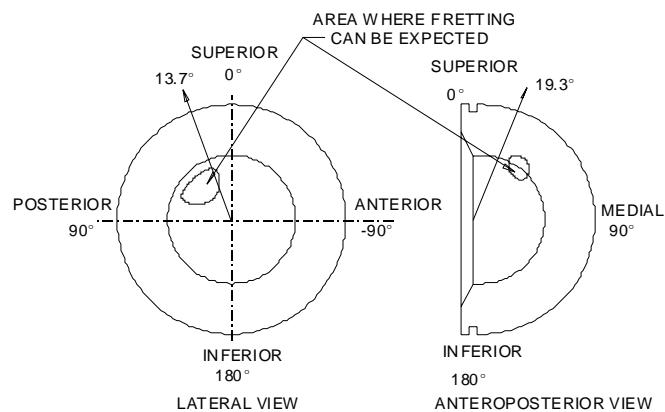
Figure 4.9: Schematic presentation of expected adhesion wear marks

and subsequent movement causes the asperities of the softer surface to be torn out, rather than breaking the bond between the asperities, the process is called *adhesion wear*, typically the areas present as rough patches and are seen in the high contact stress areas where lubrication is the poorest. An example of an acetabular cup with signs of adhesion wear is shown in Figure 4.8 and a schematic presentation of the defect is shown in Figure 4.9.
