**BITUMINOUS PAVEMENT  
REHABILITATION DESIGN**

Gerrit Jacobus Jordaan

A dissertation submitted as part fulfilment for the degree

Master of Science in Engineering (Civil)  
in the Faculty of Engineering  
University of Pretoria

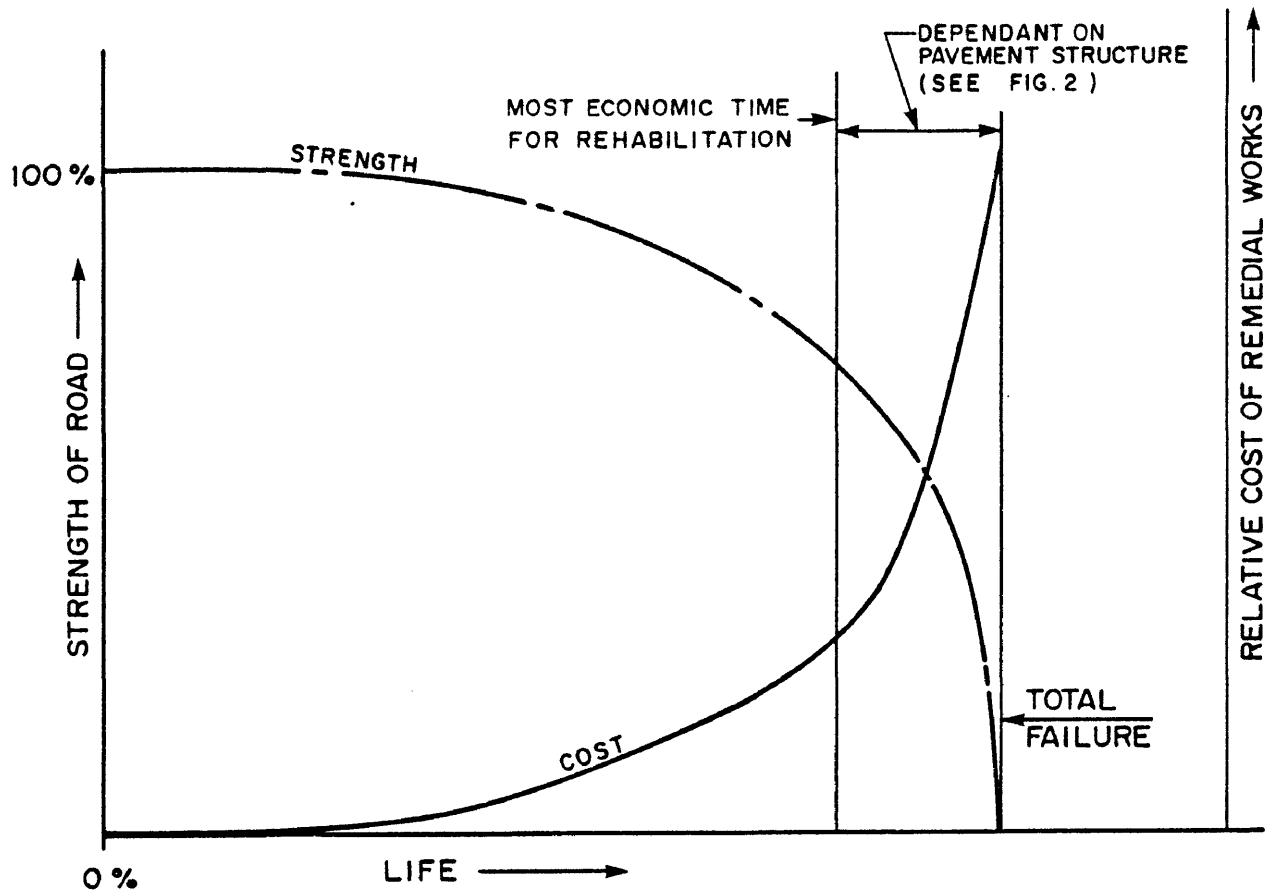
FIGURE 1 <sup>(14) (15)</sup>

ILLUSTRATION OF THE CRITICAL EFFECT OF THE TIME OF REHABILITATION ON THE COST OF REHABILITATION

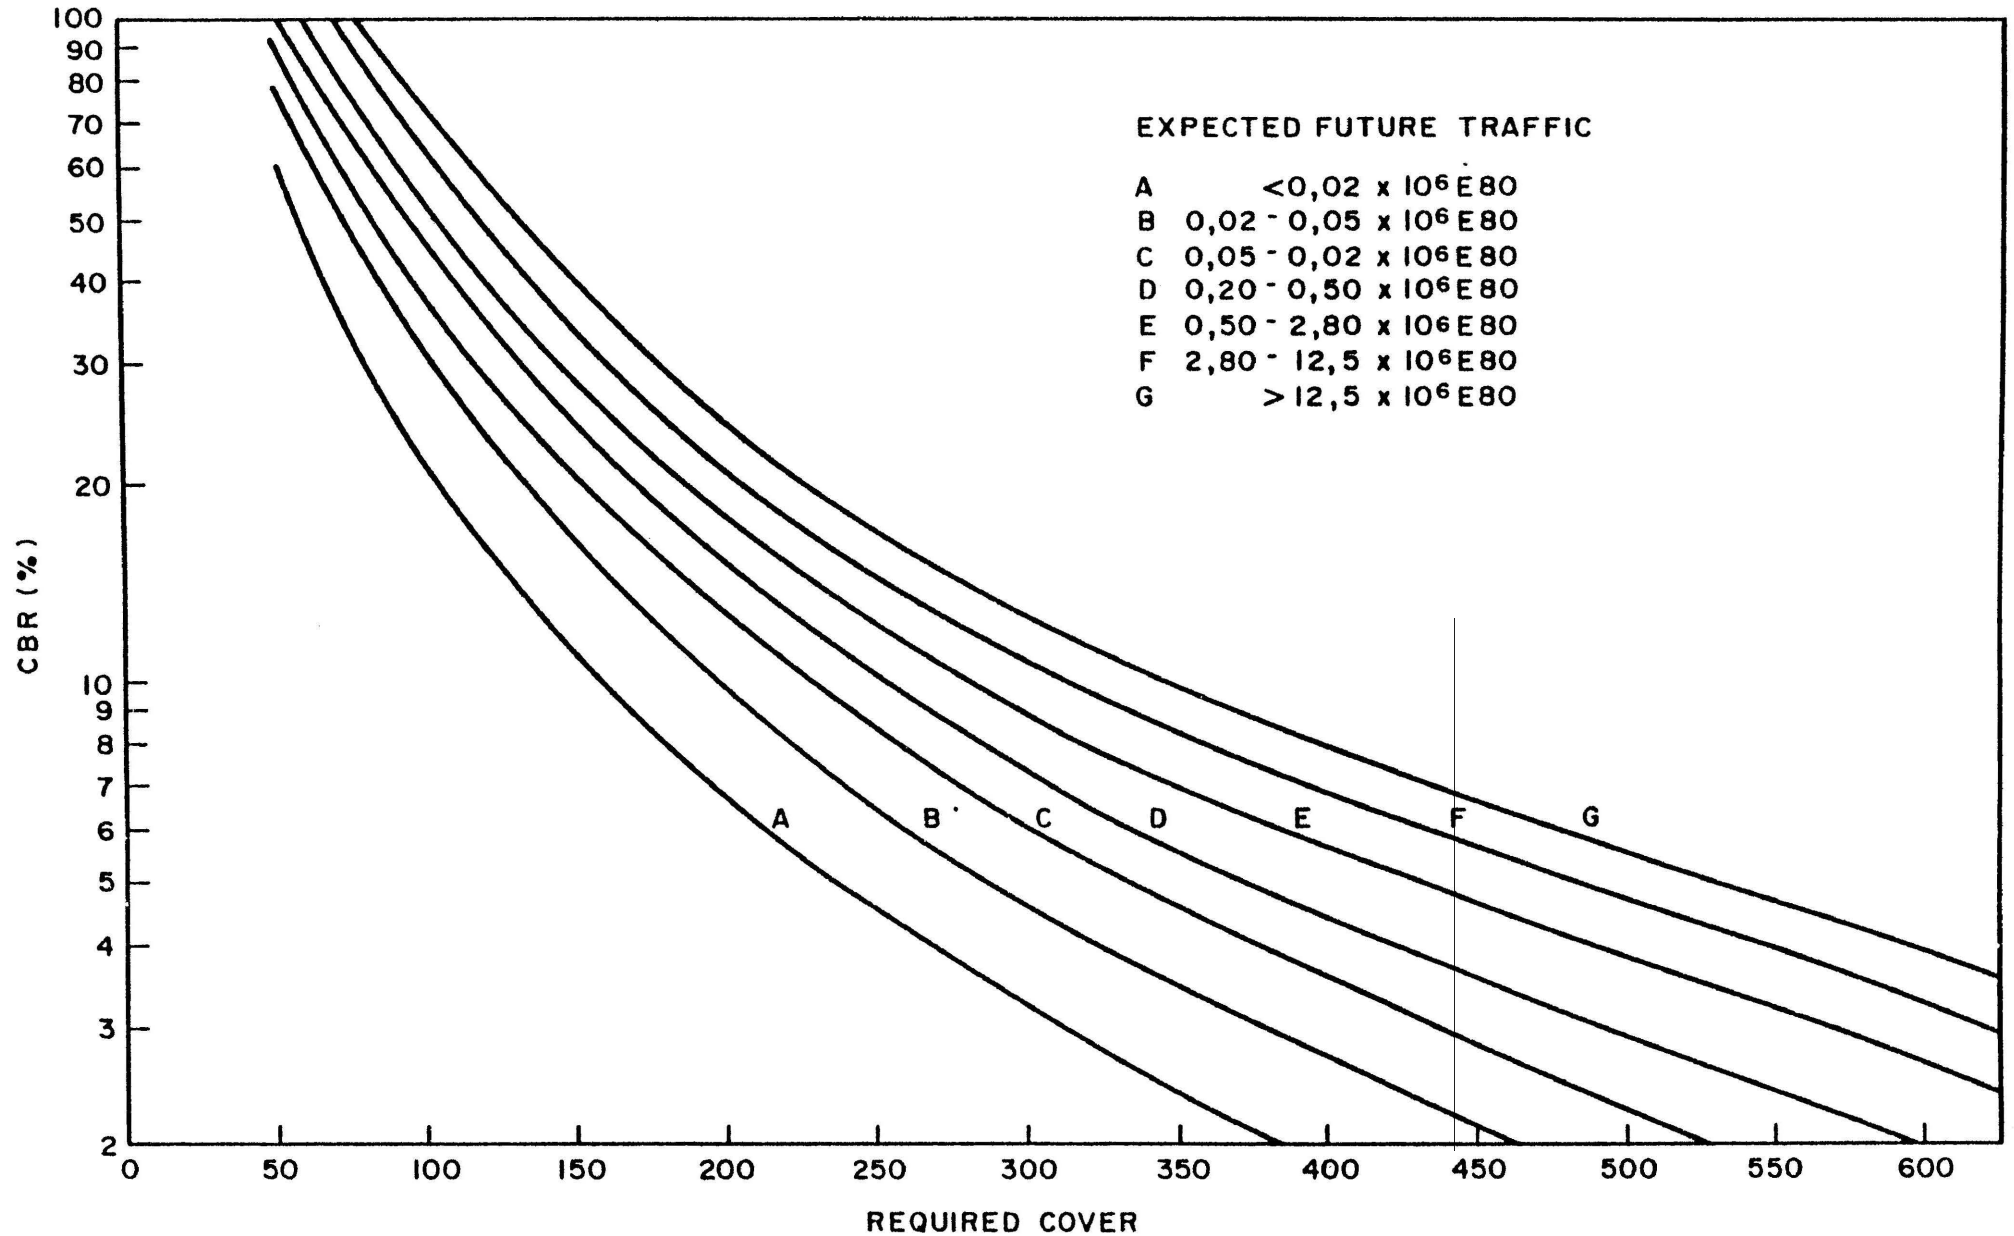
FIGURE 17  
COVER REQUIREMENT BASED ON CBR (27,28)

With available CBR results and the calculated expected future traffic for the rehabilitation design period, Figure 17 is used to obtain the cover required for each pavement layer.

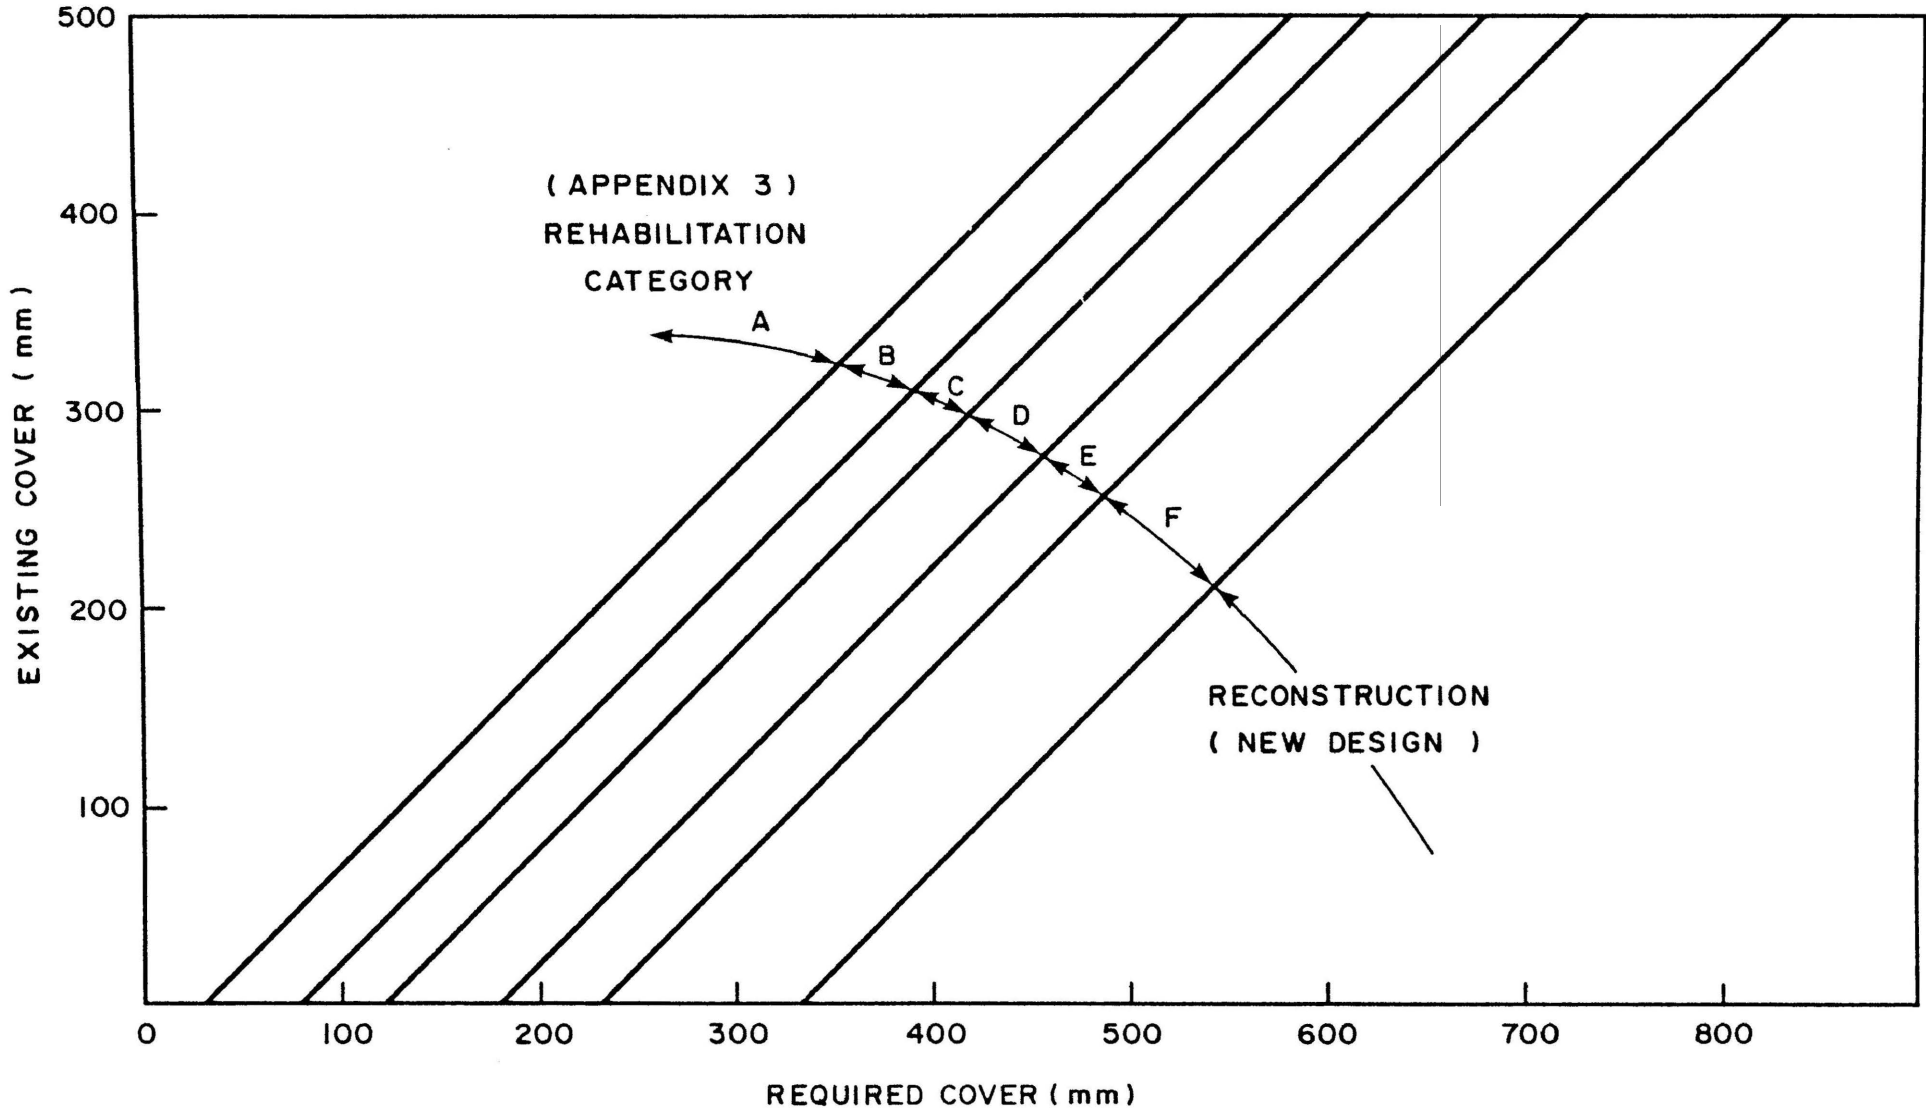
FIGURE 19  
*REHABILITATION CATEGORY CHART*

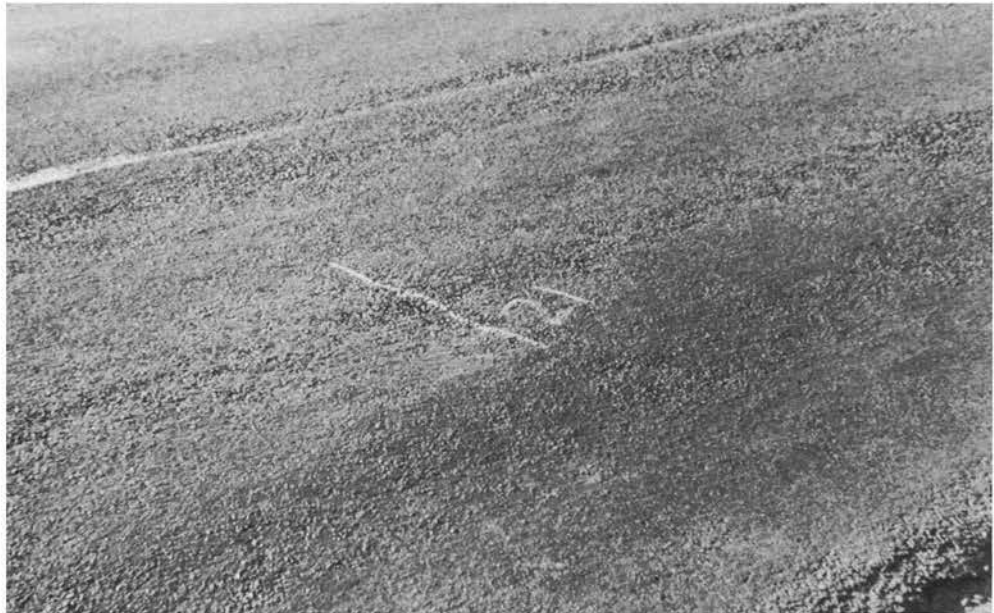
PHOTOGRAPH 2: Km 21 - Typical transverse crack shown with trafficking closing the crack in the wheelpaths (Section 1A)

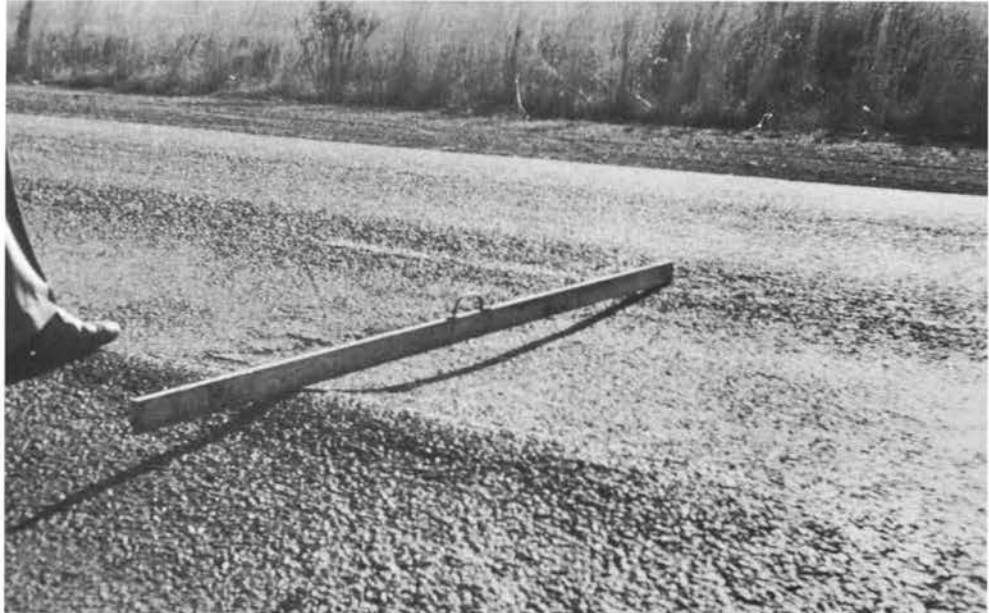
PHOTOGRAPH 3: Km 28,7 - Serious distress in the form of pavement layer failure is very evident in this section

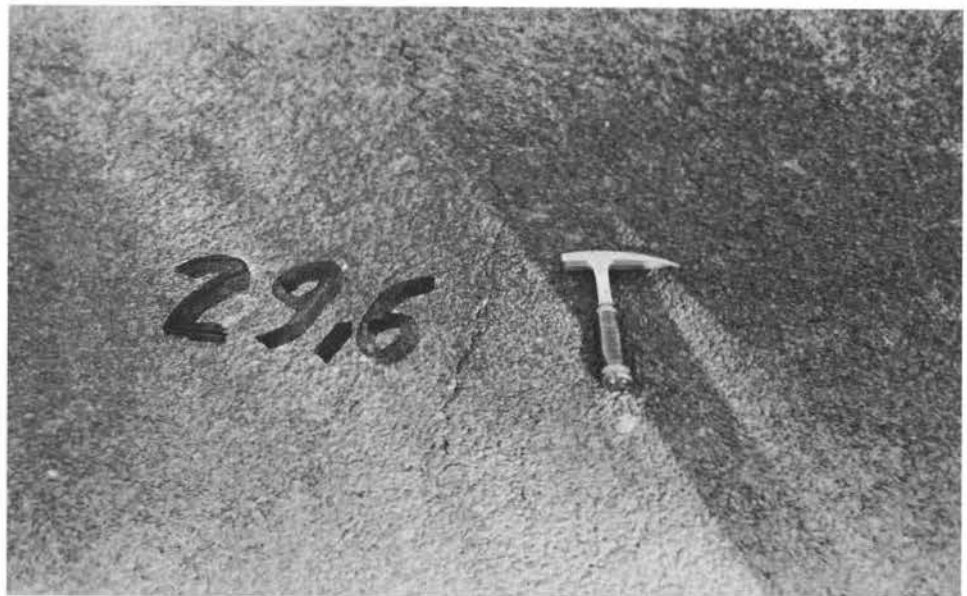
PHOTOGRAPH 4: Km 29,6 A typical transverse crack in the middle of a lane on Section 1C

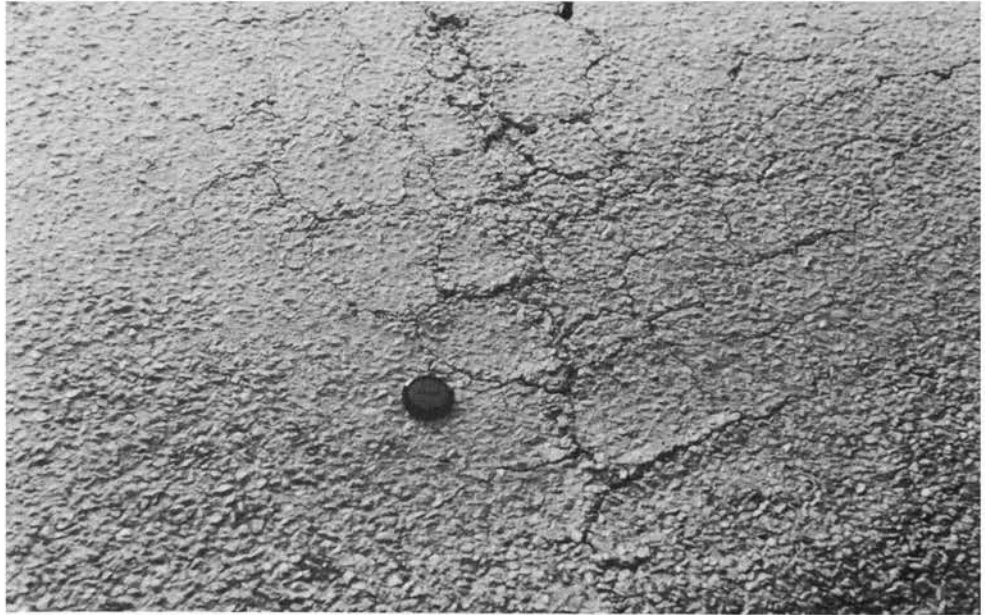
PHOTOGRAPH 5: Km 34,2 - Secondary crocodile cracking developing around a transverse crack

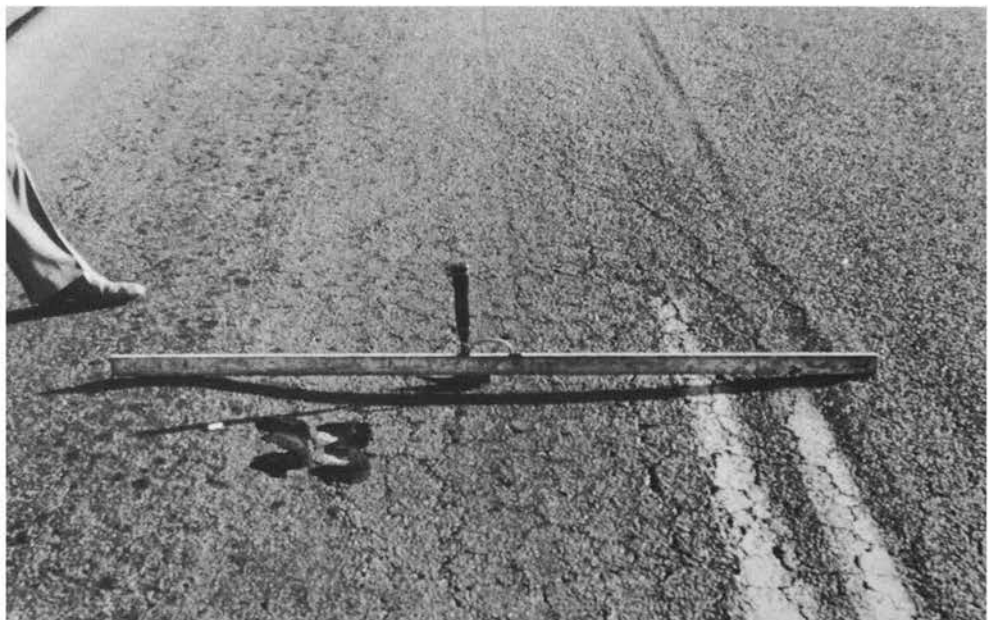
PHOTOGRAPH 6: Km 33,60 - Wide rutting with crocodile cracking indicating subgrade deformation

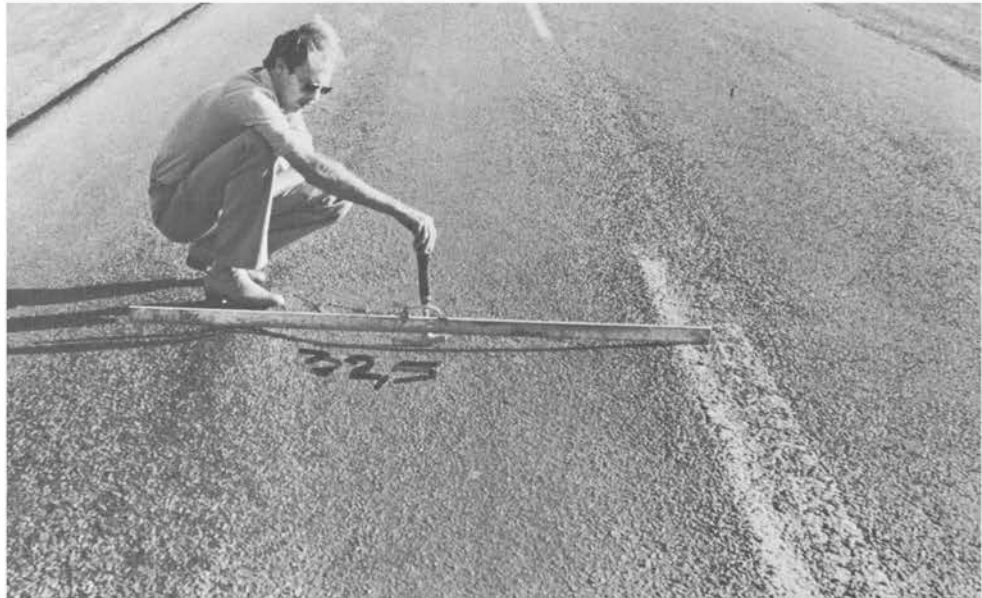
PHOTOGRAPH 7: Km 32,5 - "heaving" of the surface and base material between the wheelpaths indicating pavement layer shear distress

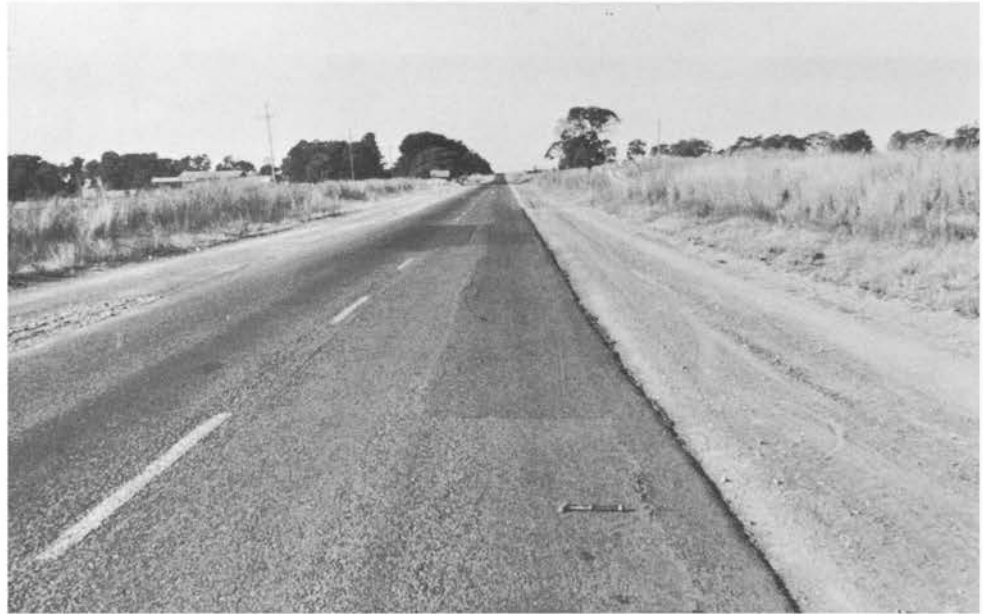
PHOTOGRAPH 8: Km 39,6 - Extensive patching with severe distress evident.

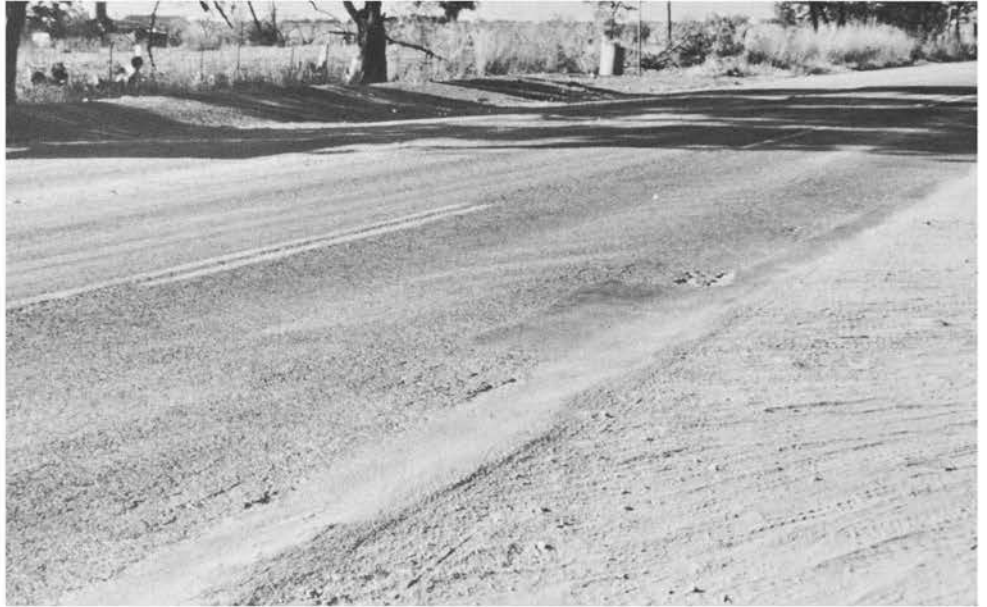
PHOTOGRAPH 10: Km 40,0 - Extensive patching, rutting, cracking and breaking up of the surface

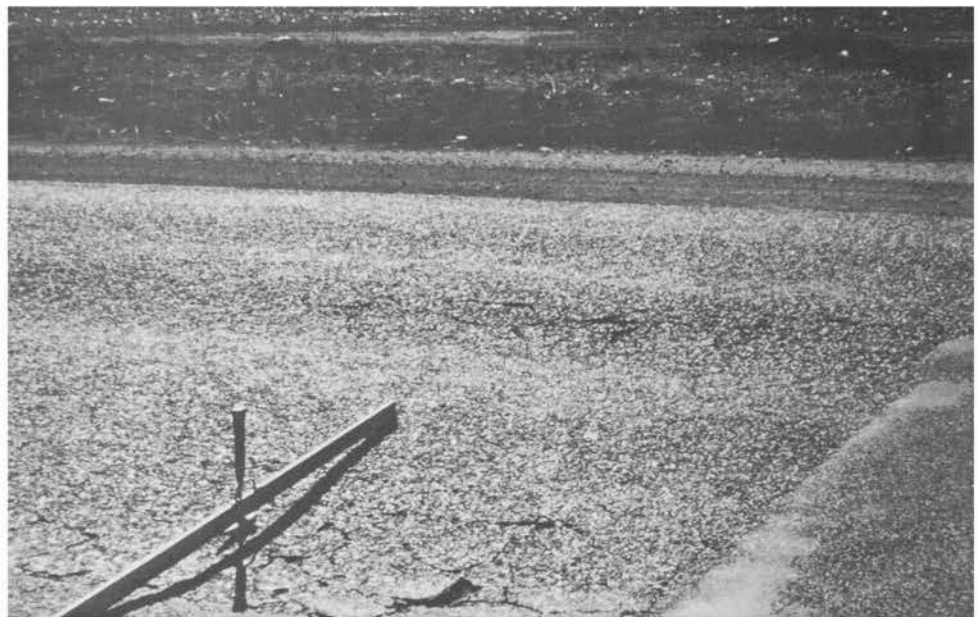
PHOTOGRAPH 11: Km 44,2 - Severity of the distress in this section is clearly shown by the rutting, patching and cracking patterns

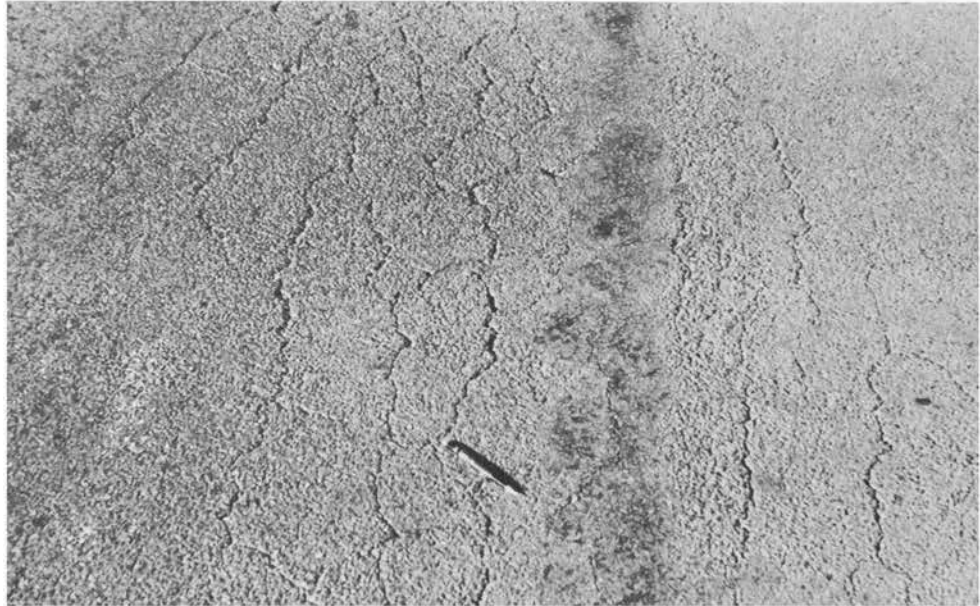
PHOTO .PH 13: Km 43,6 - Close-up of the surface of the road in Photograph 12, showing severe crocodile cracking

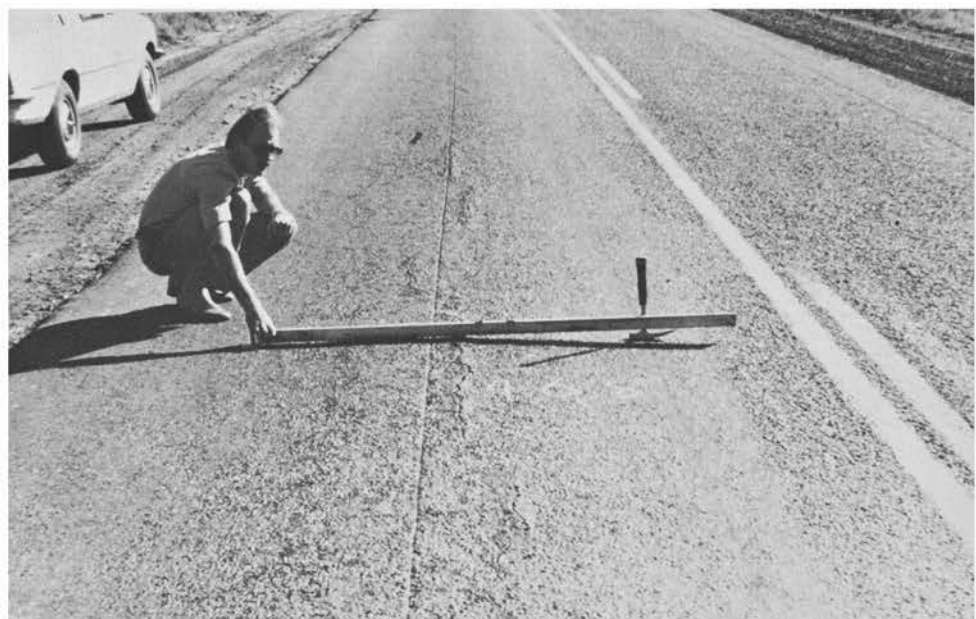
PHOTOGRAPH 14: Km 46,8 - Serious subgrade-associated deformation is evident in this section

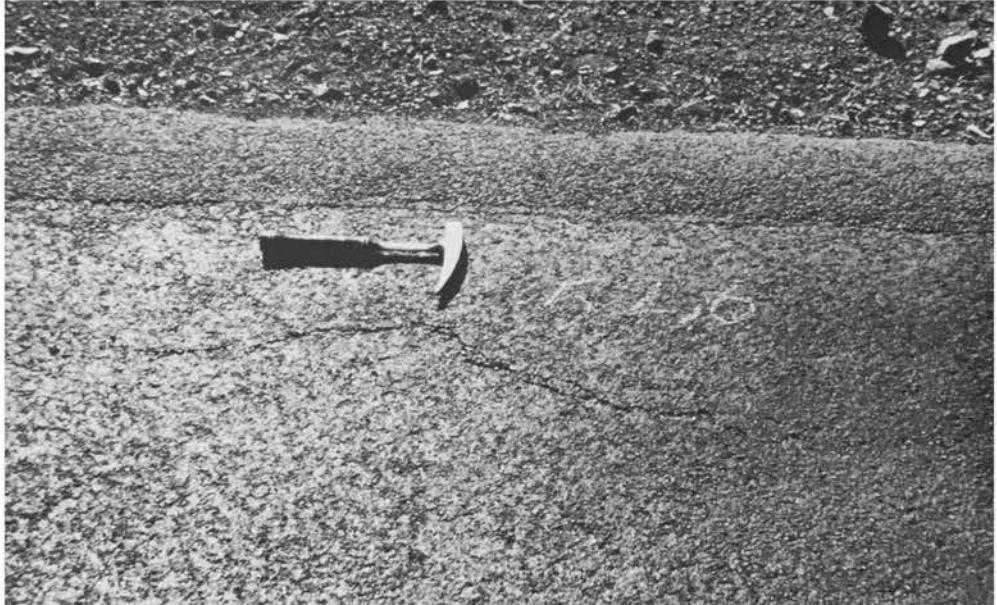
PHOTOGRAPH 16: Km 52,6 - Longitudinal cracking

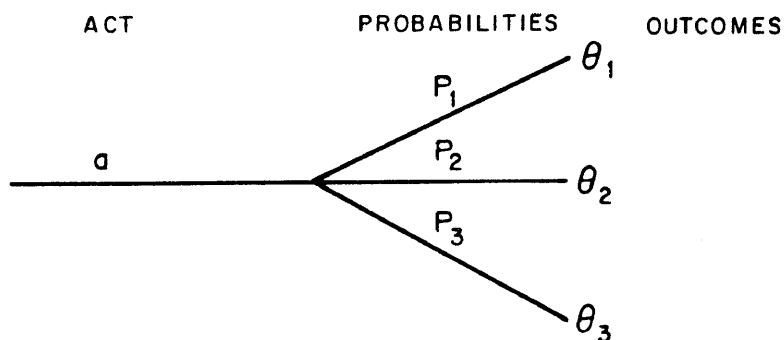
**FIGURE 55**  
**EXAMPLE OF A GIVEN ACT WITH THREE POSSIBLE**  
**OUTCOMES**
