ADDRESSING NON-MOTORISED TRANSPORT MOVEMENT ALONG AND ACROSS RAILWAY LINES IN THE CITY OF CAPE TOWN

Y VENTER*, L HERMANT*, K SHIRLEY*, E TUKUSHE** and T KOK**

Hatch Goba (Pty) Ltd, P O Box 3878, Tyger Valley 7536

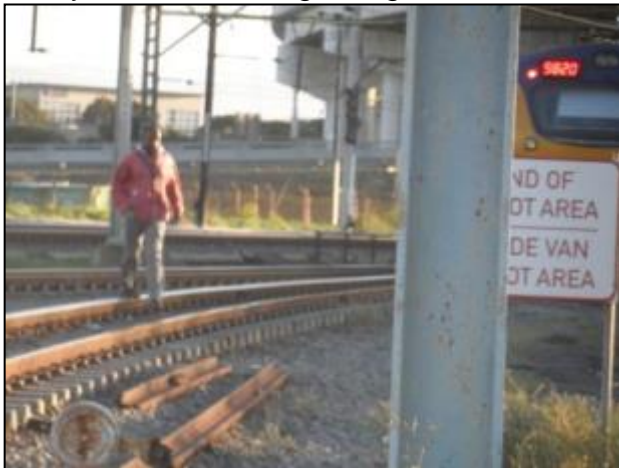
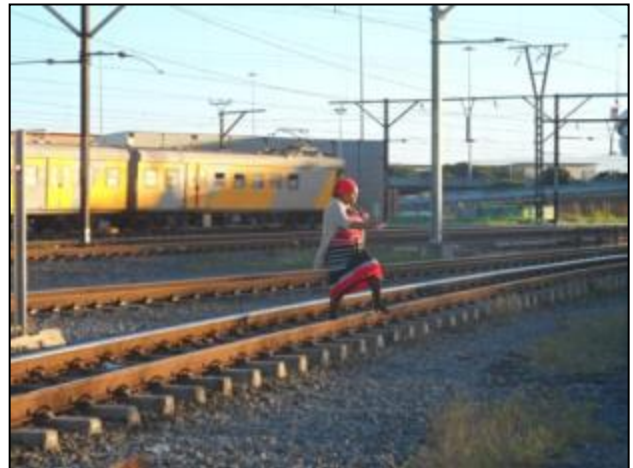
Figure 1(a) and 1(b): Examples of pedestrians crossing the railway line

The main objective of this study was to suggest ways to create a safe environment for NMT users crossing the Citywide Railway-line Corridors, which was done through a comprehensive study of non-motorised transport movement along and across all railway lines, within the jurisdictional area of the City of Cape Town, using innovative video-based techniques and assessed using GIS-mapping methods. The investigation identified several “hotspot” locations where various types of recommendations and/or intervention strategies are urgently needed to enhance public (pedestrian) safety and ensure uninterrupted train service. Intervention strategies proposed have been drawn from international best practice tailored to suit the unique South African pedestrian culture. The study incorporated three distinct phases viz. a status quo investigation¹ of the current rail network operations; a situational analysis and finally the interventions and recommendations based on the situational analysis. Figures 1(a) to 1(d) show pedestrians within the railway reserve near Ysterplaat Station (Cape Town), either illegally crossing the railway lines or walking alongside it.

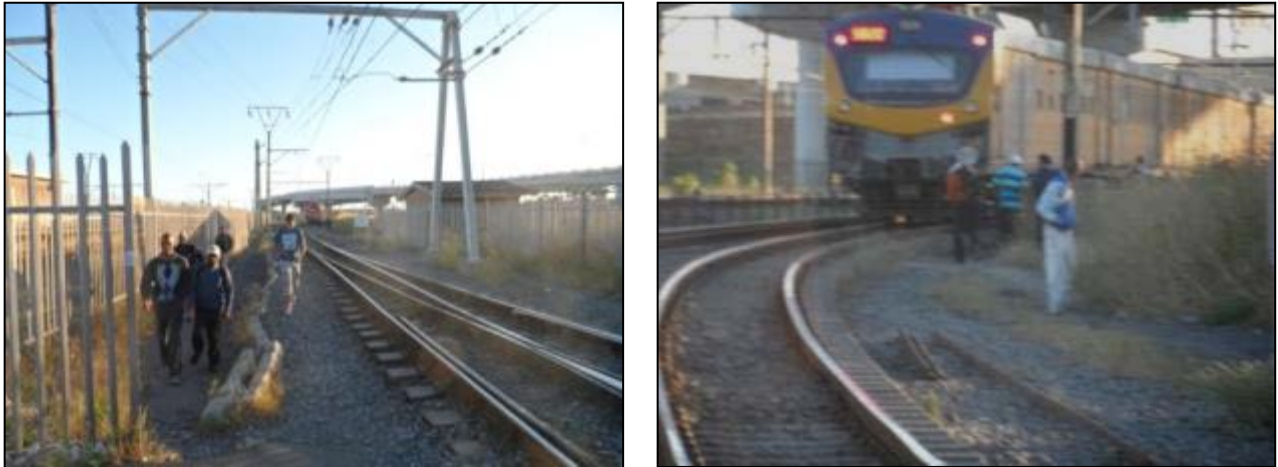
Figure 1(c) and 1(d): Examples of pedestrians walking along the railway line

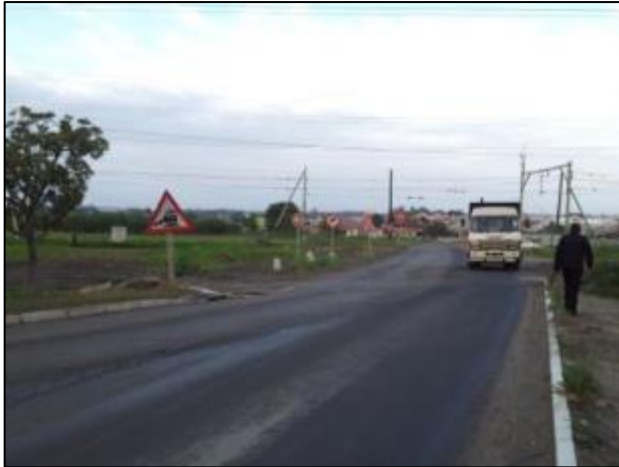
Figure 3(a) shows a poorly maintained vehicle level crossing with very little protection and safety for the users, while Figure 3(b) shows a pedestrian level crossing providing no formal walkway and/or universal accessibility leading to the pedestrian level crossing.

Figure 3(a): Level Crossing at Eerste River

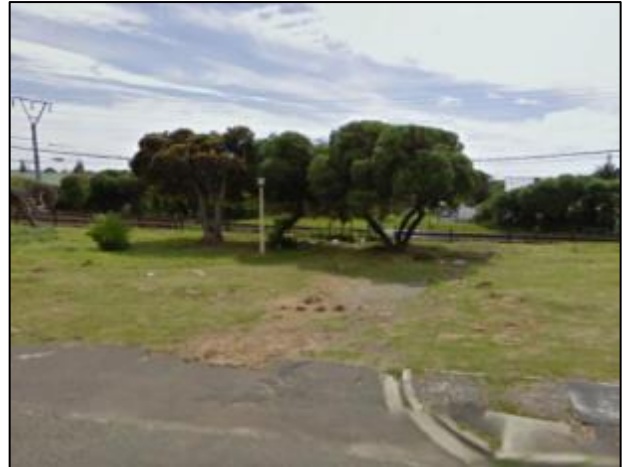
Figure 3(b): Pedestrian Level Crossing at Lakeside B

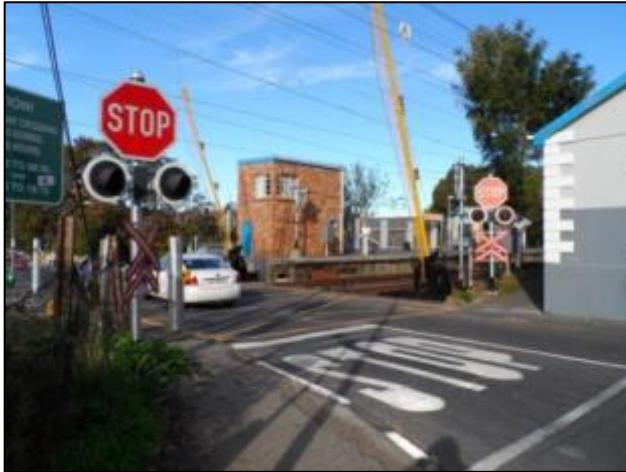
Figure 4(a): Kenilworth

Figures 4(a) and 4(b) show well-maintained vehicle and pedestrian level crossings with good pedestrian protection and access control.

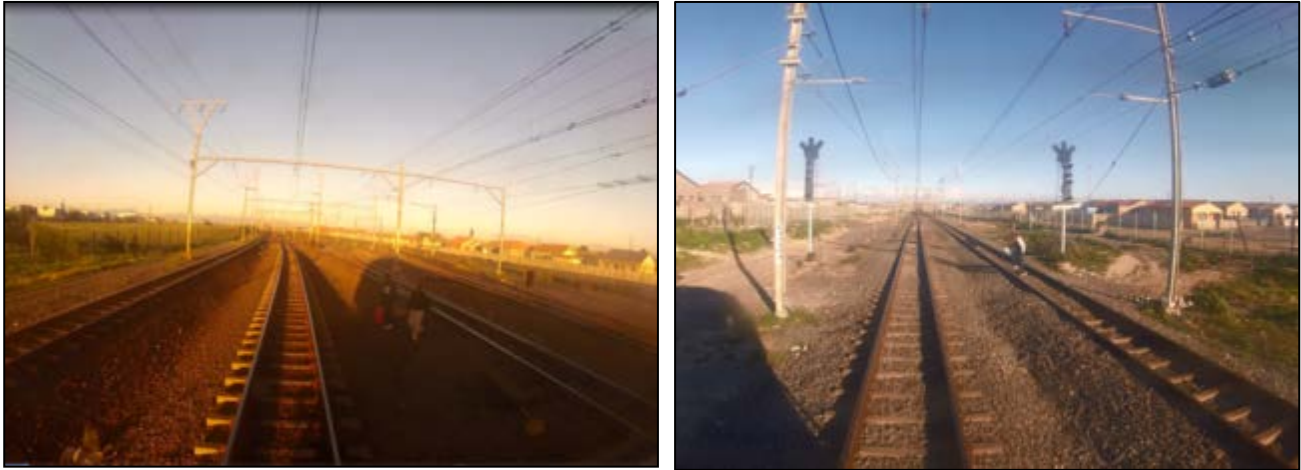
Video footage was undertaken “on-track” to assist towards identifying actual NMT movement along and across the railway lines in the study area. High quality video recording devices were mounted on the front and back of train coaches in order to capture all the possible movements. The particular video recording devices used have a wide-angle view lens which made it possible to also capture general fencing conditions in addition to the NMT movement along the railway lines (see Figure 5(a) and 5(b)).

Figure 5(a) and 5(b): Video Footage excerpts showing wide angle view

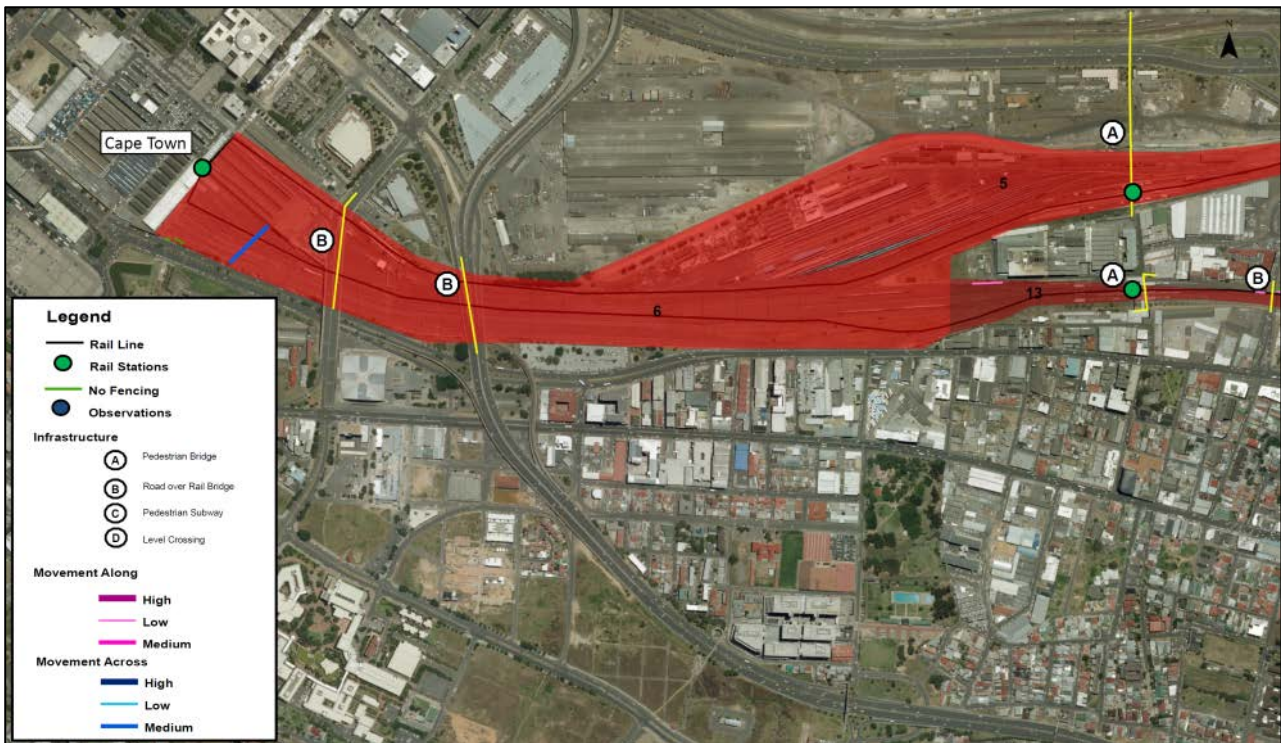
The video footage was then captured onto GIS Mapping (see Figure 6) indicating the following attributes:

- NMT Movement along railway line (identified as either Low, Medium, or High movement);
- NMT Movement across railway line (identified as either Low, Medium, or High movement);
- Infrastructure (Pedestrian bridge/subway, road bridge and level crossings);
- Locations where there is a lack of fencing.

Figure 6: GIS Mapping of Video Observations

* Red colouring indicates accident zone with the number displaying the accident rating

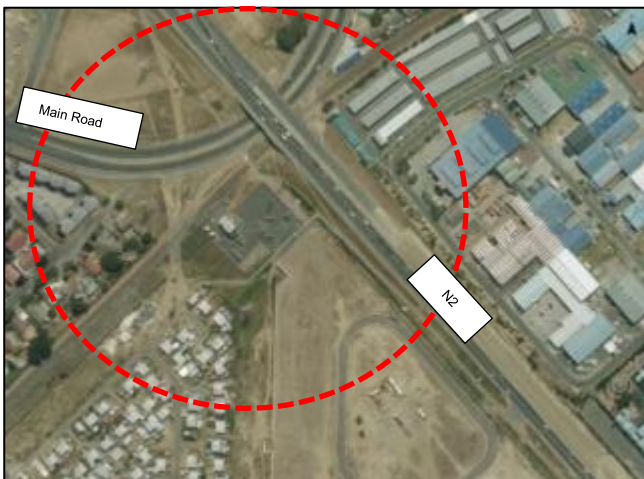
The “Nomzamo crossing” is located in the Strand area between the Van der Stel and Strand railway stations (see Figure 8(a)) and provides the communities of Asanda, Nomzamo and Lwandle direct access to Strand Main Road. From the Main Road, NMT movement is towards the Van der Stel Station, the Somerset-West CBD, Strand CBD and the industrial and commercial areas.

Figure 8(a): Nomzamo study area

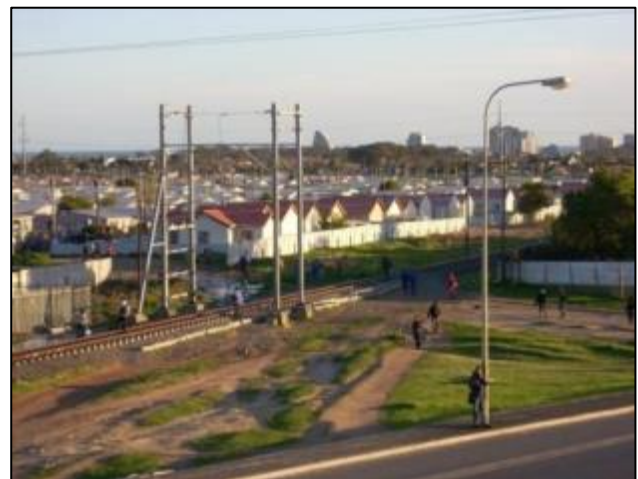
Awareness of the large volume of NMT movement (pedestrians and cyclists) across the rail line at the “Nomzamo crossing” and towards the crossing point (see Figure 8(b)) was raised for the first time in October 2012 when officials of the Universal Access and Non-motorised Transport Section of the City of Cape Town distributed visibility items to pedestrians and cyclists as part of Transport Month activities. Subsequently, the Nomzamo crossing was highlighted by the ward councillors as a concern and requested the City to address the matter. Consultants were then appointed in July 2013 to undertake a scoping process involving the identification of possible solutions and the assessment thereof as part of Phase 2 of the Citywide NMT Programme.

Figure 8(b): Pedestrian movement towards the rail line at the Nomzamo crossing

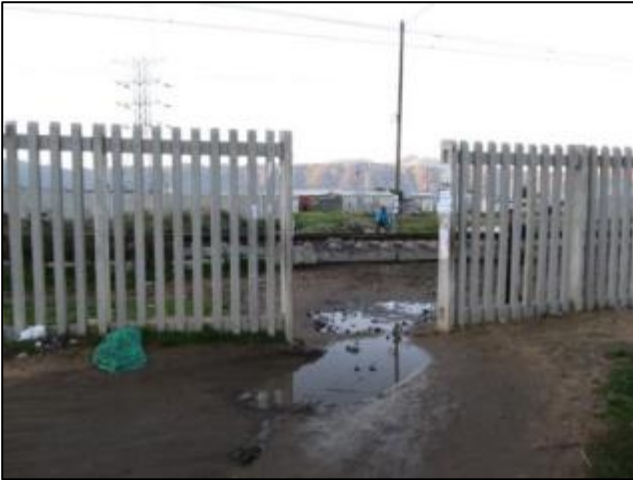
Pedestrians originating from Lwandle and Nomzamo (situated more to the east) follow the walkway along the N2, but then divert to an informal path before the bridge and then cross the rail line below the bridge as this provides a direct access towards the Somerset West CBD and Van der Stel Station, with the result that the dedicated pedestrian facility across the bridge is not optimally used. In order to prevent the at-grade crossing, a concrete palisade barrier fence was constructed along the western side of the rail line by Metrorail at the end of 2011, but was vandalised on the first night and a section removed (see Figure 9(a)). Despite repeated repairs to the fence, vandalism continues to occur.

Figure 9(a): Opening in fence where NMT users illegally cross the rail reserve

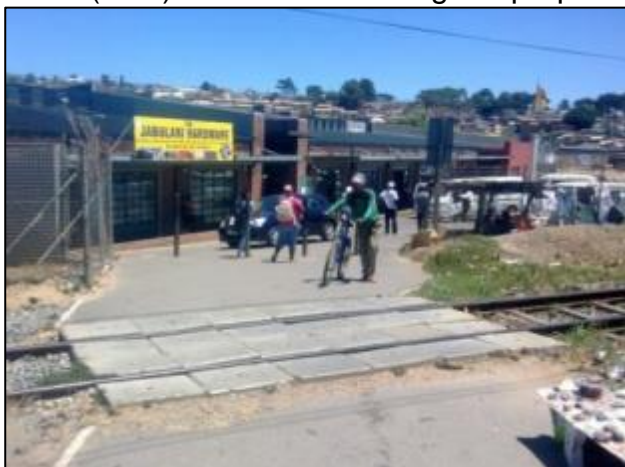
Considering the constraints, the input received from the community and representatives and information and insight gained during site visits and surveys, a formalised pedestrian level crossing (as per the example shown in Figure 10) which includes warning signage (including text) and an improved surface was considered as a feasible option viz. Option D. Whilst this project is still a work-in-progress at the time of writing this paper, it is intended that a proposal be submitted to the senior management of Transport for Cape Town (TCT) towards motivating the proposal solution to PRASA⁵ for their consideration.

Figure 10: Example of a Formalised pedestrian level crossing

- D. A pedestrian level crossing consisting of a level surface for crossing the tracks, warning signage (including text in Xhosa and English). The proposal for a level crossing is based on the following: a single rail line exists with low commuter train frequencies, high number of pedestrians cross the rail line at-grade and a formalised pedestrian crossing will include improved surface and warning signage, which will improve pedestrian safety.

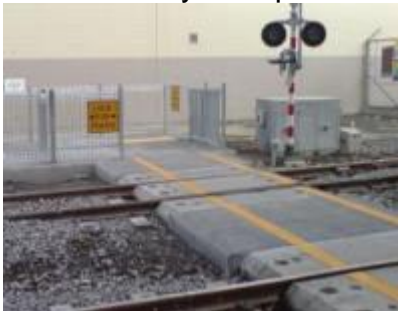
Figure 11(a): Pedestrian Maze, (Web. A Pedestrian Maze, 2010)

The following innovative infrastructure/devices (viz. Figures 11(a) to (j)) are currently used internationally to improve the safety at level crossings:

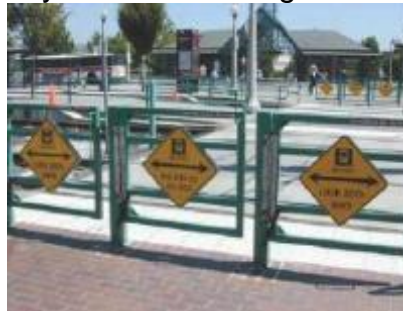
Figure 11(b): Pedestrian Swing Gates, (web. FHWA, 2007)

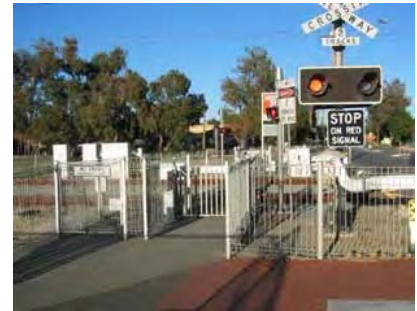
Figure 11(c): Lockable Gates, (web. FHWA, 2007)

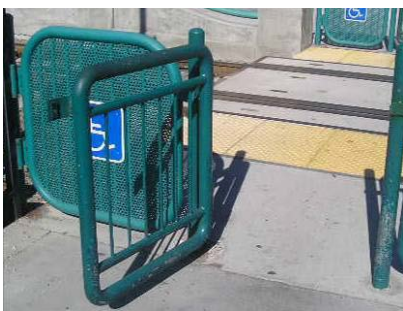
Figure 11(d): Warning Tactile ground surface Indicators, (Clark, May 2008)

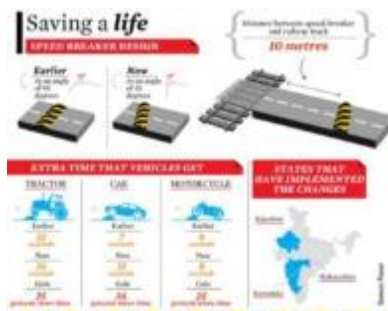
Figure 11(e): Diagonal Speed-Breaker Humps, (N.S. Ramnath and A.K. Mishra, 2012)

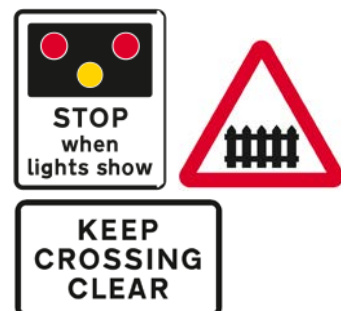
Figure 11(f): Innovative Signage, (Dept. For Transport, London).

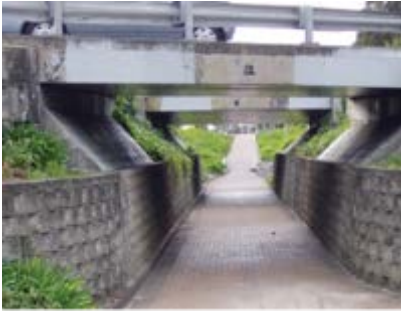
Figure 11(g): Pedestrian underpass. Clark (2008)

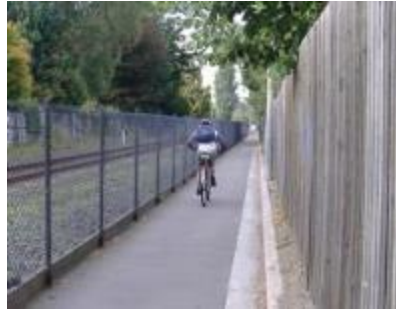
Figure 11 (h): Fence between rail and sidewalk. Clark (2008)

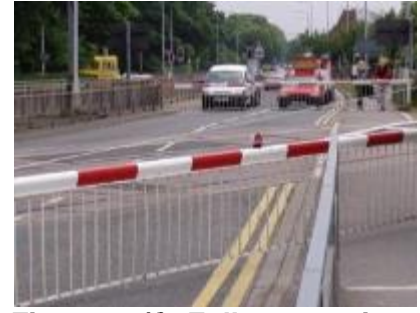
Figure 11(i): Full automatic barriers. Clark (2008)

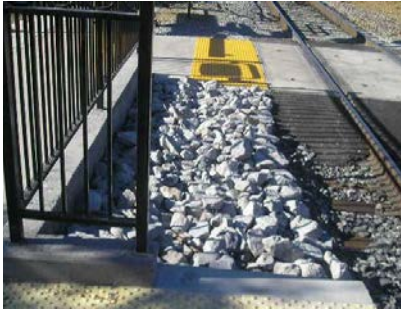
Figure 11(j): Track ballast discouraging pedestrian movement. Clark (2008)

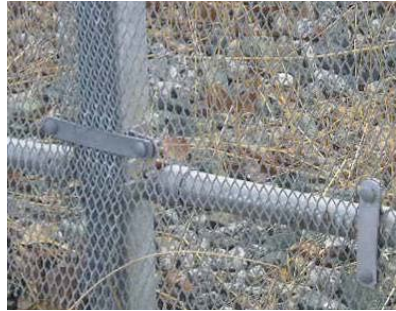
Figure 11(k): Close up view of security fencing. Clark (2008)

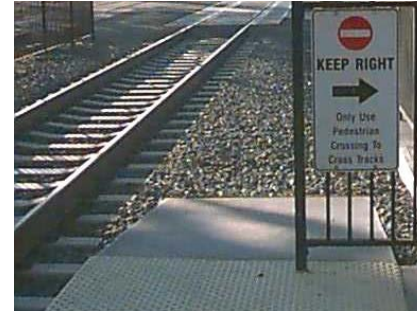
Figure 11(l): The length of ballast helps discourage pedestrians from using this route. Clark (2008)
