# DRIVING ON THE HARD SHOULDER A SAFETY ASSESSMENT

P LOUW and M SINCLAIR

Address of both authors: Department of Civil Engineering  
University of Stellenbosch, Private bag X1, Matieland, 7602

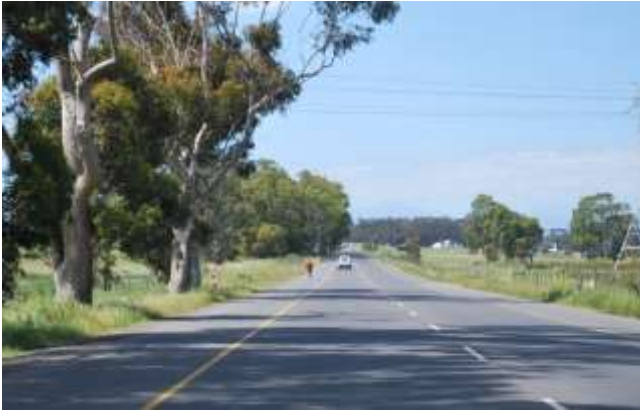
Figure 1: R302, westbound direction

For the purpose of this study, two sites were identified and used to conduct the safety assessment. The two sites are the R302 (between Durbanville and Malmesbury) and the R304 (between Stellenbosch and Malmesbury, beginning at the Joostenbergvlakte area). In both cases, a two-kilometre stretch was selected. Both study sites have a speed limit of 100km and consist of two lanes, each 3.7 metres wide and a 2.4 metre wide paved hard shoulder on each side. Both are in rural areas and carry relatively high traffic volumes - particular at peak times. Both roads also carried pedestrian traffic, including adults and children (in this case primarily learners using the road to access their schools). Images of the roads are displayed in Figure 1 and Figure 2 below.

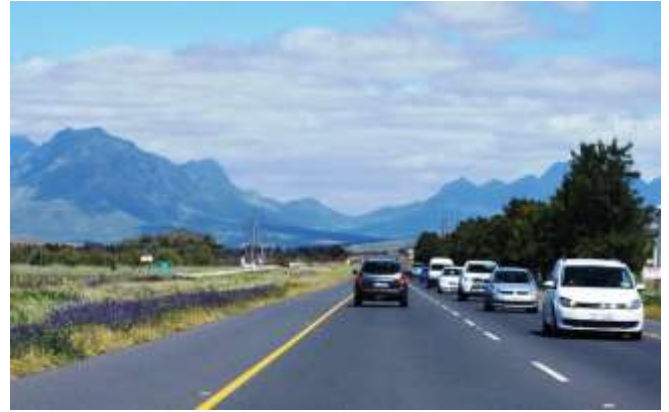
Figure 2: R304, eastbound direction

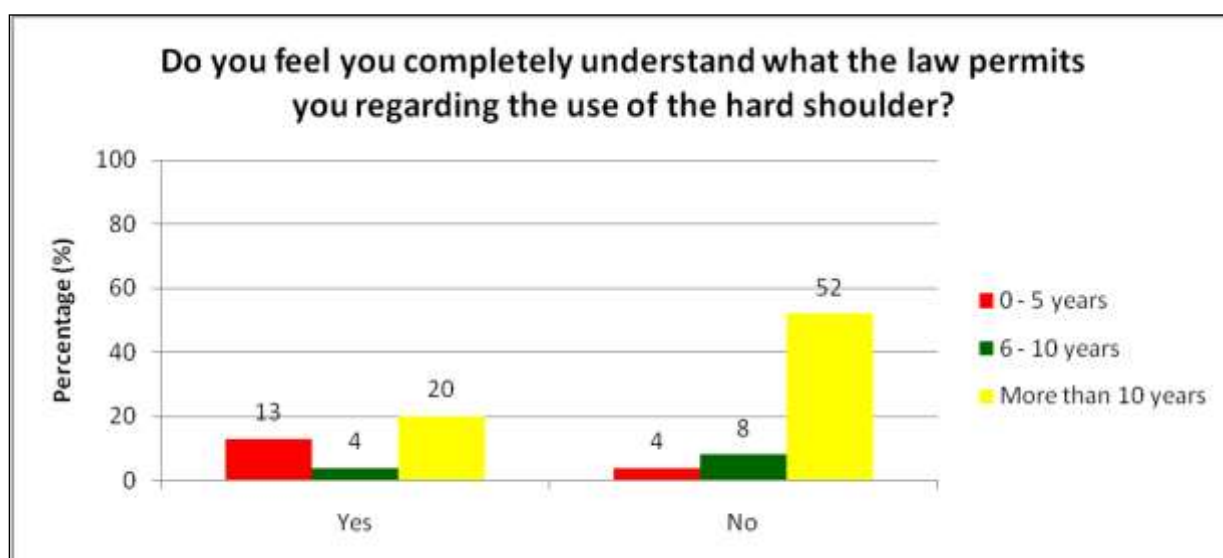
Figure 4: Respondents level of understanding of hard shoulder legislation

The first objective of the driver questionnaire was to determine whether the drivers who participated know if the law permits them to drive on the hard shoulder. A total of 101 responses were received. The majority of the drivers indicated that they are aware of laws in South Africa on driving on the hard shoulder. However the majority of the participants indicated that they do not completely understand what the laws in South Africa permit. Of 17 drivers who had between 0 and 5 years legal driving experience, 13 drivers indicated that they are aware of laws and that they completely understand these laws. Of the rest of the sample, twelve drivers had received their South African driver's licence in the last 6 – 10 years. Of these, 9 drivers were aware of laws relating to hard shoulder driving, but only 4 of them completely understand what these laws permit. The majority of the participants (72 drivers) indicated that they have a valid South African driver's licence for more than 10 years. As indicated in the figure below, 56 of the 72 drivers are aware of laws in South Africa regarding hard shoulder driving, but only 20 drivers completely understood what the law permits them regarding hard shoulder driving (see Figure 3).

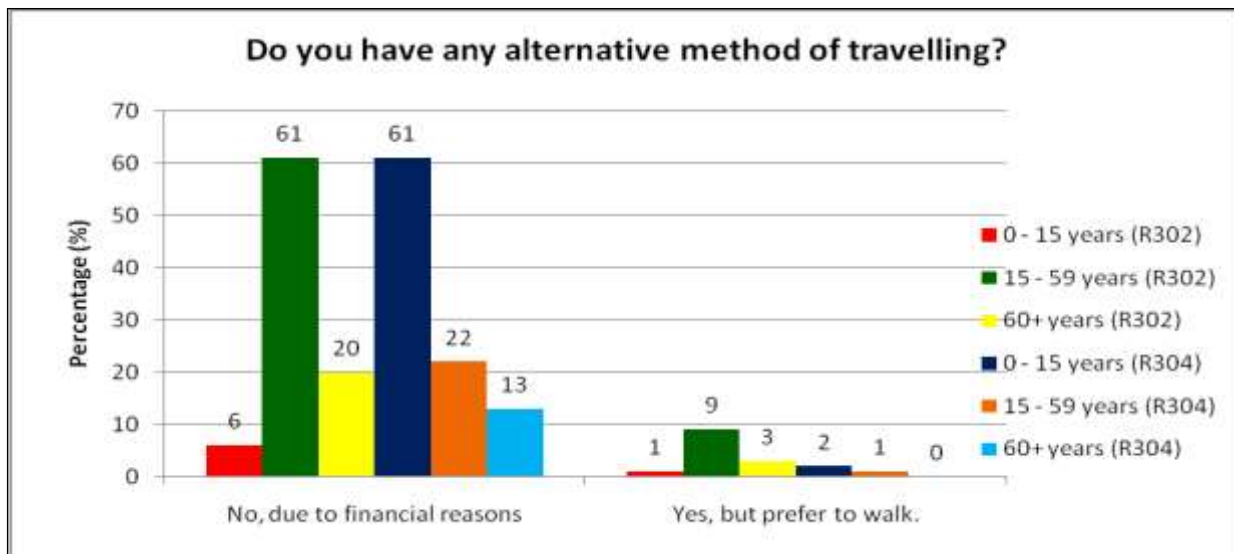
Figure 6: Dependence of pedestrians on walking as a means of access

Of the pedestrians walking on the hard shoulder of the R302, none took any measures to improve their visibility to moving vehicles, compared with the 28 of the pedestrians walking on the R304 who took no measures. Only 2 of the pedestrians approached on the R304 took measures to improve their visibility by wearing reflective gear. Figure 5 below indicates if the pedestrians who were approached have any alternative methods of travelling. The majority indicated that walking is their only method of travelling.
