HEFAT2010

7th International Conference on Heat Transfer, Fluid Mechanics and Thermodynamics 19-21 July 2010 Antalya, Turkey

## CAVITATION INDUCED ACCELERATED EROSION IN LARGE SLURRY PUMPS

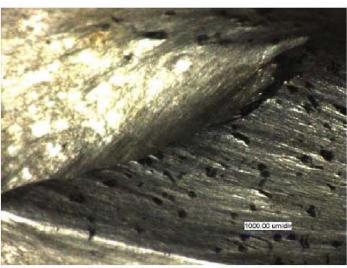
Figure 3: A directional grove and dark spots on the liner of a slurry pump (x200).

Figure 3 shows the accelerated crosion surface on the small liner, with a number of isolated dark spots which may represent surface pitting by micro jets from cavitation. It is reported that cavitation is characterised with formation of localized bubbles and their subsequent collapse when bubbles move into a region of higher pressure. It is proven that when a bubble collapses, a liquid micro-jet is formed and threads through the bubble [20]. A slurry micro-jet may cause pitting and accelerated erosion when impinges on a solid boundary. The picture also show one of the deep groves where the surface is directionally cut by the spiral motion of the slurry flow. This may suggest that cavitating slurry causes sever erosion as it moves over the liner.

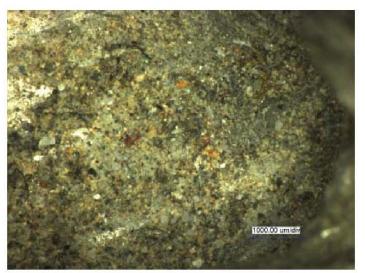
FIGURE 5: The abrasive-embeddings in the a metallic front liner of a slurry pump (x200).

Figure 5 Shows the abrasives embeddings in the deepest part of the holes generated by cavitating swirling slurries. The metallic surface is completely covered by a blanket of abrasives which prevent further material removal from the surface.

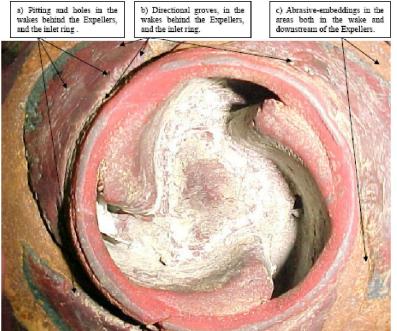
FIGURE 6. The front shroud of a rubber impeller in a small centrifugal sharry pump with common erosion patterns of directional groves, pitting, and the abrasive embedding.

Figure 6 shows the accelerated erosion patterns in the third identified area, on a front shroud of a rubber impeller. Due to the narrow gap between a liner and a shroud, similar erosion patterns are seen to be generated on liners and shrouds. In the rubber shroud, the eroded areas are in the wake of obstacles including in the inner side of the Suction Ring, and in the wake of the Expellers. These may not be eroded due to a direct contact with slurries. The are eroded by the secondary motions initiated by cavitation.

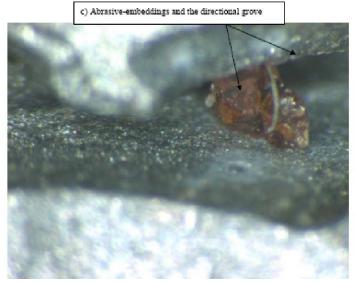
FIGURE 8: The patterns on an aluminium specimen eroded by a fast moving cavitating water jet submerged, with the common features of the directional groves, and the abrasive embedding [x245].

Figure 7 shows the surface morphology of a submerged aluminium specimen in abrasives and eroded by a nearly parallel fast moving cavitating water jet. Figure 8 shows abrasive embedding on the surface. Directional groves cut by abrasives in the flow direction, cavities and pitting, and abrasive embeddings are all in common with those on the liners and the shrouds. It seems that the surface bombardment by the slurry micro jets cut groves at lower contact angles, while may cause embedment of abrasives and fatigue on the surface at larger angles. on the surface. It was noticed that the embedment of slurry on the liner and the shroud have blanketed the surfaces and consequently alleviated material removal from the robber shroud, and the metallic liner and preventing to create a hole on the surfaces. While in the larger liners, where embedment was absent, the accelerated erosion has led to creation of holes in the surface.
