# Avoiding structural failures on mobile bulk materials handling equipment

by M.J. Schmidt\* and B.W.J. van Rensburg†

## Synopsis

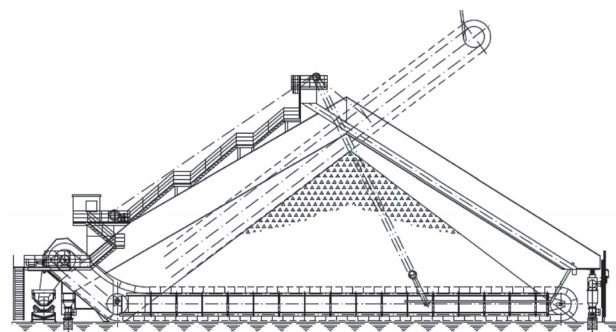
Prior to failure, the machine had been in production use for several months, although commissioning of the collision protection system had not been completed. The general arrangement of a typical portal reclaimer is shown in Figure 1.

Figure 1—Typical arrangement of a portal reclaimer

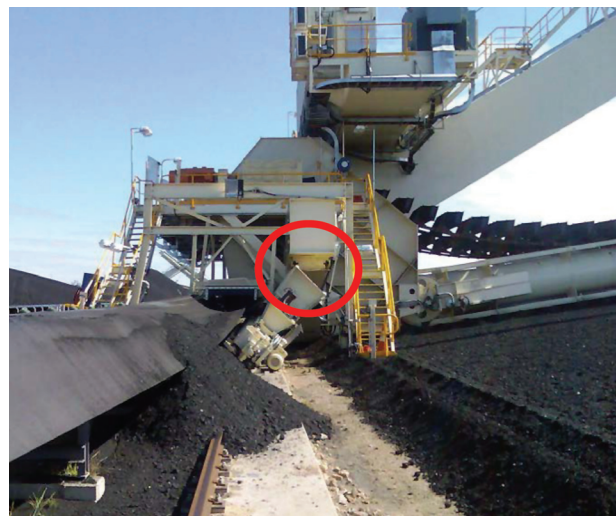
At the time of the collapse, the designed reclamation rate was exceeded by approximately 30%. The stockpile proximity probes appeared to not be working, resulting in unexpectedly high digging forces which led to the failure of major structural connections as shown in Figure 2.

The lateral resistance of the machine was insufficient to withstand the forces generated within the structure when excessive digging was experienced. Proximity probes, detecting the stockpile height, are fitted to ensure that the digging depth of rake buckets is maintained within the prescribed limits. These devices did not function properly or had not yet been commissioned, so were switched off, resulting in excessive digging forces (Anon., 2007; Krige, 2012).

Electric drive motors are equipped with protection relays to limit the electrical current that can be drawn during operation, *i.e.* the applied system torque can be limited. Industry practice suggests that the overload protection is set to a value of 5–10% above the peak system design load (Bateman, 2013). The protection study report, compiled subsequent to the failure, indicated that the motor protection relay setting on the reclamation drives was at a default value of 2 instead of 1.05 (Anon., 2007). Furthermore, the mechanical design for the scraper drive system dictated an installed motor power requirement of 154 kW, which implies that the next size up of 160 kW was specified. During procurement, 185 kW motors were supplied due to the unavailability of the 160 kW motors. This decision was made without consultation with the relevant design engineers.

Figure 2—Failure of the bogie on a portal reclaimer

Upon investigation, it was also found that the fluid couplings installed between the drive motors and reducers were rated at service factors such that a reclamation drive torque could be delivered that was only marginally below the maximum electric motor torque. Torque transfer through fluid couplings can be limited according to the design requirement by reducing the percentage oil fill, which is normal practice. The commissioning data revealed that the fluid coupling was overfilled by approximately 15%. Small amounts of oil at high percentage fill levels will lead to a significant increase in torque transfer capacity (Anon., 2007).

Final acceptance and approval of the machine, and more specifically the validation of protection systems by the OEM's structural design engineer or representative who understands the structural limitations of the equipment, are crucial. This collapse highlighted the importance of understanding the additional risks associated with the production use of a machine that has not been fully commissioned, and where protection systems may be inoperative and stockpile volumes have not yet been fully calibrated. The operation of machines that have not been fully commissioned must be prohibited, regardless of production pressures.

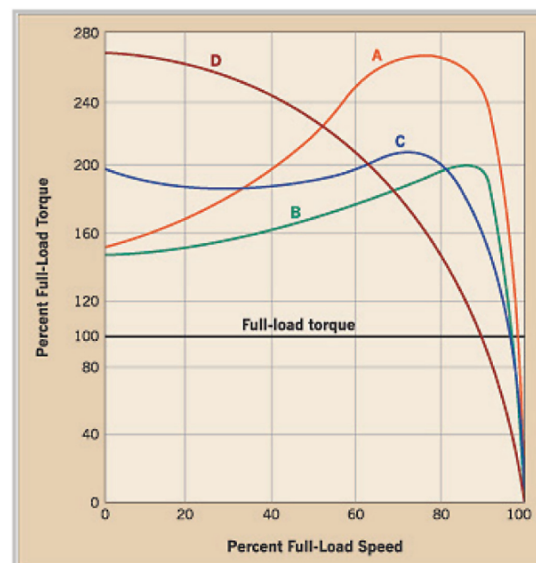
The machine could not withstand the motor starting torque as prescribed for the abnormal digging resistance criteria as outlined in ISO 5049-1 (1994). Depending on start-up torque control, the motor torque during start-up could exceed twice the operating torque on the motor, depending on the motor type selection, as shown in Figure 3. (Curves B and C represent a typical conveyor drive selection).

Figure 3—Characteristic start-up curves for different electrical motors (Baldor, 2004)

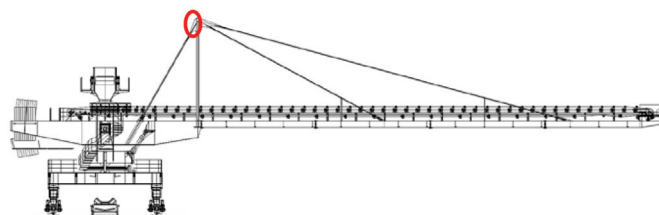
year before collapsing completely. An incident in which the boom conveyor belt was overloaded preceded the failure event. The failure of a critical tie-beam connection, which is highlighted in Figure 4, initiated the collapse of the boom and ultimately ruined the entire machine.

Loading conditions were underestimated because an incorrect material bulk density was used in the design. The incorrect commissioning of the speed switch settings associated with the boom belt contributed to the structural overloading of critical tie-beam connections when slippage of the boom belt occurred.

Based on the design requirements of ISO 5049-1 (1994), critical tie-beam connections were overloaded, although the ultimate carrying capacity exceeded the most severe design load combination. The design of these connections is therefore considered to be marginal. The tie-beam connections utilized bolts in double shear in such a way that fastener threads intercepted a shear plane. Furthermore, high-strength electro-galvanized fasteners, which are susceptible to hydrogen embrittlement (Erling, 2009), were used in this critical tie-beam connection. The topic of corrosion and embrittlement is discussed at length in the American Institute of Steel Construction (AISC) Guide to design criteria for bolted and riveted joints (Kulak *et al.*,

Figure 4—General arrangement of slewing stacker. Critical connection highlighted

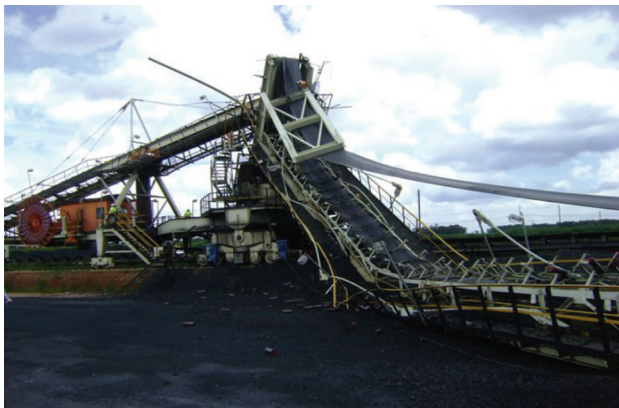
The extent of the damage can be seen in Figure 5.

Figure 5—Collapsed stacker

Supervisory control and data acquisition (SCADA) recordings revealed that the boom loading significantly exceeded the intended design parameters prior to the collapse. The alarm set-point to alert a boom overload condition was specified at a level that was too high to prevent structural overload. The machine could therefore be exposed to severe loading conditions without any operator abuse. The probability that operator abuse contributed to the failure could not, however, be ruled out altogether.

Design deficiencies contributed to a marginal design of critical connections, which was further exacerbated by defective bolts, adversely affecting the carrying capacity. The absence, malfunctioning, and incorrect commissioning of machine protection systems allowed an overload condition to develop, which led to the catastrophic collapse of the stacker.

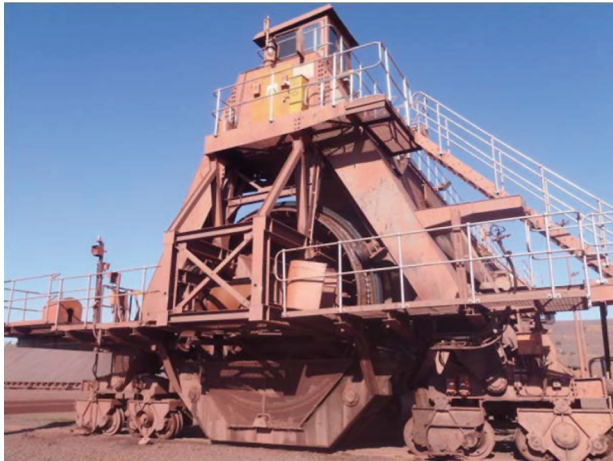
The overall machine control system was originally configured without interlocks between the independent long travel drive systems located on adjacent bogie wheel sets. When the control system for the drives at the one end malfunctioned, the drives on the opposite end continued with the long travelling sequence until the drives tripped on overload as a consequence of the skewing of the machine. Severe local damage and permanent deformation were caused to the boxed plate structural section of the fixed legs. The machine, as shown in Figure 7, had been in service for decades.

Figure 7—Side elevation of drum reclaimer

Skew control can be achieved by comparing signals from incremental encoders on both sides of the machine (McTurk, 1995). Skew should occur only if one side of the machine cannot travel for accidental reasons, *e.g.* an obstacle on the rails, and if this happens a signal must trigger the immediate shutdown of the machine. The control systems associated with the long travel of the machine were not fail-safe. Abnormal loads, not anticipated in the original structural design, were subsequently exerted on major structural members. The equipment was nevertheless operated successfully for many years prior to the skewing incident. Insufficient design integration existed between the OEM’s structural, mechanical, electrical, and control and instrumentation engineering disciplines during the detail design phase of the original project. The damage could have been avoided by the incorporation of additional protection instrumentation for negligible additional capital cost.

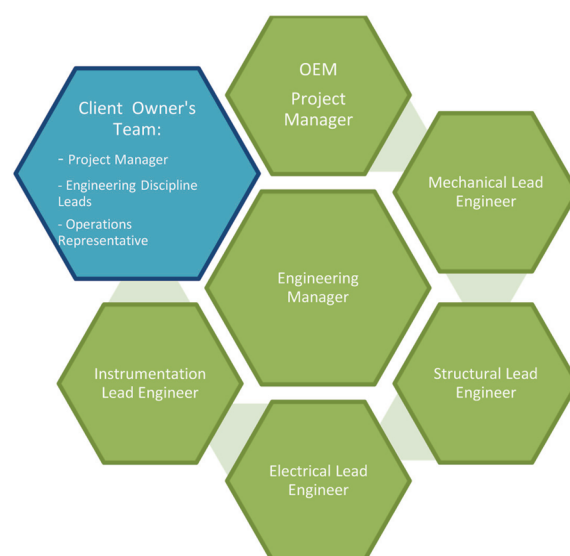
A typical integrated design team organization structure that is conducive to a high level of design integration with a systems design approach is depicted in Figure 8. The

- Within the OEM's design team organizational structure, there is a free flow of information *directly related to design interfaces* between engineering disciplines *without interference in discipline-specific matters*

- Design interfaces are approached as an *integrated system* with input from relevant role-players as a team effort across engineering disciplines
- The respective engineering disciplines have a sound understanding of how equipment selection and systems dictated by engineering counterparts influence their individual designs

- The client owner's team participates in the design scope definition and design risk assessment with specific reference to machine protection and controls. Engineering input, oversight, liaison, and progressive review are provided by relevant representation from the client

- Specific design requirements are agreed between the OEM and client owner's team within the agreed contractual arrangement
- There is a free flow of information between the discipline-specific engineers from the owner's team and their OEM counterparts responsible for the design, without compromising the latter party's intellectual property rights.

Figure 8 – Ideal design team organisational structure for facilitating design integration
