INTRODUCTION

As an introduction to this study this chapter identifies a point of departure and a problem within the city which needs investigation. The problem is investigated on different levels before a methodology is set out on how to approach the problem.

One of the buildings on this northern city edge of Boom Street, is the old *Staatmuseum* building (see Figure 1.7). The museum is an example of the northern edge as a terminating edge of the urban fabric, as it is the terminating point to Thabo Sehume Street. The museum is centred at the end point of the street at a 90 degree angle to Boom Street (Figure 1.3). Even though the building was one of the very first civic buildings in this precinct, it has been neglected as having a possible design influence on the evolving context around it, leaving it like many other buildings in the vicinity, isolated.

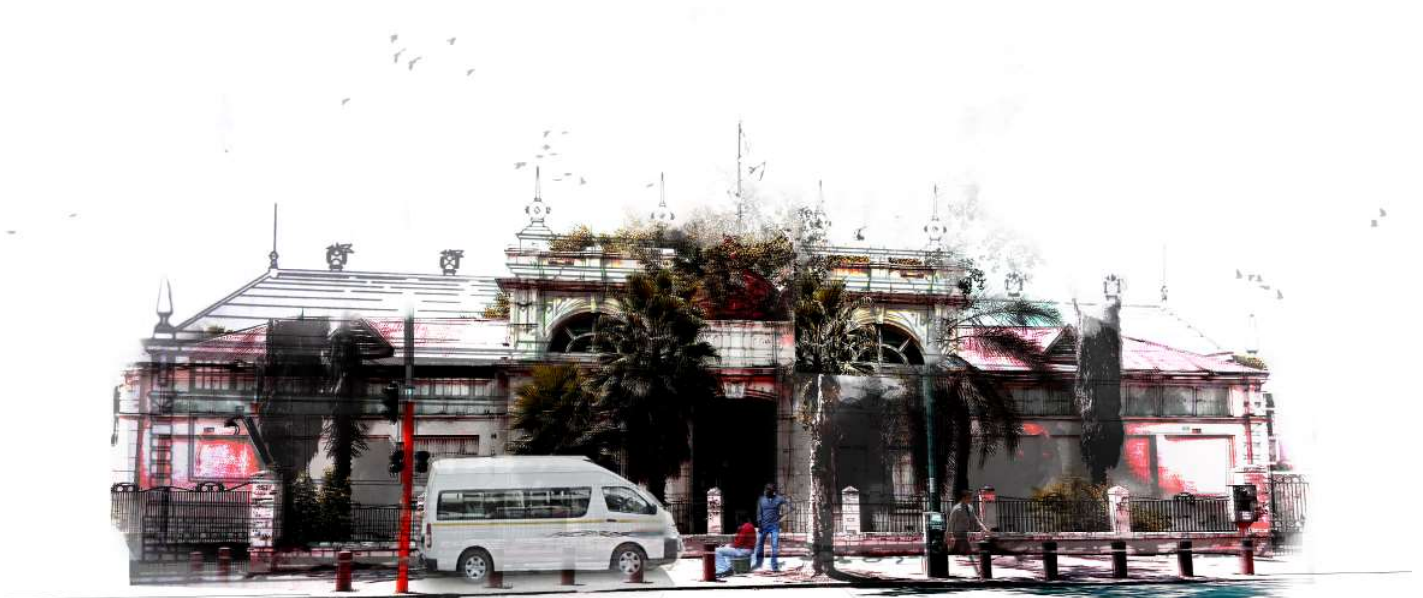
Figure 1.10 What the future Staatsmuseum might look like if it continues to decay

A MONUMENT WITHOUT DIGNITY

The *Staatmuseum*, as it finds itself in its current context and resultant condition, is unappreciated, it is segregated from its context, stripped of its dignity, its worthiness and its respect (see Figure 1.9 and Figure 1.10). The building is in a derelict state due to water damage and normal weathering. Some old collections and display cabinets are still evident in the building but because of a lack of maintenance, the building is currently in a static

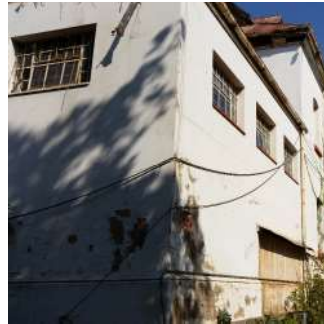
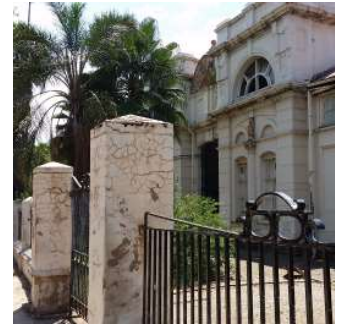
The building has originally been finished with a lime plaster. The plaster is giving way and is peeling off in various places. Hairline cracks, are also visible in the plaster, due to the lack of maintenance and water seeping into the walls. The bricks, used for the construction of the building, are very soft and porous, and easily erodes when coming in contact with water.

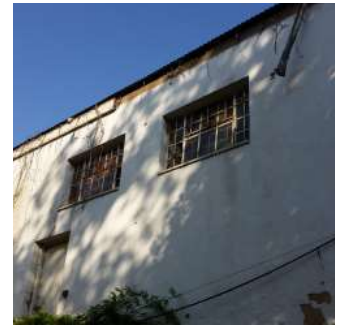
Windows

The clerestorey windows on the southern side as well as the western side has been painted, and so no light can penetrate through. This makes the southern wing and the western wing very dark inside.

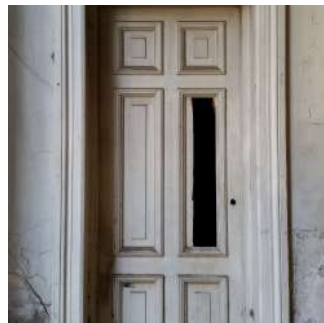
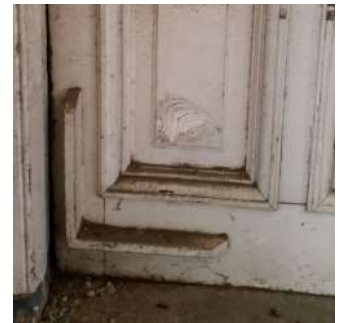
Some doors have been vandalised and have broken panels. There are also traces of repair work carried out on doors, in an attempt to close holes in the timber. Doors to the foyer space, have been nailed into a semi-closed position.

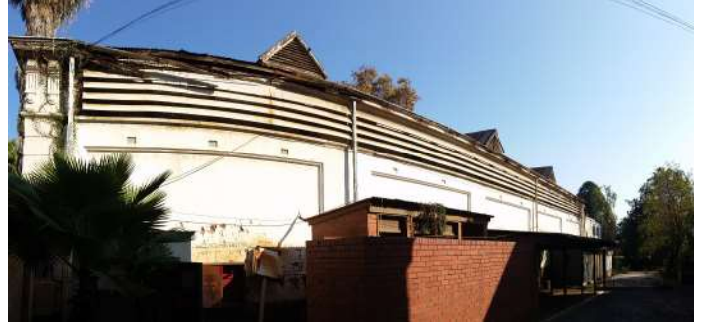
Roof

Gutters and downpipes are rusted and weathered, and at some places missing.

The roof panels are very old, and at places rusted through, causing water to seep into the building.

The roof structure is very old, and although an investigation of the trusses could not be made, it is advised that the trusses be inspected for structural integrity and replaced or strengthened where needed.

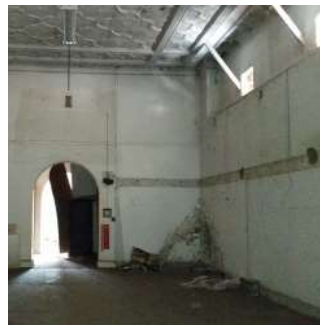
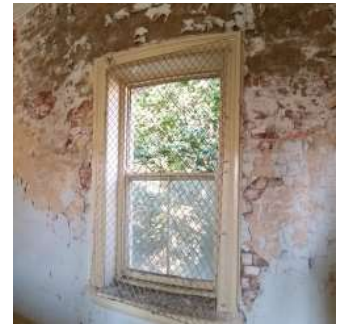
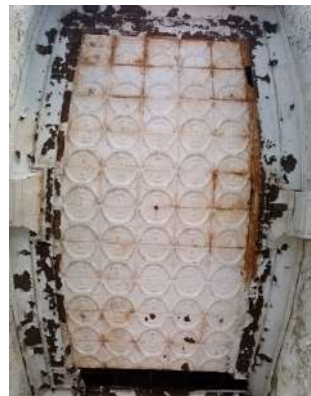
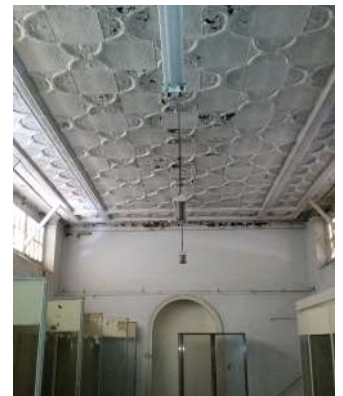
At some places the paint is peeling off, and where roof panels have sustained major damage, water has in turn also caused major damage to the plaster. This is mostly evident on the first floor of the northern wing.

The original pressed steel ceiling panels are rusted in places and the paint is also peeling in some areas.

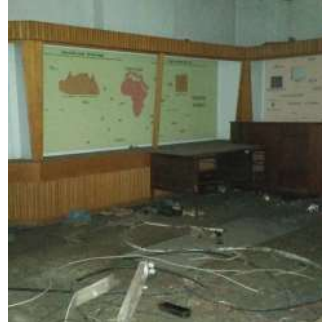
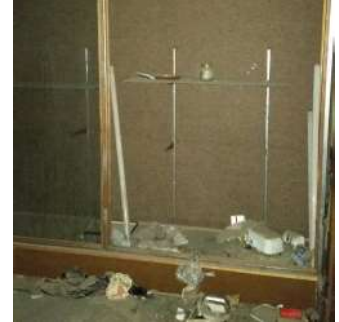
Various partitions (for exhibition show cases), have been added to the interior at later stages, but have, with the building being vacated, been damaged and half-removed. Partitions have been added to define different office spaces in the northern wing of the building, but have been vandalized and are in a poor condition.

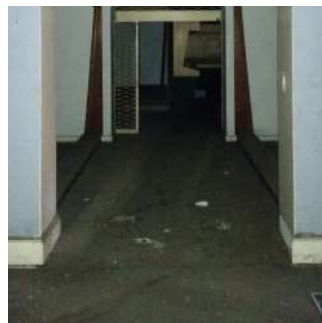
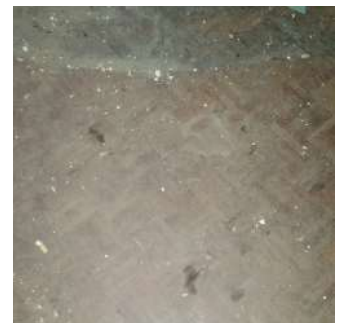
The imported black and white checkered marble floor in the entrance foyer, is in a good condition. The original 110mm Oregon Pine timber floors have, sustained minor dents and breakages to planks. The floors were been covered with battleship lino floor covering in the western wing and with "Hunt Leuchars & Hepburn" parquet flooring in the eastern wing in the late 1960s.

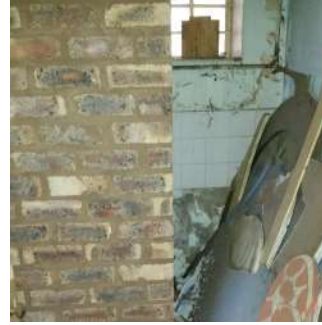
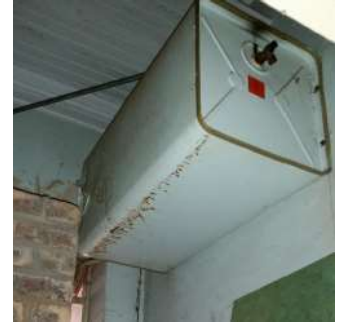
The addition of a toilet, shower and wash hand basin, to the administrative wing of the building, has been done poorly without a conscious response to the building fabric in a respectful manner.

The staircase to the first floor, of the administrative wing, has been built according to the original plan, but goes past a window right up against the wall, and is a poor execution of a staircase in the space with relation to the façade. This window has consequently been boarded up.

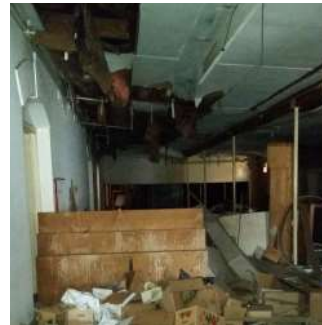
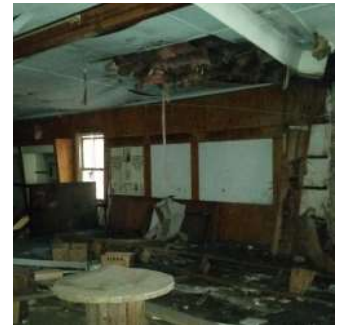
A large part of the roof, of the added building section in the courtyard, has collapsed due to water. This space is in a very poor condition and is badly vandalised.

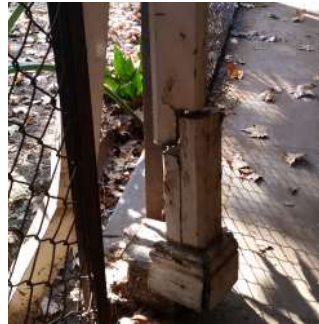
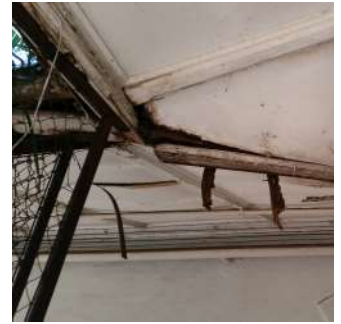
Roof

The veranda roof has due to a lack of maintenance, corroded severely. Various roof panels are rusted through, which has damaged ceiling panels. Some of the timber beams are rotten and not structurally sound any more. The timber columns are also rotten at places, and some are even missing in total.

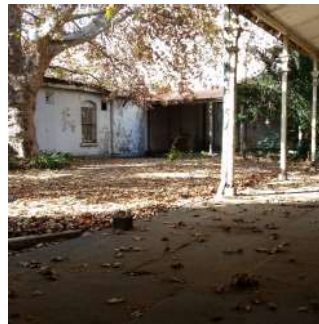
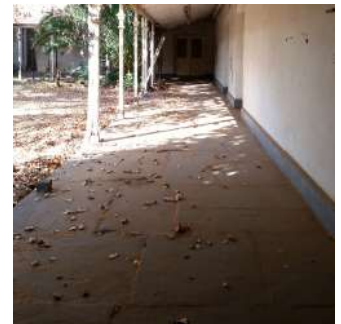
Floor

Local Blue slate slabs (presumably from the Erasmuskloof quarry), have cracked at some places. Half of the veranda has been covered with a building addition in the courtyard, and the floor has been covered over with a new floor covering.

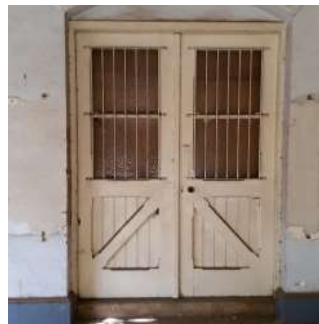
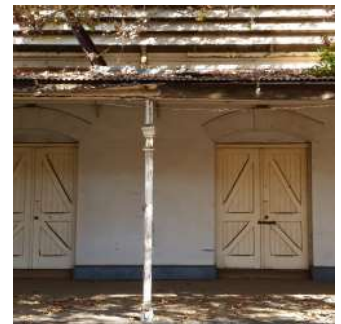
Doors

The roof has ensured that most of the doors opening out onto the veranda have been preserved fairly well. The only need for maintenance is missing ironmongery and paint.

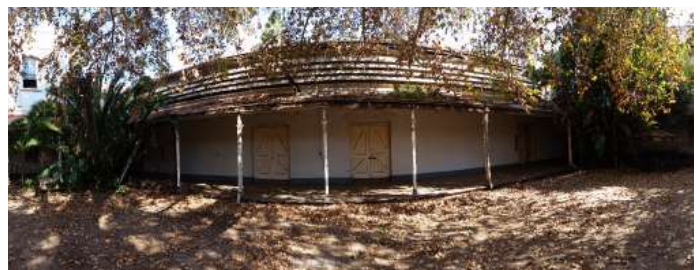
Garden

The oak tree in the center of the courtyard, has presumably been planted after completion of the building work. The roots of the tree have not been cut back in recent years, and is causing some disruptions with the foundations and with water and drainage pipes.

The garden in general, has been neglected and most of the plants have died. The garden, as

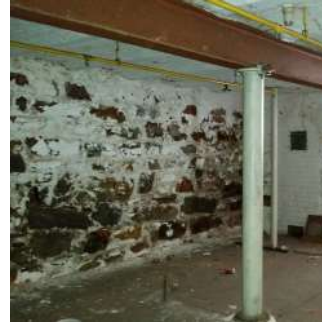
The granite foundation walls of the basement have been painted and the paint is peeling due to dampness on the walls.

Later additions are also evident in the way arches and openings have been closed, in order to create separate spaces within the basement.

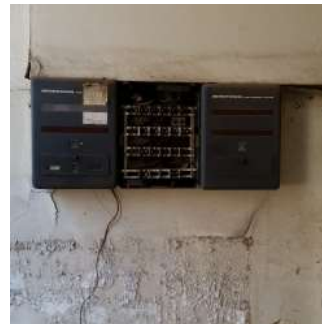
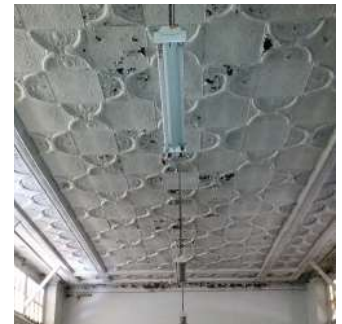
Electricity

There are very few indications of electricity being part of the original building design. According to a previous study and analysis of the building, as part of her Masters dissertation, I Niebuhr (2007:163) had found an old chandelier hanging from the ceiling in the entrance foyer of the building. The chandelier is not present in the building any longer. An old breaker switch is however, still present in the foyer, which is indicative that some sort of old electrical installation had been part of the building from an early stage. Other electrical installations only include fluorescent lighting in some areas as well as an electrical geyser, which are evidently later additions. The electrical supply and wiring of the building is very old, and might not be in safe working order.

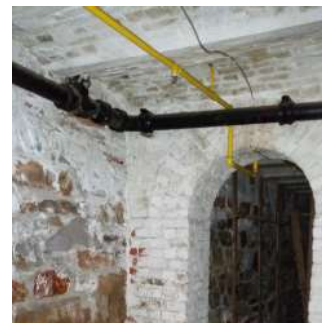
There exists no evidence of water or sanitation being part of the original building. A toilet, wash hand basin and a shower, have been added to the northern wing of the building. A wash hand basin has also been added to the western tower of the building. A 100mm galvanized steel pipe is visible in the eastern tower, and it is assumed that the pipe was used to relay water from the central foyer's roof. A 100mm LCC (London Country Council) cast iron vent pipe (Niebuhr, 2007:164) is also present in the northern tower. This pipe, is also taken right past the windows of the basement, in order to connect to the sewerage connection at Boom Street.

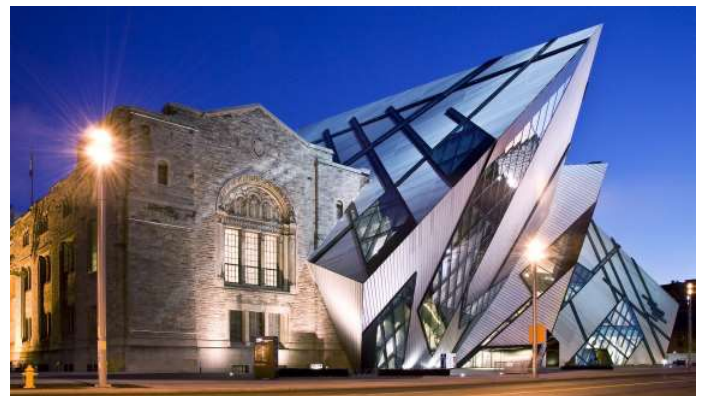
Figure 4.23 View of the building with the parasitic intervention

The additions to the Royal Ontario Museum is an example of a parasitic addition to a heritage building. The new addition is in form, layout and material, a juxtaposition to the existing fabric. It is a clear new entity placed in the front courtyard of the existing building. Daniel Libeskind has received critique in the way the addition overpowers the existing building in a seemingly disrespectful manner. The interior spaces are according to many who visit the building, poorly designed and there are a lot of wasted space inside the building due to its unconventional shape.

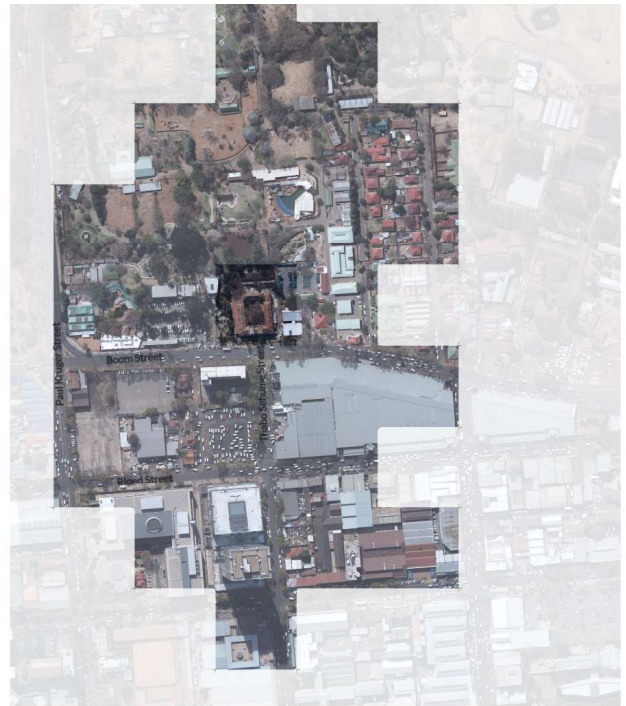
Figure 5.1 Existing larger urban context

As part of the larger urban vision (discussed in Chapter 2) and in light of furthering, or bettering the Tshwane Vision 2055, the old *Staatmuseum* has been identified as a place that can mediate the integration between the formal and the forgotten parts of the urban fabric (see Figure 5.1).

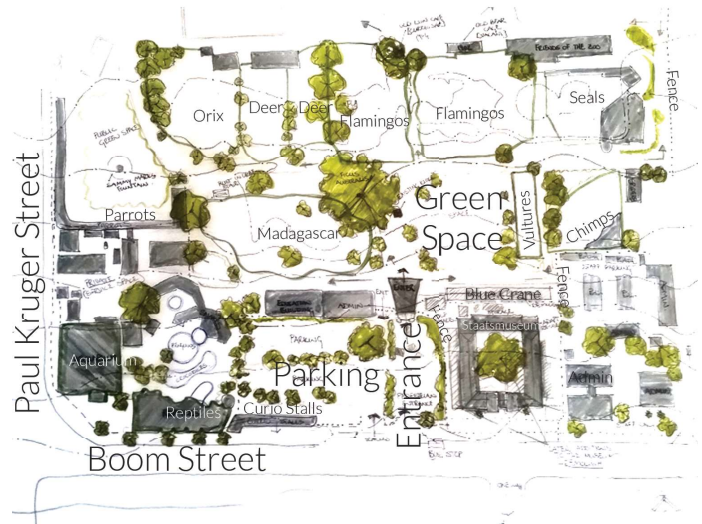
Figure 5.2 Existing micro context

As part of the design process of the urban context (see Figure 5.2), this investigation challenges the barred nature of the zoo, the relationship thereof with the city and the threshold between city and recreation, and even nature.

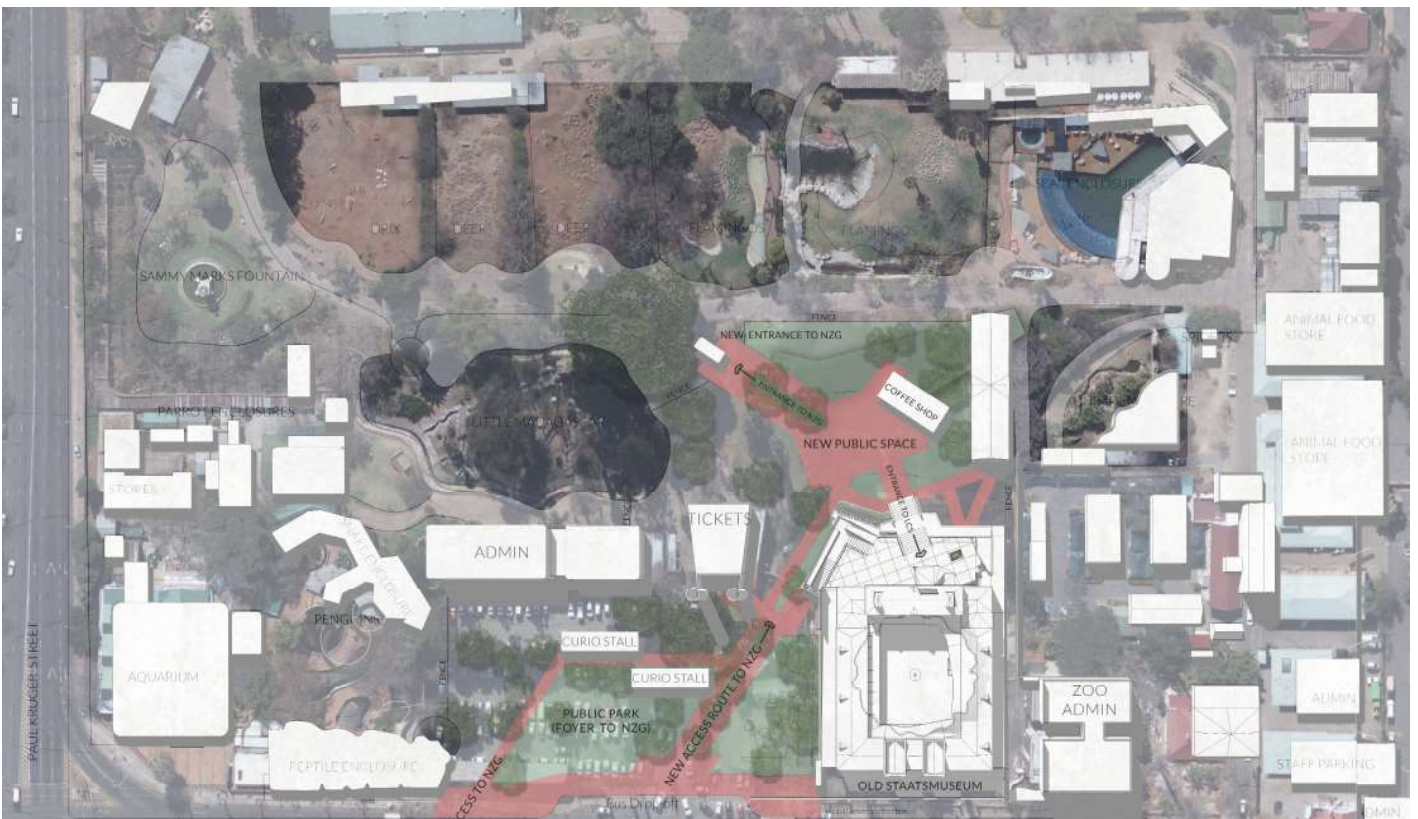
Figure 5.4 New urban context

The NZG is a place without cultural and social boundaries as it is inviting to all culture- and social groups. The *Staatmuseum* is proposed to form part of the NZG context very directly (see Figure 5.4), allowing the building to participate in, and form part of, the co-existence of cultural values.

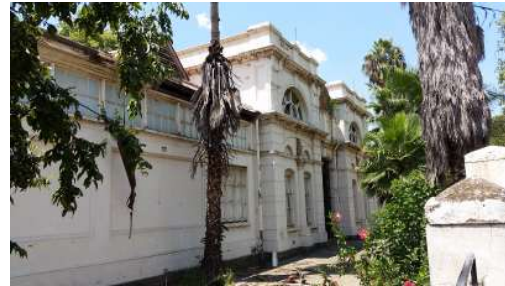
Figure 5.14
Entrance facade

2. The entrance facade (see Figure 5.14) is important, due to two things. The first is, the fact that it is the most highly detailed and decorated facade of the building, making it clear that it is the most important point on the external envelope. The use of fabric and detailing in the decoration, is also evident of the Wilhelmiens persona of the building (which is very scarce throughout the rest of the building). The other factor adding to the importance of the entrance facade is, the fact that it has formed part of the street edge for more than 100 years, and has been very resilient as part of this street edge.

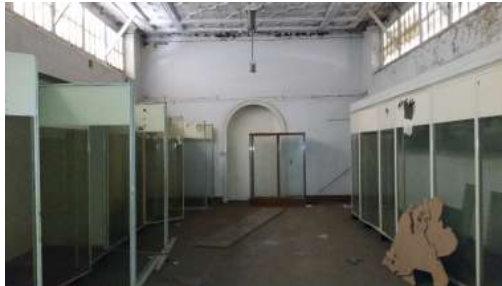
Figure 5.16
Exhibition hall

4. Internal exhibition spaces (see Figure 5.16), are important as evidence of the buildings programmatic function, as per the initial design of the building (the building has only been used as a museum as per the original design). Not all the exhibition spaces have to be preserved as is, but a person should, at some point, be able to perceive what the original internal spaces were like. The idea of exhibition can be challenged. Any

- Internal spaces: The main function of the interior spaces is to house exhibitions. The spaces were designed as plain as possible, to allow for different responses in terms of exhibition. Some of the old exhibitions are still visible in the building today (refer to Figure 5.16). The new programmatic intervention, once again allows the interior spaces to be exhibition spaces. The way in which exhibitions are designed and set out however, has changed a lot with our better understanding of the influence of space planning on people's experience.

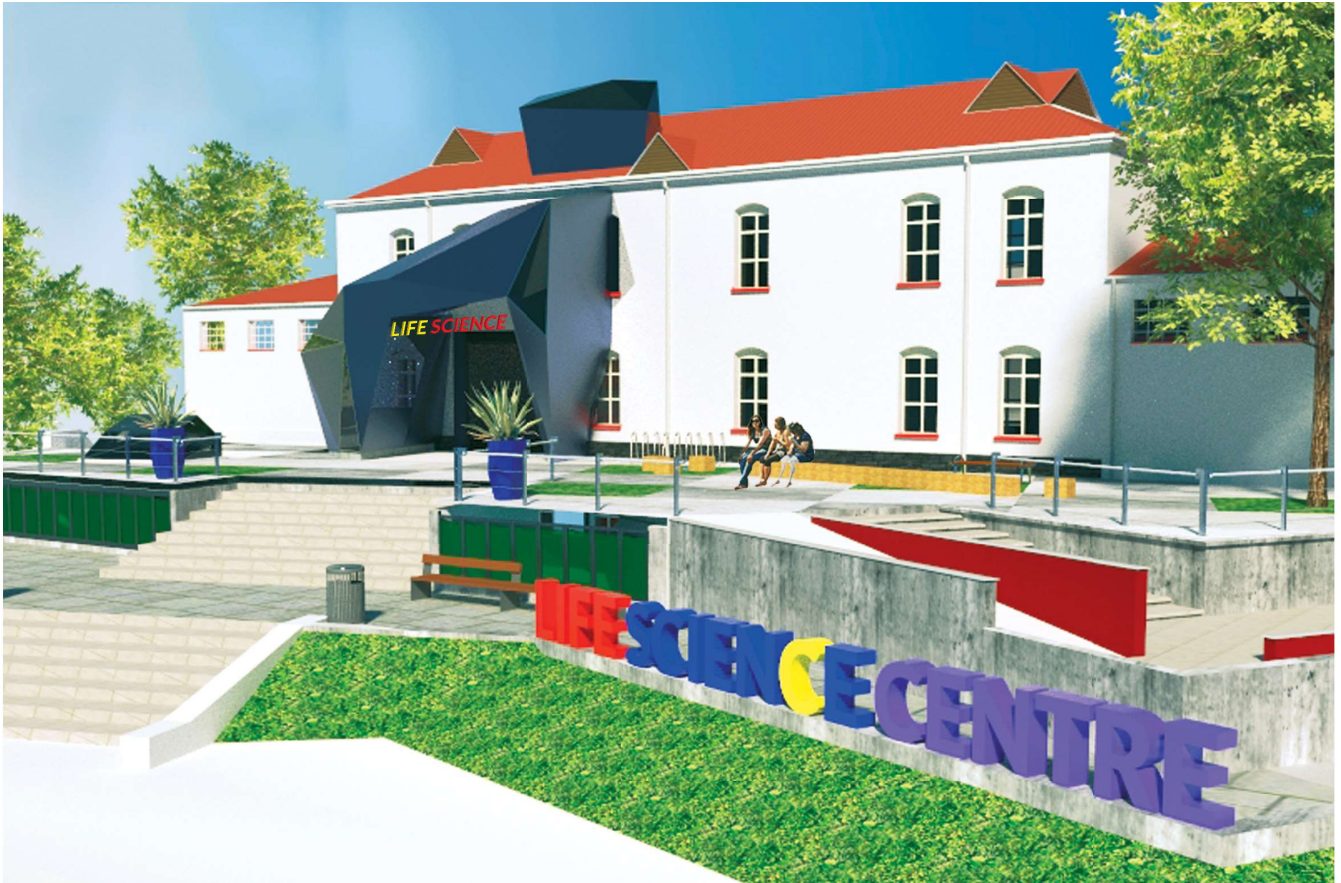
Figure 5.17 Perspective view of the new entrance from the public zoo green space: looking south

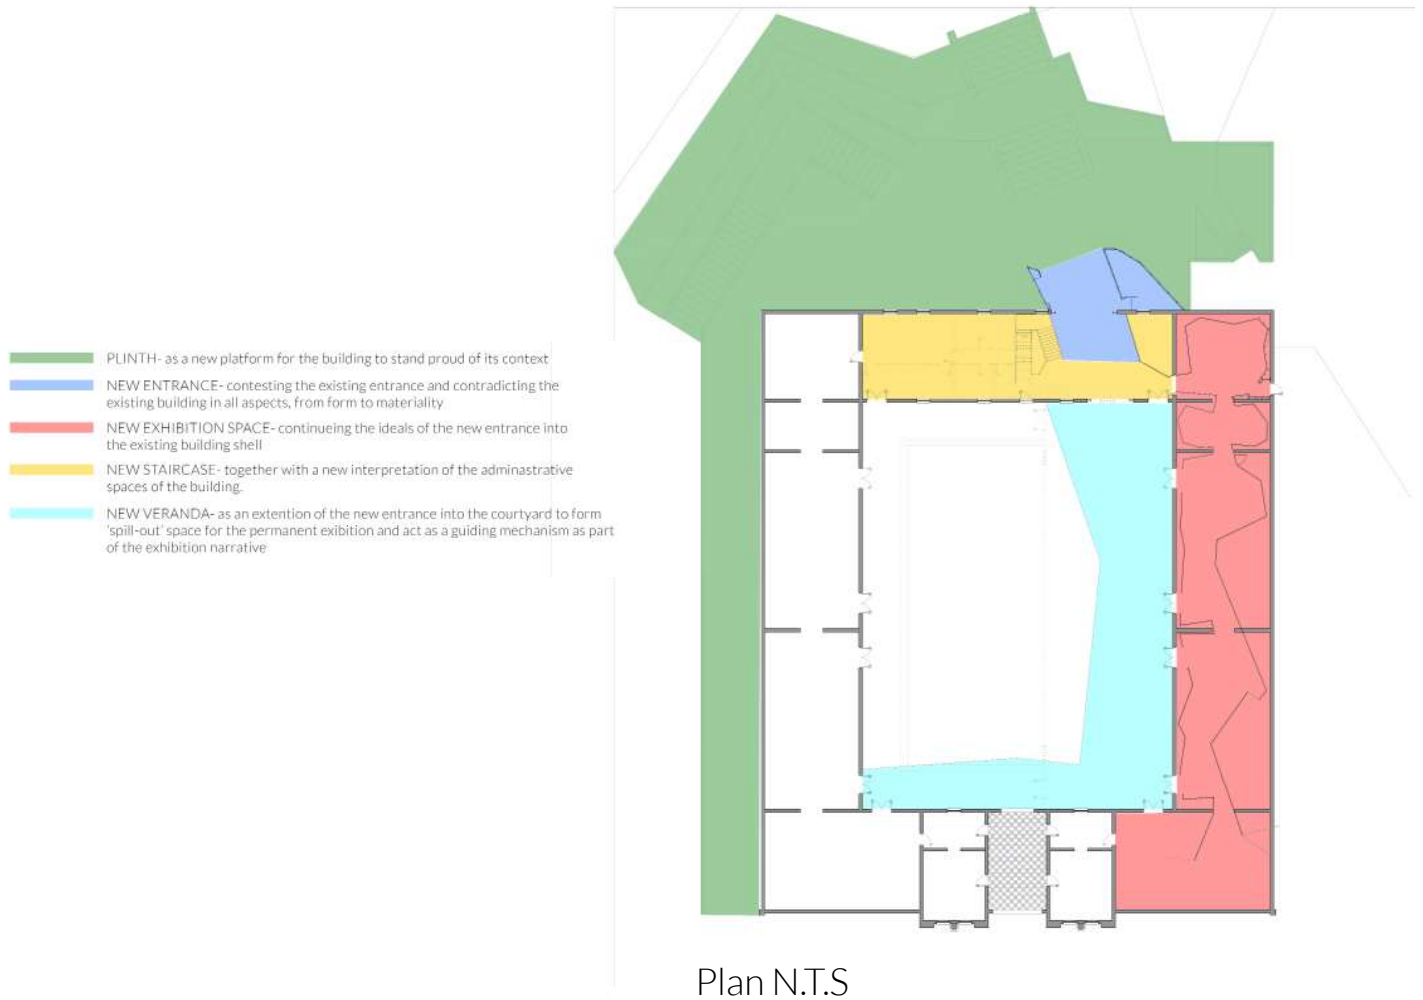
Figure 5.18
Isometric exploration
showing different places
of intervention by means
of colour

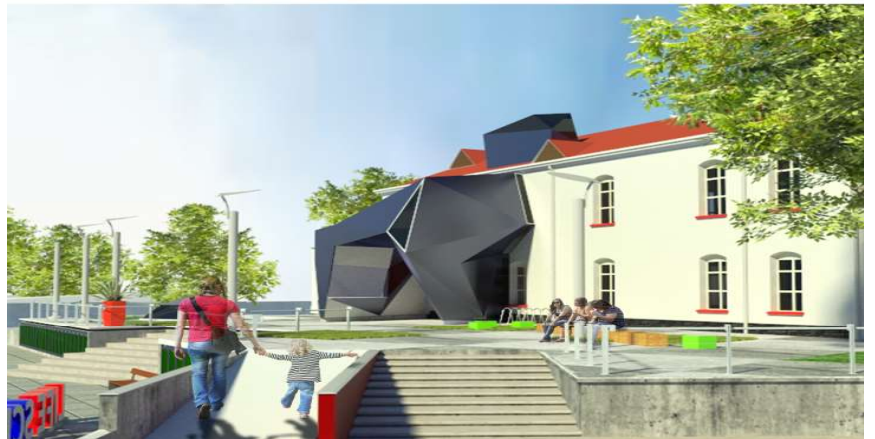
Figure 5.30 Perspective view of the new entrance from the ramp toward the east

creates a new set of axes that juxtapose the formal grid and axis system of the city. This contradicting axis, places emphasis on, and clearly indicates the new interventions on a larger scale. The shape of the new entrance will also be a juxtaposition, in terms of the form giving shapes, to emphasise the intervention as new and not originally part of the building. It will make a clear statement, as a new insertion in the existing built fabric. Faceted panels will be assembled in such a way, that it creates a morphing object that not only latches onto, but also penetrates the existing building structure.

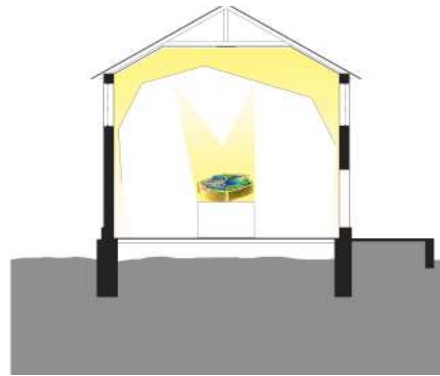
Figure 5.36 Using artificial light as focus lights on artefacts

A study has shown that this kind of indirect light is not the most beneficial light for exhibitions. The light places no emphasis on any artefact on display, but rather lights up the entire space. It is important when exhibiting items, to make use of artificial or natural light, to place emphasis on items on display, without causing any radiation damage to them (see Figure 5.38).

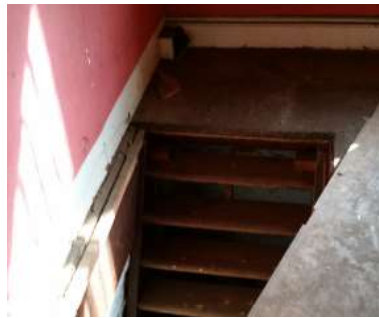
Figure 5.44 Existing trap-door to basement

The existing staircase and trapdoor will be removed and a new staircase will be installed, that relates better with the spatial layout of the new foyer.

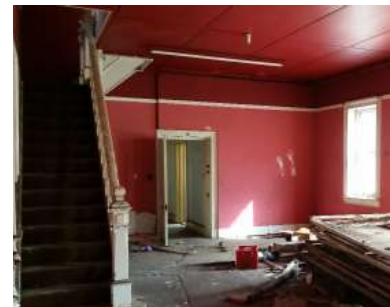
Figure 5.45 Existing staircase to first floor

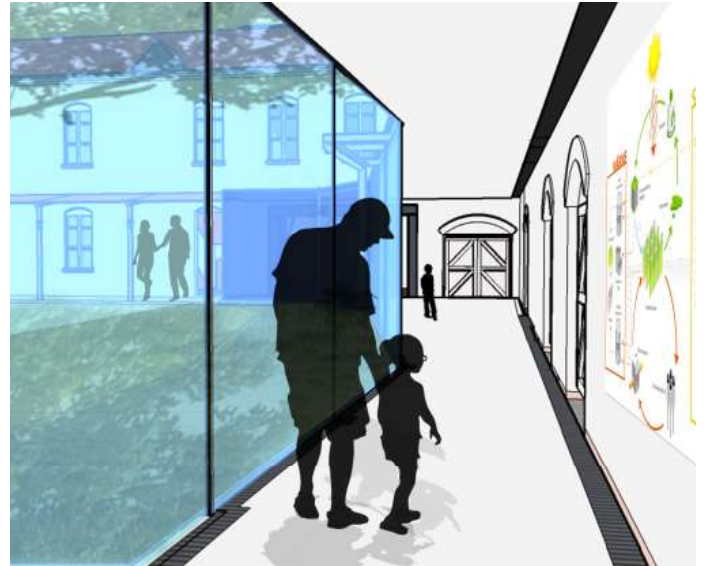
Figure 5.46 Perspective view of the new veranda roof in the courtyard

The addition to the courtyard will be demolished as it detracts from the courtyard as being the central space of the building. The veranda roof that was demolished at that time, will be re-interpreted as a combination of the construction line of the demolished addition (where it touched the north and south wings), and the new insertion by means of the new axis formed as part of the new insertion. The new line will make the user of the space aware of the fact that the roof is an addition. The envelopes of the additional roof will be double glazed (see Figure 5.48) in order to create additional exhibition space that relates to the courtyard, visually. The construction of the roof will be done in such a manner that it creates the effect of a flat, lightweight structure that guides the user of the space visually on a horizontal level (refer to ground floor plan and details in Chapter 6).

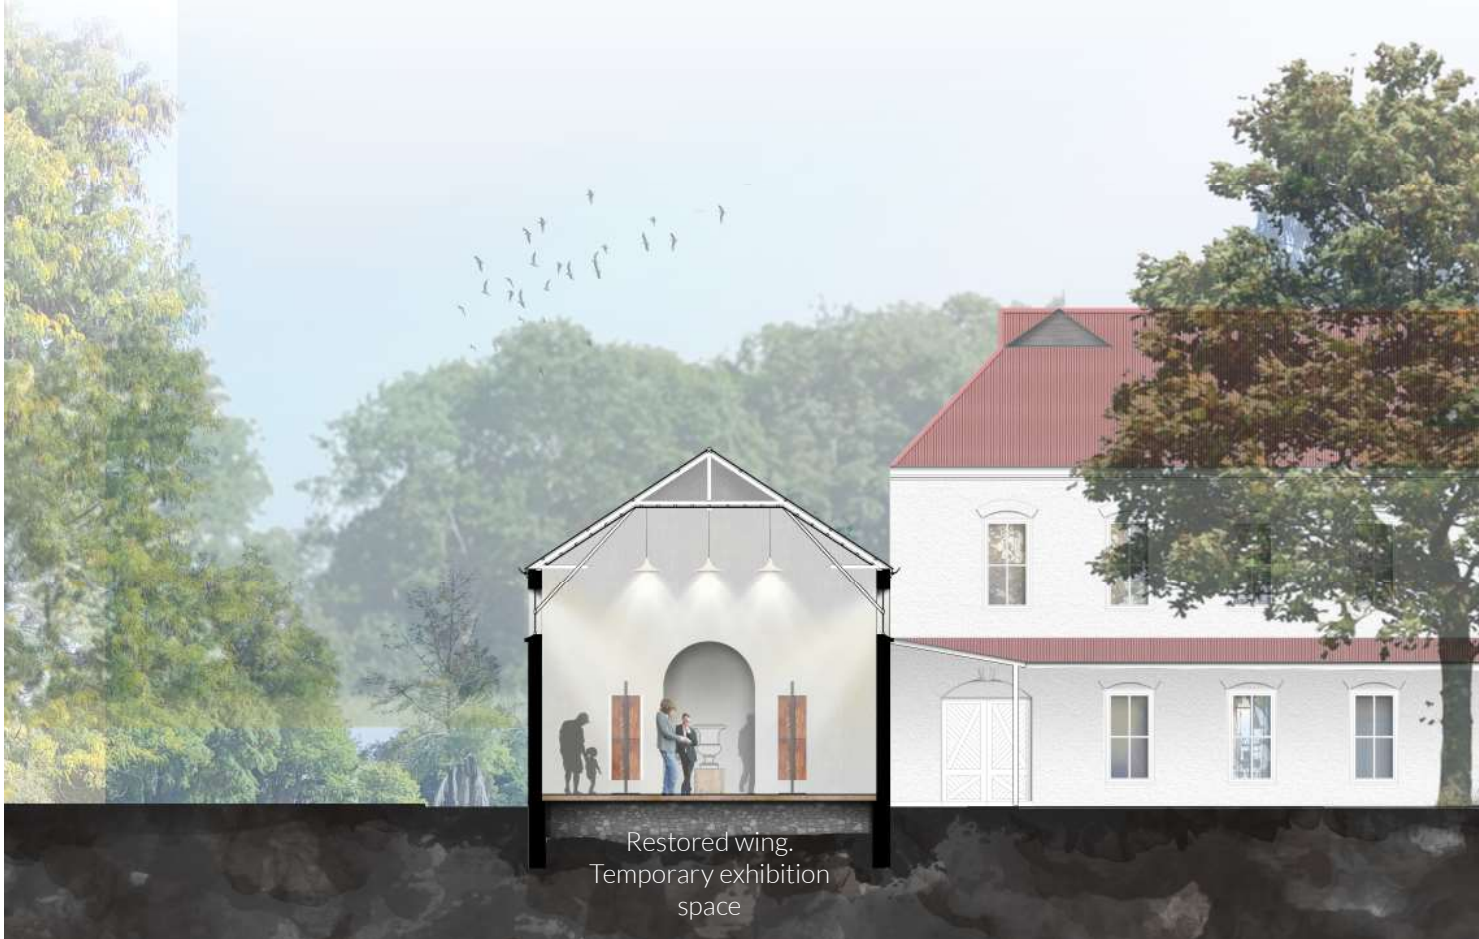
Figure 6.6 East west section indicating new intervention as well as restored wing NTS

A new interior shell is inserted throughout the eastern wing of the *Staatmuseum*. This shell is designed and understood as being apart from the existing structure, and reads as one membrane that morphs through the spaces. To achieve this, a light gauge steel sub-frame is built to accommodate faceted panels to be attached to the structure. The panels will mostly be gypsum plaster board with plywood infill.

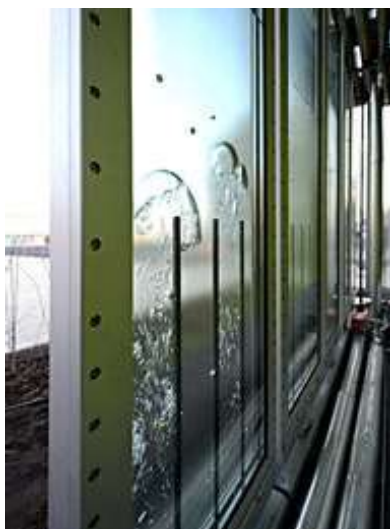
Figure 6.19 Algae bioreactor glass

The environmental systems, that allow the building, to function as a self-sustaining entity, will be placed in the plinth and will be accessible to the public. The main system is a digester system that makes use of organic waste material, gathered from the NZG, which is grained and added to a digester system. The digester decomposes the waste and generates methane gas. The methane gas is collected in a container off site, to be burned in an electrical generator. The CO₂ gas produced by the generator, will be driven through algae bio reactors which converts the gas to O₂ and generates heat, that can be used for space heating inside the building.

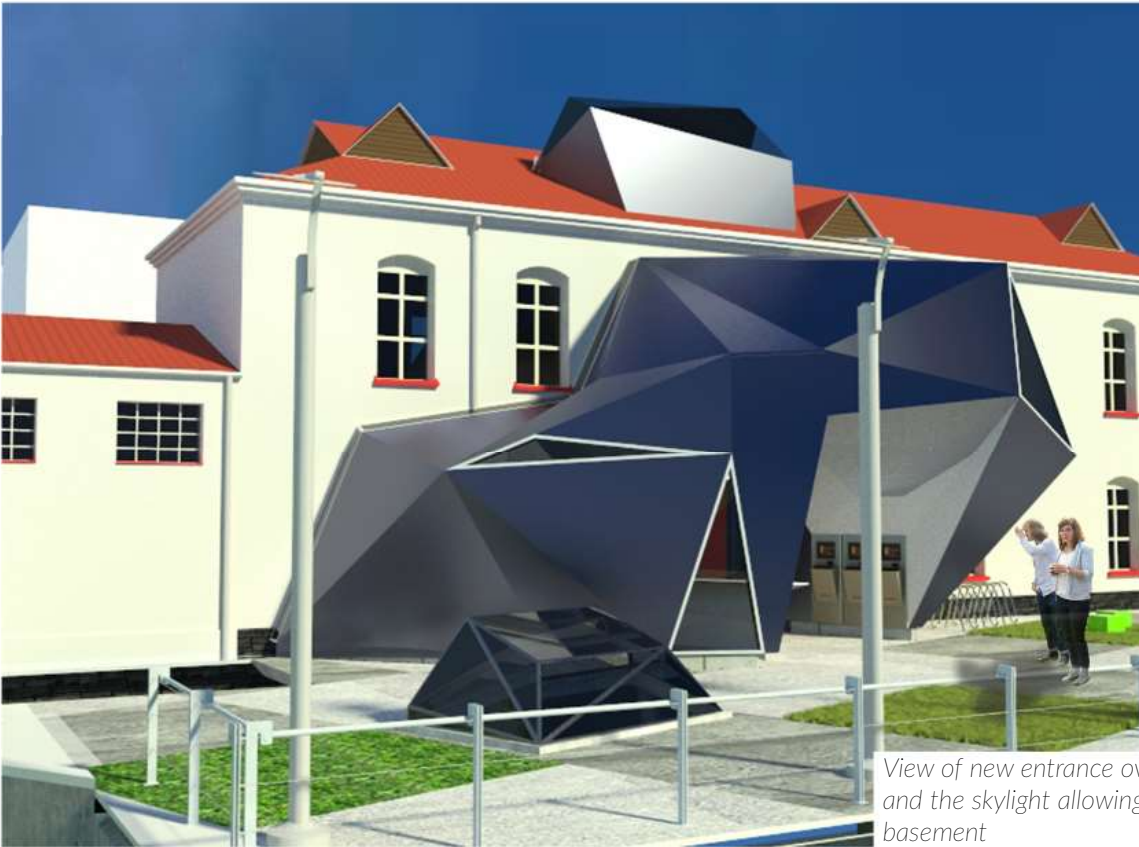
View of new entrance over the plinth and the skylight allowing views into the basement

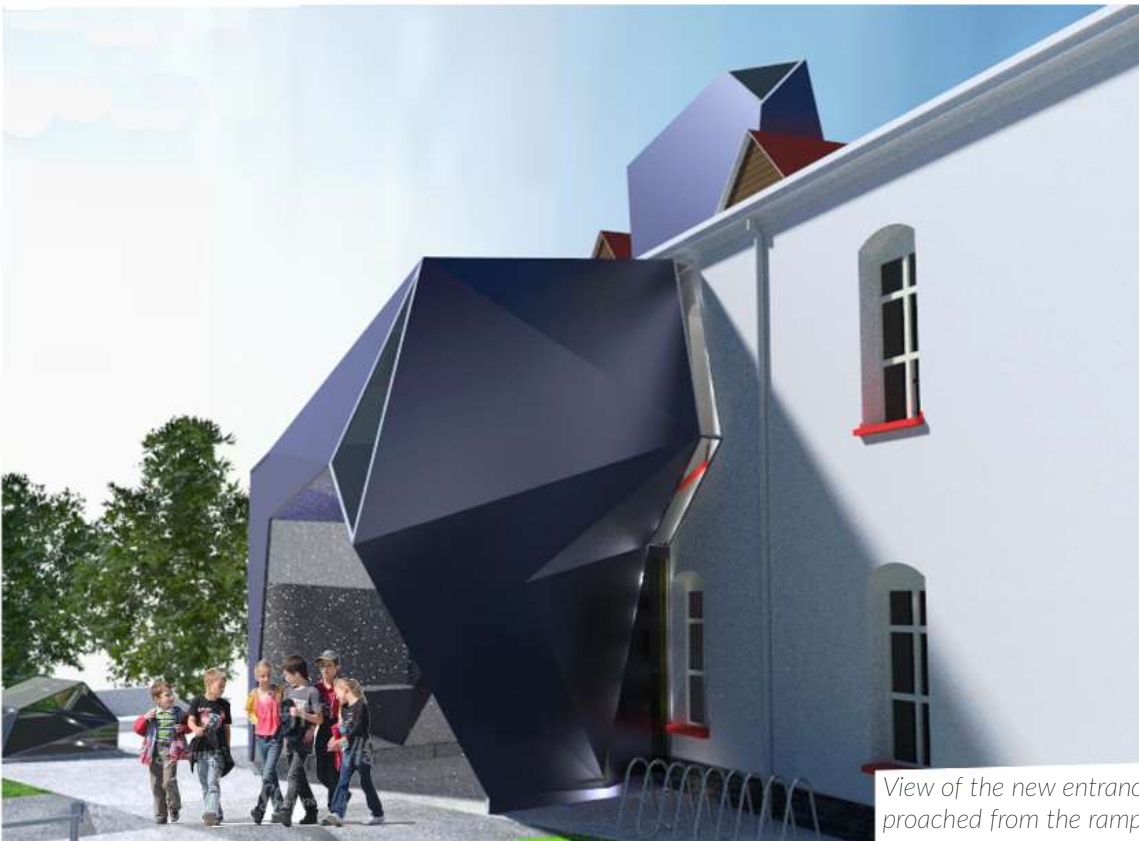
View of the new entrance as approached from the ramp linking from Boom Street
