HEAVY VEHICLE SIMULATOR TESTING ON PRE-CAST CONCRETE PANELS

This paper focuses on the results obtained from recent accelerated loading testing in California with a Heavy Vehicle Simulator (HVS) on a particular system of pre-cast slabs, referred to as Super-Slab®.

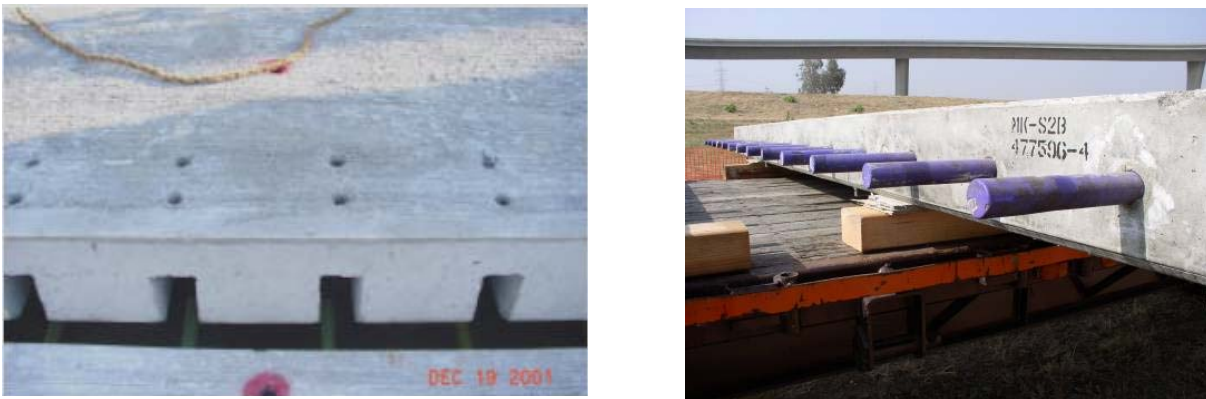
Standard load transfer dowels are cast at one end of each slab at locations that match the location of dovetail-shaped slots cast in the bottom of each adjacent slab, as illustrated in Figure 1. Similarly, standard tie bars are placed at one side of each slab matching the location of slots cast in the adjacent slab.

Figure 1. Pre-cast dowels and slots showing slot/dowel bar connection

accessed from the top of the slab through grout ports cast into each end of each channel (red dots in Figure 1). Also visible in Figure 3 are black foam gaskets glued to the bottom edges (and between the half-round channels) of each slab to create discrete, sealed grout chambers.

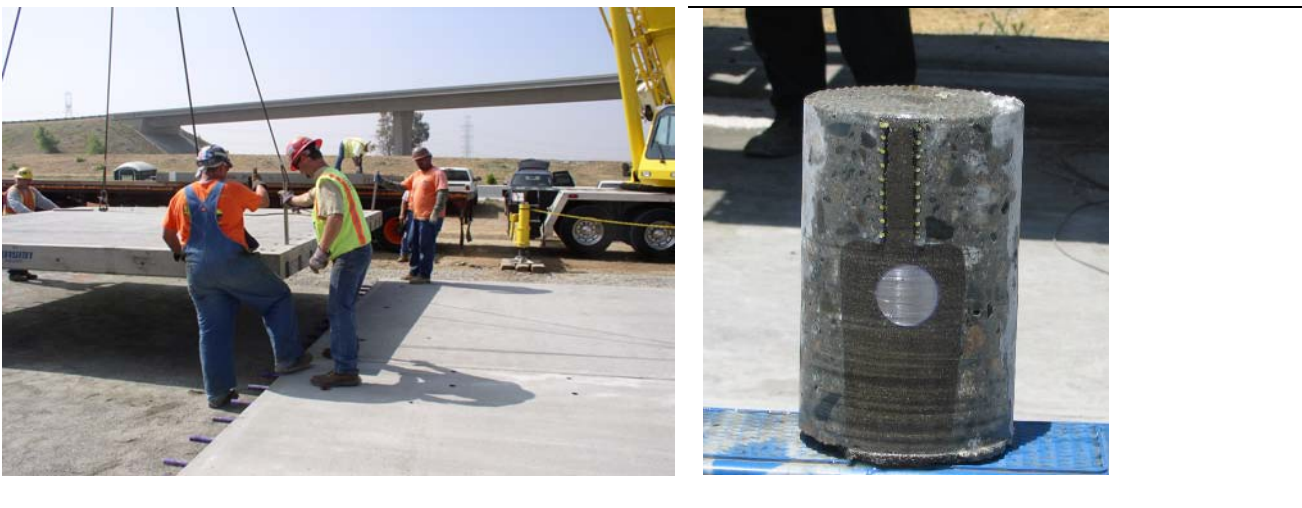
Two grout ports are cast in the top of each slot to make it accessible for grouting after the slab has been placed. Grout is pumped into one port until it exudes from the other, completing the structural load transfer connection from slab to slab. Fully grouted slabs are essentially the equivalent of cast-in-place pavement slabs and perform in the same way. Dowel slots cast on the bottom of the slabs provide two benefits. First, they keep dowel grout on the bottom, protecting it from de-icing chemicals and degradation from freeze/thaw activity. Secondly, they keep the dowel grout out of sight, thus maintaining a uniform-looking, high-performance pavement surface. Figure 2 shows slabs being positioned as well as a core showing the dovetail slot/dowel bar connection.

Figure 2: Slab positioning and core showing dovetail slot/dowel bar connection

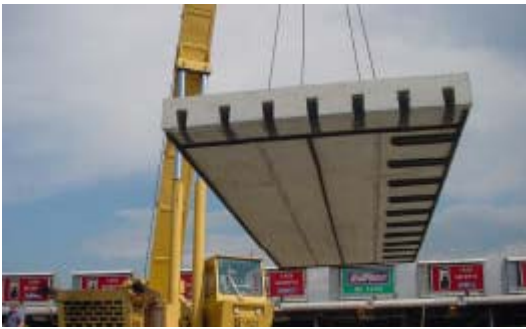
The bedding grout distribution system, visible on the bottom of the slab illustrated in Figure 3, comprises of a series of half-round channels cast in the bottom of the slab which extend across the slab to distribute the bedding grout to the entire slab contact area. They are

Figure 3. Bedding grout channels and gaskets

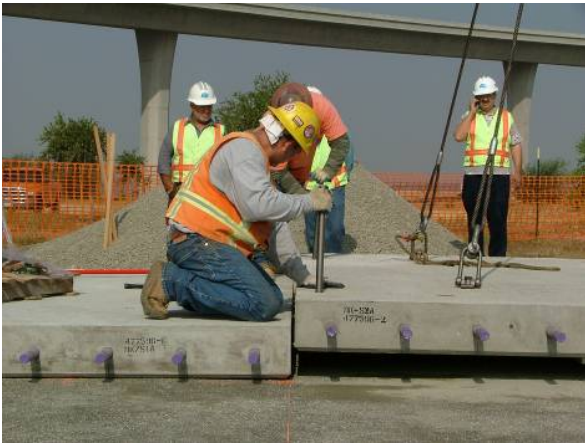
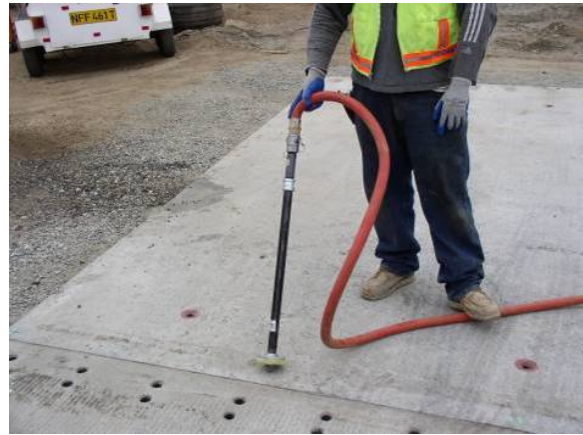
- The construction of a 100mm cement-treated base course;
- Placing of a thin layer of fine bedding material (stone sand) on top of the sub base;
- Placing of pre-cast Super-Slabs®, 5.72 m long by 3.962 m wide and 225 mm thick upon the precisely graded bedding sand and grouting of these as described above and shown in Figure 4; and
- Diamond grinding of the top surface of the slab to meet the smoothness requirements of the project.

Figure 4. Precise placement of the slab on the sand bedding layer and hose with fitting for injecting grout

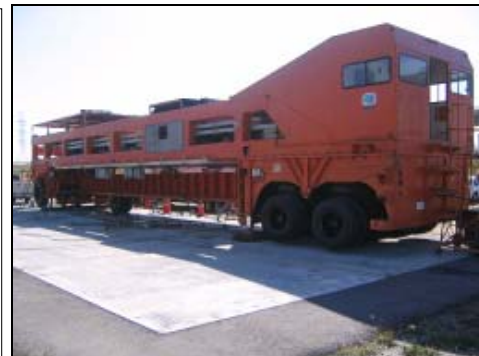
Two test sections were evaluated between June 2005 and August 2006 using a Heavy Vehicle Simulator (HVS), as shown in Figure 5. The main test objectives in the evaluation of the Super-Slab® System were:

Figure 5. Layout of test sections and HVS during load testing

To meet the second and third objectives, the two test sections (Figure 5) were loaded for extended periods under different conditions in the sequence shown in Table 1. Test Section 1 was heavily loaded to identify failure modes and Test Section 2 was utilized to determine performance under more realistic, yet accelerated, loading conditions. The number of Equivalent 80kN axle loads (E80s) shown in Table 1 was calculated using a 4.2 power of the ratio between the actual half-axle load and a standard 40kN half-axle load. As Southern California receives very little rainfall, wet pavement conditions were artificially simulated by pouring water on a continuous basis directly onto the joints. Approximately 380 litres of water per week were poured on to the section at the joints for the duration of the wet test. Assuming that the water completely covered the 1x8 m test area, a total equivalent rainfall of approximately 7 mm per day was simulated during the wet cycle.

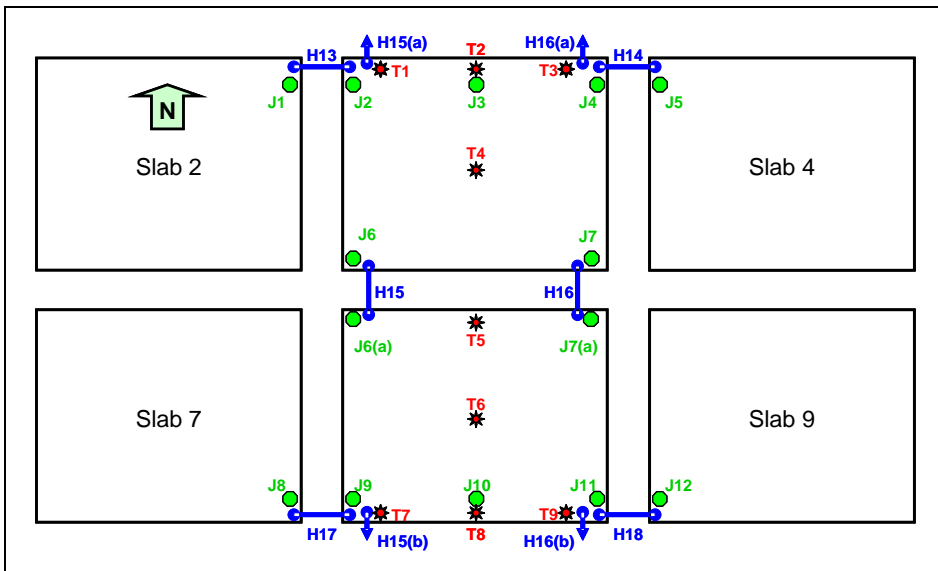
The instrumentation of the test sections consisted of displacement sensors mounted vertically on each section near the two trafficked joints and at mid-panel. Horizontal sensors were used to measure joint opening and multi-depth deflectometers were used to record the vertical deformation in the various layers of the system directly in the trafficked area. Thermocouple stacks were used to record temperatures throughout the depth of the slabs. The locations of the displacement measuring instrumentation and thermocouples are shown in Figure 6.

Figure 6. Location of displacement instrumentation and thermocouples

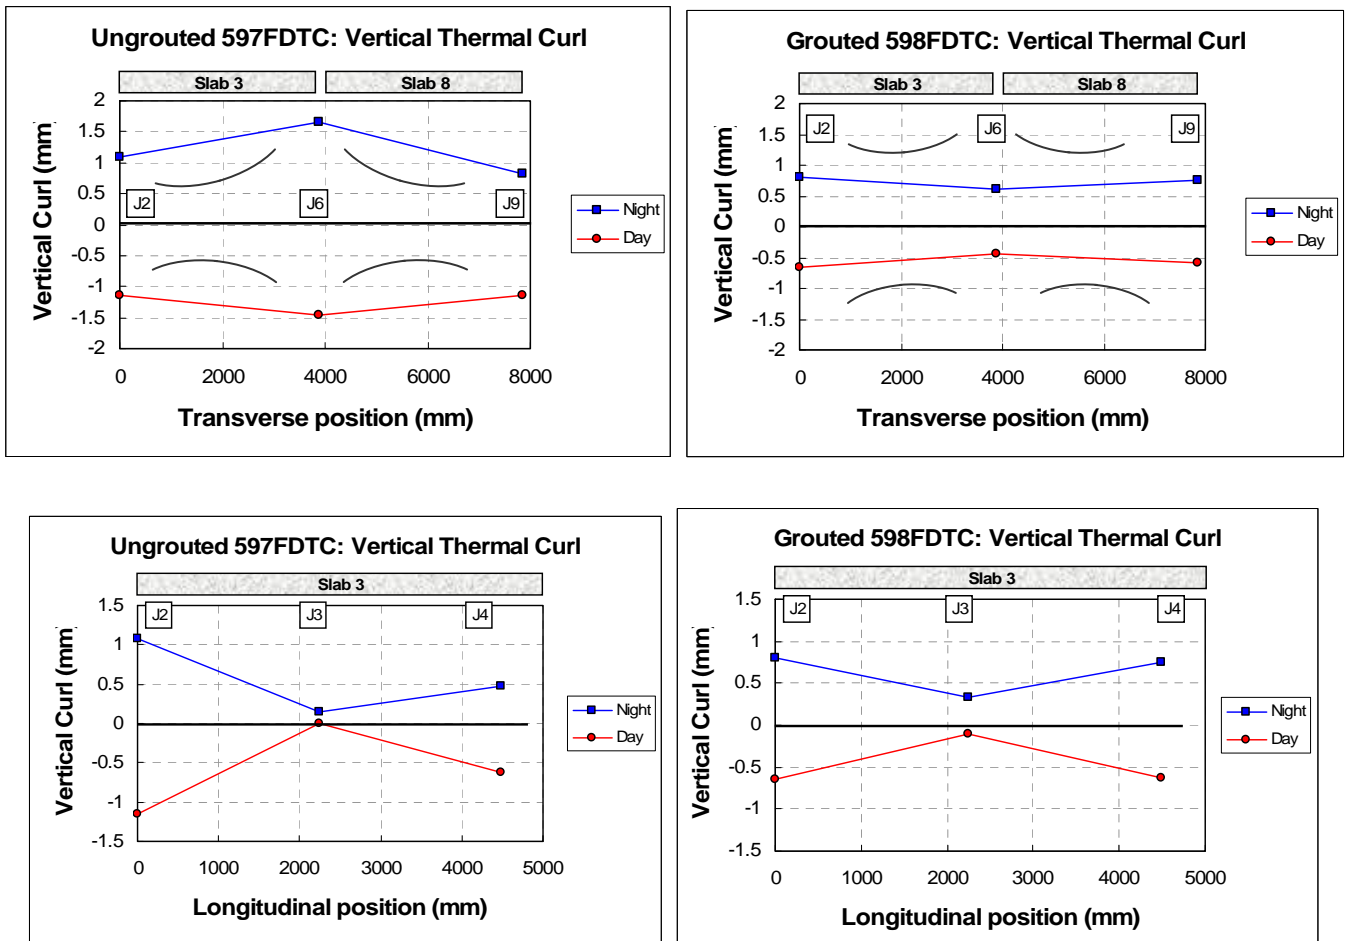
The thermal deformations (with no traffic loads) were compared before and after grouting. The vertical displacement at an interior corner after grouting decreased from ± 1.5 to ± 0.5 mm measured transversely across the slabs as shown in Figure 7. In the un-grouted condition each slab curled separately, whereas after grouting the presence of tie-bars and grout in the joint (in the tie-bar grout slots) restrained this movement. In the longitudinal direction, at the exterior corners (those that would be adjacent to the shoulder) the effect of grouting was minimal (see Figure 7).

Figure 7. Comparison of the vertical deformations caused by thermal curl of the slabs before and after grouting, in the transverse and longitudinal directions

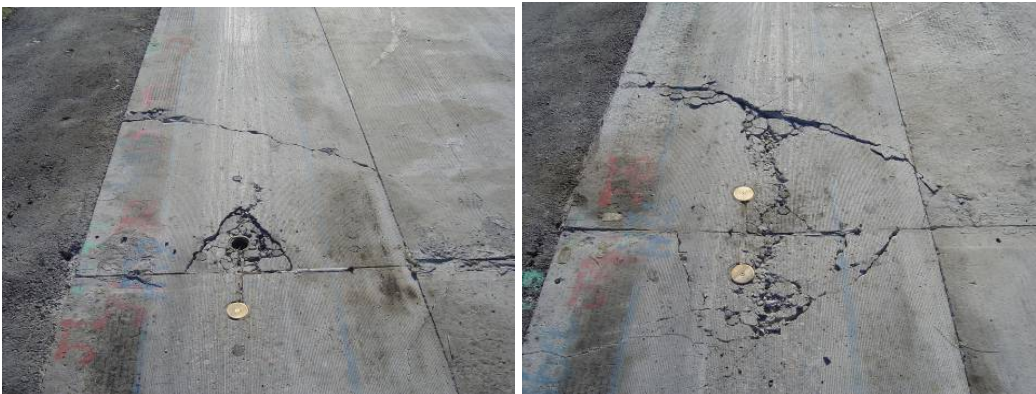
Failure of the section took the form of a localized collapse in one of the joints and a more extended corner crack on the other joint. Forensic investigation revealed that the localized failure happened in between the dowel bars, exactly where the channelized wheel traffic loaded the pavement. The combined observations point toward concrete fatigue under channelized traffic and the loss of support caused by pumping. The other joint presented a failure that can be considered typical of cast-in-place slabs, with large concrete cracks. Both failed joints are shown in Figure 9. (As an indication of their size, the brass sensor caps are 75 mm in diameter.)

Figure 9. End of life at the two joints of section 1, loaded to failure

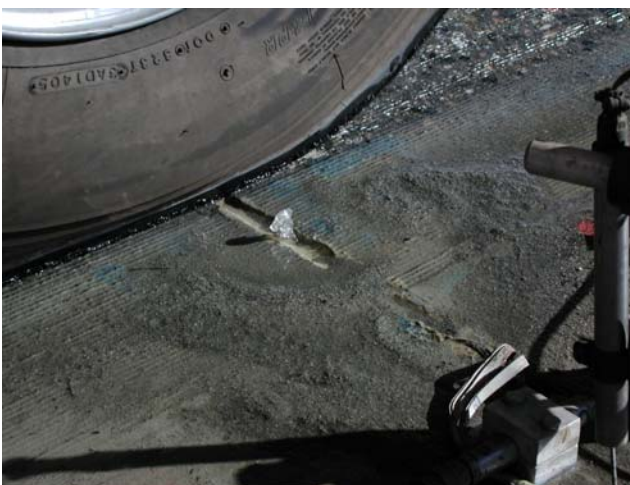
Pumping of fine sand was visible at the joints after the first day of the wet cycle. This, however, did not result in any significant increase in corner deflections. When the load was increased to 80kN, the amount of pumping increased and water spouts approximately 50 mm high were detected as the HVS wheel ran over the joints. Figure 10 shows the amount of pumping and water sprouting which was observed at that time.

Figure 10: Water pumping from a joint during the wet cycle

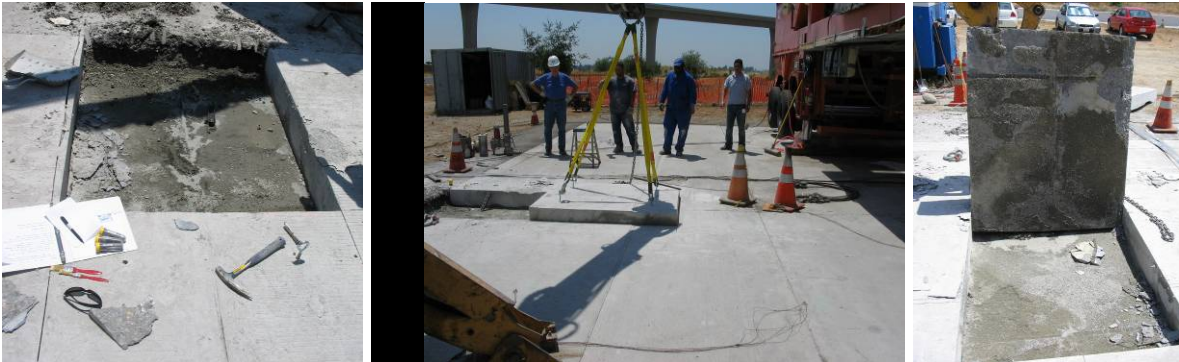
Apart from this, no other forms of distress were observed, despite the fact that considerable pumping of material from under the slab occurred during wet trafficking. An investigation was carried out to evaluate the extent of the suspected voids under the slab caused by pumping (See Figure 11). It revealed that the pumped material consisted of the finer particles from the sand bedding layer and of disintegrated bedding grout. There was no clearly noticeable void in the wheel path under the joint, but there were rather widespread marks of washed fines.

Figure 11. Investigation of void under the slab in Section 2
