# Chapter 4

## S I T E   A N A L Y S I S

## 4.1 INTRODUCTION

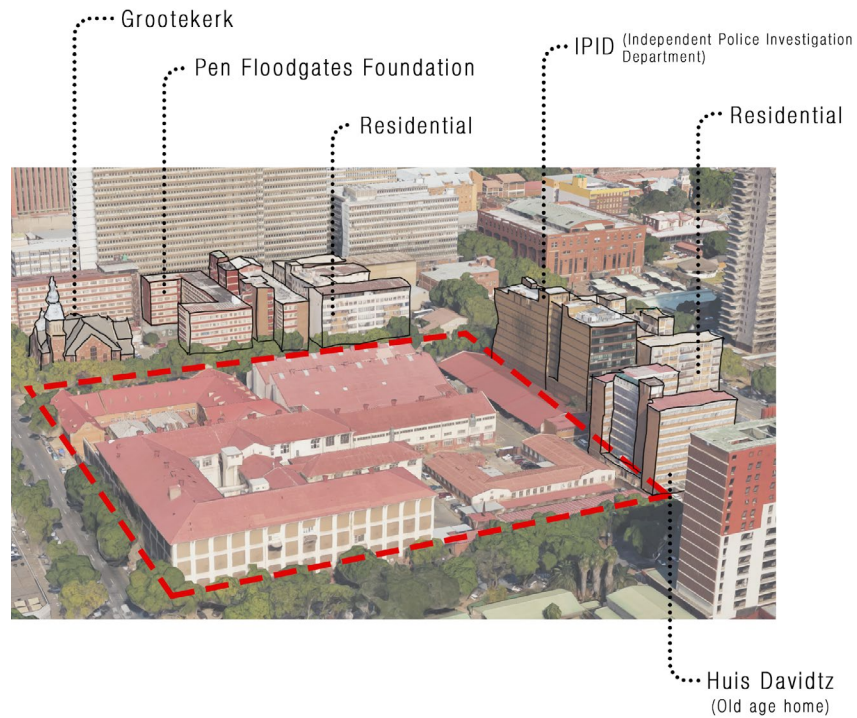
Figure 4.1: Programmatic context, looking south-west (Author)

The programmatic functions surrounding the GPW block are generally drawn between two poles: community-oriented and more institutional; as illustrated in Figures 4.1 - 4.3, to the west there are many residential blocks of which the most prominent are the Schubart Park blocks (currently unoccupied and dilapidated) and the new Thembelihle Village which is a social housing and mixed-use development currently being constructed. Directly north of the GPW block is Laerskool Eendracht and to the south is the Bosman Street 'Grootekerk' and other religious and social institutions, as well as housing in its neighbouring buildings. The neighbouring block to the east constitutes the concrete Telkom Towers that dominate the city skyline.

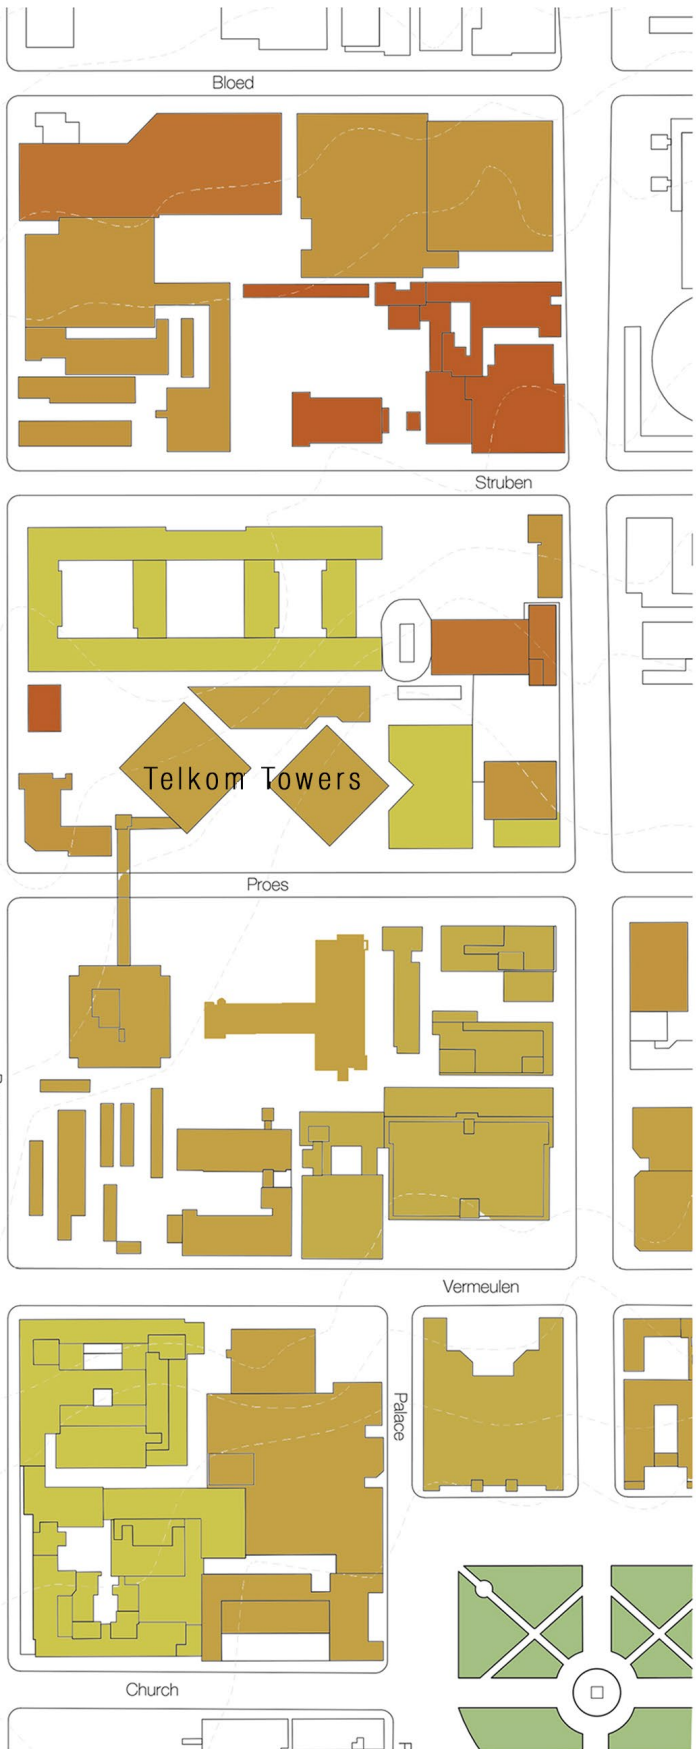
Figure 4.4: Site lines and Views of surrounding buildings

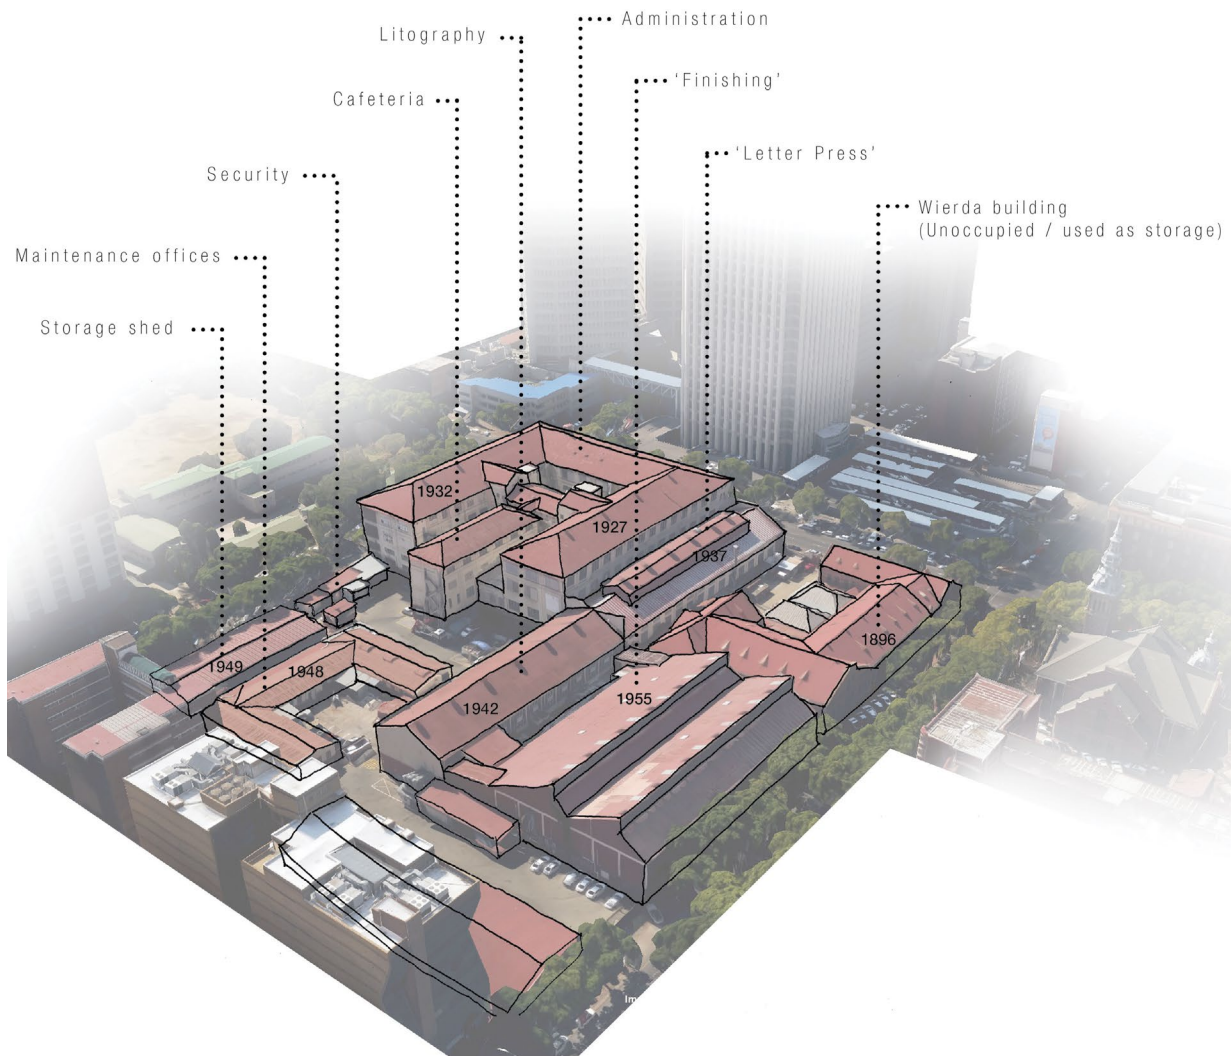
**Figure 4.5:** Existing uses & timeline of buildings on block

The Department of Public Works (DPW) owns the property and the Government Printing Works institution rents the buildings from them. As previously mentioned, the GPW is relocating to another site in Visagie Street as the new location offers more space and is mostly on one level, therefore it will not present the challenge of moving heavy printing equipment between different levels as the current site does (Deppe, 2016). Figures 3.7 and 4.5 highlight the timeline with which the block developed over the period between 1896 and 1955. From what documentation suggests, there was no decent masterplan for this block; the DPW just expanded over time as the GPW was in need of more space. De Villiers and Clarke (2015:97) note that “the original program of the site has remained roughly the same for decades, but as new technologies evolved, it has become obsolete and will now enter a new era of use”. Figure 4.5 also indicates the different uses of each building as it is currently being operated.

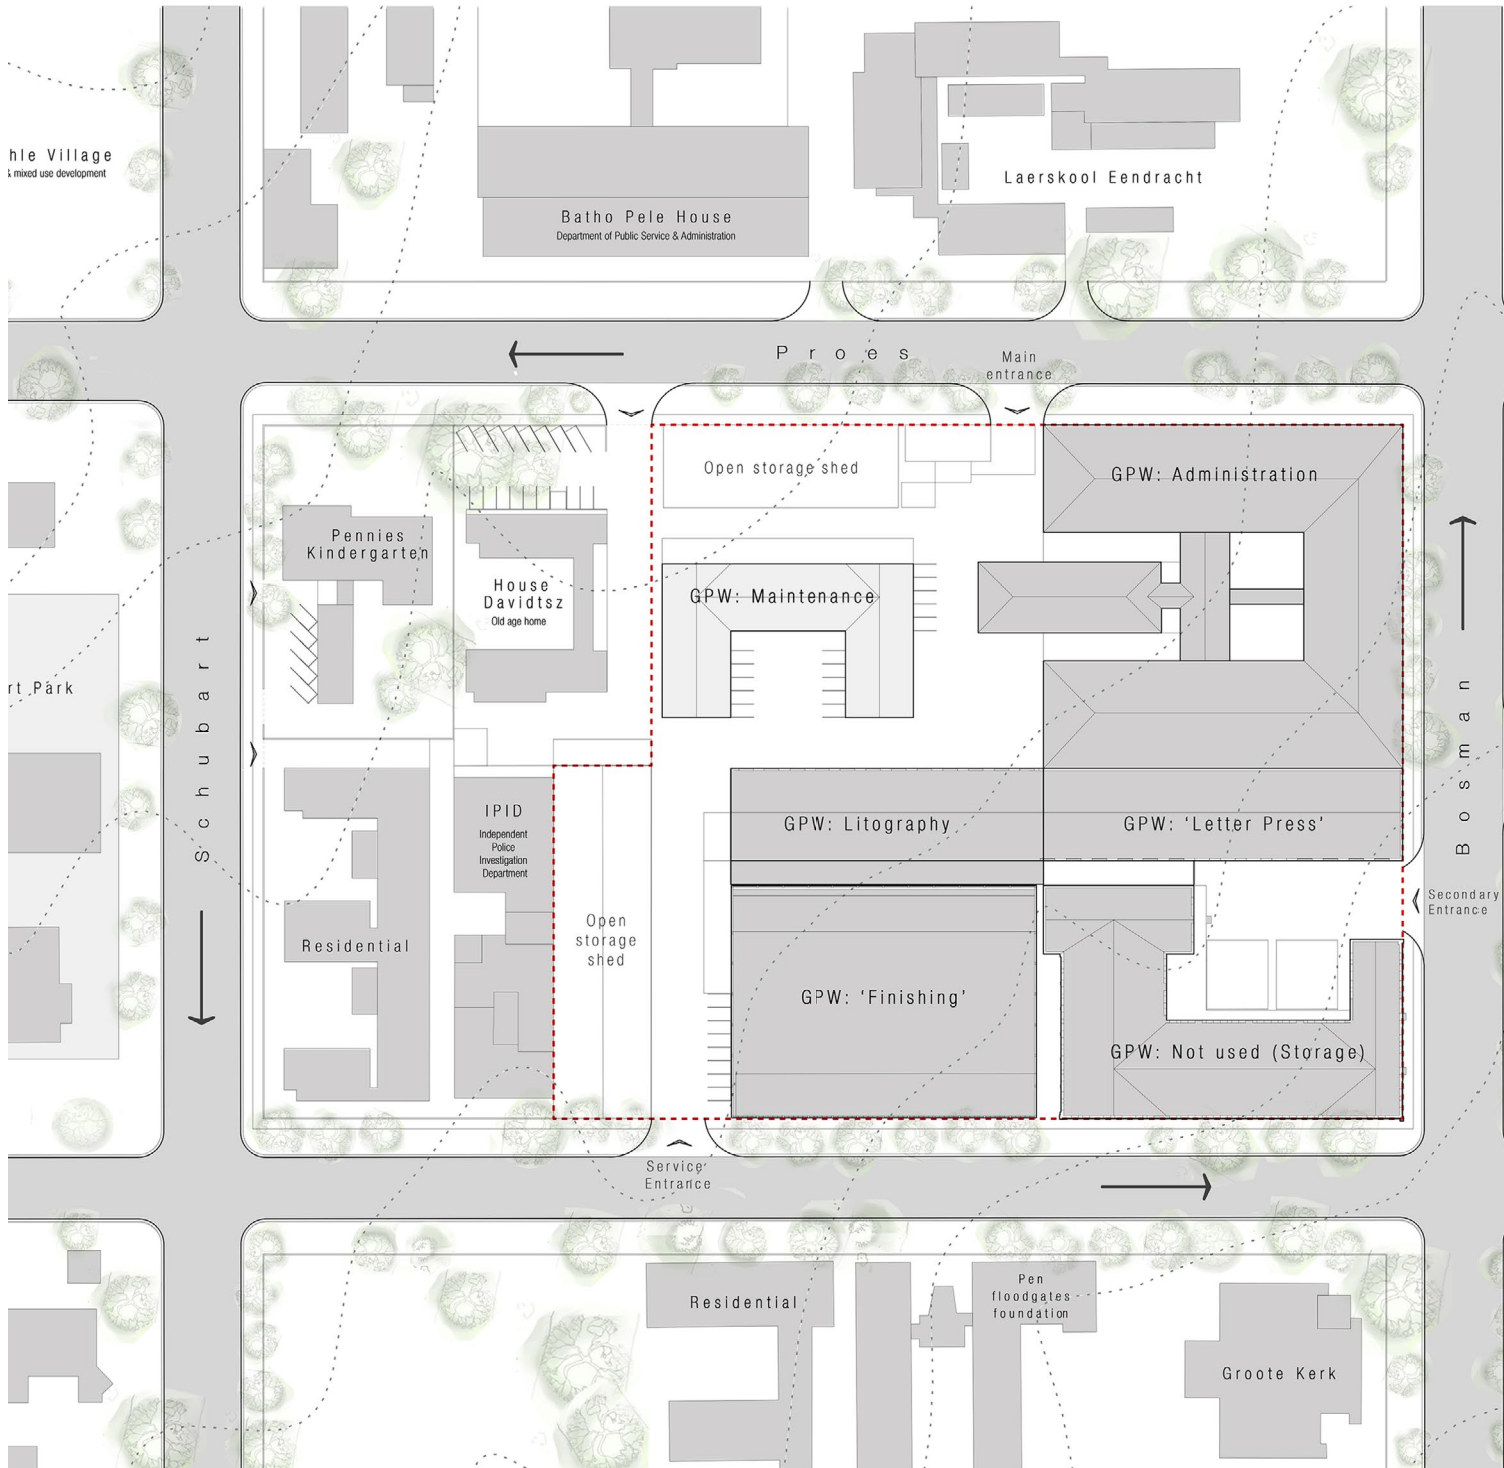
Figure 4.6: Site Plan, NTS (Author)

Figure 4.6 illustrates the site plan of the GPW block in its existing condition as well as the immediate surrounding context.

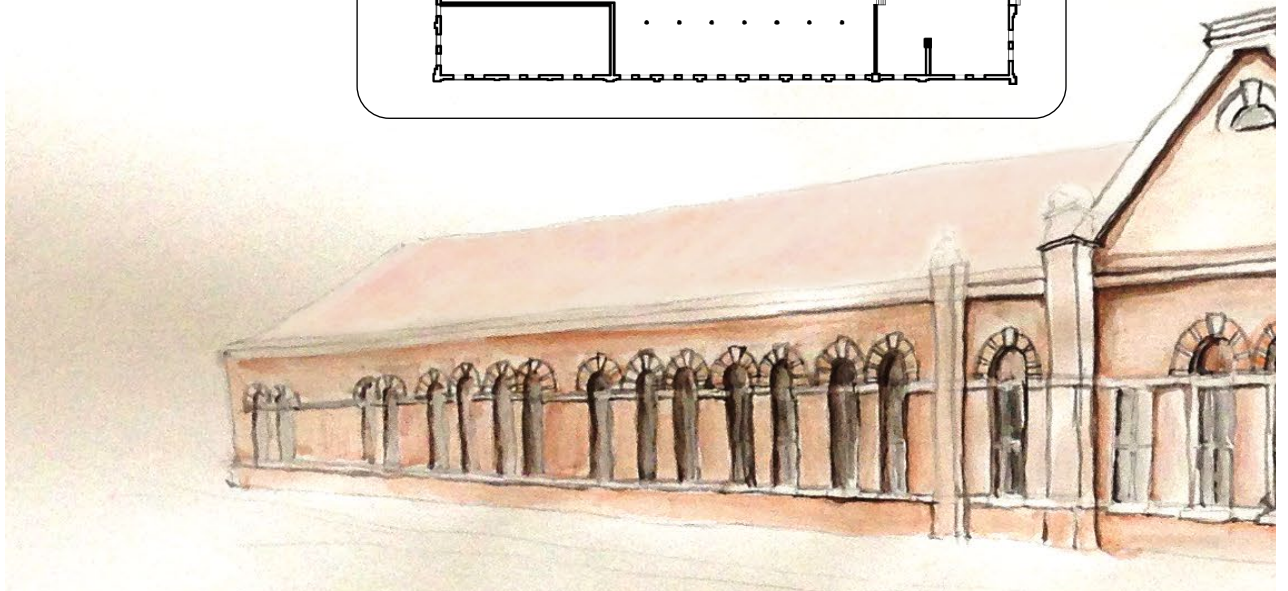
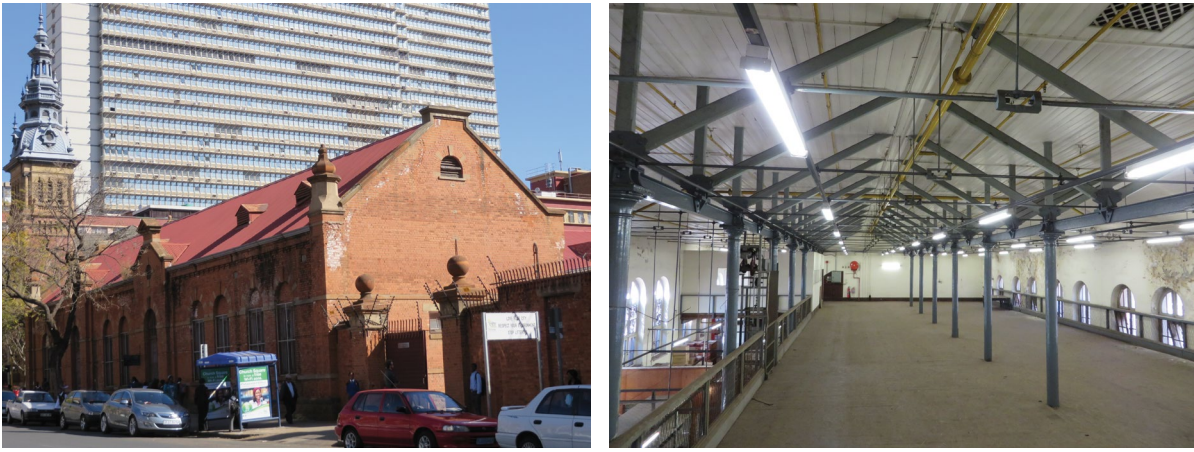
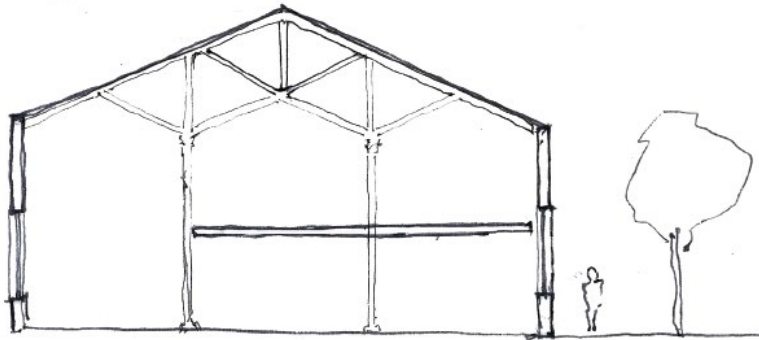
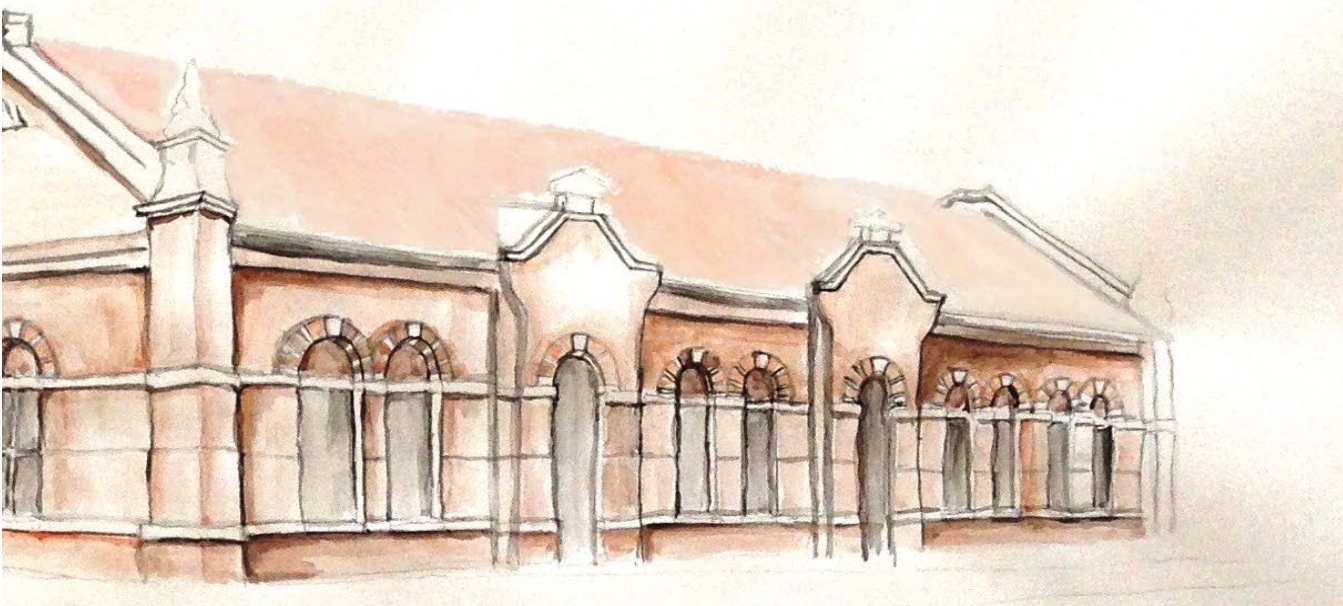
Figure 4.7: Description of Wierda building

**Year of completion:** 1895 -1896

**Architect:** Sytze Wopkes Wierda

**Commissioner:** Departement Publieke Werken, ZAR

**Architectural style:** 'Dutch Renaissance Revival'

**Uses:** Government printing works, now vacant (used as storage space)

**Current heritage status:** Article 34 of the National Heritage Resources Act (structures older than 60 years) is applicable. (Clarke and de Villiers, 2015: 79)

The building's aesthetic value presents itself mostly on the red face-brick facade which is characterised by sandstone decorations in the form of streaky-bacon coursing, key-stones, quoining and bollards or pinnacles/obelisks as pediment finials (Clarke and de Villiers, 2015: 79). Furthermore the decorated arched window is a repetitive facade element as well as the stepped-gables with Neo-Classical styling; these were all architectural features used in many similar industrial buildings in the Netherlands at the time (Clarke and de Villiers, 2015: 79). Besides these, the red corrugated iron roof sheeting was chosen as a result of the local climatic conditions and the roof ventilators (discussed in relation to the scientific significance) became a characteristic element of the Pretoria regionalist building style (Clarke and de Villiers, 2015: 79). Furthermore the building has a U-shaped plan which frames a central courtyard.

The building has an exposed structural system that allows for large open-plan adaptable spaces that are not dependent on the perimeter walls for their structural integrity (Clarke and de Villiers, 2015: 79). According to Clarke and de Villiers (2015: 80), this structural system is an 'ingenious system' and a 'beautiful amalgam of cast-iron columns and brackets supporting a timber roof structure, all kept in equilibrium by steel tie-rods with adjustable tumbuckles'. Furthermore the roof-ventilators were included due to the need for buoyancy-driven natural ventilation in that time of earth-roads surrounding the building and the requirement to keep the interior printing equipment dust-free (Clarke and de Villiers, 2015: 79).

Later additions to the building include the mezzanine floor level in 1984, the fire escape stairs, the two square shape structures in the middle of the courtyard as well as the arched roof covering along the courtyard perimeter.

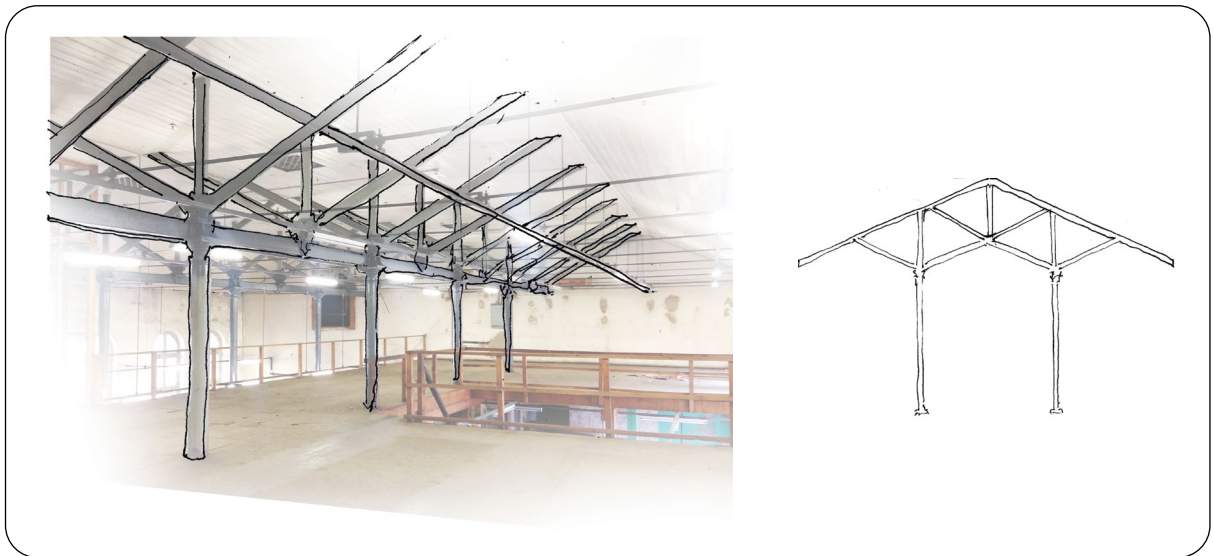
**Figure 4.8:** Exposed structural system - Allows for large open-plan adaptable spaces that are not dependent on perimeter walls for structural integrity.

The scientific value is instilled in the building’s structural system which was ingenious at the time for a light-industry building to be able to present largely uncluttered open space; furthermore the roof ventilators were also a valuable technique used.

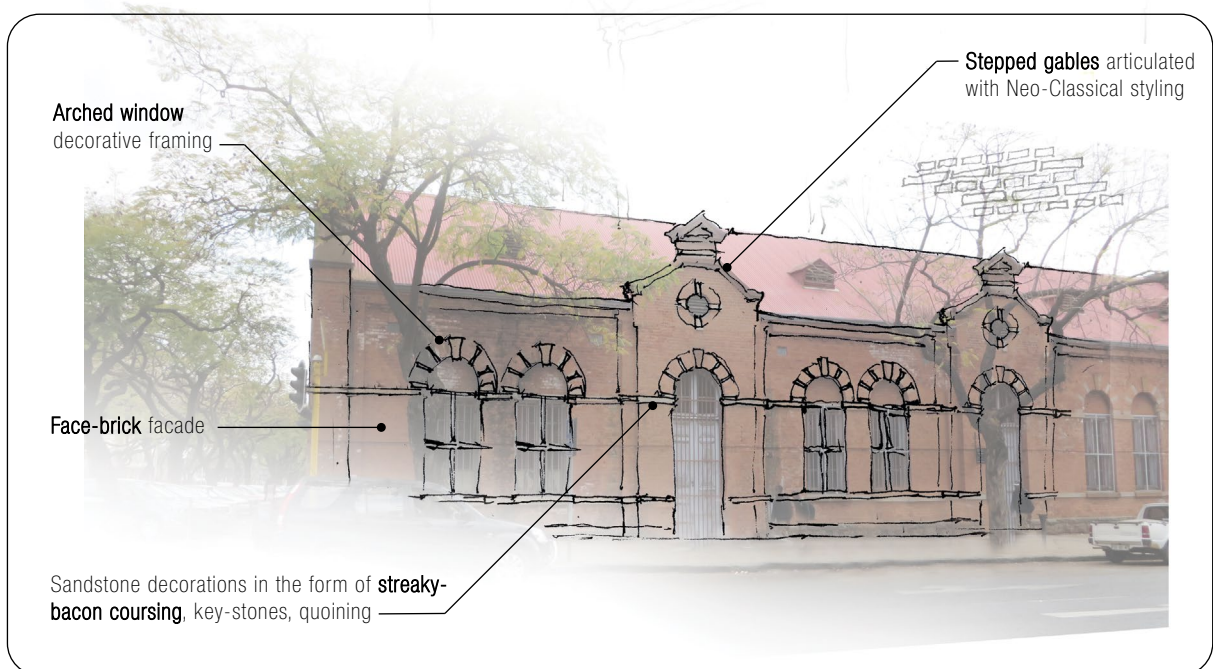
**Figure 4.9:** Stylistic characteristics

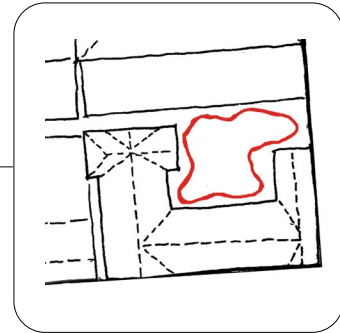
Figure 4.10: Wierda building - strengths

**Face-brick facade** [english bond]

- Consists of alternating courses of headers and stretchers, with the alternative headers centred over and under the vertical joints of the stretchers.

- **Stepped gables** articulated with Neo-Classical styling

- **Arched window** & decorative framing

- **Sandstone decorations** in the form of streaky-bacon coursing, key-stones, quoining

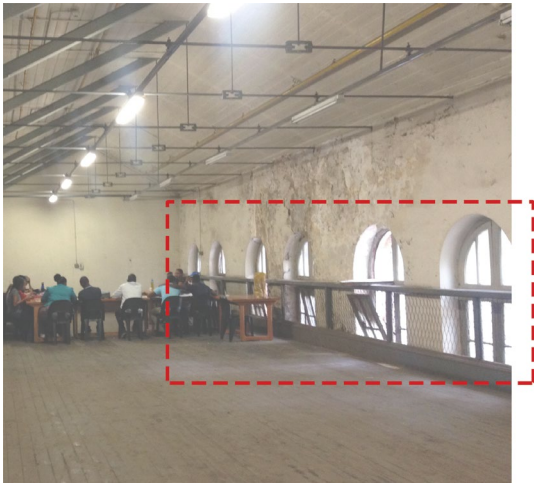
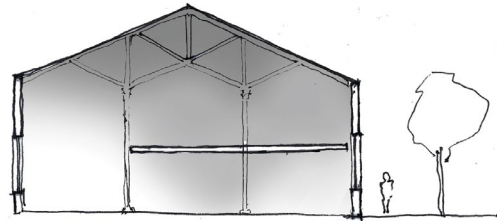
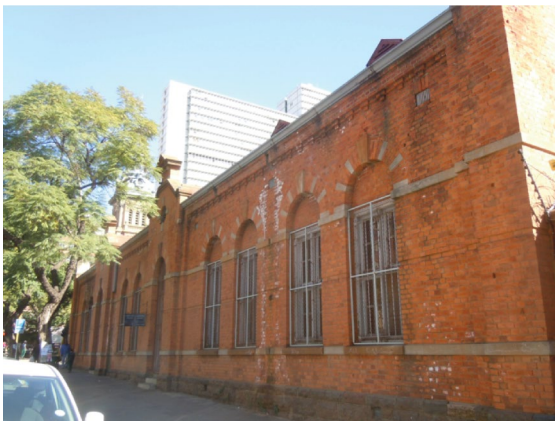
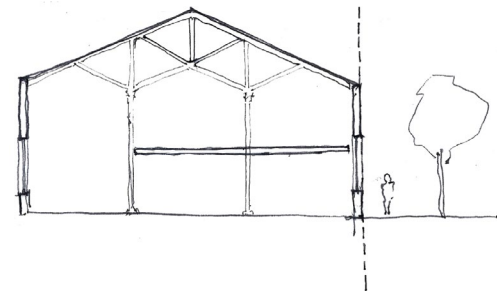
Figure 4.11: Wierda building - weaknesses

1.) POOR INDOOR DAYLIGHTING QUALITY

Especially on mezzanine level (1984 addition) as arched windows' height were intended only for ground floor level

2.) BLUNT STREET EDGE

- No street interaction

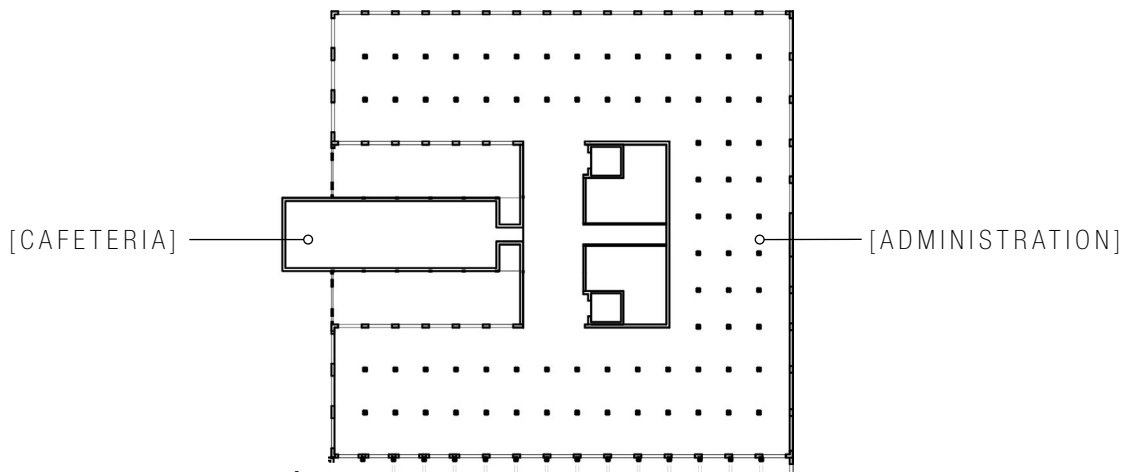
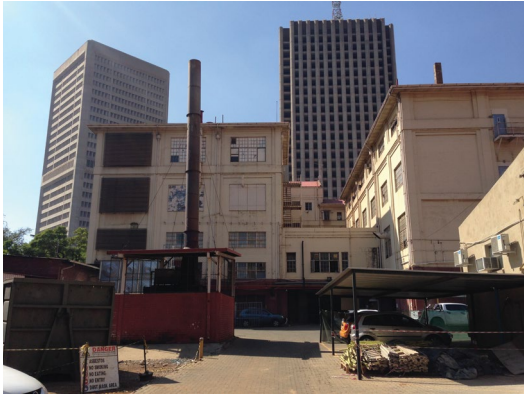
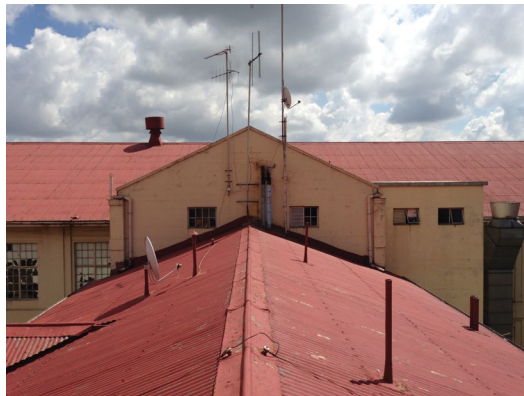
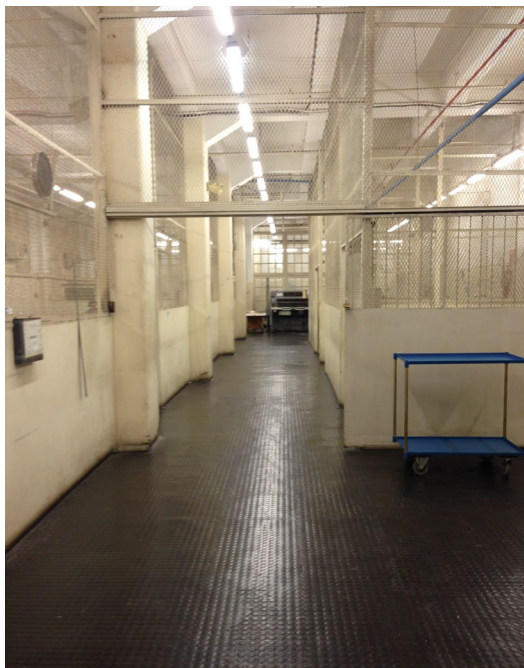
Figure 4.12: Description of Administration building

PLAN SHOWING STRUCTURE OF BUILDING  
5-story building with a concrete column and beam infill structure

SECTION SHOWING STRUCTURE OF BUILDINGS

This is a four-storey concrete column and beam, with brick-infill, structure with the main building primarily u-shaped in plan. Besides this it has an extra protrusion, of the same construction, sticking out to the western side (in which the cafeteria is currently situated), connected to the main building by the central circulation and services core. The roof is constructed of timber trusses and red corrugated iron roof sheeting, to fit into the rest of the block's roof tradition (see 'tectonic coherency' at section 4.5.1). The floor to soffit heights of the four levels range between 4 and 6 meters - higher than normal to accommodate some of the printing equipment.

It has an all-round monotonous facade of relatively large square window openings; these windows (with the additional heat produced by the printing machinery inside) rendered the interior space too hot and during the 70s (when air-conditioning was not yet 'trusted' in buildings (Deppe, 2016)) all the window openings on the east, north and western sides were covered with horizontal steel louvred screens to keep the sun out.

The ground floor level functions as a storage garage where small carrier-trucks and vans can drive in and unload materials and supplies. The ground floor storage garage runs directly through to the longitudinal buildings south of it, and also through underneath the saw-tooth building. On the first floor, on the southern side, it is connected to the longitudinal building (from the outside and above it looks like two separate buildings but inside the space functions as one).

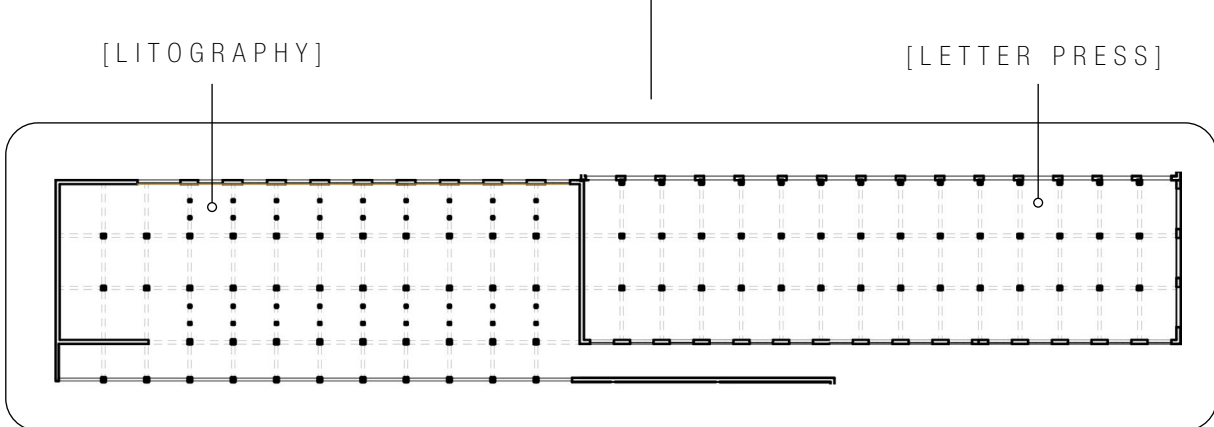
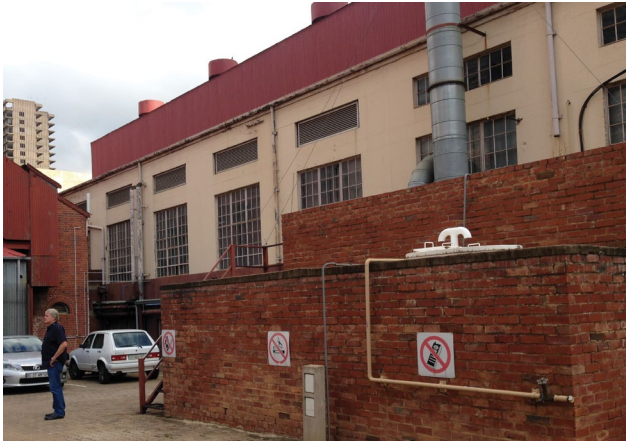
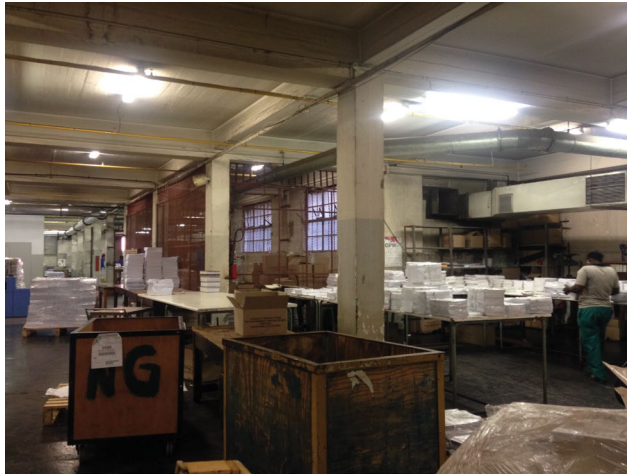
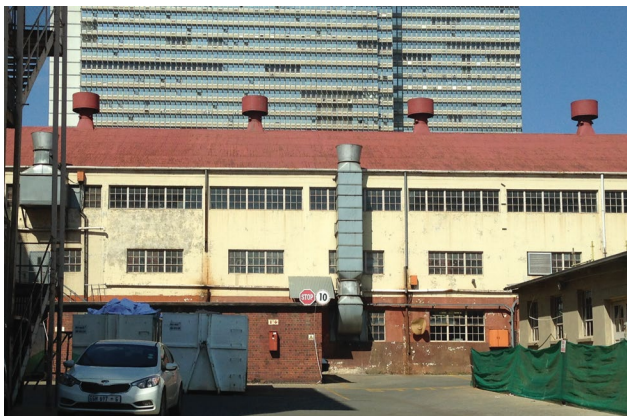
Figure 4.13: Description of Lithography & Letter Press buildings

PLAN SHOWING STRUCTURE OF BUILDINGS  
Concrete column and beam structure with beams spanning in both directions

SECTION SHOWING STRUCTURE OF BUILDINGS

These two buildings have exactly the same construction as the administration building, square concrete column and beam structure with the same monotonous window spacing.

The first floor slab is supported by two rows of columns spaced about 6m apart (the western building has extra, smaller columns in between). The slab consists of two-directional concrete beams (running in both directions). On first floor, the roof is supported entirely by the perimeter walls, therefore there are no columns on the first floor.

These buildings are also characterised by the red corrugated iron roof sheeting tradition, with distinctive circular shaped roof ventilators on top of them. As mentioned earlier, the southern building ('Letter Press') is an extension of the administration building, both on ground and first floor.

The western building ('Lithography') on the other hand, is an extension of the saw-tooth building ('Finishing') on ground floor level. On the first floor, the two are separated, as the saw-tooth was only built in 1955.

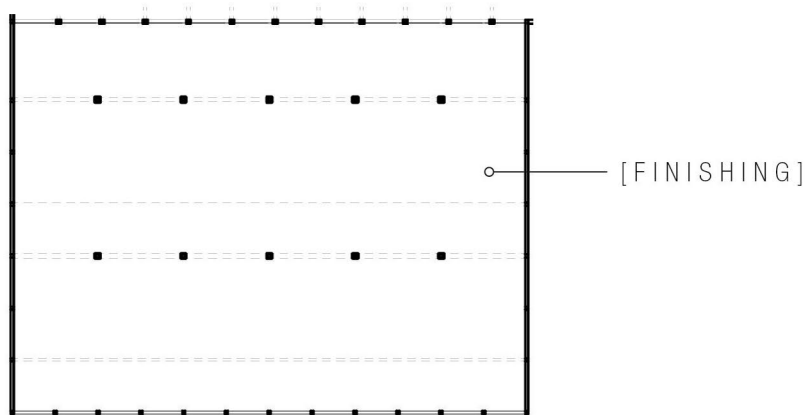
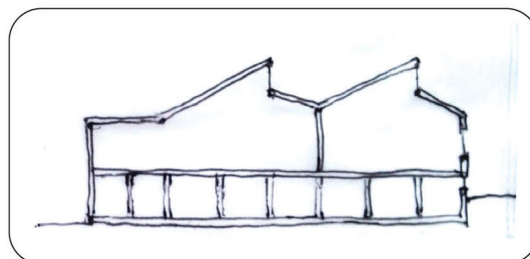
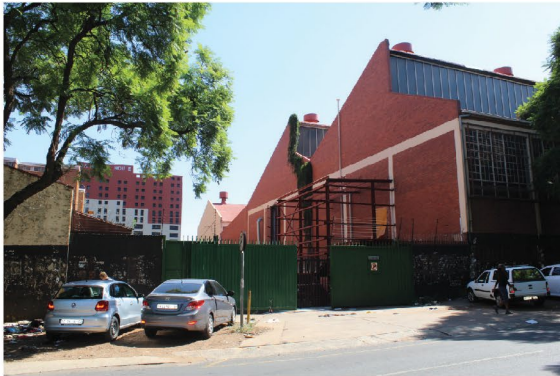
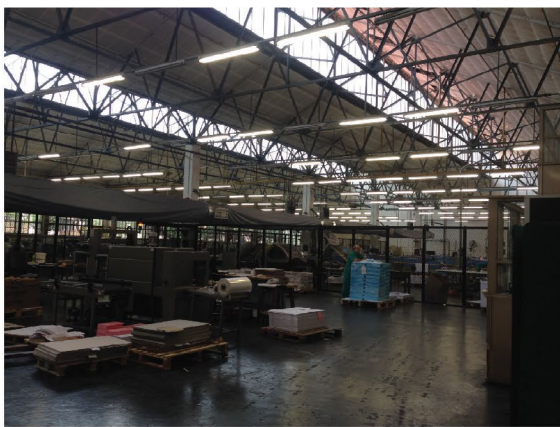
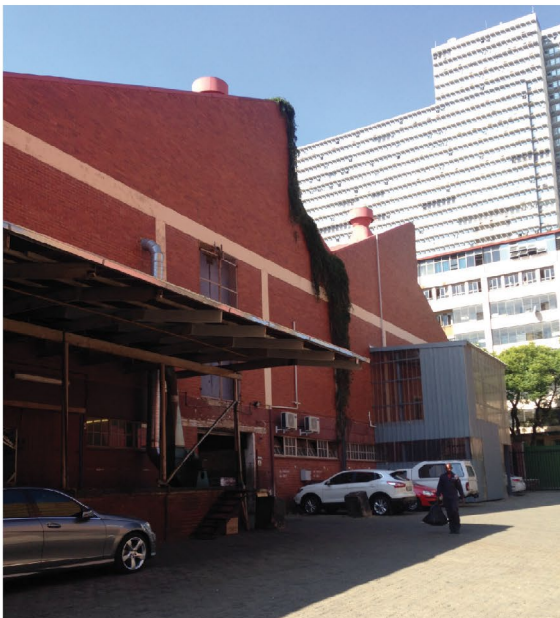
Figure 4.14: Description of Finishing (saw-tooth) building

Concrete beam and column with brick infill structure with characteristic saw-tooth roof profile with exposed steel structure to let natural light in

#### SECTION SHOWING STRUCTURE OF BUILDINGS

This building constitutes a concrete beam and column structure with red face-brick walls (Figure 4.14). The ground floor level is sunken in to the ground with a semi-basement opening on the southern street side, then it extends into the ground floor underneath the 'Litography' level (see Figure 4.13).

The first floor slab is supported by the same column structure as the Litography building. The building features a characteristic saw-tooth roof profile with clerestory windows facing south to let natural daylight into the open volume space.

The roof also features the traditional red corrugated iron roof sheeting and is supported by steel trusses, which are carried by only one row of columns down the middle of the floor.

The saw-tooth profile-roof allows for a completely open plan and a well-lit, large volume that can accommodate many industrial production functions.

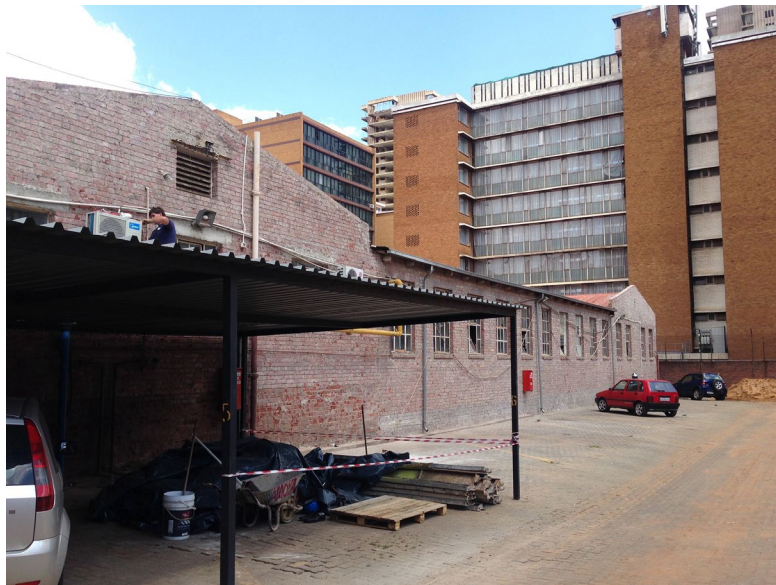
Figure 4.15: Maintenance offices building, Huis Davidtz in the background

The maintenance offices comprise a one-storey u-shaped building on ground floor level. On the site visit in February the building was very dilapidated (Figure 4.16) and some attempts at maintenance were in the process of being carried out - all the plaster was cracked and needed replastering, all the ceilings were rotted and services were hanging out over the offices. The operations director also complained that the building was extremely hot in summer and cold in winter (because of the lack of any insulation and low pitched roofs resulting in direct heat induction) and that the occupants inside this small building could not wait to relocate to their new premises (Deppe, 2016).

- Dilapidated structure
- Arbitrary (small) scale in relation to the rest of the block and for its central position in the city
- Random placement on the block - does not add any value to the rest of the block as a whole.

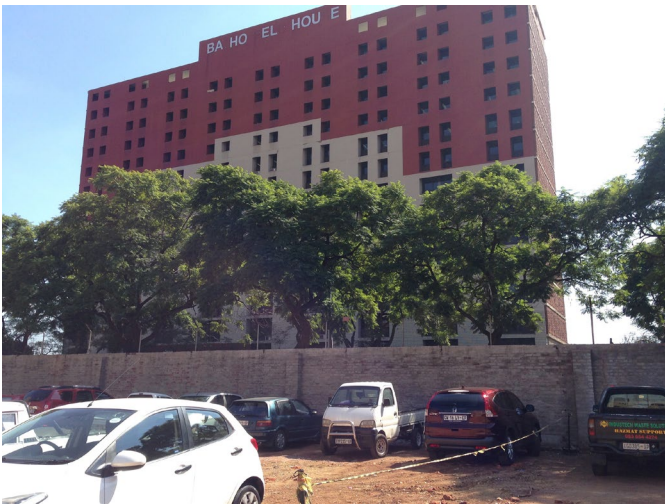
**Figure 4.17:** Empty space where storage shed structure once stood (recently removed)

The 'storage shed' (which constituted an open steel structure and roof covering) just north of the maintenance offices was removed and people started using the space for parking (see Figures 4.17 and 4.18)

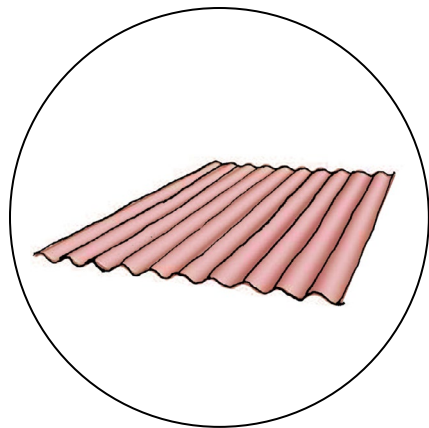
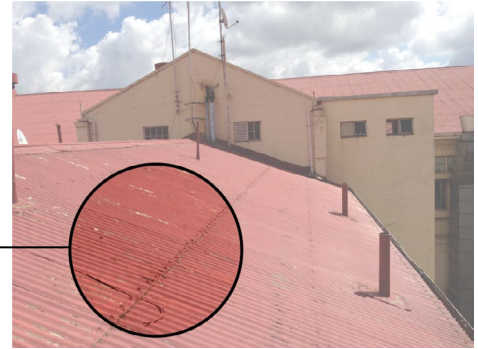
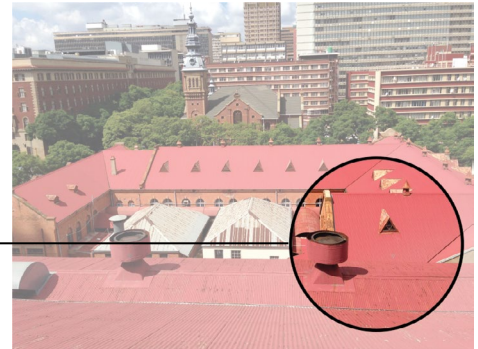
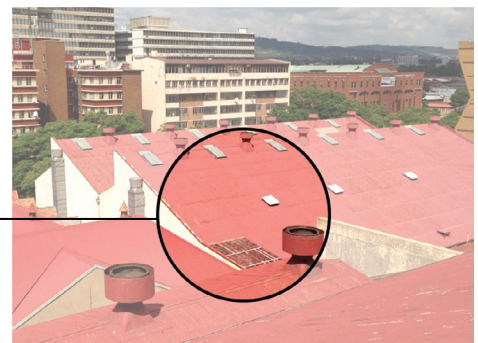
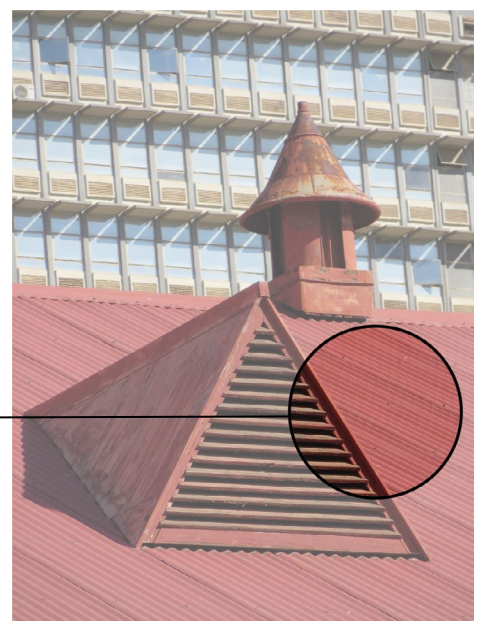
Figure 4.22: Tectonic coherency: Roof sheeting

- All buildings on this block have the same red coloured corrugated iron roof sheeting with various shaped roof ventilators which becomes a part of the aesthetic.

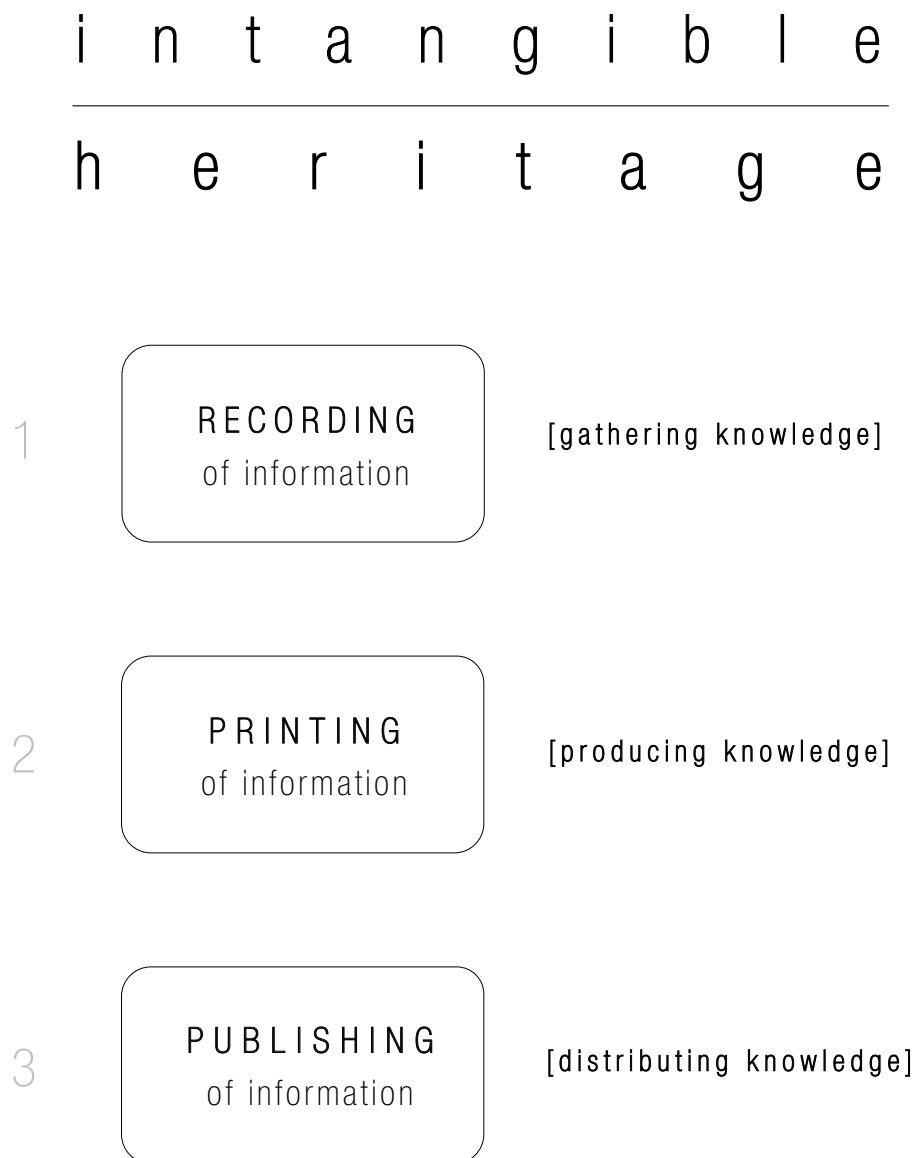
4.25: Intangible heritage of GPW block (Author, 2016)

The GPW block is a light-industrial complex built for the “production and dissemination of information” (Clarke, Kuipers and Swart, 2015: 115). This site is about the recording, printing and publishing of knowledge and the architecture tells this story. Figure 4.25 is a summarizing illustration of the intangible heritage that is captured by the physical and meta-physical qualities on this site.
