## 2.5 SITE: PROGRAMMATIC CONTEXT

## 2.7 SITE: ANALYSIS MAPPING

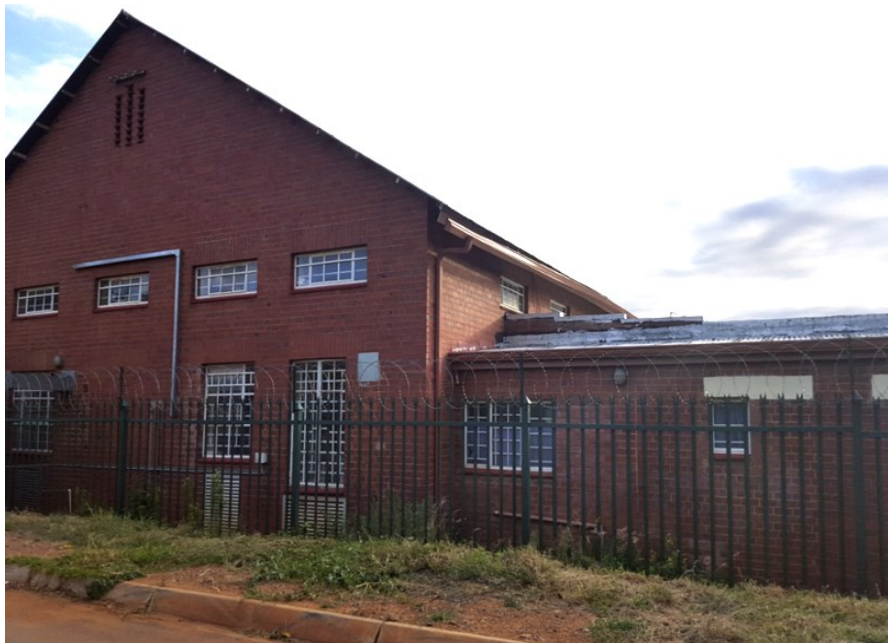
Figure 2.45. Industrial buildings in Oumashoop Street and Soutpansberg Road. Author, 2016.

Buildings are mostly single storey in height with a few double storeys (see Figure 2.43). Higher buildings are found towards the CBD. The use of steel sheeting as a roofing material is ubiquitous (see Figure 2.45). Most residential building roofs are hipped. Walls are mostly white painted plaster, some with face brick. The use of face brick in some of the multi-storey commercial buildings is not rare. The land use is owned by institutional facilities. This includes health care and educational facilities as well as a site for a telecom company. The educational facilities are focussed on the disabled and on educating people in the medical profession. Two schools are situated on the site, both for the disabled. Tshwane University, Department of Arts are also situated on the site. The northern part of the greater site is defined by the Department of Environmental Affairs (see Figure 2.46). Adjacent building programs include (see Figure 2.47):

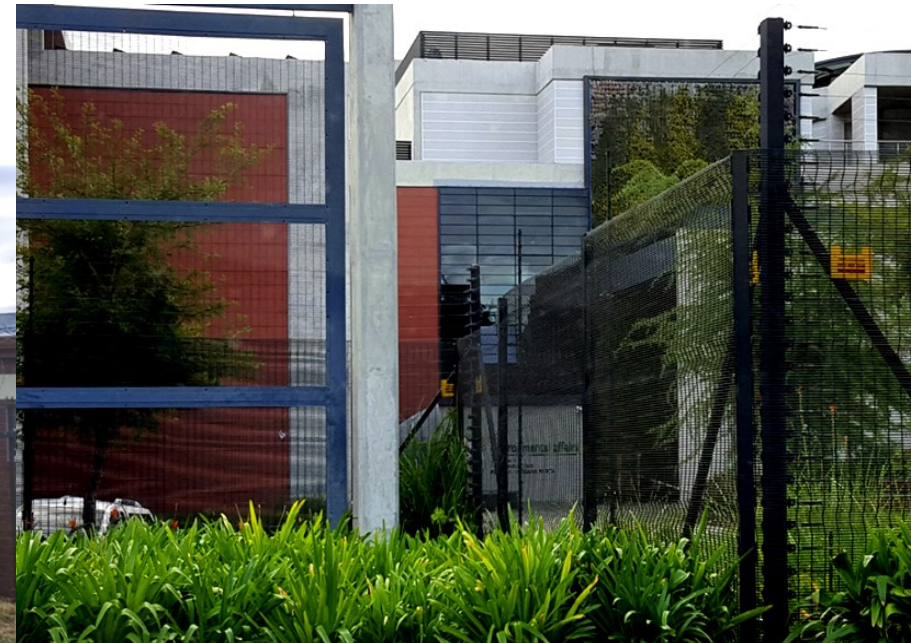
Figure 2.46. Department of Environmental Affairs facade. Author, 2016.

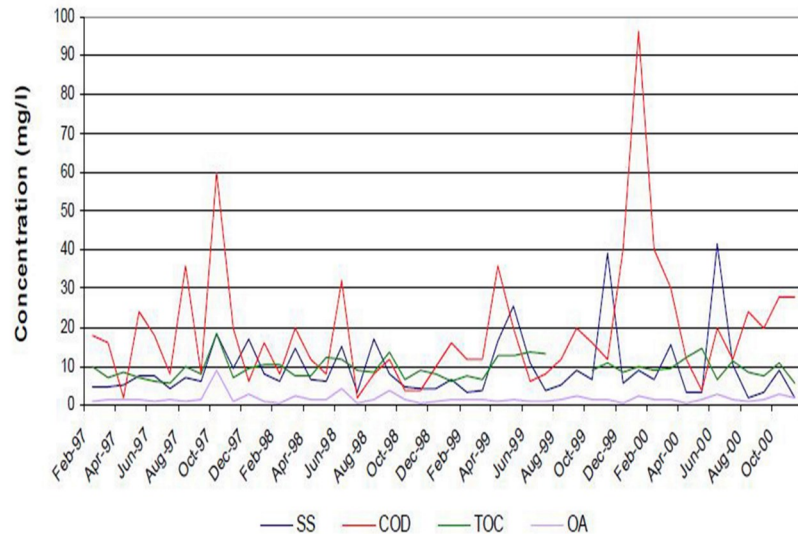
Please note: Total deviation at October 1997 are probably due to the clearance of a blocked stormwater pipe.

Figure 2.55. Water quality of the Apies River at the Pretorius Street Bridge and Walkerspruit before the Apies River Junction, Ahlers, T. pg. 117, 2006.

In addition to the physical condition since the construction of the Apies River channel (see Figure 2.53 and 2.54) and its water quality, (see Figure 2.55) six spatial and elemental layered mapping exercises were investigated. This mapping technique is similarly illustrated in the manner the Kallang River is mapped as part of an overall urban storm water decentralisation strategy (see Figure 2.56). As mentioned below, represent the current spatial conditions are mapped on site with regard to which natural and man-made systems can potentially intersect.

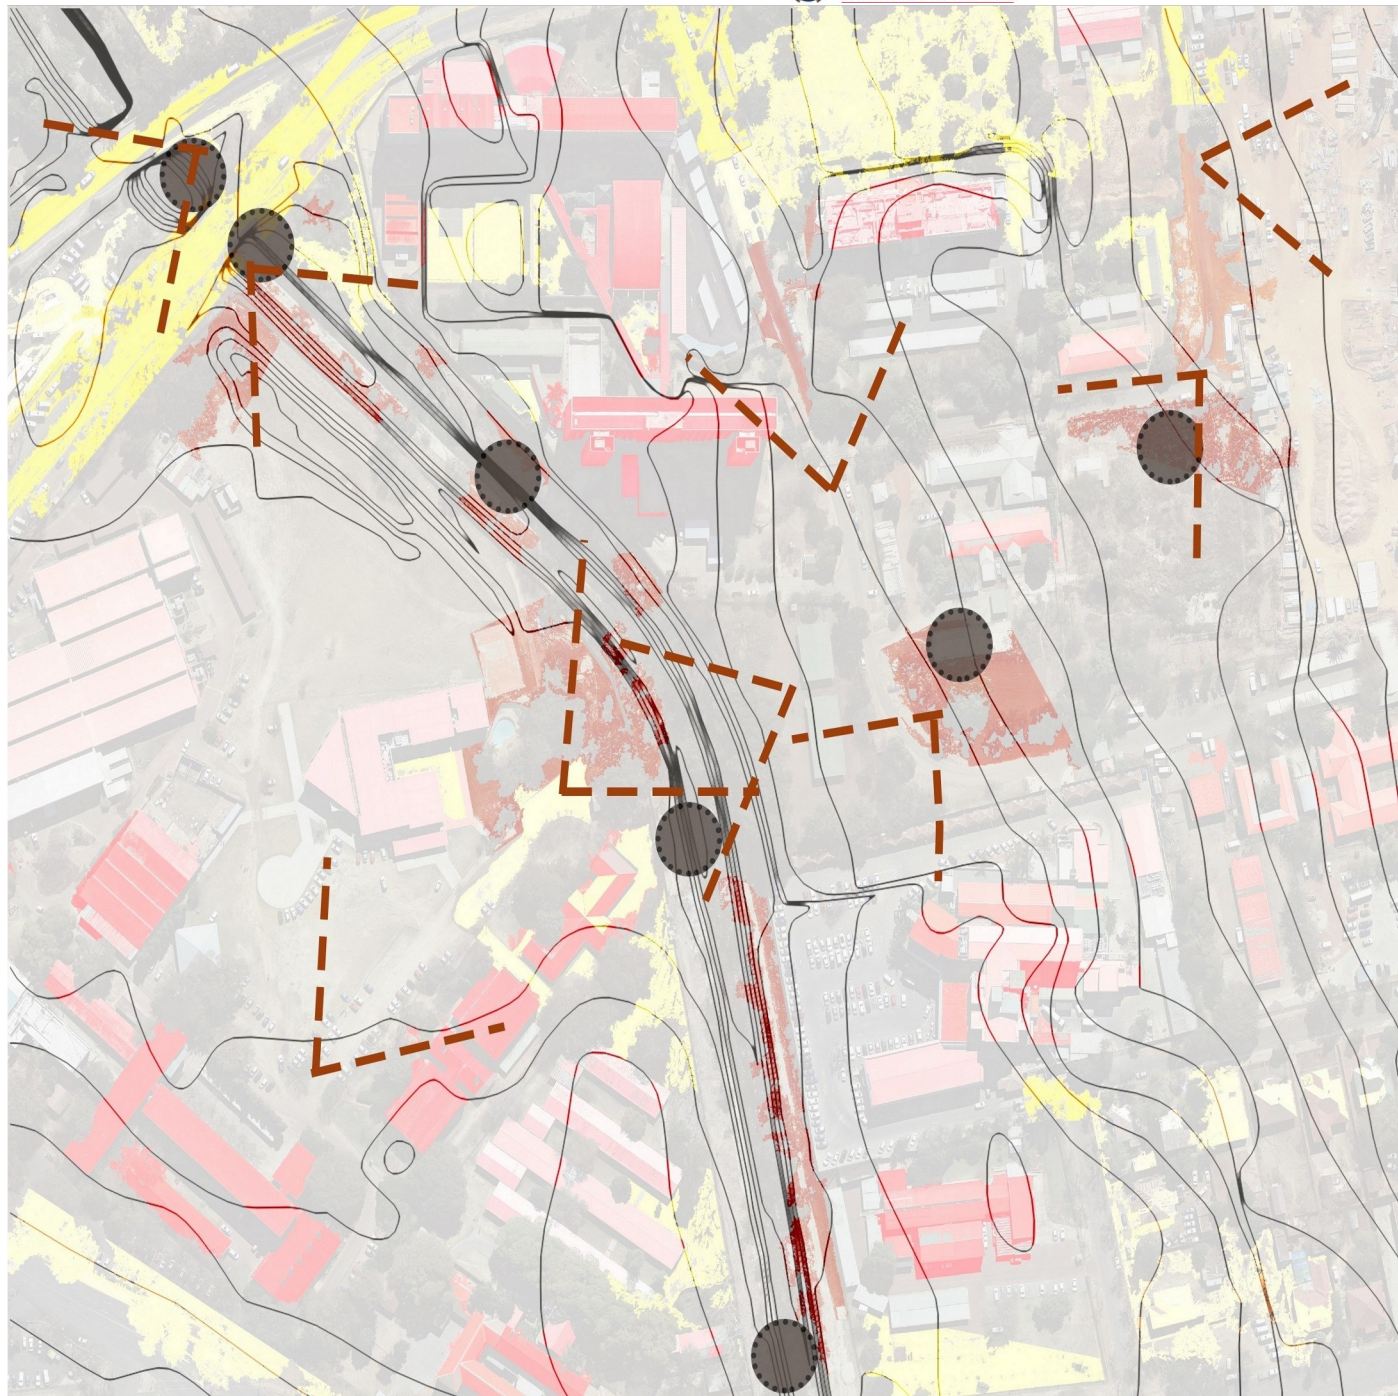
Figure 2.58. Site Analysis Mapping: Experiential layer. ArcGIS layers with author's adaptation, 2016.

Daily movement patterns, sites where production occurs and where occupants relax during breaks, viewpoints, pollution nodes, and points where memory responsive space exists can be found on the site (see Figure 2.59).

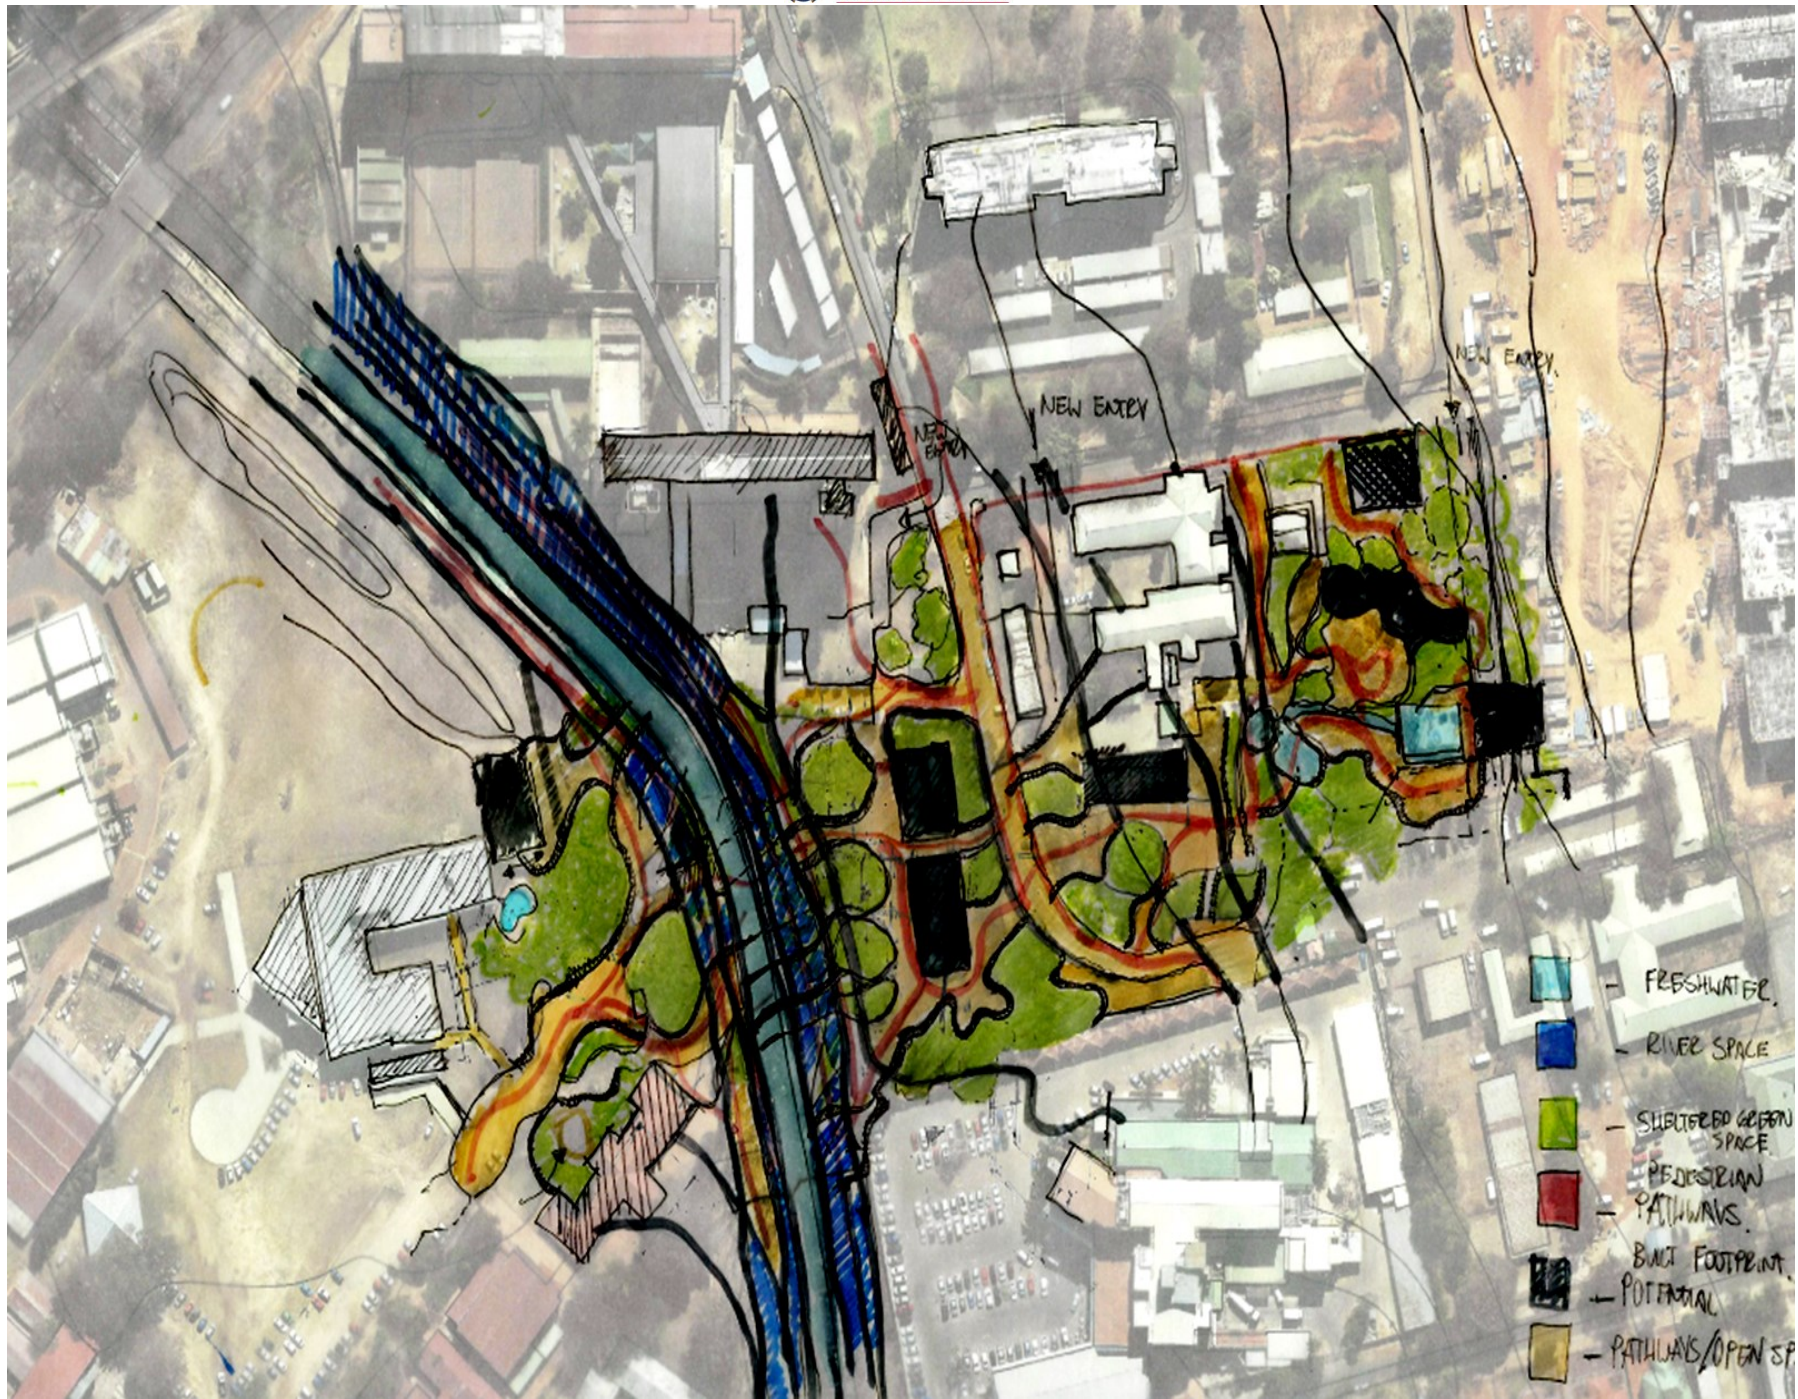
Figure 2.63. Site Potential: Organic site patterns parti diagram. Author, 2016.

Given the multiple layers that exist on the site, natural and artificial systems exist in a symbiotic manner, and the potential for both to interact or perform on a level of exchanges can be explored or investigated further (see Figure 2.63). These can be spatially translated, facilitated or accommodated by considering a regenerative catalyst. The variables have been exposed and require a theoretical vehicle in order to eventually manifest towards a design.
