Nº 4

# Node, site and surroundings

# 4.1 Reservoir Park Node

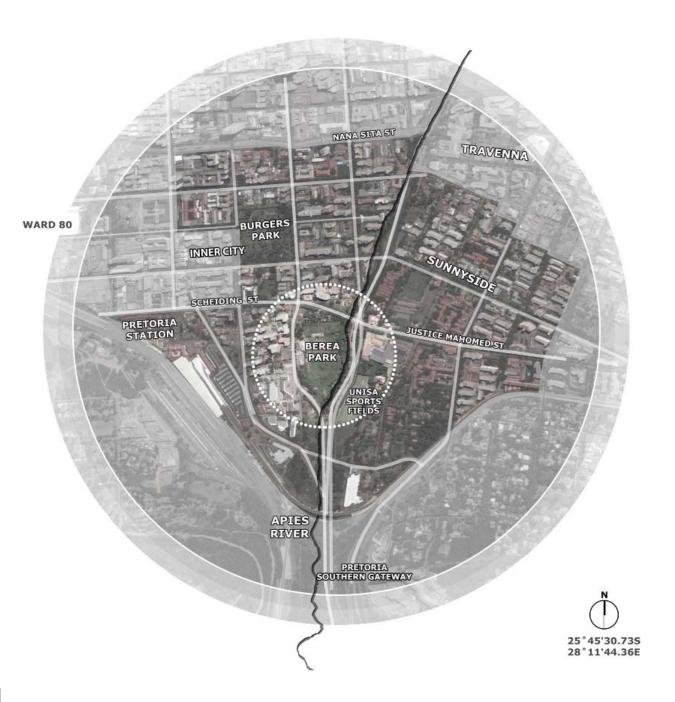
Figure 4.1  $\sim$  Reservoir park node.jpg

Selected urban vision node: Reservoir Park node Source: Google Earth, amended by author

(refer to Fig.4.1 and 4.3) from where it continues, subdued, along the Apies River corridor.

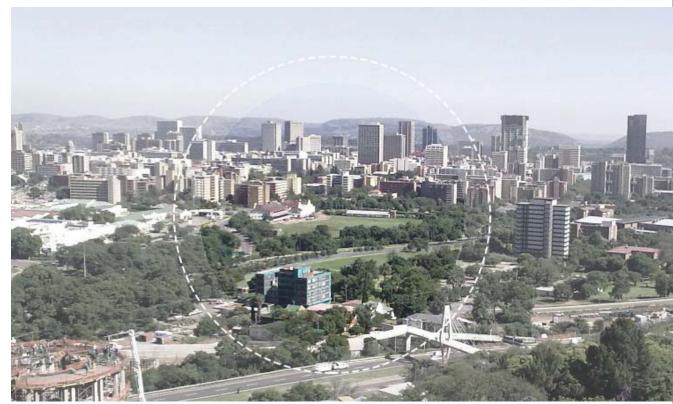
Figure 4.2 ~ Berea park and surrounds 2009.jpg

Photograph taken towards the city and Berea Park during the construction of Unisa's Kgorong building in 2009 Source: Lorinthe, amended by auhtor

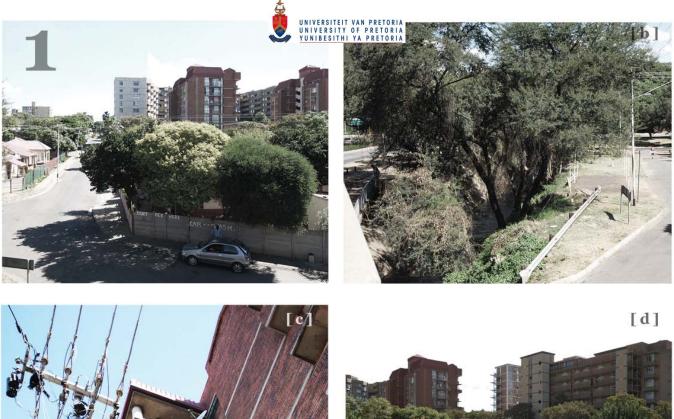
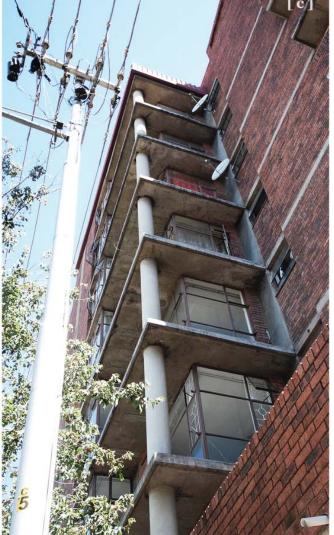
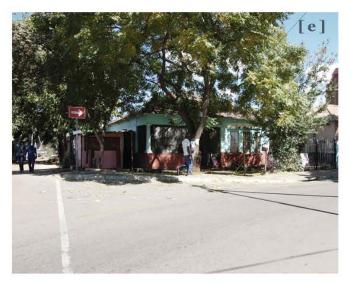
Figure 4.5 ~ Area 1.jpg

**Collage 1**: Area between Scheiding Street & Read Avenue, bordering the Apies river and the Sisulu Street fly over bridge on the east.

- [a] Drastic drop in scale towards the river channel as the grain and typology changes to single story dwellings along the river edge
- [b] The sunken river channel is cut off on either side by road infrastructure and the presence of the river, or water is completely unnoticed
- [c] Berea towers, 13 Read Street
- [d] 8 and 9 storey brick and concrete residential apartment blocks from a prominent urban edge condition north of Scheiding Street [e] a cluster of single story dwellings along the river has been re-appropriated into uses such

as day care facilities and internet cafe's

cheiding Street as the northern border of the macro site, is a quiet neighbourhood street active with pedestrian movement, particularly at the eastern corner where it meets Justice Mahomed Street and Lilian Ngoyi Street. This energy point (in front of the landmark Berea Mansions building) signifies the original entrance to the inner city of Pretoria (Le Roux, 1990:147). From here pedestrian and vehicular movement to the north connects to Burgers Park and its active residential surroundings. Towards the west it connects to the main entrance of the Pretoria Central Train and Gautrain stations. The northern edge consists primarily of medium density apartment blocks (refer to Fig 4.5 and 4.6).

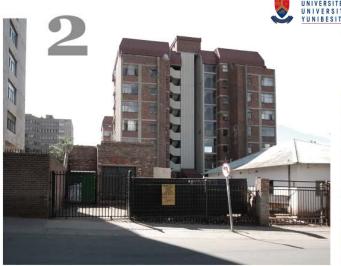
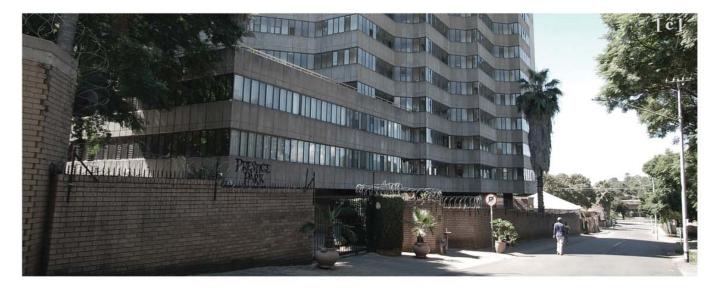
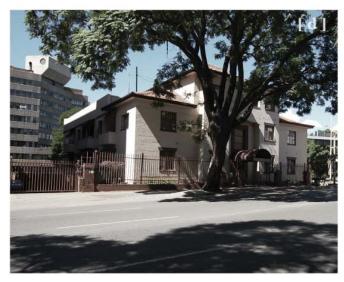
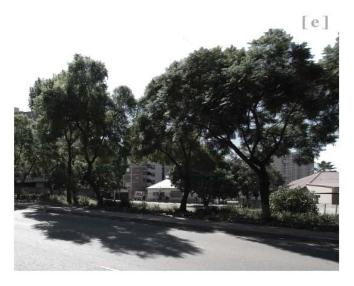
Figure 4.6 ~ Area 2.jpg

**Collage 2:** Scheiding Street north of Justice Mahomed Street.

- [a] Varied grain and urban fabric A sudden transition in mass and scale highlights the varied grain and typologies within the node
- [b] Empty un-programmed spaces line Justice Mahomed street, with some remaing houses from a demolished neighbourhood visible in the background
- [c] Prestige park, a modern concrete and glass giant facing Scheding Street, a popular pedestrian route connecting to the city
- [d] Berea Mansions, a double story residential building with art deco characteristics, on the corner of Scheiding St and Lillian Ngoyi St, is a landmark and signifies the original entrance to the inner city of Pretoria.
- [e] Justice Mahomed Street, view towards the north

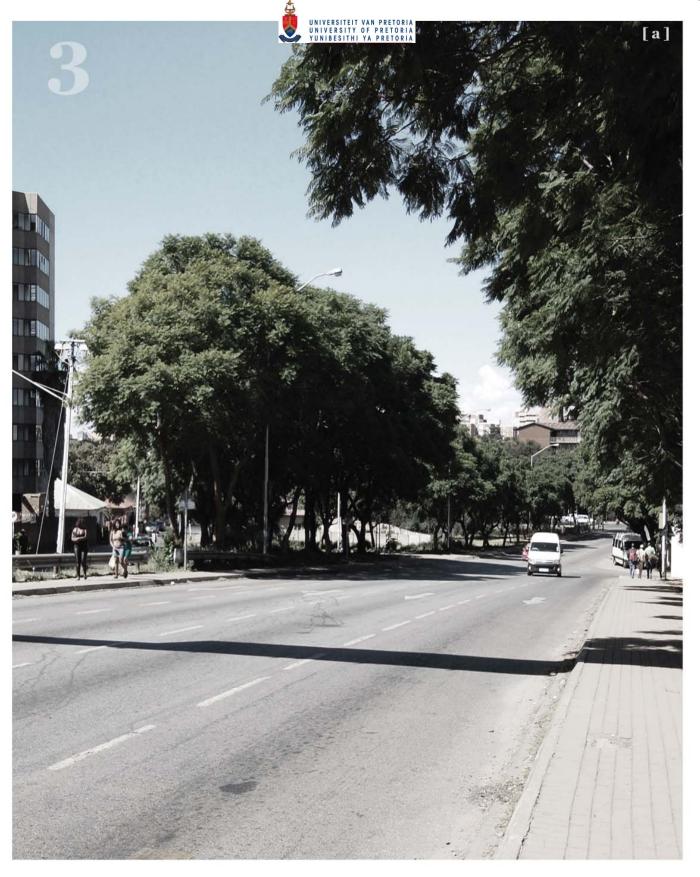
Figure 4.7 ~ Area 3 a.jpg

Collage 3: Rhodes Ave, south of Justice Mahomed Street, forming the northern edge of Berea park [a] Justice Mahomed street as a barrier between the city and Berea park

- [b] Walled off area along the eastern edge, south of Justice Mahomed ST, close to the river channel
- [c] Council owned dwellings with ad-hoc structures, between Justice Mahomed St and

Rhodes Ave, are used for several informal businesses. There are primary accessible from the Rhodes avenue side, therefore contributing to negative spaces along Justice Mahomed St which creates yet another barrier between the city and the park.

- [d] The abandonment of Berea park and the use of its facilities has led to an infiltration of informal activity along Rhodes Avenue during the day.
- [e] Carwash on a vacant lot where the property has been demolished
- [f] The northern edge of the derelict Berea park, bordering Rhodes ave. View towards the south, with the ruins of the original bowling clubhouse in the foreground

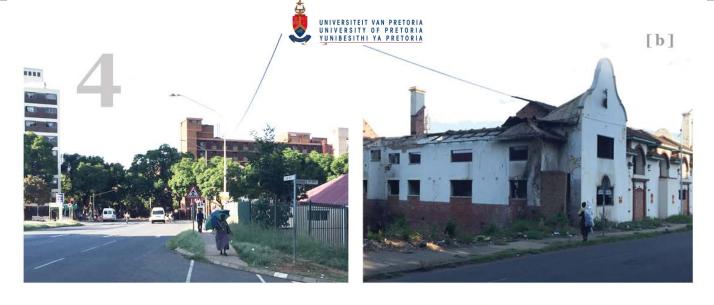
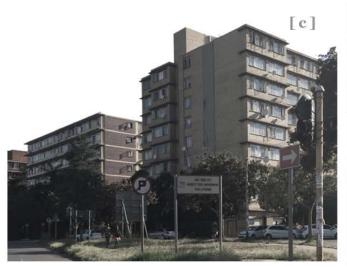
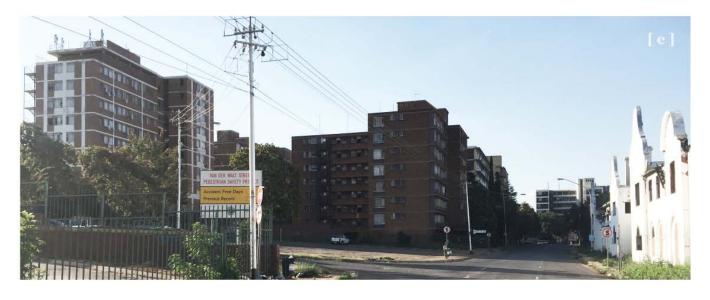
Figure 4.9 ~ Area 4.jpg

Collage 4: Lillian Ngoyi Street, western edge along Berea park, images taken north and south of Rhodes avenue [a] Corner of Rhodes Avenue and Lillian Ngoyi Street towards Berea mansions and Burgers park

- [b] Derelict and abandoned Berea park clubhouse facilities
- [c] Medium density apartment buildings along the western edge of Lillian Ngoyi St
- [d] Vacant stand across from the clubhouse, originally allocated and used as parking facility for Berea park is now used a trucker resting area
- [e] Change in scale along the western edge of Berea Park,

Like the river, Berea Park, as a natural and cultural landscape, has also lost its significance. The current condition of the park creates an additional barrier between the park, its landscape and the city. This has seemingly also affected areas surrounding the park, with further disintegration visible, especially in the single story dwellings located to its north (refer to Fig 4.8 and 4.9).

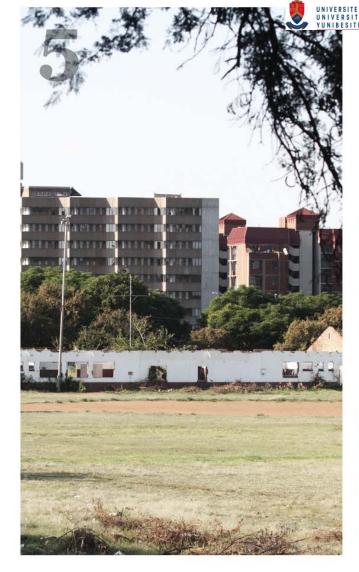
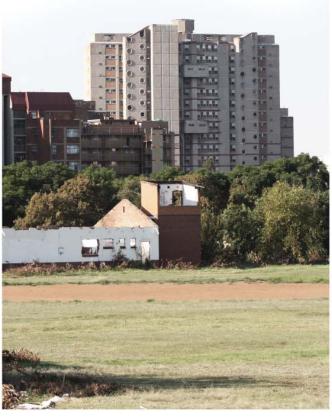
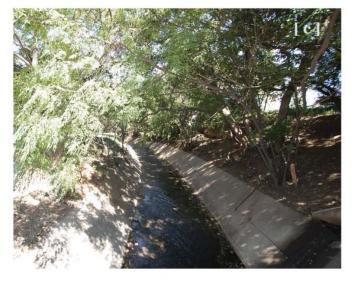
Figure 4.10 ~ Area 5.jpg

**Collage 5:** Berea park and Apies river channel adjacent to the park. [a] Views from the Berea park sports fields towards the city

- [b] The landscape and old clubhouse facilities are in poor condition
- [c] The river channel, completely isolated and not accessible

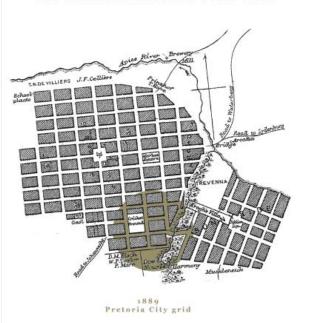
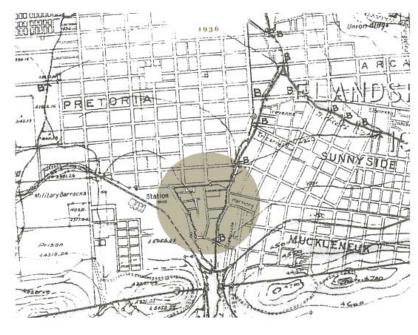
Figure 4.11 ~ Grid over time.jpg

The urban landscape over time

Sequence of drawings, map and images documenting the Pretoria and node context. Refer to grid and lot configuration of Berea park and its surroundings.

Historical maps, drawings and aerial photos (refer to Fig 4.11-4.13), which indicate the early settlement patterns of Pretoria and the spatial structure of the city fabric, reveal that residential neighbourhoods, consisting of single level dwellings, provided a stable edge to the park's northern and western boundaries. The dwellings were

which include a 1993 drawing of the inner city by S. le Roux and N. Botes, Google earth images from 2001 and Tshwane zoning maps, indicate that the northern neighbourhood situated between Rhodes Avenue and Scheiding Street was demolished in the latter part of the 1990s (between 1993 and 2001) to allow for infrastructural changes. The M11 generally known as Justice Mahomed Street (then Walker Street) was extended diagonally across the original neighbourhood site to connect directly with Scheiding Street, which leads to the main entrance of the Pretoria central train station. This blatantly disregarded the historical city grid, the character of the neighbourhood and the spatial disintegration that would follow due to the changes.

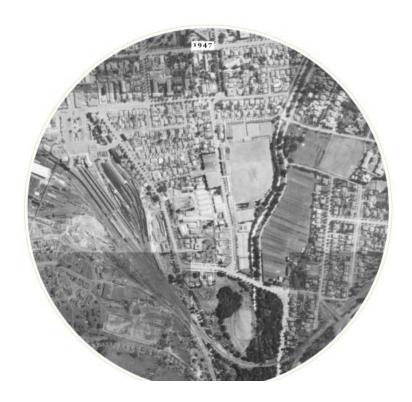
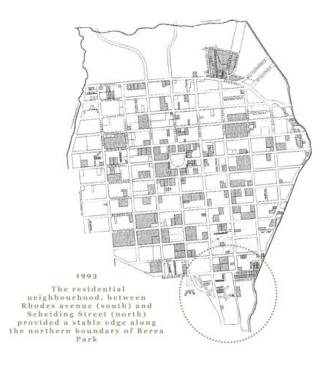
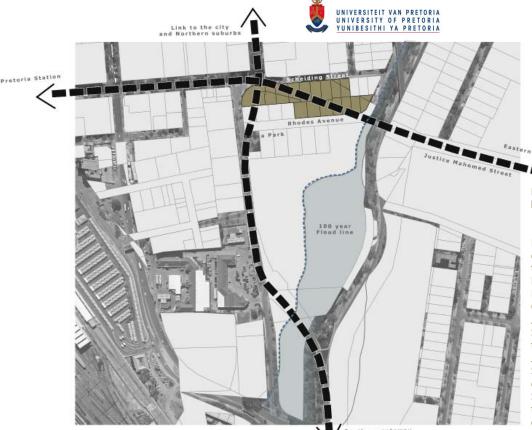
Figure 4.12 ~ Extension of Justice Mahomed.jpg

### Extension of Justice Mahomed Street, 1993-2001

Road infrastructure changes to strengthen transport linkages between the sprawled Eastern suburbs and CBD has rendered Justice Mahomed Street as a primary transport arterial. Justice Mahomed Street was connected diagonally to Scheiding Street, disregarding the existing and original city grid.

The consequential spatial changes lead to fragmentation, and the road infrastructure has created a of series barriers between Berea and its surrounding neighbourhoods. On a macro scale proximity to both regional and national transport networks has in principle made the site highly accessible, but ironically also destroyed and restricted access on a human and pedestrian scale. Source: City of Tshwane Ortho tile, Arc GIS, amended by author

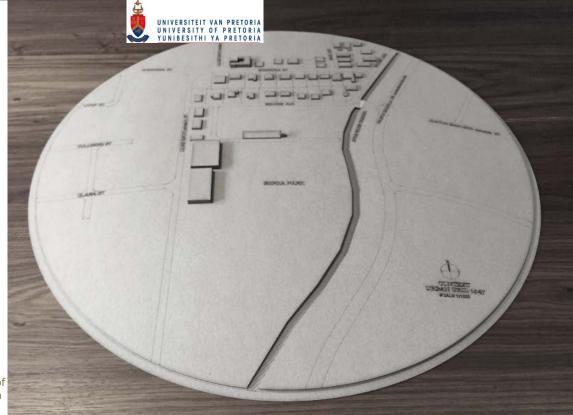
Source: Author Figure 4.14 ~ Context model 1947.jpg

Photo of context model, indicating the neighbourhood north of Berea Park, representative of the conditions in 1947

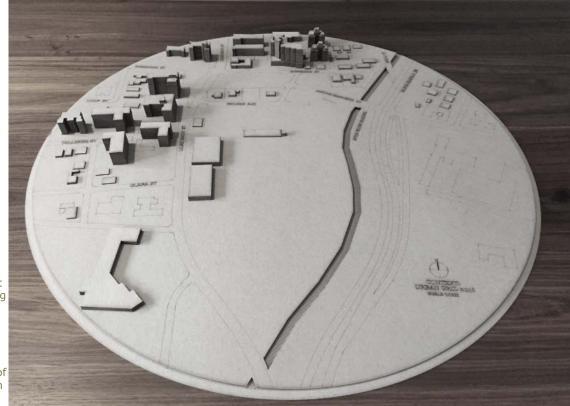
Source: Author Figure 4.15 ~ Context model 2016.jpg

Photo of context model, indicating the fragmented buffer areas north of Berea Park, varied scale and grain representative of the conditions in 2016

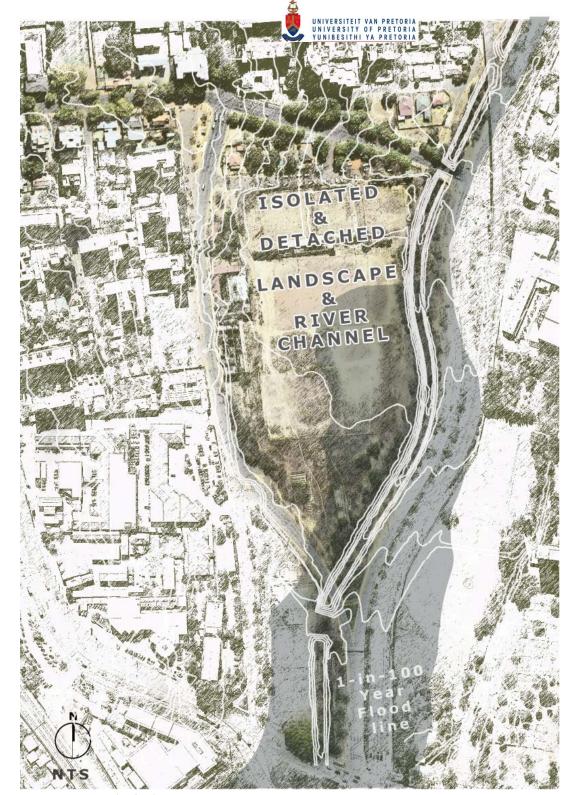
Figure 4.16 ~ Lack of cohesion.jpg

Lack of cohesion on human and pedestrian scale

The consequential spatial changes lead to fragmentation, and the road infrastructure has created a of series barriers between Berea and its surrounding neighbourhoods. On a macro scale proximity to both regional and national transport networks has in principle made the site highly accessible, but ironically also destroyed and restricted access on a human and pedestrian scale.

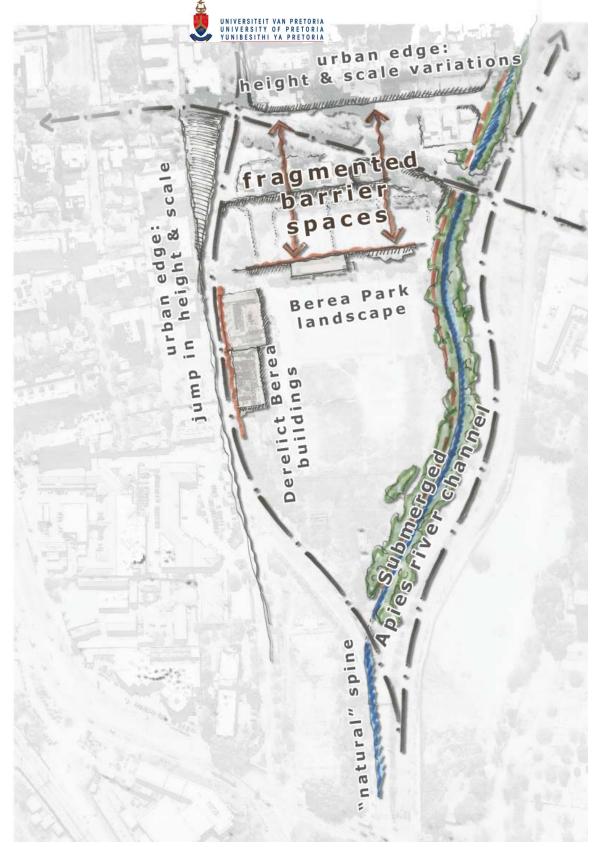
Figure 4.17 ~ Fragmented barrier spaces.jpg

Identified zone of disconnection

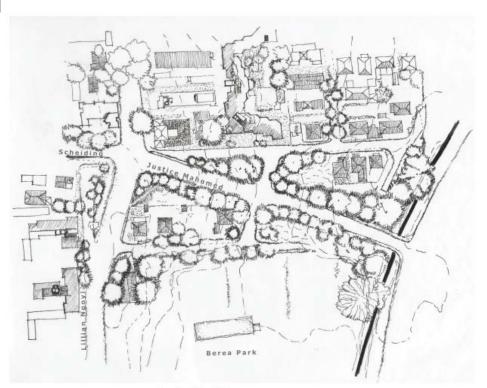
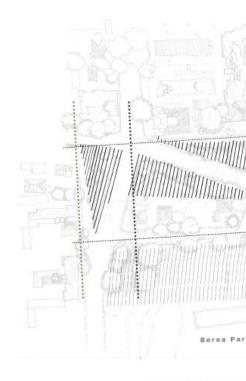
Figure 4.18 ~ Area for intervention.jpg

Identifying the lost barries

Drawing sequence to determine site and area of intervention

The current configuration of Justice Mahomed Street, a main arterial with single direction traffic flow, and planning regulations such as building-line restrictions and road servitudes, limit the possibility of viable development within the remaining land parcels. Therefore consolidation of the indicated land parcels

and the reconfiguration of Justice Mahomed Street (refer to Fig 4.18) are proposed. The reconfiguration was designed in compliance with Table 7.12 contained in the Roads Geometric Design and Layout Planning section of the CSIR's Guidelines for Human Settlement Planning and Design (2000:2.7-14).

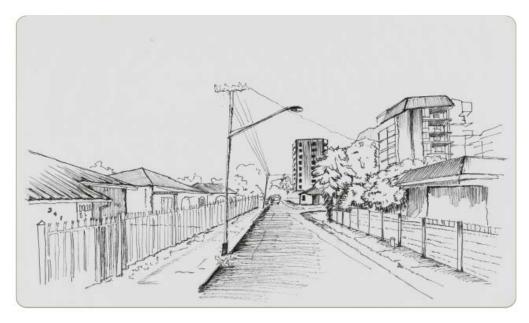
Scheiding Street character and typologies. Source: Author Figure 4.21  $\sim$  Scheiding street.jpg

The majority of single story dwellings between Scheiding Street and Rhodes avenue was destroyed with the diagonal extension of Justice Mahomed Street through the neighbourhood to meet Scheiding Street west of Lillian Ngoyl (van der Walt) Street.

The character of the area was drastically altered and disconnected clusters of the single dwelling homes remain, among Modeen high rise apartment blocks, vacant land and the channelised Apies river edge to the east.

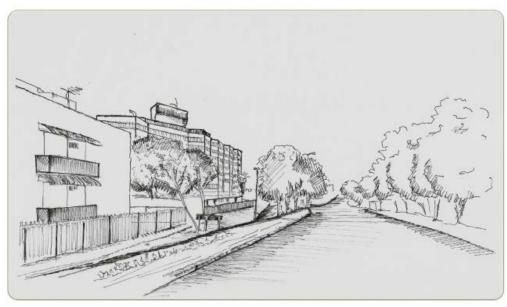
Justice Mahomed Street, view towards the east. Source: Author Figure  $4.22 \sim \text{Justice Mohamed edge.jpg}$

### Justice Mahomed Street, view towards the east Justice Mahomed is a main infrastructure arterial into inner city, but it is also a barrier that cuts Berca Park off from the city

Road infrastructure amendments between 1993 and 2001 destroyed the original edges along the north and west of berea park, creating a series of infrastructural barriers, which combined with the resulting fragmented vacant and unprogrammed spaces have contributed to the degradation and decay of the area.

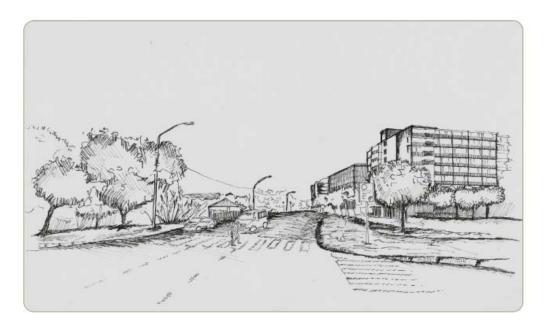
Corner of Lillian Ngoyi & Justice Mahomed Street. Source: Author Figure  $4.23 \sim \text{Lillian Ngoyi.jpg}$

Several Medium density residential units are located along the western side of Lillian Ngoyi Street. Across the street 3 remaining single dwellings (in poor condition, connected to informal activity along Rhodes ave), create a drastic drop in scale and a change in neighbourhood character and perception.

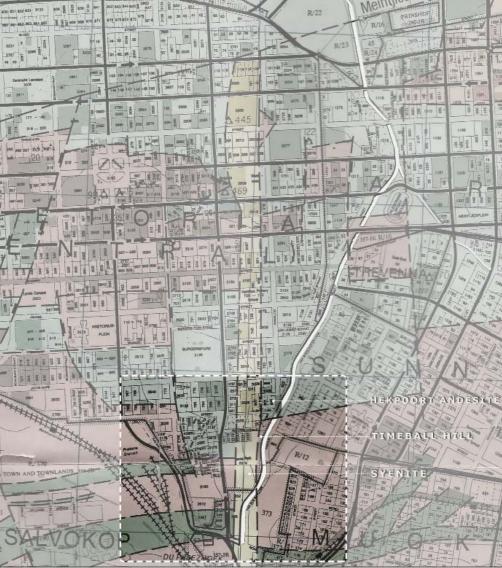
Figure 4.24 ~ Geological site map.jpg

Geological map of Central Pretoria. Source: D.G Purnell, adapted by Author

The site geology consists of a combination of three geological formations: the first is the Timeball hill formation, a shale subgroup that underlies the majority of the southern and central part of Pretoria. Other formations include Hekpoort andesite, as well as Syenite, of which a dyke of approximately 100 metres wide runs in a north-south direction across central Pretoria (Purnell, 1994:22-23) (refer to Fig 4.24). Inflows of water in and around the Syenite should be anticipated in deep excavations as Syenite is a wellknown aquifer (Purnell, 1994:22-23). [Syenite is not to be confused with the chemical compound cyanide.]

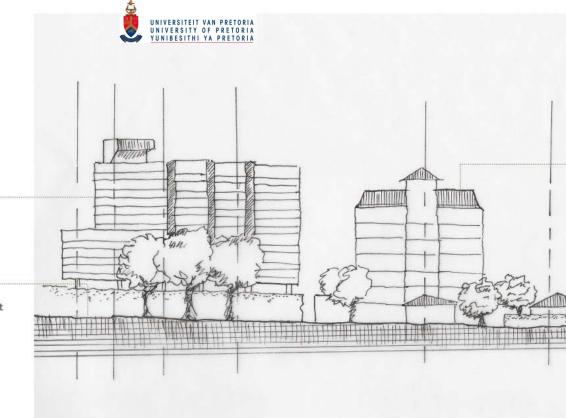
Figure 4.27 ~ Horizons.jpg

Justice Mahomed Street

New Scheiding road connection to

Prestige park residential bock

Unisa buildings seen in the back drop

The site lies at an intersection point of two horizon's: the natural landscape of the South and the man-made city to the North

Situated at the intersection point of the city and "nature", the northern edge of the site is distinctly urban in character, while the southern edge with views towards the ridges Klapperkop and Schanskop, Freedom Park and over Berea Park is in the main more "natural" as depicted in Fig 4.27.
