3. Context

3.1 Introduction

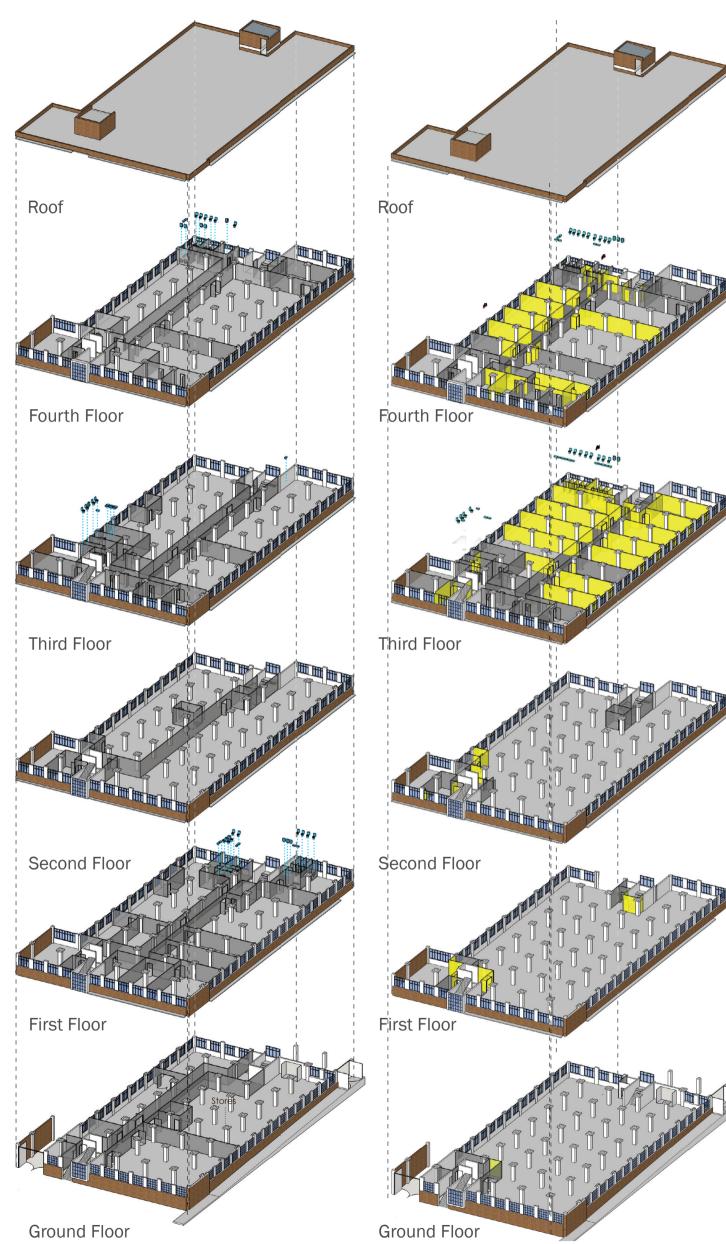
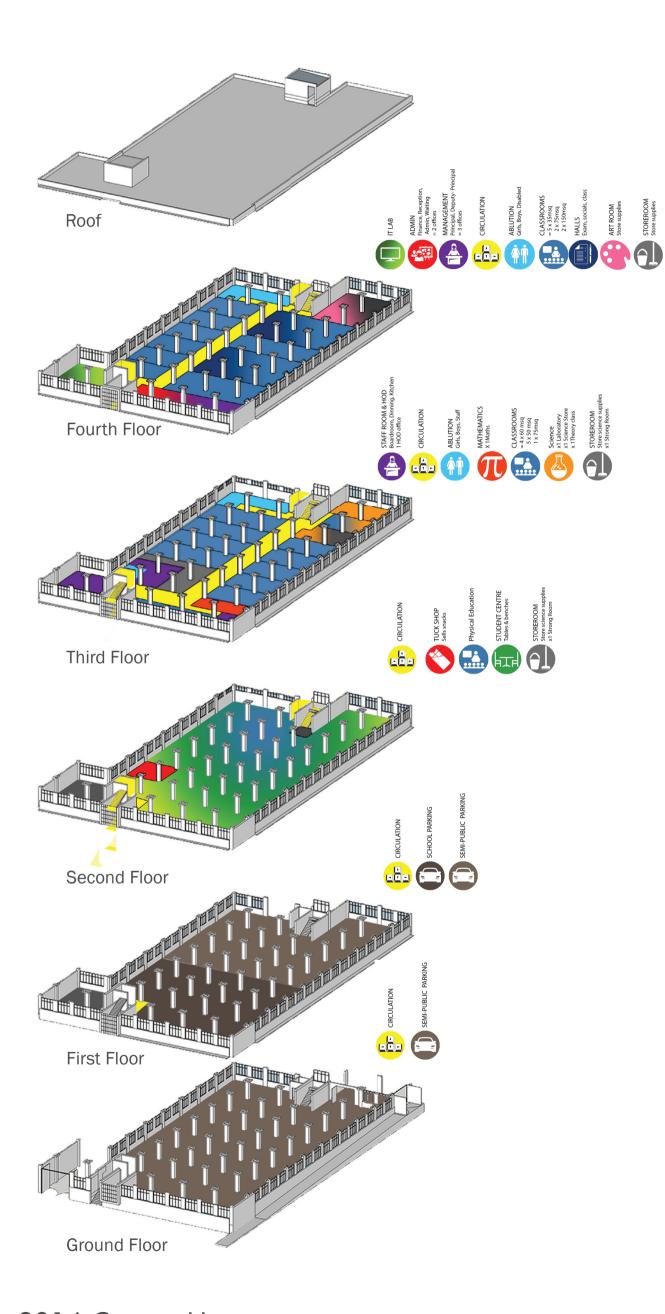
Figure 3.16 Axo of building appropriation over time

1955 Original Building

2009 Alterations in to School

2016 Current Use

In 2009 City Property made alterations to the building to adapt it into a secondary school. From 2009 until now the interior had minimal alterations.

On the ground floor most of the interior walls were demolished. The two stairwells and lifts were maintained. Currently, the northern side of the ground floor houses a small foyer through which pedestrians may access the school. The rest of the floor is a parking lot rented out by City Property.

The first floor can be accessed by the northern stairwell or by a car ramp on the southern side. Most of this floor's interior walls were demolished to readapt it into a parking lot. The car ramp was added on the southern side.

On the second floor most of the original interior walls were also demolished with the intention that the floor may be rented out. Currently, the school uses this empty floor as their student centre and for physical education. After the 2009 alterations a tuck shop was added.

On the third and fourth floor most of the original interior was kept. The spaces were subdivided to form classrooms. The parquet finish was also kept.

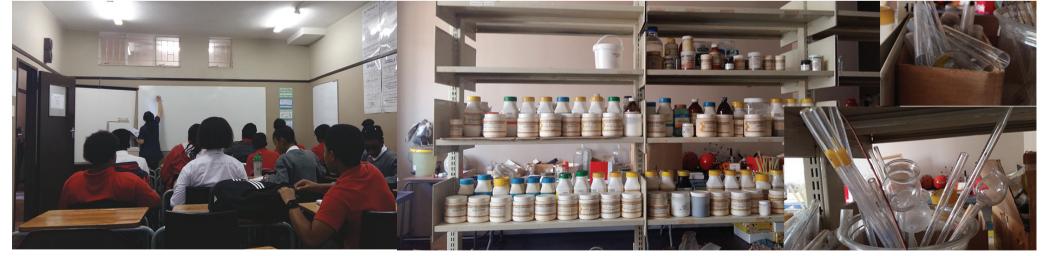
Figure 3.18 Mathematics class

Figure 3.19 Science store

The Science store was the most exciting and interesting space in the whole school, yet this space was locked and hidden away for exclusive use by the Science teacher. While the equipment and chemicals stored here spark a sense of endless possibilities and discoveries to be made.

The Mathematics classroom had a rigid layout. The desks were placed in neat rows and the students filed into the spaces from the front. The natural light was blocked out by a curtain and the teacher used a projector and screen to explain mathematical problems. Some pupils sat quietly, but one student became fidgety in this environment even though he was enthusiastic about participating.

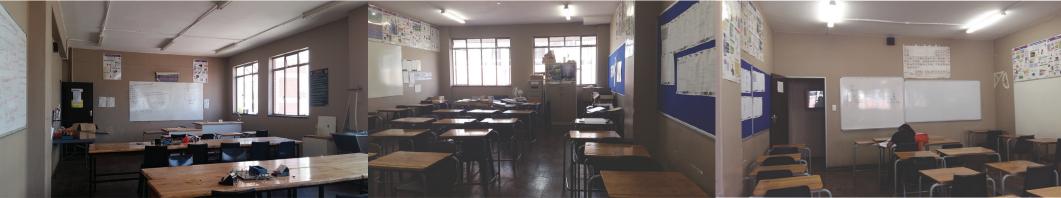
Figure 3.20 Science laboratory

Figure 3.21 Science theory class

Figure 3.22 Science theory class

The second lesson attended was a Science practical. The students were excited when they were told that they should go to the lab. In the lab there were a few Science objects displayed on a table. The lab desks are long timber tables that are 730mm high. These tables were fixed to the floor and the way that they were arranged made working in groups less effective. Also, their height meant that it would not be comfortable to stand while busy with a practical investigation.

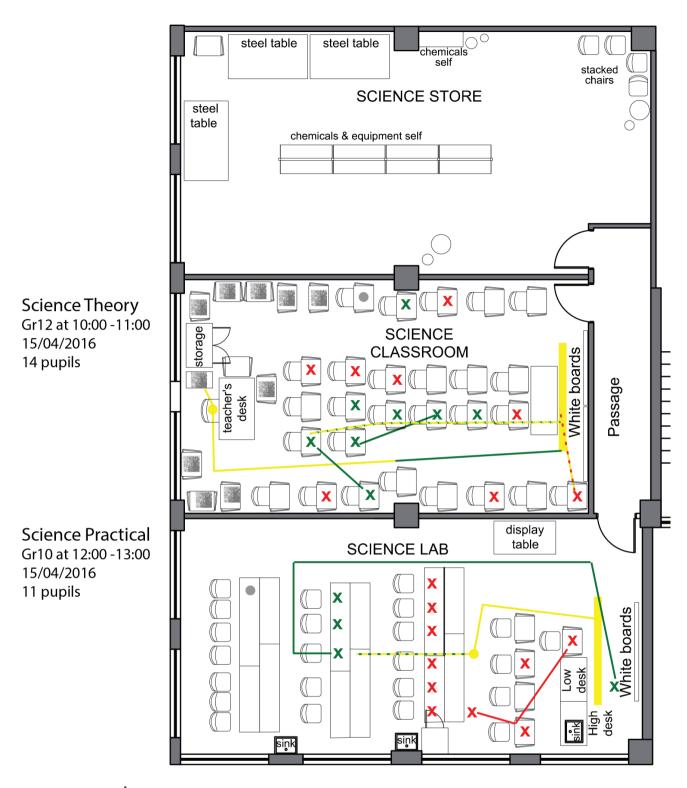
Figure 3.23 Plan diagram of user interaction

Science Class

The author spent a day in the school as an observer. The layout of the Science laboratory and the Science and Mathematics classrooms were sketched out. Furniture, chairs and equipment together with the students' and teachers' movements and interactions were mapped over layout sketches.

The first lesson was a science theory class. The teacher's desk was located at the back of the room and the white board at the front. The teacher stood in front of the class and used the white board to explain theory, concepts and the application thereof. He adapted two normal school desks as a desk in front of which he can stand. Students choose their own seats and some students moved desks during the theory class. Some students preferred to sit alone and others were more interactive with each other.

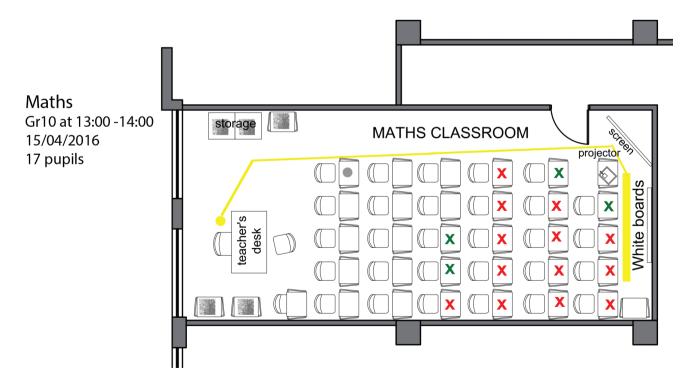
Figure 3.24 Plan diagram of user interaction

Mathematics Class

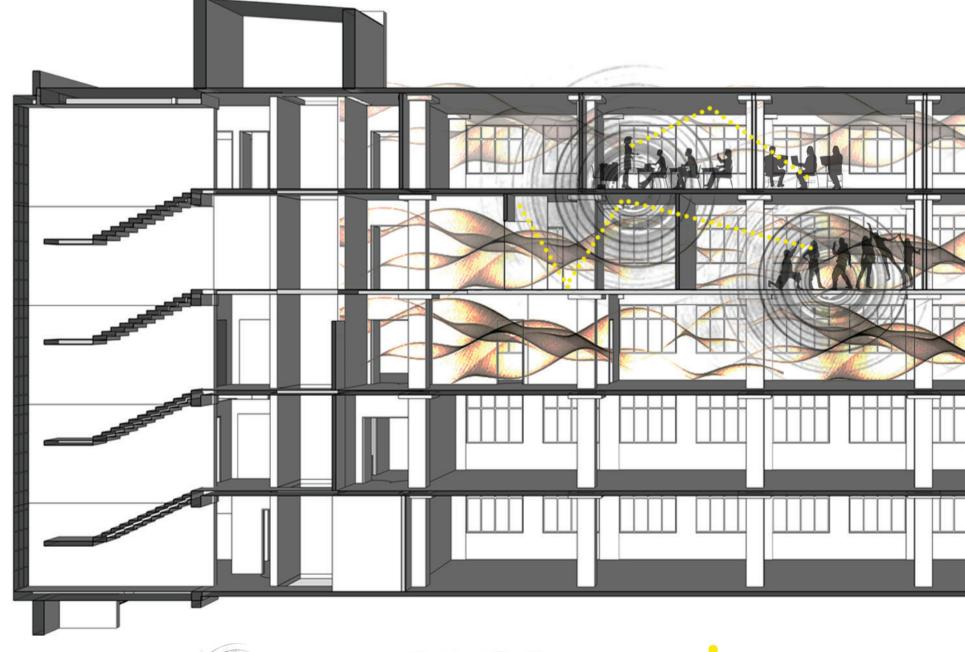
Impact noises travelling through slab

Parallel surfaces causing a lack of sound dissipation

Representaion of sound reflection off hard surfaces

The building interior consists of many hard, sound-reflecting surfaces. The classroom acoustics are not appropriate for teacher-fronted lessons even though that is the main method of instruction.

Also, the hard surfaces lead to the generation of impact sounds. These sounds travel through the concrete slabs affecting the classrooms underneath and around. Thus, each person in the building generates unnecessary sounds when they walk or pull out a chair.
