Recent research on the erodibility of subbases under concrete slabs

- Elsabé Ras* and Alex T Visser-
*Ndodana Consulting Engineers (Pty) Ltd

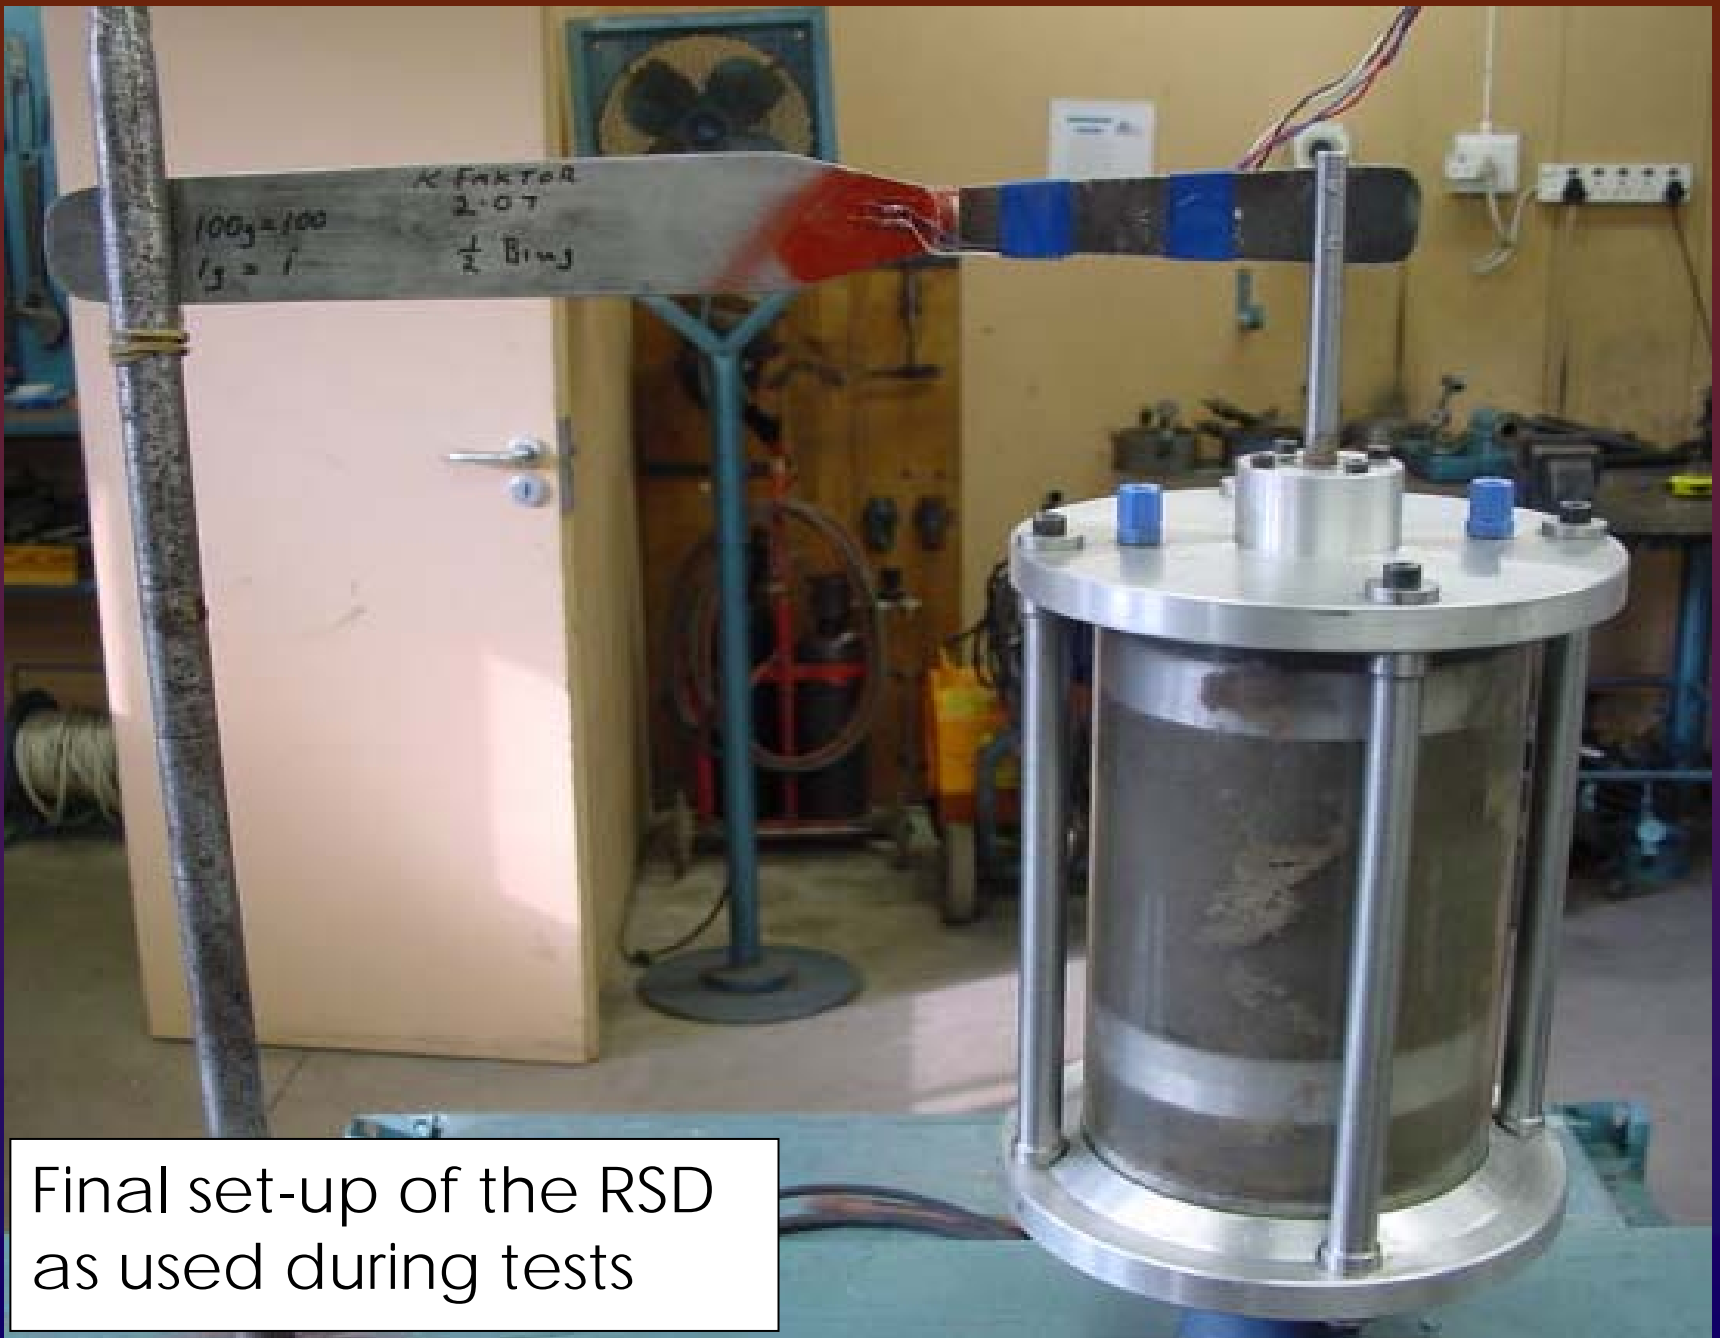
Final set-up of the RSD
as used during tests

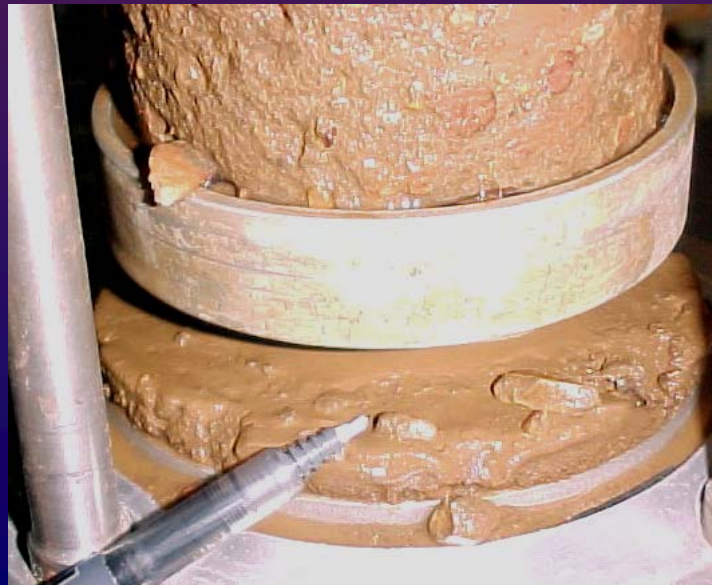
- ❖ N3, Heidelberg test section
- ❖ One sample successfully cored, but in a fragile condition
- ❖ Rotated for 20 minutes at 33.3 km/h (1750 rpm)
- ❖ Mass loss 92.7 g or 4.9 mm (2055 kg/m³)

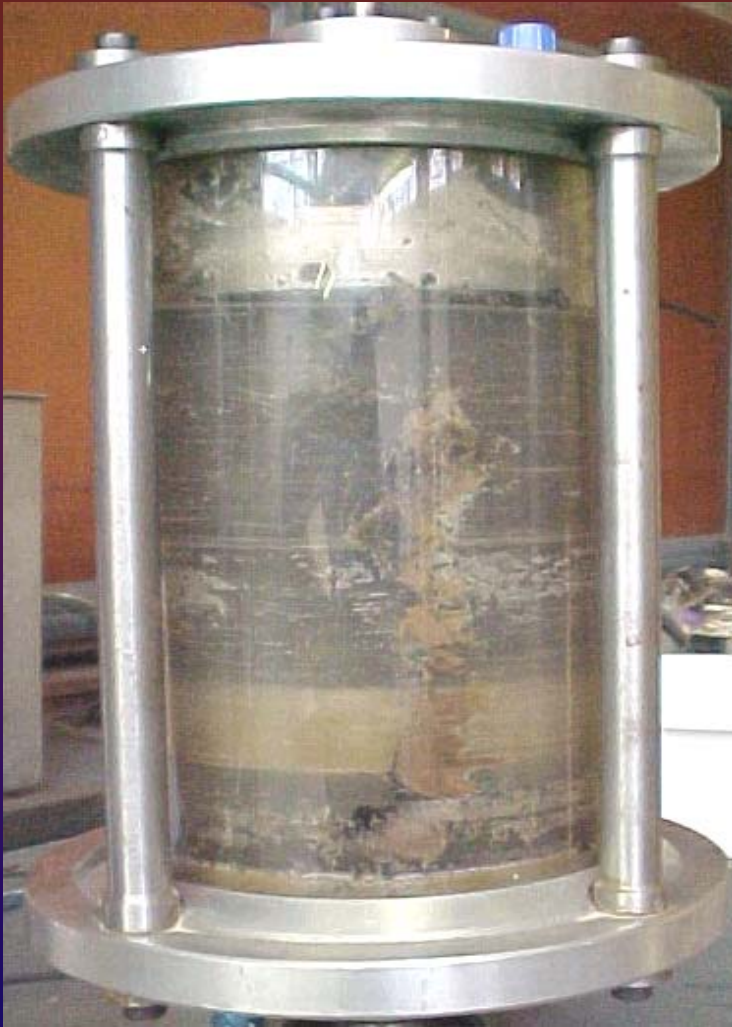
Asphalt sample in RSD

- ❖ Quartzite Hornfels material
- ❖ Binder content of 5% and void ratio between 4.41% and 4.93%
- ❖ Mix design has high stripping potential
- ❖ Compacted with 40 ton press
- ❖ Material loss after 240 minutes, washed clean of bitumen
- ❖ Sample 1 – 480.11 g or 0.2 mm (2350 kg/m^3)
- ❖ Sample 2 – 546.79 g or 0.23 mm (2362 kg/m^3)

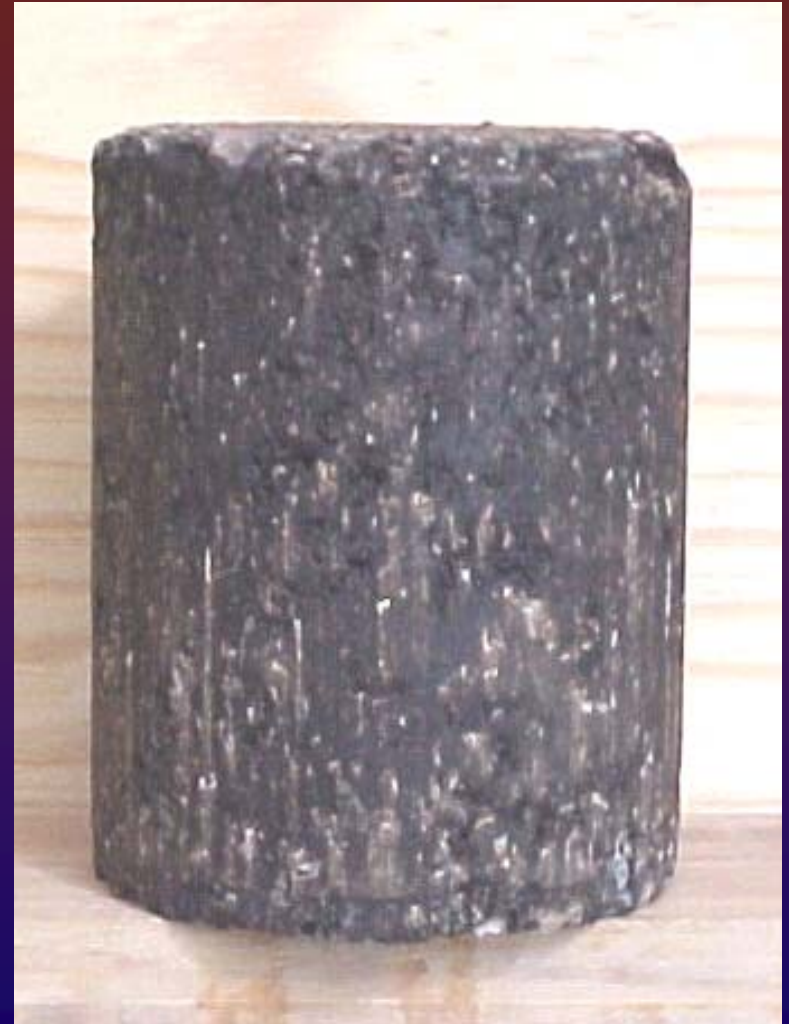
Eroded asphalt sample
