COMMONWEALTH OF VIRGINIA'S (USA) IMPLEMENTATION OF STONE MATRIX ASPHALT

T.M. CLARK and K.K. McGHEE*

Virginia Department of Transportation, P O Box 308, Luray, Virginia, USA 22835

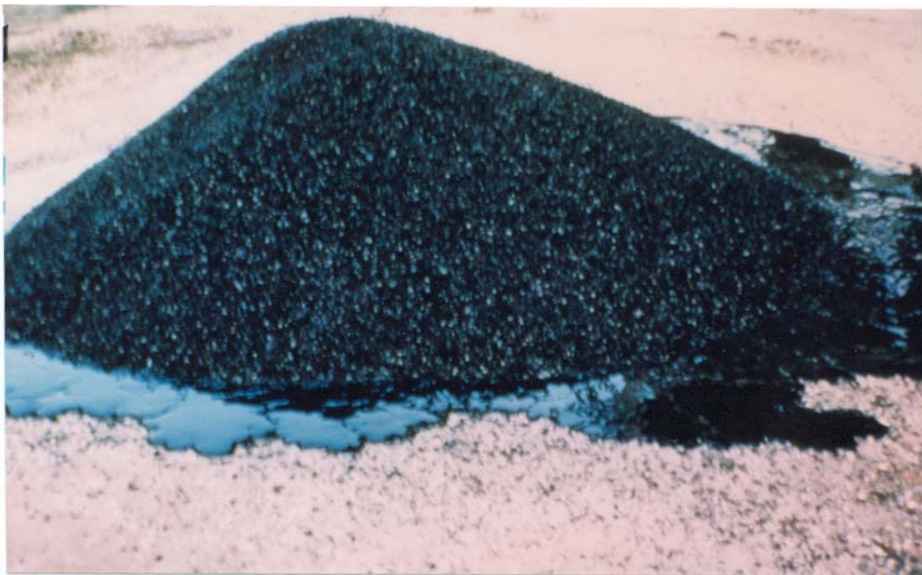
Reduction or loss of fiber additive to the mix resulted in excess liquid asphalt in the mix not able to bind to the aggregate – effectively reducing the mixes AC content. In the field, this resulted in two different conditions. One, “drain down” or excessive asphalt binder flowing to the bottom of the mix in the truck or on the mat occurred. When the gate of the truck was released, the excess asphalt binder flowed onto the ground. Once placed on the ground, the asphalt binder puddled around the mix. The second problem was flushing. After placement, the excess liquid rose to the surface and created a safety problem due to reduced skid resistance. Picture 1 illustrates the results of fiber loss in the mix.

Picture 1. “Drain Down” Due to Lack of Fibers.

The high liquid asphalt content of SMA mixtures typically requires the use of a fiber additive to suspend the addition liquid during transport and placement (i.e., prevent drain-down). Adding fiber at the plant presents a unique challenge. It requires the use of a “fiber dispersion” machine that was interlocked into the plant control system. Essentially, when the fiber machine either runs out of fiber material or breaks, the plant was shutdown automatically. This creates two distinct problems. One problem was equipment breakdown, which could be expected but resulted in lost production. The other problem encountered was clogging of the feed line for the fibers. The cause was typically the result of a “kinked” line, which would not allow flow of the fibers. In order to reduce the possibility of this happening, it was recommended that the amount of bends in the line be minimized. In addition, a clear piece of tube can be strategically placed in the line to assure visually that the fibers were flowing freely.

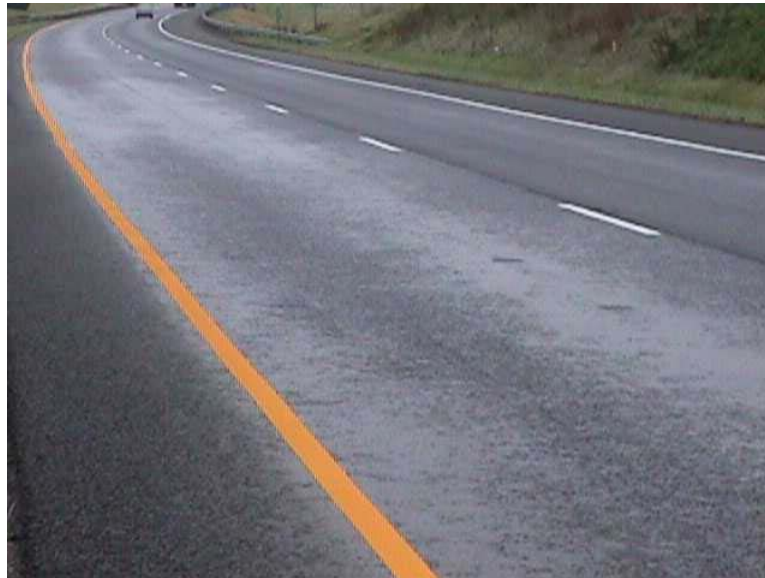
Mineral filler was used in conjunction with the binder to form an asphalt mastic/mortar. The material was a very fine graded material that had a tendency to retain moisture. Therefore, it was very important to store this material in a manner to reduce the chance of moisture infiltration. Typically, Contractors used tarps to cover the mineral filler stockpile. Although the tarps work when covering the stockpiles, there were occasions when during production, a rainstorm occurred before the stockpile could be covered. Once the material became wet, it was very difficult and in some cases impossible to dry it to a point where it would not be detrimental to the mix. Wet mineral filler led to flushing of the asphalt (see Picture 2). Not only was this undesirable for the mix, but led to reduced friction properties

Picture 2. Flushing Due to Wet Mineral Filler.

As mentioned before, it was important to keep the mineral filler dry. If the mineral filler became wet and was introduced into the mixture, the moisture prevented the asphalt liquid from adhering to the mineral filler and the excess liquid worked upward and became part of the finished surface. The result was flushed areas of various extents, and a consequential loss in supplied friction. Based on a VDOT investigation of a flushed pavement as seen in Picture 2, wet mineral filler was determined to be the main cause.

and safety concerns. In many cases, the SMA was removed and replaced. For small areas, diamond grinding of the SMA was performed to remove the AC film and increase friction. To mitigate the possibility of having mineral filler become wet, some contractors utilized sheds to store the mineral filler.
