Strapping of pillars with cables to enhance pillar stability

by L.R. Alejano*§, J. Arzúa†, U. Castro-Filgueira* and F. Malan‡

Synopsis

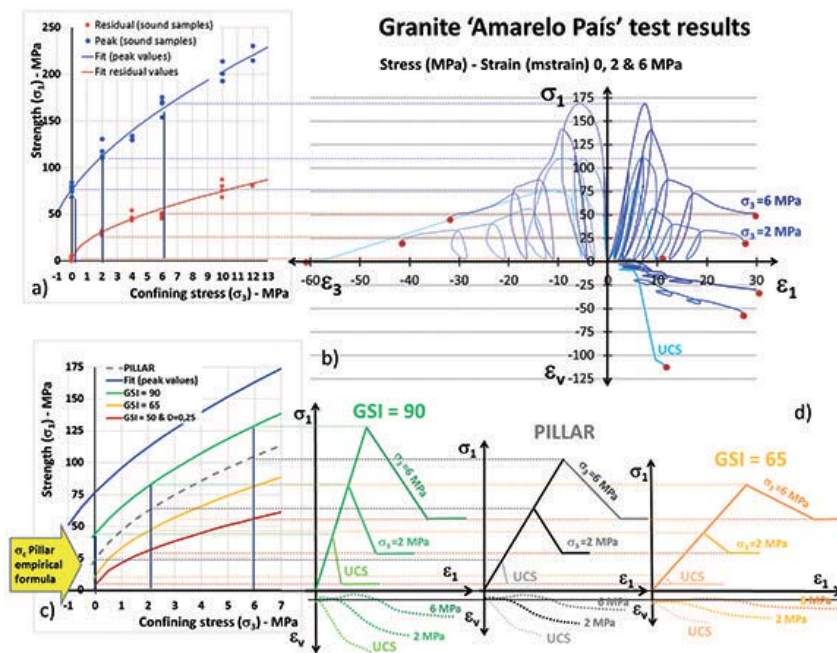
Figure 3—(a) Peak and residual Hoek-Brown strength envelopes for Amarelo País granite specimens, (b) complete stress-strain curve of three samples of Amarelo País granite specimens tested at 0, 2, and 6 MPa confinement, (c) peak and residual strength envelopes for Amarelo País granite samples (computed from actual tests); GSI 90 and GSI 65 Amarelo País granite rock masses (computed based on the GSI approach) and a pillar on Amarelo País granite (adjusting a value of UCS to an equivalent GSI so the UCS coincides with the value supplied by an empirical formula), (d) complete stress-strain curve for rock masses and pillar behaviour as derived from the GSI approach and observations

The peak and residual strength envelopes were fitted using regression analysis techniques (Figure 3a). Information regarding the post-failure behaviour was obtained based on the full stress-strain results (σ_1 , ϵ_1 ; σ_1 , ϵ_3 ; and ϵ_v , ϵ_1) as shown in Figure 3b. In order to extend these observations to the behaviour of large-scale rock masses, the Hoek and Brown (1997) approach based on GSI (Marinos and Hoek, 2000) was adopted. According to Exadaktylos and Tsoutrelis (1993) and Cai *et al.* (2007) and our own observations (Arzúa, Alejano, and Walton, 2014), the residual strength of intact rocks, as interpreted from triaxial tests, could be similar to the that of jointed rock masses. It was also observed that the stress drop from peak to residual values, when confinement increases, results in a shallower slope (Figure 3b).

Statistical fitting of unconfined and triaxial strength results enabled the intact rock strength envelope (blue) to be fitted (Figure 3a and c) and estimation of the Hoek-Brown parameters of this rock as UCS= 76.59 MPa and $m = 40.96$. This, in turn, can be used to compute strength envelopes for different quality rock masses (*e.g.*, GSI 90 or 65, following the GSI approach), shown in green and orange colours respectively in Figure 3c. It is also possible to back-analyse

the GSI value that would make the UCS of the rock mass equal to that estimated according to pillar formulae. Thus, for a 4 m wide and 8 m high pillar, and using the Hedley and Grant (1972) formula $\sigma_{pillar} = 0.74 \times \sigma_{ci} \times W^{0.5} \times H^{-0.75}$, a compressive strength of 23.8 MPa is estimated for the pillar, equivalent to that for a rock mass with GSI 79. This would lead to a strength envelope shown by the dotted grey line in Figure 3c.

confinement levels is shown in Figure 3d. Note how a decrease in rock mass quality decreases dilation of the pillars. This dilation also becomes smaller as the confining stress increases. Although these estimates of pillar behaviour are first approximations only, they may provide insight on the effect of strapped pillars based on the strength testing of strapped rock specimens.

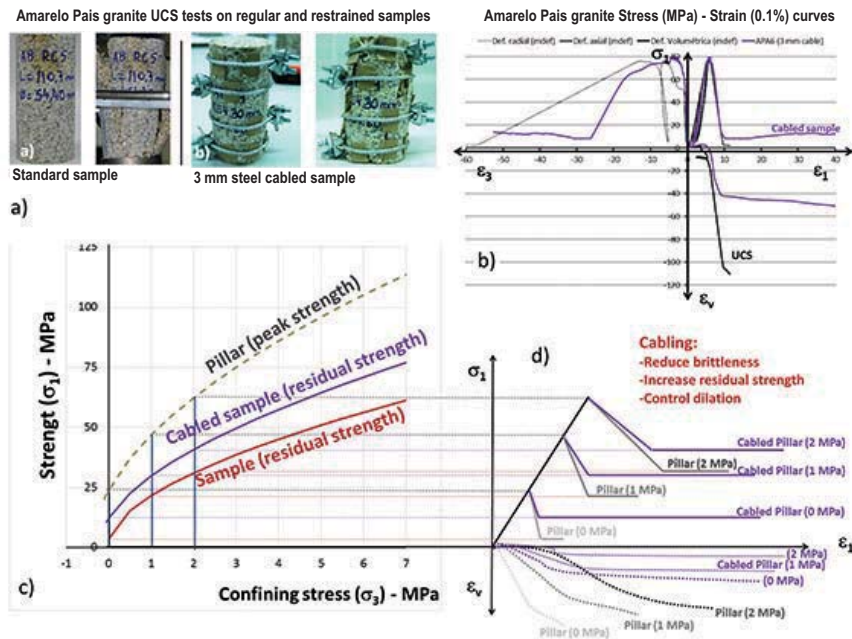
Figure 4—(a) Amarelo País granite specimens tested under uniaxial compression without and with four 3 mm steel cables, (b) complete stress-strain curves for unconfined and cabled Amarelo País granite specimens, (c) pillar peak and specimen (and pillar) residual (cabled and non-cabled) strength envelopes, (d) complete stress-strain curves for cabled and non-cabled pillars as derived from estimates and observations

As a next step, we compared results obtained from the standard uniaxial strength test on Amarelo País granite specimens described above with results obtained from a specimen strapped using four steel cables of 3 mm thickness (Figure 4a and b). The complete stress-strain curves (Figure 4b) reflect similar trends to those observed for the Indiana limestone specimens. For the cabled specimen, dilation occurred in a more controlled fashion. Additionally, a significant residual strength, around 10 MPa was maintained by the strapped sample after 4% axial strain.

The results presented in Figure 4 and associated considerations would indicate that strapping pillars with a reasonable number of steel cables does not affect their elastic (generally pre-peak) behaviour, whereas it does affect their post-failure behaviour by significantly increasing residual strength, controlling dilation, and slightly reducing brittleness. This increase in residual strength could possibly contribute to the stability of a room and pillar mine.

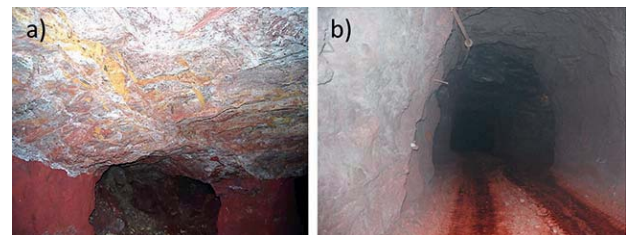
Figure 5—Typical excavations in Santa Rosa mine not needing reinforcement. (a) Shallow room more than 50 years old. Note the stability of the pillars and roof, although at the bottom a small fall of ground is observed. (b) Typical unsupported drift

The rock mass in the immediate vicinity of the reef is bedded and contains four joint sets. This rock mass was originally highly discontinuous due to Carboniferous -age tectonic stresses (the Variscan or Hercynian orogeny). Subsequently, the rock was subjected to metamorphism of Alpine age that reassembled the rock mass and ‘froze’ the faults and joints. This has produced a good-quality rock mass (GSI in the range of 60–70). As a result, 4 m wide drifts and rooms up to 15 m long do not need to be supported. This is very convenient for reducing mining costs, and very few cases of instability (very local and small rockfalls) have been reported in these excavations (Figure 5).

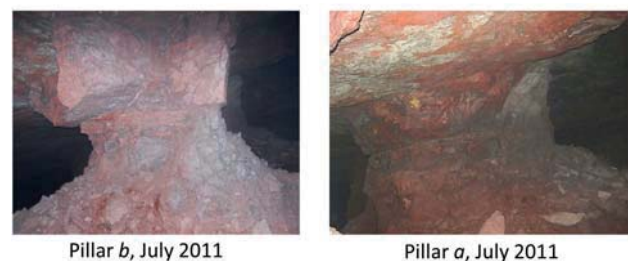
Figure 7—Photographs of pillars *a* and *b* during the visit conducted for the stability study (July 2011)

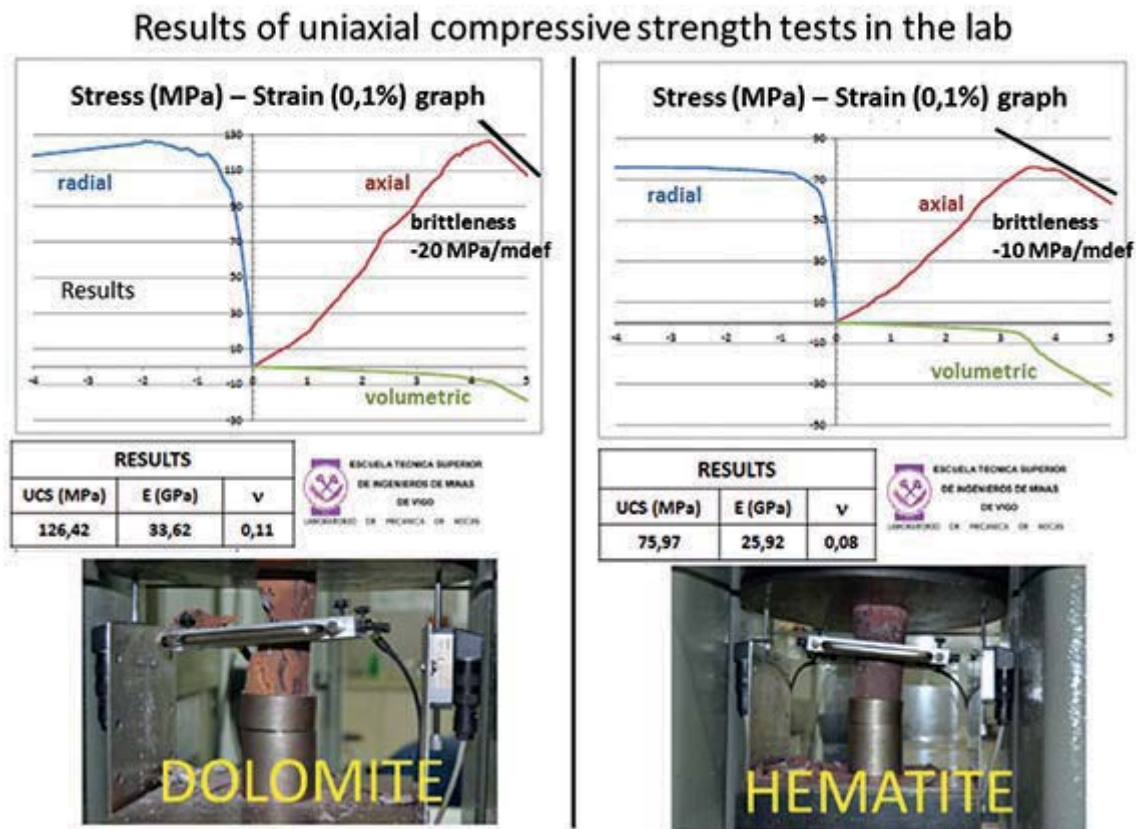
Figure 8—Stress-strain curves for rocks of the roof and pillar. The roof rock (dolomite) is more brittle than the pillar rock

In the general stability study, it was observed that the post-failure behaviour of the haematite was more ductile (less brittle) than that of the dolomite rock of the roof and floor. Based on this consideration, it was evident that catastrophic pillar failure was not to be expected based on energy considerations (Figure 8) and according to Zipf (2001).

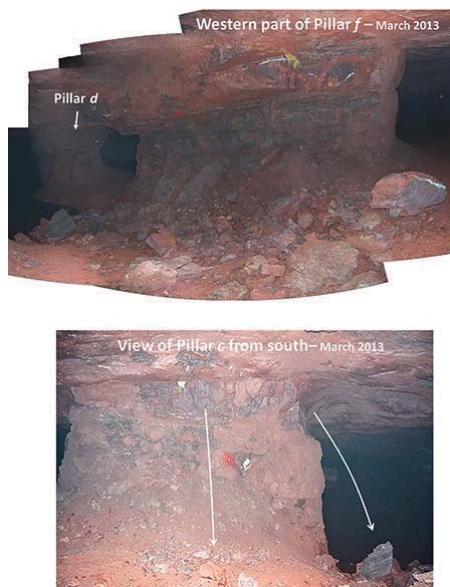
Figure 11—Condition of pillars *f* and *c* in March 2013

A further visit in May 2013 was conducted to examine the condition of the pillars. Pillars *e* and *h* were intact, but slight scaling of pillars *i* and *g* was observed. Pillar *c* showed signs of more severe scaling and two significant blocks fell from this pillar (0.3 m (1 ft) side cubes) (Figure 11). The stability of pillar *f* was particularly poor, with significant scaling on its western side. This reduced its width – and consequently its section – by around 1 m (Figure 6c and 11).

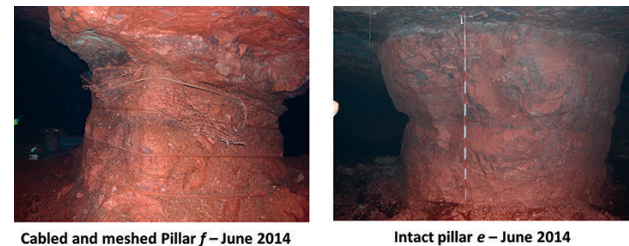
Figure 12—Condition of pillars *f* and *e* in June 2014

No significant instability was reported during the following year and a follow-up visit was made to the site during June 2014. Photographs of the strapped pillar *f* and of the intact pillar *e* taken during this visit are shown in Figure 12. No movements or pillar instability was recorded during this inspection and it appears that the pillar support was functioning as intended. A further visit was conducted in June 2015 with similar observations, and it was decided to start filling this excavation with available waste material (scarce in this mine). A final visit in January 2016 indicated no further instability problems.

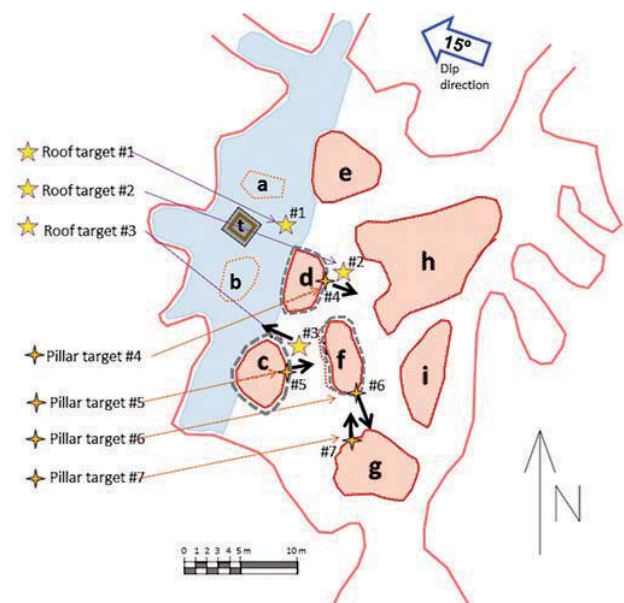
Figure 13—Plan view of the experimental site with the location of the monitoring targets in the roof and on the pillar sidewalls

A third period of measurement started in June 2013 after the strapping of pillars *f* and *c*. The measurements recorded using the targets shown in Figure 13 are presented in Figure 14 for the roof and Figure 15 for the pillars. The period of recording was 700 days, after which the area seemed to reach a new state of equilibrium. A maximum vertical displacement of 1.5 cm for this period was observed in the roof.

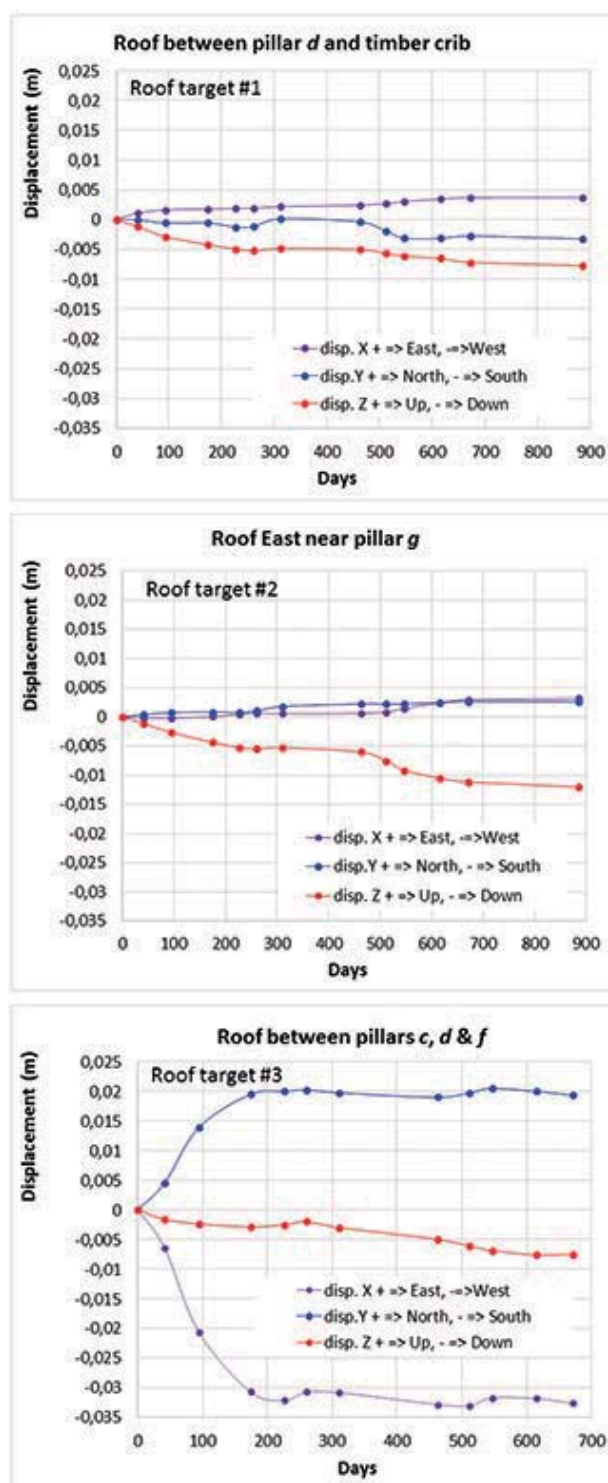
Figure 14—Displacements measured using the roof targets from June 2013 to the end of 2015

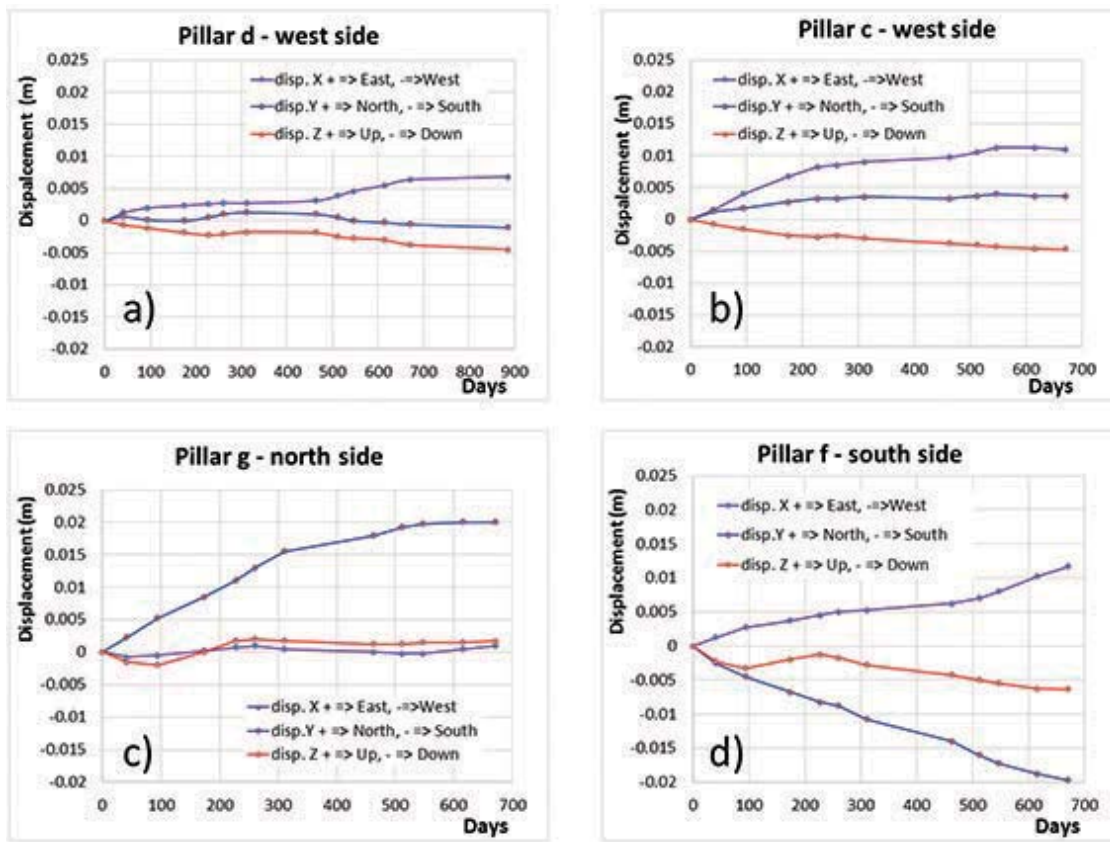
Figure 15—Displacements measured using the pillar targets from June 2013 to the end of 2015

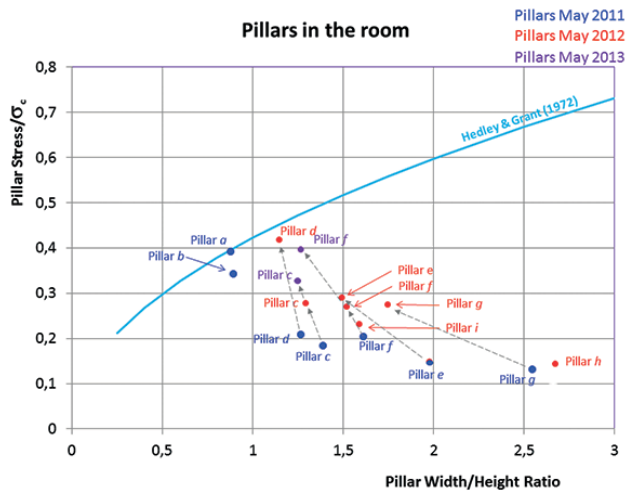
Figure 16—Graph representing the pillars in terms of the ratios (strength/UCS) and (W/H)

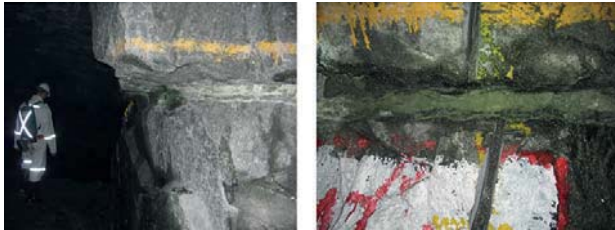
Figure 17—Shear zone with clay-like infilling in the middle of a pillar (left). A close-up of this layer is shown on the right

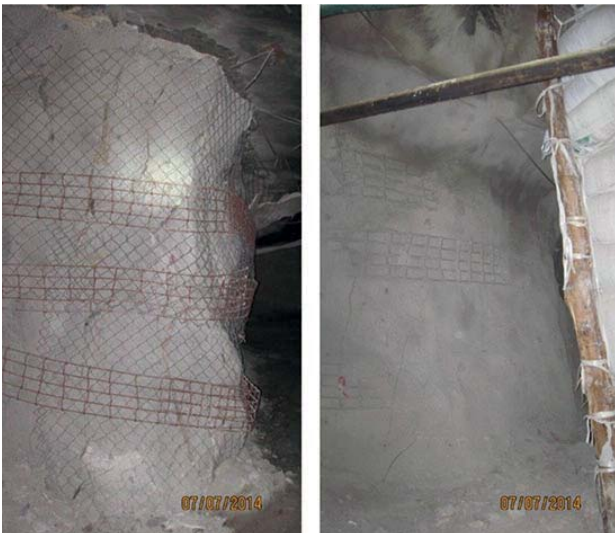
Figure 18—Strapping of the pillars in the mine shown in Figure 17. The strapping consisted of two layers of shotcrete, mesh, and steel straps

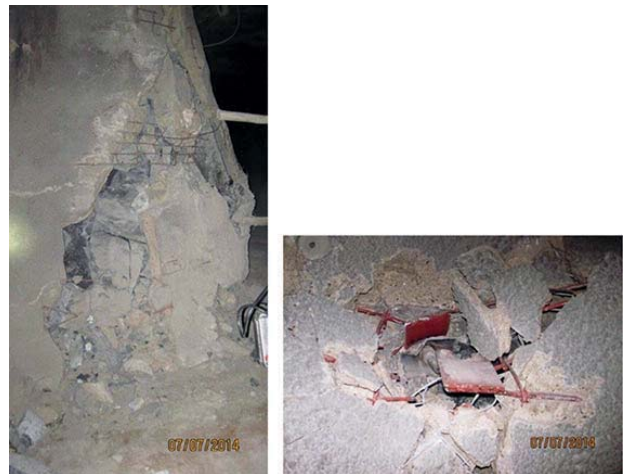
Figure 19—Typical damage to the supported pillars (left) and a roofbolt pulling through the bearing plate as the pillar continued to undergo dilation (right)

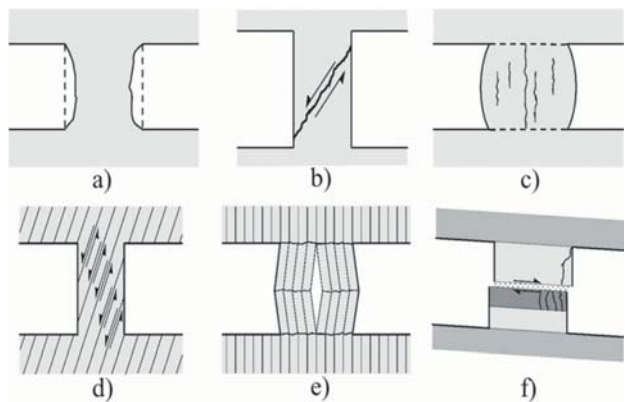
Figure 20—The modes of failure shown in (a) to (e) can possibly be arrested with the cabling method (after Brady and Brown, 2006). The mode of failure shown in (f) may not be corrected with the cabling method

Figure 20 (modified from Brady and Brown, 2006) shows typical pillar failure modes. If pillars are cut in massive rock with no weak contacts with the floor and roof, failure will occur by spalling from the pillar surfaces (Figure 20a). This

leads to a progressive reduction in the width of the pillar and will increase the stress on the pillar. If the width/height ratio of a pillar is small, an inclined shear failure could develop (Figure 20b). If there are weak contacts between the pillar and the hangingwall and footwall, there will typically be internal axial splitting of the pillar (Figure 20c). If there is a joint set (or more than one) with a dip angle larger than the angle of friction, the pillar can yield due to slipping on the fractures (Figure 20d). If the joints are parallel to the principal axis of loading, the pillar may fail by buckling (Figure 20e).

It is hypothesised that for the first five cases in Figure 20, cabling will contribute to an increase in pillar stability. The deformation of the pillar will tension the cables, increasing the confining stress and, consequently, the pillar strength.

collapse described above. It should be noted that for this particular collapse, some pillars may have failed according to the mechanism in Figure 20d where the shear zone was some distance into the footwall. It is very clear from this particular case study that no amount of pillar reinforcement will be successful in the case of such a large mine-wide instability.
