## A Fire Extinguisher Death: The Macklin Effect

From the Department of Forensic Medicine, School of Medicine, Faculty of Health Sciences, University of Pretoria, Pretoria, South Africa.

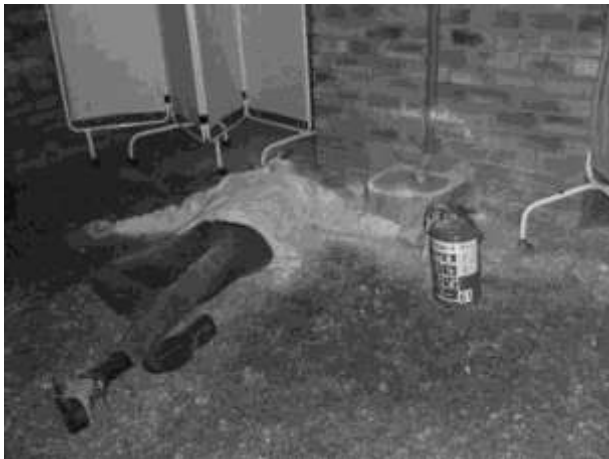
The brick wall behind the deceased showed a “shadow area” created by the fine white powder, where the deceased had been sprayed. The deceased was found to be lying on the ground, face up, covered with fine white powder. An empty fire extinguisher was present to the left of the deceased's body (Fig. 1). Fine white powder covered the deceased's face (Fig. 2). Fine white powder was also present within the concrete drainage area and on the grass. The label of the fire extinguisher showed it to contain 34% to 40% monoammonium phosphate base (Fig. 3). Examination of the scene suggested that the deceased was sitting at the time the fire extinguisher discharged.

FIGURE 1. Scene of death at psychiatric hospital, Pretoria, South Africa.

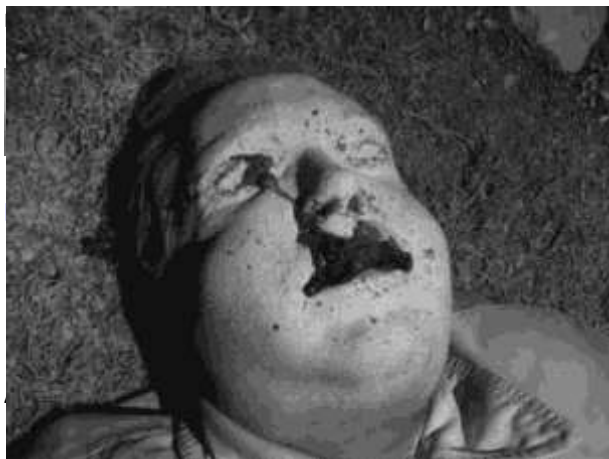
FIGURE 2. Close-up view of the face at the scene of death.

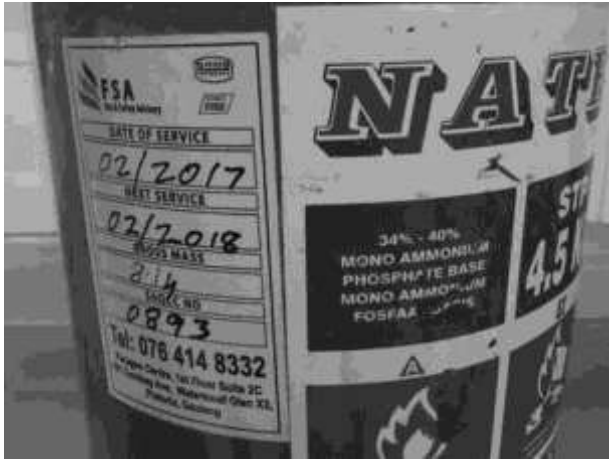
FIGURE 3. Close-up view of the label of the fire extinguisher recovered fully.<sup>8</sup>

On its last inspection, 13 days before the incident, the fire extinguisher had a working pressure of approximately 1400 kPa (203 psi). The powder was composed of monoammonium phosphate (34%–94%), ammonium sulphate (1%–58%), mica (<4%), magnesium aluminium silicate (1%–30%), methyl hydrogen polysiloxane (<1%), and amorphous silica (<2%).<sup>1</sup> The deceased had a known psychiatric history and was diagnosed with an underlying mood disorder.

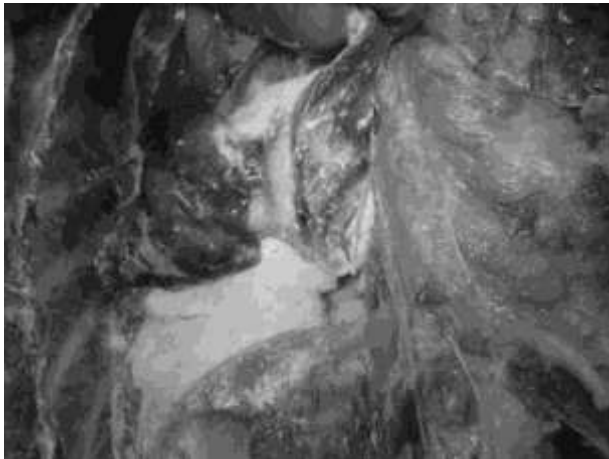
FIGURE 4. Approximately 500 g of fine white powder present in the thoracic cavity, on and between the lobes of the right lung, due to the esophageal rupture. Fine white powder in the thoracic cavity, beneath the lungs.

Autopsy examination showed an adult white man with fine white powder (monoammonium phosphate) deposited over the entire face. Fine white powder was present within the mouth and sinuses and lined the upper airways. There was subcutaneous emphysema in the cheeks and congestion of the eyes. On opening the thoracic cavity, approximately 500 g of fine white powder was present within the right thoracic cavity (Fig. 4). The esophagus was ruptured (Fig. 5). Traumatic emphysema of the posterior sternum wall was present (pneumomediastinum). The ethmoid bones were fractured because of barotrauma (Fig. 6).

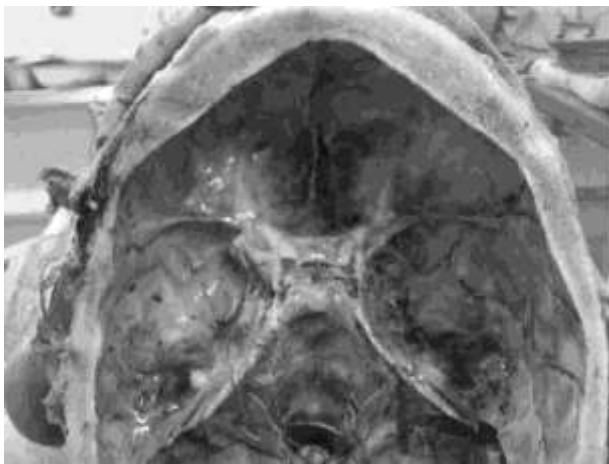
FIGURE 6. Fractures of the ethmoid bones, on the base of the skull.

The fire extinguisher powder did not play a significant role in the death of the individual but rather, the air pressure that caused the powder to be distributed. These findings were appreciated on observing the fractured ethmoid bones as well as the extensive laceration of the esophagus.

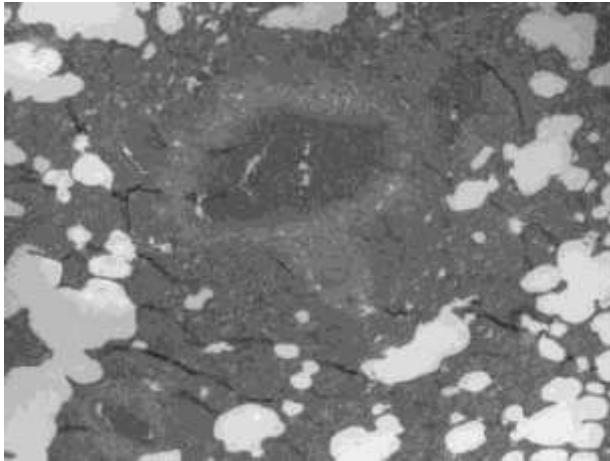
On polarization, birefringent material was noted in a bronchovascular distribution and within the subpleural membranes (Figs. 7–9). The distribution of the birefringent material provided the first real visual evidence in support of the Macklin effect.

FIGURE 7. On polarization of the lung tissue, birefringent material is noted in a bronchovascular distribution.

On polarization, birefringent material was noted along the bronchovascular sheaths and along the subpleural membranes. This finding supports the hypothesis of the Macklin effect. It also provided the first visual evidence of the phenomenon.

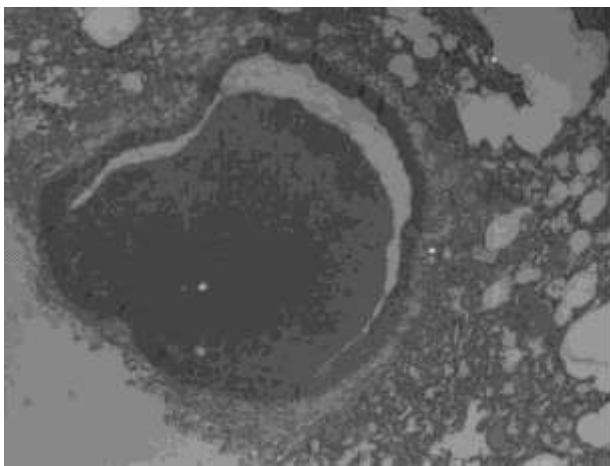
FIGURE 8. On polarization of the lung tissues, birefringent material is noted within the bronchovascular sheaths.

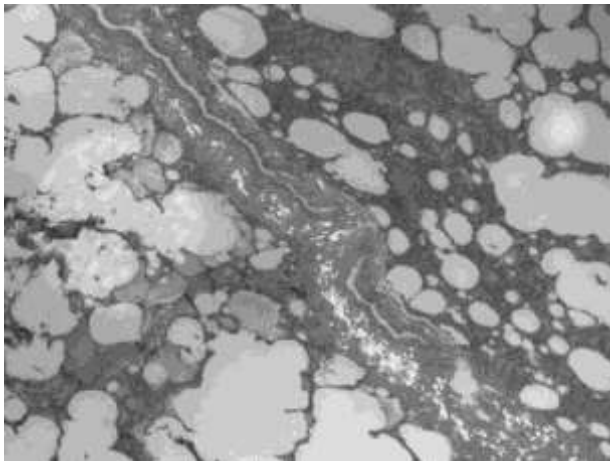
FIGURE 9. On polarization of the lung tissues, birefringent material is noted within the bronchovascular sheaths and subpleural.
