UNIVERSITEIT VAN PRETORIA
UNIVERSITY OF PRETORIA
YUNIBESITHI YA PRETORIA

Department of Mechanical and Aeronautical Engineering

In-belt vibration monitoring of conveyor idler bearings by using wavelet
package decomposition and artificial intelligence

By: W.A. Roos

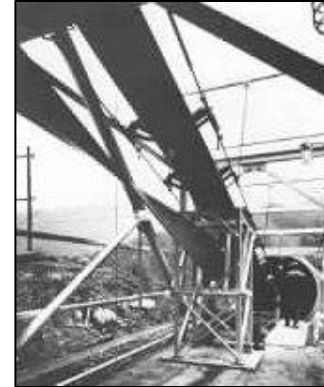
Figure 1.3: Implemented Turnover Conveyor Belt
(Darling, n.d.)

By twisting the belt half a turn on the bottom section of the conveyor allows the belt to wear on all of its exposed surfaces and not only on the one side like conveyor belts we know today. Although, at the time, the Turnover Conveyor Belt System was more durable than the other untwisted belts, modern day belts are more durable because they can be constructed from different layers consisting of different materials and this lead to the twist in the belt to be phased out (Darling, n.d.).

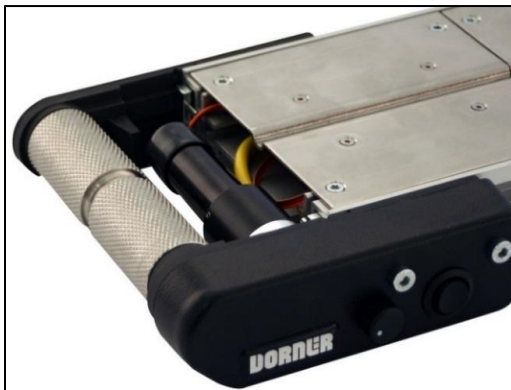
Figure 1.5: Small drive unit of an iDrive conveyor (Automation Supplies Ltd, n.d.)

The heart of the conveyor is the drive unit. The sizing of the drive unit depends on the amount of payload that needs to be transported, how fast it needs to be delivered as well the length of the belt that needs to be circulated. Some power units can be as small as a 24 V DC motor like the drive unit in an iDrive compact conveyor from Dorner (Automation Supplies Ltd, n.d.) as seen in Figure 1.5. Other drive units like those found in the mining industry can range from 45 to 3000 kW with some of the drive units rated at a maximum torque of 600 kNm (David Brown, n.d.). A large drive unit like this is shown in Figure 1.6. As seen in the figure, the yellow enclosure protects the gearbox, the flywheel and braking system. The size of the drive unit depends on the requirements of the transportation of the payload. Some conveyors make use of direct drive where the motor is connected directly to the head pulley but it is not widely used yet (Siemens, 2013).

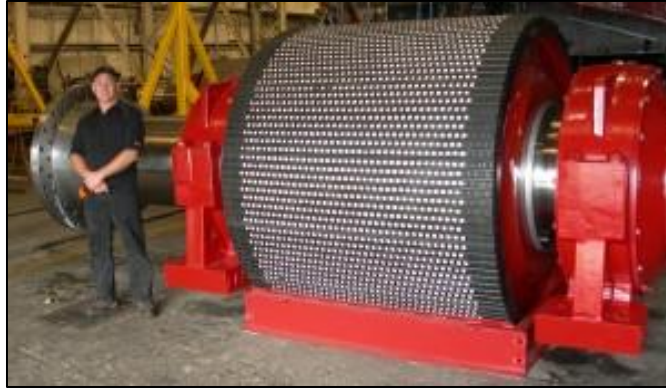
Figure 1.7: Large drive pulley
(RAS, n.d.)

The head pulley, or also known as the drive pulley, is a big drum around which the belt of the conveyor is wrapped around. The head pulley, with the assistance of the drive unit, provides the driving force that circulates the belt. The payload on the belt, and the weight of the belt itself, induces a large amount of tension on the head and tail pulley. The head and tail pulley is designed to withstand these large forces and the drum, shaft and bearings can become massive. Figure 1.7 shows a very large pulley used in a copper project in Peru where a designed tension of 1,422 kN needed to be withstood (RAS, n.d.).

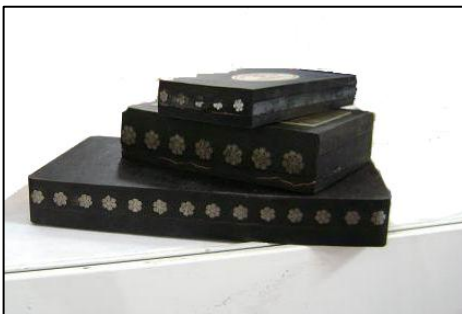
Figure 1.8: Different steel cord and belt size
(Shandong Rubber Six Xiang Te Conveyor Belt Co., Ltd., 2015)

Some belts are produced with different layers to increase the strength. The inclusion of steel cord is not uncommon when the belt's strength needs to be increased (Dunlop Conveyor Belting, n.d.). As seen in Figure 1.8, different size steel cords can be used depending on the strength needed. Some belts may only have steel cord along the longitudinal direction of the belt, but other manufacturers may also add transverse strengthening as seen in Figure 1.9.

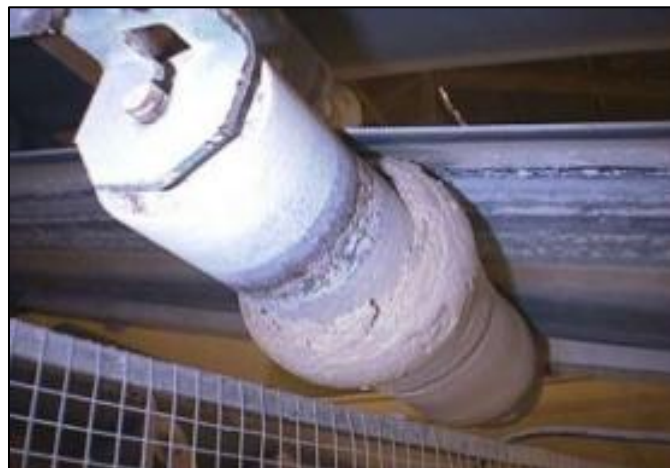
Figure 1.14: Material build-up and visible belt damage (Kinder, 2013)

The belt of the conveyor system is an expensive component. For a nylon or polyester embedded belt, the cost of the belt is about one third the installation cost of the entire system and can be even more expensive if the belt is reinforced with steel cord (Owen, n.d.). Preventing damage to the belt is a good way of keeping the maintenance cost down. The belt can be damaged in a few ways. Large rocks on the belt or material build-up on the idlers can stress the belt to an extent that the strengthening structure, or carcass, of the belt gets weakened (Kinder, 2013). These weaknesses in the belt can lead to a tear in the belt or the complete severing of the belt. This will mean that the conveyor has to come to a standstill to repair or rejoin the belt. Figure 1.14 shows material build-up on an idler and how it stretches the belt, weakening and sometimes even tearing it.

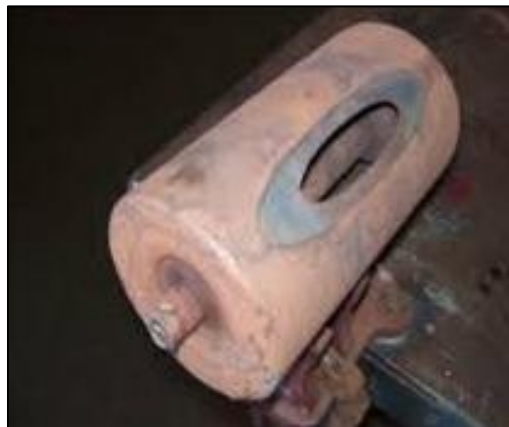
Figure 1.15: Idler seized and belt wore through the steel shell (Intium, 2015)

Figure 1.15 shows an idler that had seized but that had not been replaced for a while. As the belt travelled over the idler, it wore through the steel shell. Sharp edges from the worn section could potentially slice or rip the belt.

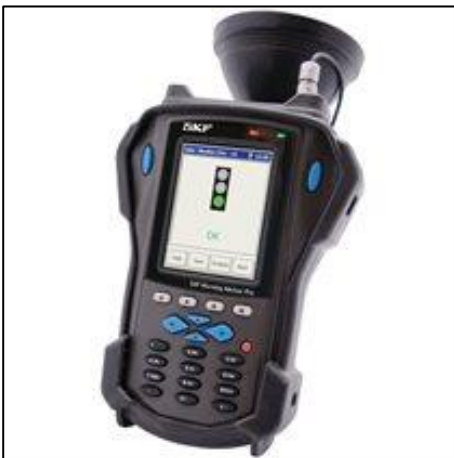
Figure 1.20: SFK idler sound monitor kit (SKF, n.d.)

To help the inspector to identify possible faults or failures, acoustic equipment are used to identify audible and inaudible noise. Specialized acoustic equipment like SKF's idler sound monitor kit, depicted in Figure 1.20, can be used to identify small deviations in bearing vibrations and serve as a fault identifier (SKF, n.d.).

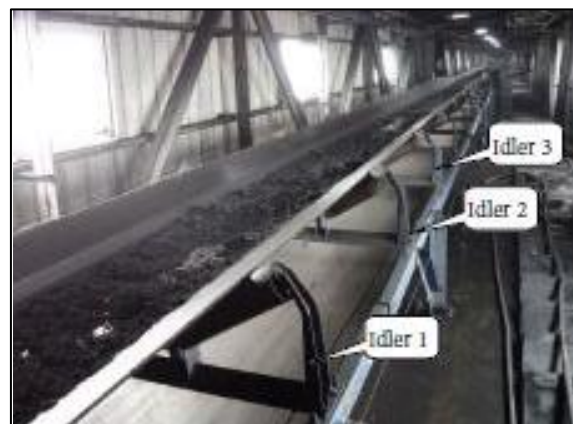
Figure 1.23: Three idlers being monitored by a single accelerometer (Li, et al., 2013)

An investigation was done on the vibrations of conveyor idlers by the School of Mechanical and Electrical Engineering of the China University of Mining and Technology. (Li, et al., 2013). This investigation looked at the vibrations of the idlers and identifying which of the idlers close by is failing. The vibrations were captured by accelerometers placed on the supporting structure of the conveyor as seen in Figure 1.22. Seeing that some conveyors can be very long, and having an accelerometer at every idler can become costly, a single accelerometer was used to monitor three idlers – the idler at the accelerometer and the two neighbouring idlers. Figure 1.23 shows the three idlers that were monitored in the investigation. The accelerometer seen in Figure 1.22 is placed at the idler marked "Idler 2". The accelerometer was then used to monitor the neighbouring idlers as well - "Idler 1" and "Idler 3".

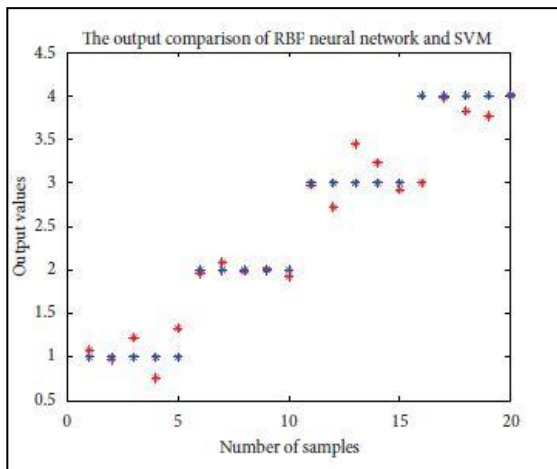
Figure 1.24: Neural network (Red), Support vector machine (Blue) classification of gear faults (Li, et al., 2013)

Figure 1.24 shows the classification of faults on a mechanical fault simulator. The simulator was used to illustrate the feasibility of using wavelet package decomposition and artificial intelligence to classify mechanical faults (Li, et al., 2013). An output of 1 was given for a normal, healthy state. Depending on a gear defect in the mechanical fault simulator, either a 2, 3 or 4 were given as output. Figure 1.24 shows the classification of the gear faults. The red data set represents the classification of the faults with a neural network and the blue data set the classification by a support vector machine. It can be seen that the support vector machine classifies the faults more specifically - the output is one of four values, where the neural network classifies the faults with a little less certainty. It has been found that the support vector machine is the more accurate classifier (Li, et al., 2013) and was then used for faulty idler identification and classification.

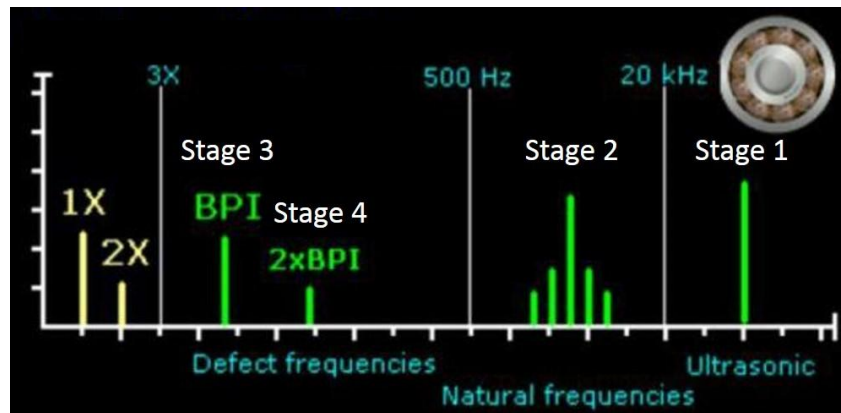
Figure 2.1: Vibration stages of failing bearings

Figure 2.1 shows a frequency plot of the vibrations found in a bearing as it fails. The first signs of bearing failure can be detected in the ultrasonic frequency range above 20 kHz (Graney & Starry, 2012). Stage two is where the natural frequencies of the structure are excited (Graney & Starry, 2012). Stage three are the frequencies associated with the bearing components like the race pass frequencies and the roller element frequencies also known as the bearing fault frequencies (Graney & Starry, 2012). Stage 4 is where the harmonics of the bearing fault frequencies appear.

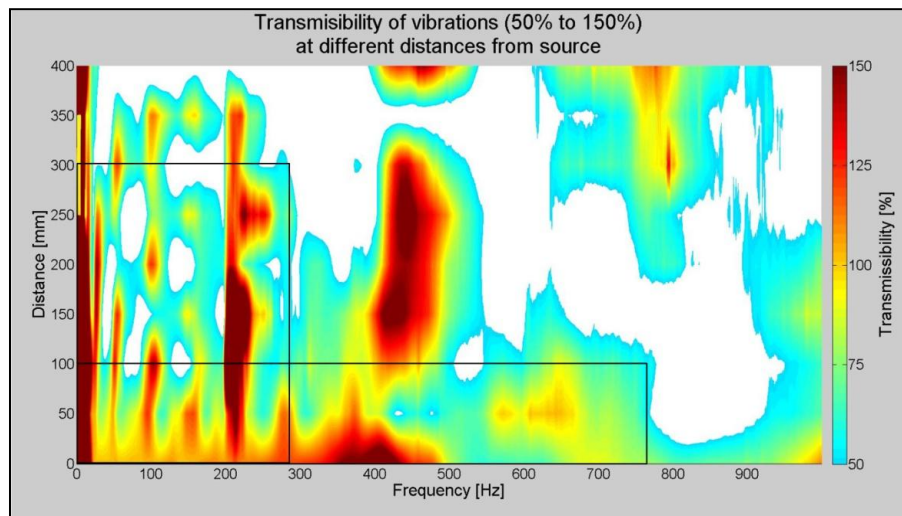
Figure 2.5: 50% Transmissibility and higher

From the contour plots it can be seen that the vibrations are, as expected, attenuated more at high frequencies far from the source.

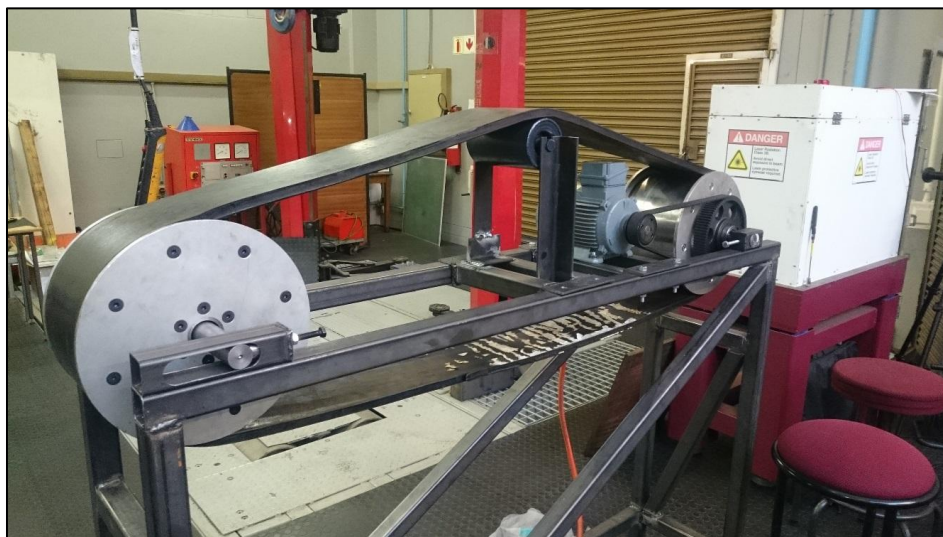
Figure 2.6: Test bench representation of a conveyor

A short conveyor was designed and built. Figure 2.6 shows the test bench that was used to acquire vibration signals of different idler bearing faults. The test bench has a head pulley, drive motor, tail pulley and an idler. The 1.5 kW motor has a belt reduction to aid with the acceleration of the inertias. The motor was powered by a variable speed drive which gave great control over the start-up and operational speeds. The rotational speed for all the tests were kept constant with the variable speed drive with as little variations as possible (<5%) and confirmed with a handheld tachometer. Both the head and tail pulley has tensioners and alignment mechanisms. These mechanisms were used to tension and align the drive belt and the conveyor belt alternatively and can be seen in Figure 2.7 and Figure 2.8. The idler is easily removed by releasing the tail pulley tension – allowing the conveyor belt to be lifted. This allows the removal of the idler without having to release tension of the drive belt and having to re-align it every time a new idler condition has to be tested. The idler was positioned a bit higher than it would normally be found on a conveyor. This was done to easily apply a downwards force on the idler, simulating the effect of a payload on the conveyor. Figure 2.9 shows the idler and the belt wrap.

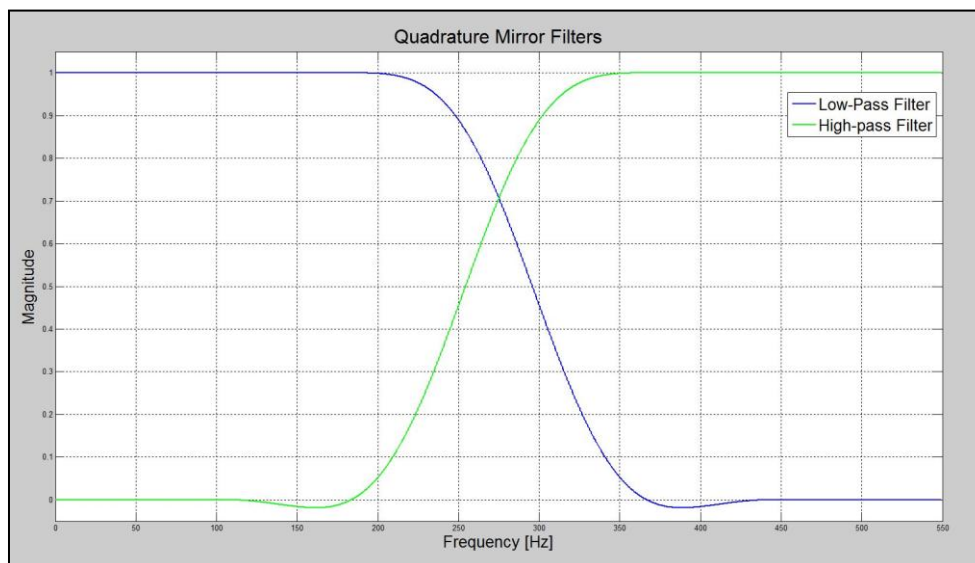
Figure 2.16: Quadrature mirror filters - First level Wavelet package decomposition

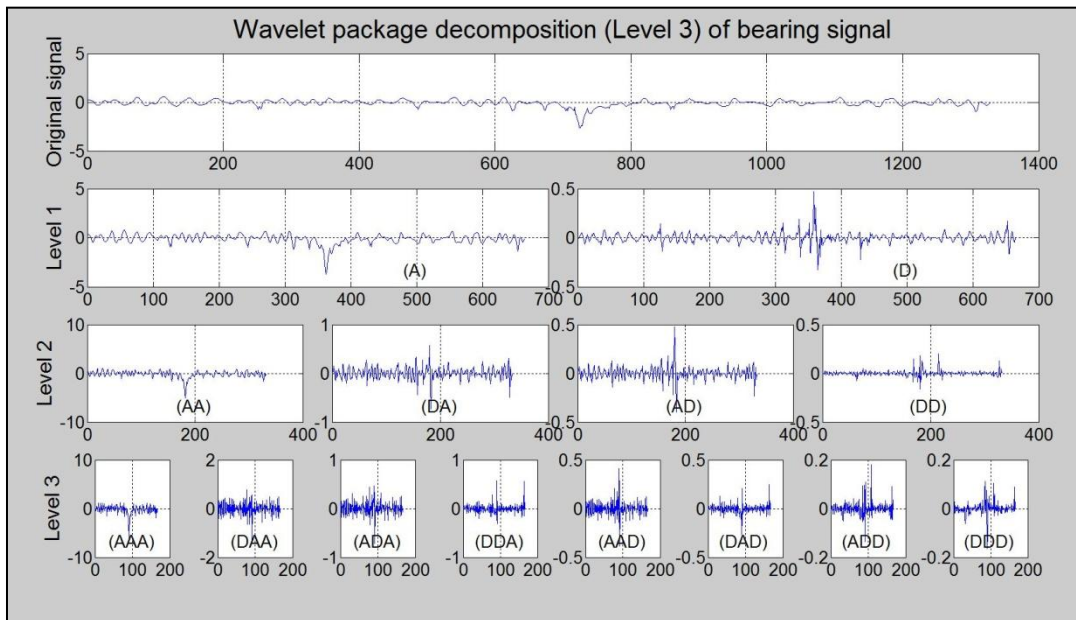
Figure 2.19: Level 3 wavelet package decomposition

Higher level wavelet package decompositions can be done on the original signal. Figure 2.19 shows a level 3 wavelet package decomposition that is done on a bearing signal. The higher level decompositions divide the original signal into more signals that distinguish the base signal and the underlying vibration signals even better from one another.

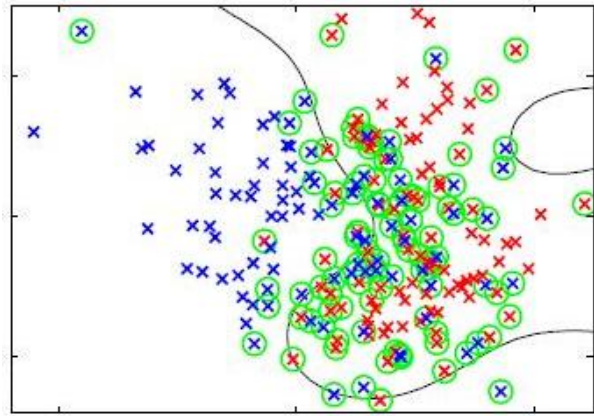
Figure 2.23: Overlapping classification to ease the optimization problem (Bishop, 2006)

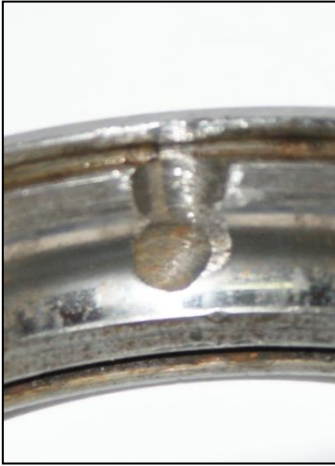
Figure 3.1: Outer raceway defect

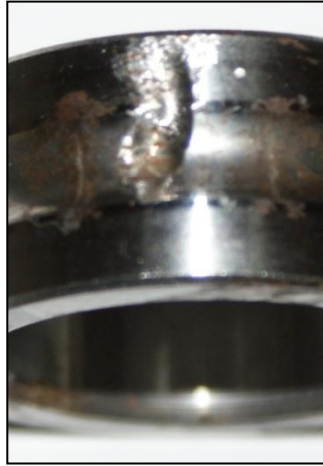
Figure 3.2: Inner raceway defect

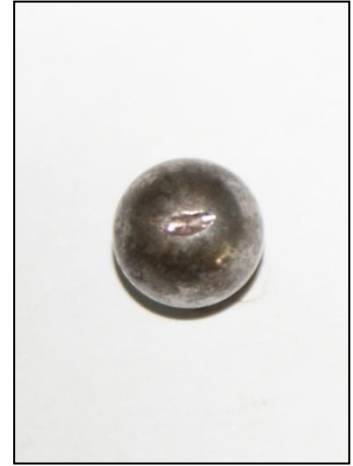
Figure 3.3: Rolling element defect

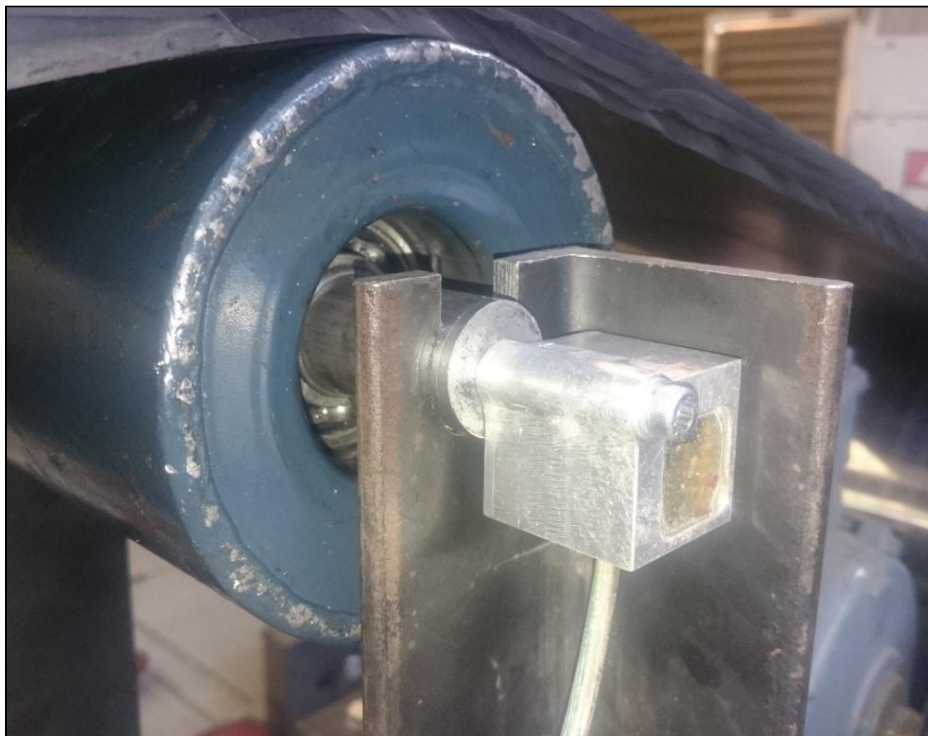
Figure 3.4: Accelerometer attached to idler shaft

As discussed in Section 1.5.4. vibrations have been used with success to identify bearing faults in conveyor idlers and monitor them. Before the accelerometer was fixed to the moving belt, the same investigation was done to ensure the equipment, pre-processing and intelligent systems worked and was as accurate as the current monitoring done on the supporting structure. This was also done to validate if the measured frequencies corresponded to the calculated fundamental frequencies. The accelerometer was fixed to the shaft of the idler with a bolt and some wax in between to help with vibration transmission. Figure 3.4 shows the accelerometer bolted to the shaft of the idler. The sensor was attached near the faulty bearing and measured the vibrations in the vertical direction.

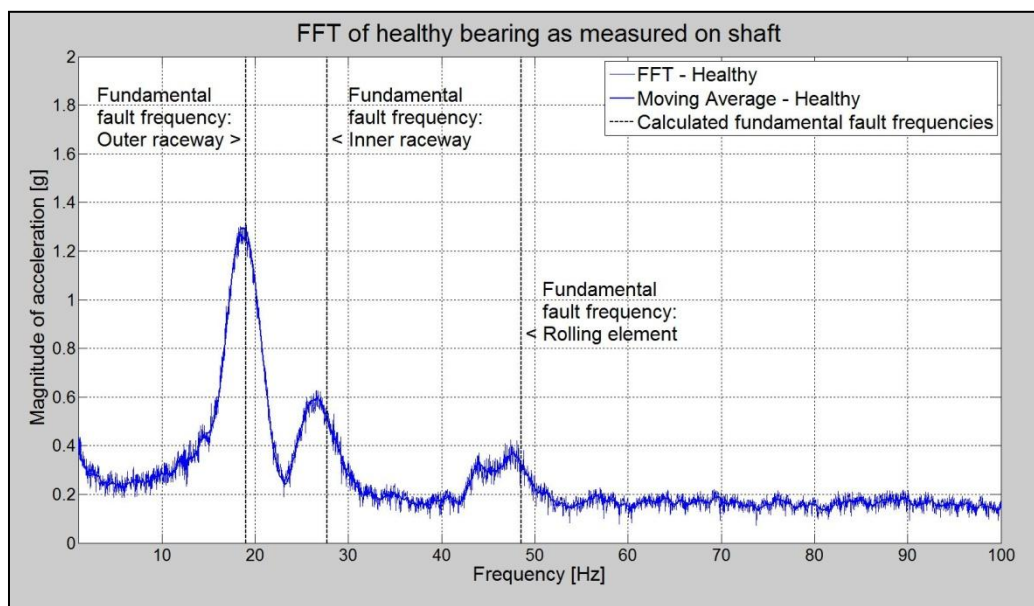
Figure 3.5: FFT of healthy bearing measured on the shaft

The inner raceway was fixed, and a belt speed of 1 m/s was maintained with as little variations as possible throughout the test with the use of a variable speed drive. The idler speed was monitored as well with a hand-held tachometer. Figure 3.5 shows the fast Fourier transform, or FFT, of a vibration signal measured with the accelerometer when both bearings in the idler were healthy. The three fundamental frequencies are also indicated on the figure. The fundamental frequency produced by the outer raceway was calculated to be 18.97 Hz and was measured on the FFT to be 18.63 Hz, a 1.8% difference. The fundamental frequency that corresponded to the inner raceway was calculated as 27.68 Hz and was measured at 26.79 Hz, a 3.2% difference. The fundamental frequency of the rolling element was calculated as 48.51 Hz and was measured at 47.63 Hz, a 1.8% difference. From this, it can be seen that the accelerometer measured vibration signals produced by the bearing that corresponded to the calculated fundamental frequencies. A total of 16 vibration signals were measured of a healthy bearing in the idler.

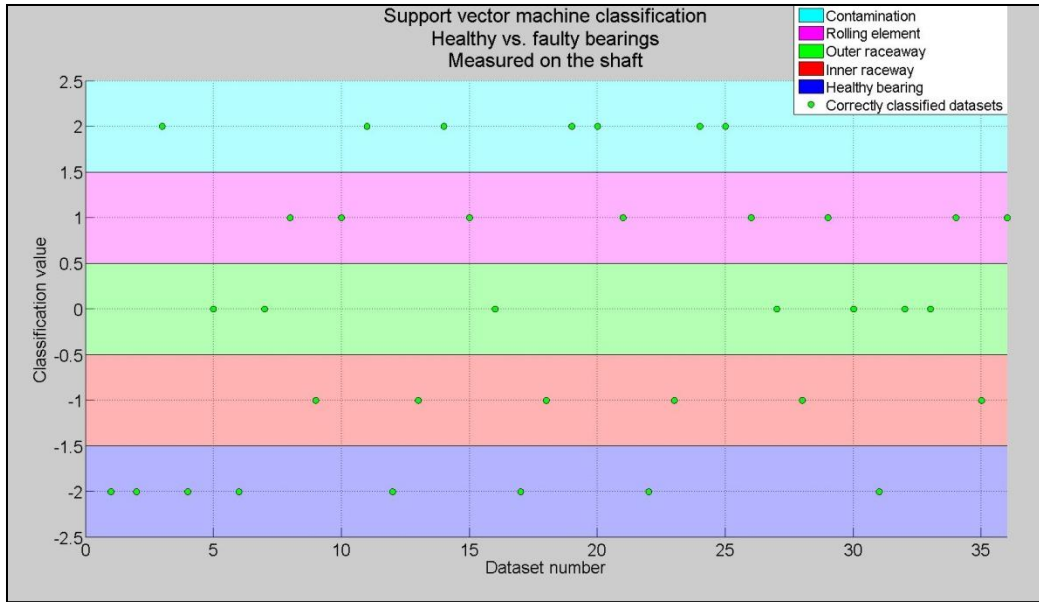
Figure 3.13: Five-class Support vector machine classification as measured at the shaft

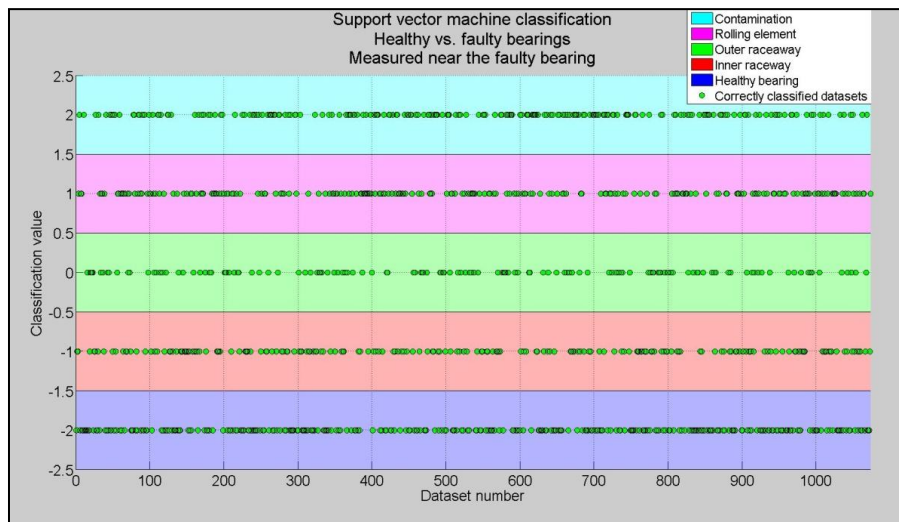
Figure 3.27: Five-class, near bearing, Support vector machine classification

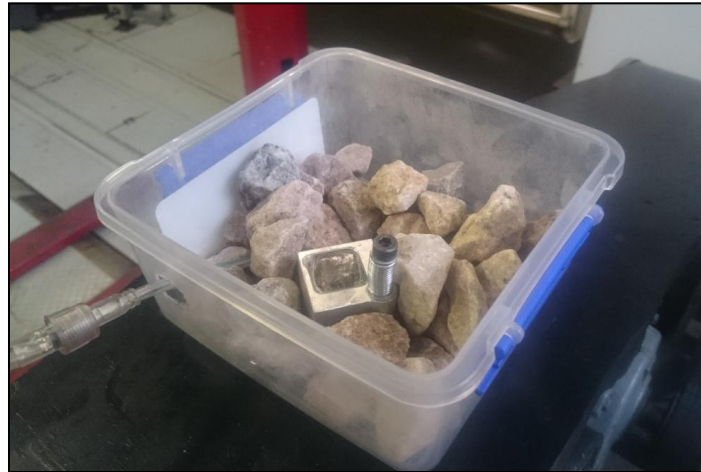
Figure 3.38: Payload surrounding the accelerometer

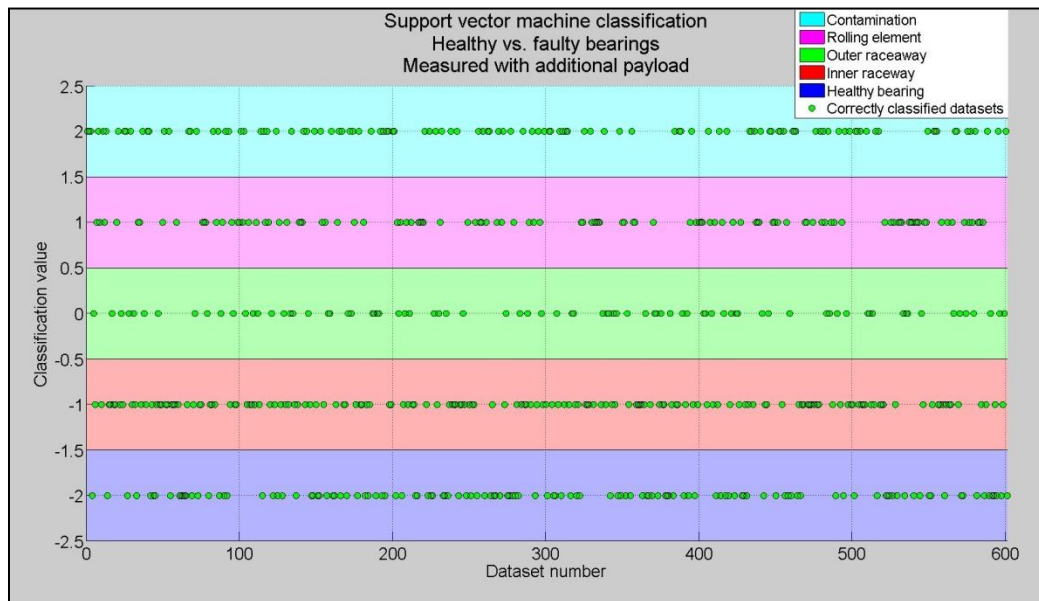
Figure 3.43: Five-class Support vector machine classification with additional payload

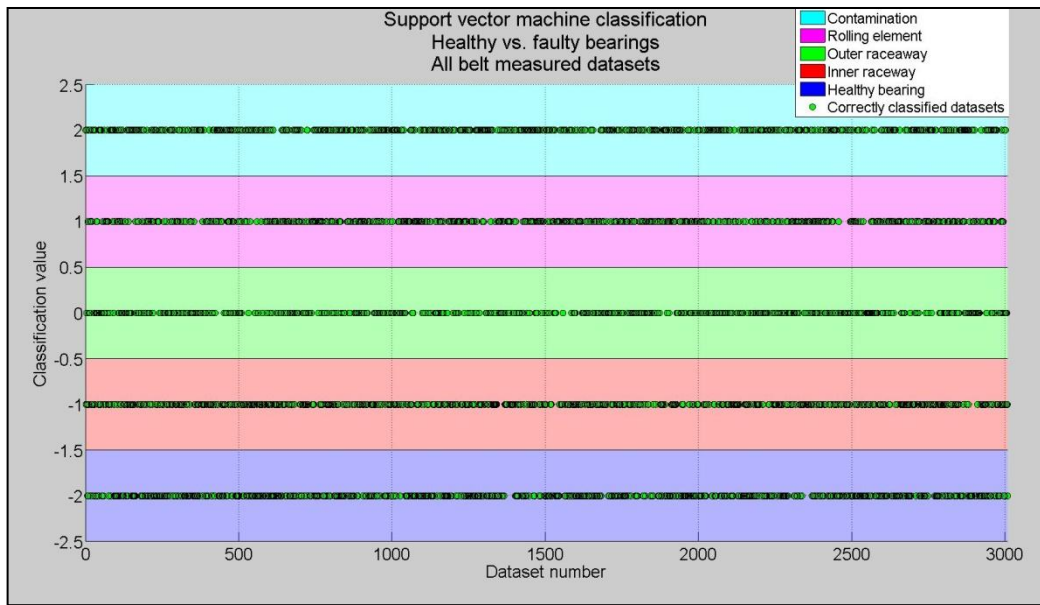
Figure 3.44: Five-class Support vector machine classification of all the on-belt measurements

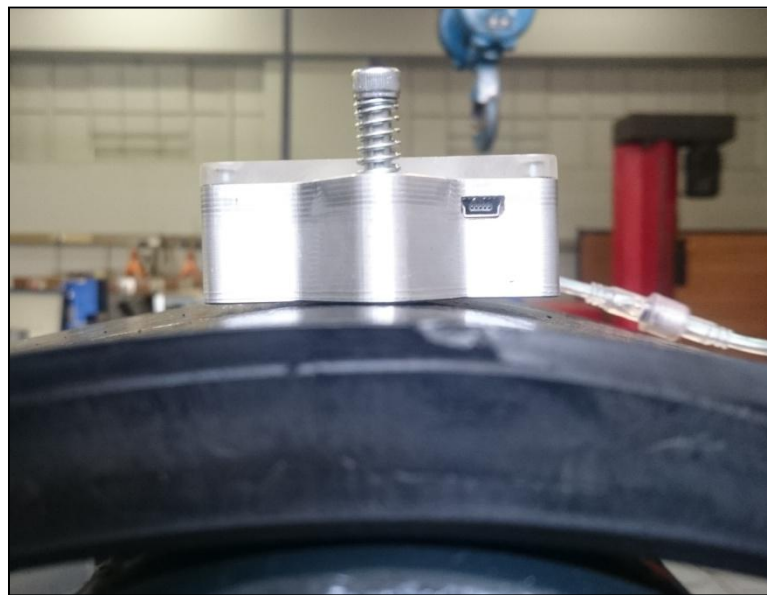
Figure 5.1: Comparison between belt and logger thickness

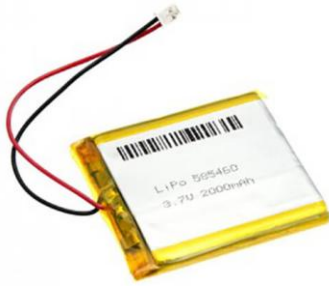
Figure A.0.4: Lithium-polymer battery
