# BHUTANESE ROAD AND BRIDGE RESILIENCE TO FLOODS AND LANDSLIDES – FIRST SUGGESTIONS FOR ASSESSMENT AND RESPONSE

**AR DAWSON<sup>1</sup>, LAC NEVES<sup>2</sup>, R SARKAR<sup>3</sup> AND T DIJKSTRA<sup>4</sup>**

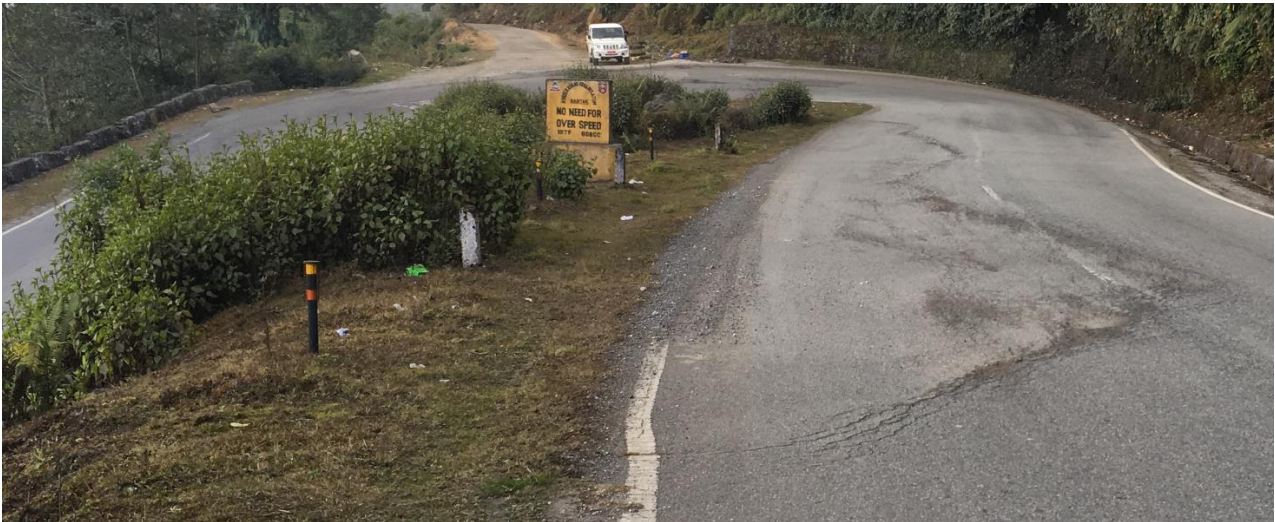
**Figure 1 Incipient failure of fill slope made apparent by deformation arcs in asphalt road surfacing**

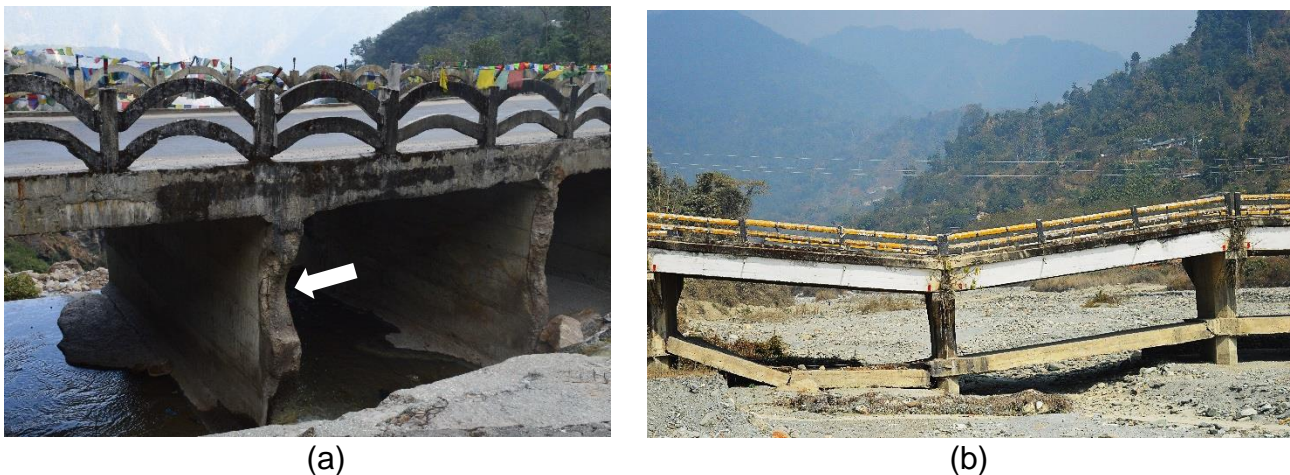
**Figure 4 Examples of damage to bridge causes by high energy flows: (a) impact of boulder on culvert (see arrow); (b) the results of scour, seen in the dry season**

The failure of a bridge or a culvert will result in very severe consequences to the network. However, unlike landslides, failure of bridges are, to some extent, easier to predict. Erosion of concrete is easily observable visually, and once reinforcement is exposed, repair is clearly necessary (Figure 4a). A record of thickness of critical members would provide a good indication of the need to perform maintenance in the short term. Blockage, too, is easy to see once monsoon river/stream levels have abated. Scour is, in most cases, very difficult to observe. However, in this respect, the Himalayan region is unique. Since the rivers flood yearly, most piers stand outside the river bed for most of the year, making visual inspection, mitigation and repair activities significantly simpler than in other regions (Figure 4b).
