CHAPTER 4

4.1_INTRODUCTION

The study area is located along the railway line within Johannesburg CBD and Doornfontein. The railway creates a distinct barrier within the context creating a clear seperation between north and south.

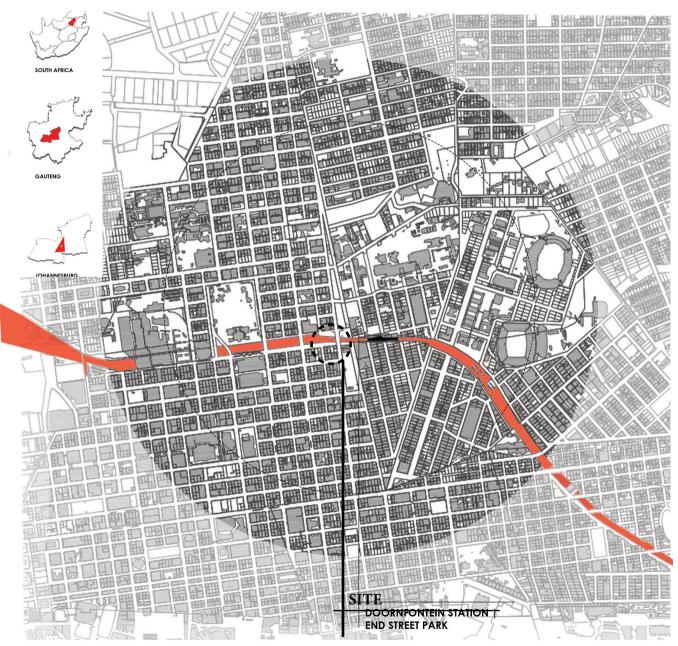
Figure 4-02: Figure ground of JHB illustrating railway line and site location (Author, 2019)

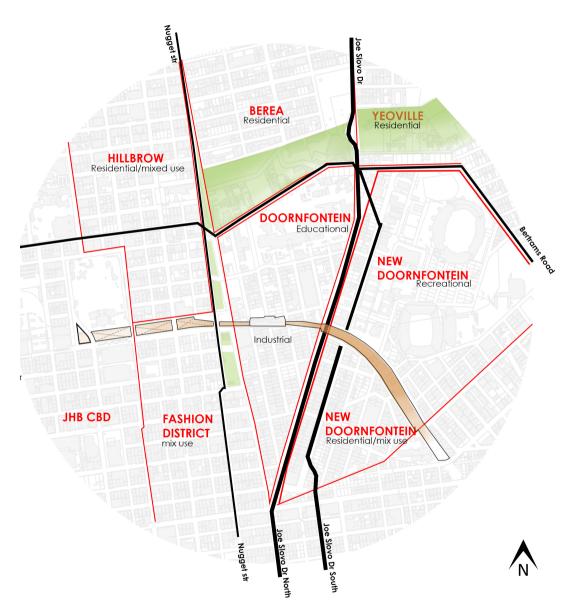
Figure 4-13: Macro analyses - infrastructure and districts (Author, 2019)

Doornfontein is bordered by the main feeder routes of Joe Slova drive towards the east, Nugget Street towards the west that establish the north-south connections to the city, and Smit street forming the northern boundary that connects the city from east-west.

The sunken railway line creates an incredible scar and barrier in the urban landscape. It separates the poorer residential neighbourhoods towards the north from the central business districts, decreasing the level of permeability, access and movement from the north towards the south.

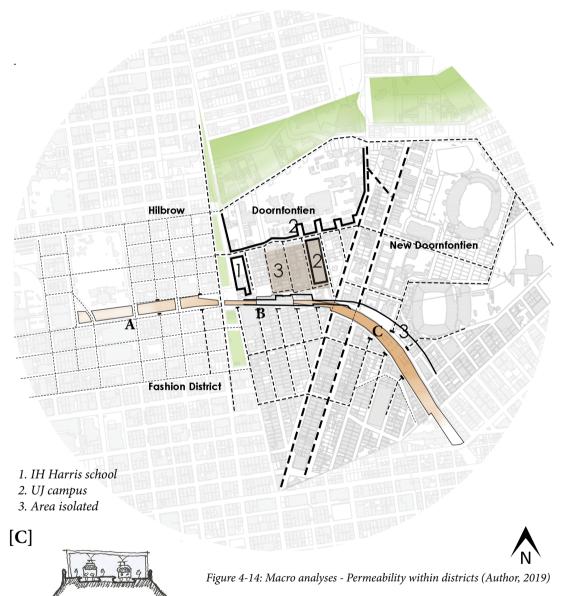
Figure 4-15: Macro analyses - Railway line sunken, level and elevated

The fall of the topography further increases the problem of the railway line towards the east when it reaches the downtown core of Doornfontein. The condition of the railway line changes from being sunken to being level with the street, further decreasing permeability and access within the urban environment. This creates a physical, visual, social and ecological barrier as it divides Doornfontein, social life and End Street Park into two distinct areas.

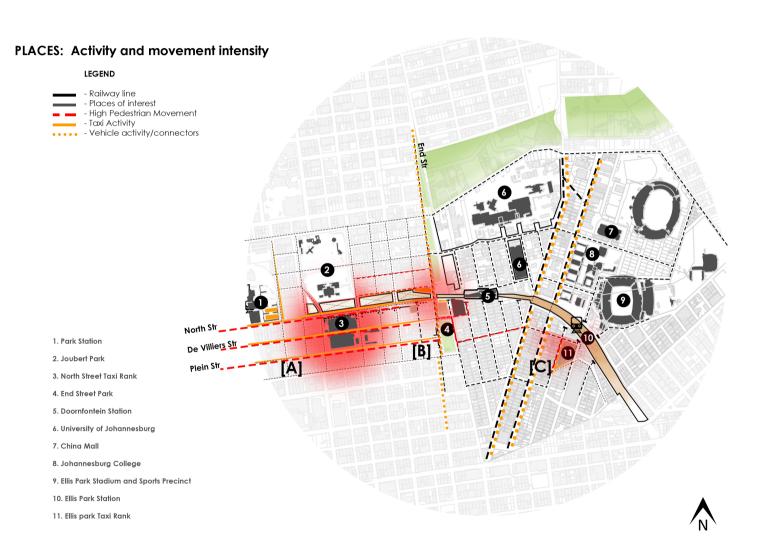
Figure 4-16: Macro analyses - Movement, Social and cultural places (Author, 2019)

Noord street shows a high activity of movement that correlates with the transport infrastructure in the area. The intensity of pedestrian movement in the area allow economic oppertunities for the informal traders that occupy the street edges. The movement intensity declines towards the east, moving towards Doornfontein station.

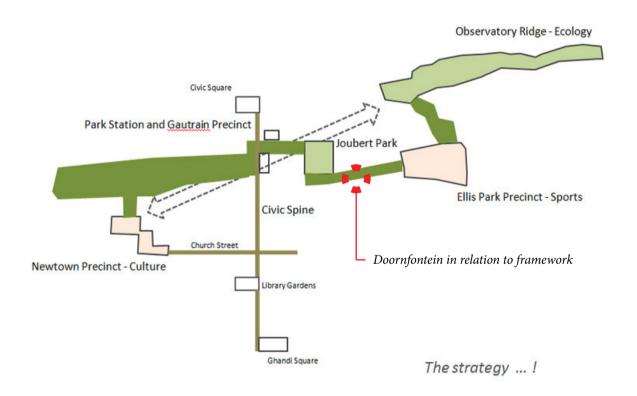
Figure 4-18: The Seam and the spine framework proposal by Newtown Landscape Architects (https://www.newla.co.za/projects/johannesburg_inner_city_park.php, 2019)

'The Seam' is a strategy developed by Newtown Landscape Architects that respond to the current lack of green open space and parks. The strategy employs an approach that makes reference to landscape urbanism theories. By identifying a series of urban voids and brown field sites on the scale of the CBD of Johannesburg, it aims to reclaim, remediate and creatively stitch back the lost fabric to provide new places for citizens to socialize and safely move between districts (Barnard and Young, ud).

The intervention manifests itself as a linear system of parks that originates from a natural ecosystem that stretches from the western edge of Observatory ridge, towards the railroads from Ellis park and Doornfontein, continuing further west towards Park Station and finally ending at Newtown's Cultural precinct. The ecological value of the scheme will provide and built resilient capacity within the urban environment to respond and adapt to the future growth and development of the city (Barnard and Young, ud).

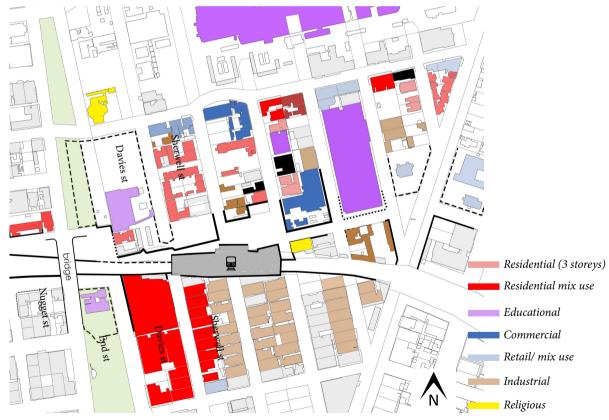
Figure 4-24: Site analyses - Zoning surrounding site (Author, 2019)

The area surrounding the railway line is predominantly industrial in terms of building typology. The proximity of the area to the CBD and the University of Johannesburg saw a recent regeneration in the area where adaptive reuse strategies where applied to accommodate mix use development for social housing and student accommodation.

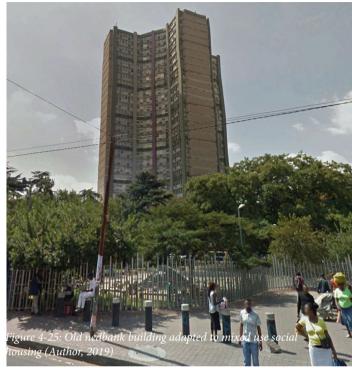
Figure 4-26: Old industrial buildings south of the railway line (Author, 2019)

The area shows characteristics of urban decay as a large portion of the industrial built fabric is abandoned. Existing houses and apartment blocks that are in use today are not maintained, further detracting from the image of the area.

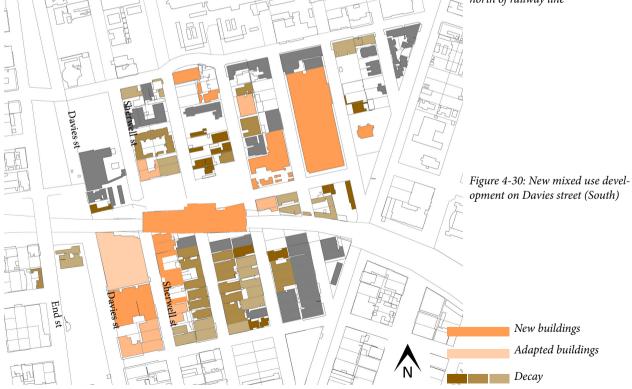
Figure 4-27: Site Analyses - Decay, New and adapted buildings (Author, 2019)

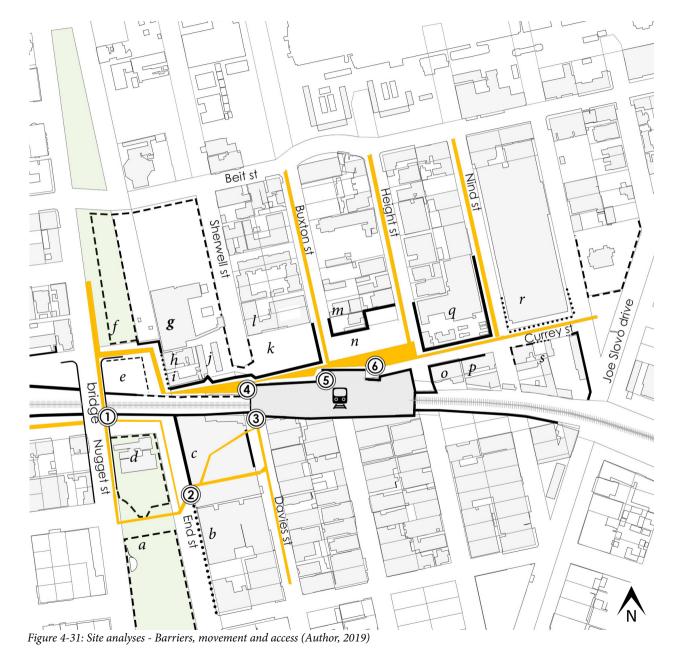
- a End Street Park (South)
- b Mixed use/ Retail and Housing
- c Mall and AFCHO Social housing
- d Old Creche (AFCHO offices)
- e Parking lot
- *End street park (North)*
- IH Harris Primary school
- Mixed use / Retail and Housing
- Shed building / Retail
- Parking lot
- School play area
- Student housing
- m Industrial / mechanic repair
- n Station plaza
- Church
- Housing
- Offices
- Univ of JHB extention

- Bridge access
- Mall Access
- Station Access on Davies st
- Station Access on Currey st
- Station Access
- Station Access
 - Pedestrain movement
- Dead edges
- Fences
- • Active edges

The movement of pedestrians is empeded by various boundaries that obstruct movement within the area, particulary to and from the train station. The most prominent barrier is that of the fenced off railway line that is level with the ground. Other barriers are the fenced off parks and the existing inwards facing mall that does not respond or contribute to the existing park. Dead edges of boundary walls along the route towards the station creates spaces that do not engage with people. The low level access caused by the various barriers contradicts the role of the train station as an accesible public space.

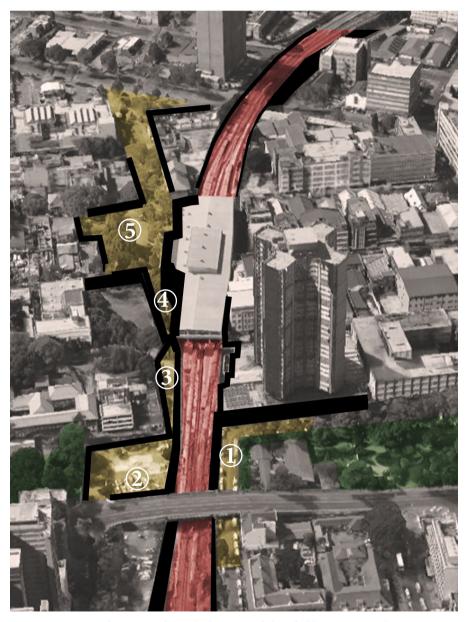
ZONE (1)	Isolated street
ZONE ②	The parking lo
ZONE ③	Alley way 1
ZONE ④	Alley way 2
ZONE (5)	Station Plaza

Figure 4-38: Site analyses - Aerial view looking west of identified lost spaces (Author, 2019)

The following zones (Figure 4-33) are highlighted as being lost spaces and will be analysed individually to understand its legibility and other conditions that give expression to it being classified as being lost.

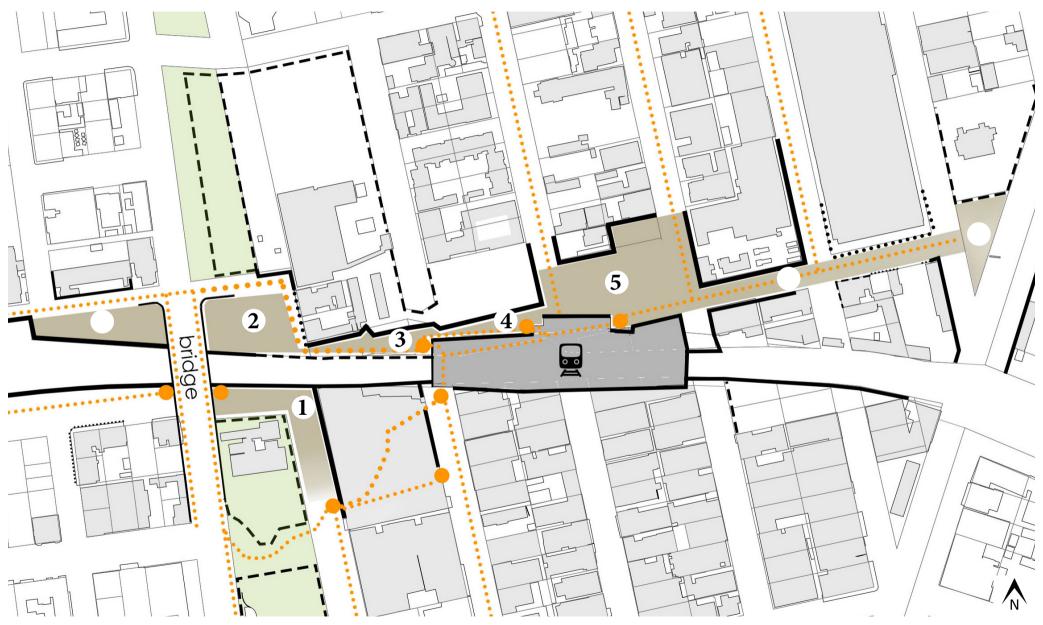
Figure 4-39: Site analyses - Plan view of identified lost spaces, movment and access points (Author, 2019)

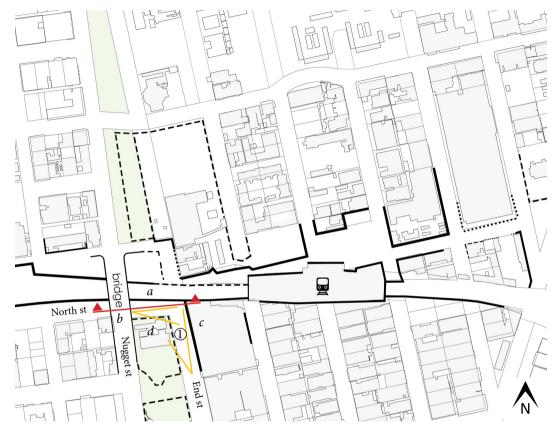
Figure 4-40: Site analyses - Zone 1 key plan (Author, 2019)

The dead and inactive edges of the railway line and the bridge overpass create a physical barrier in the context. The mall currently functions inward and does not respond towards street and the park, detaract from potential movement patterns on site. The placement of the creche in the park creates obscurity in what lies behind it. Lastly, the bridge over the railway line serves as the only point of crossing over the railway line. The elevation between the park and the bridge makes the park a sunken space, deviod of pedestrian movement.

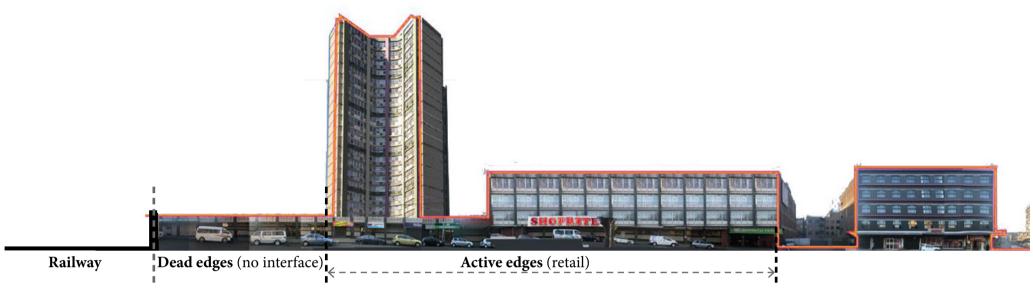
Figure 4-42: Site analyses - Section through end street, illustrating active and inactive building edges and facades (Author, 2019)

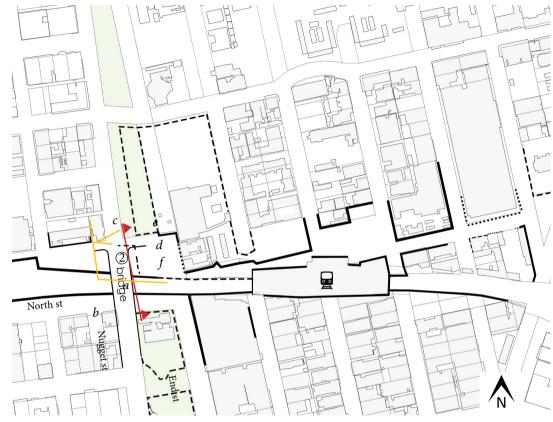
Figure 4-46: Site analyses - Photo analyses of Zone 2 from entrance ramp to Currey street and End street park on the left (Author, 2019)

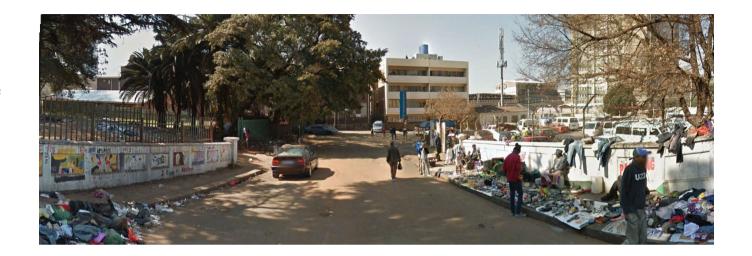
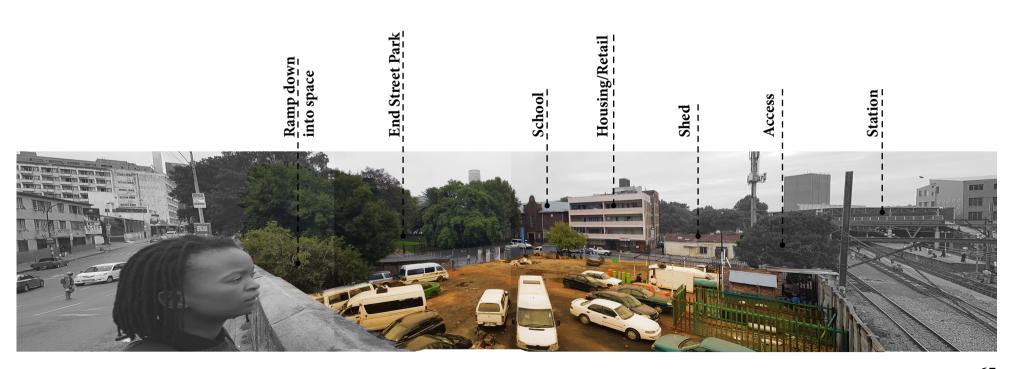
Figure 4-50: Site analyses - Photo analyses of Zone 3 from train station looking down (Author, 2019)

Figure 4-51: Site analyses - Photo analyses of Zone 3 showing dead edges and informal traders along the route (Author, 2019)

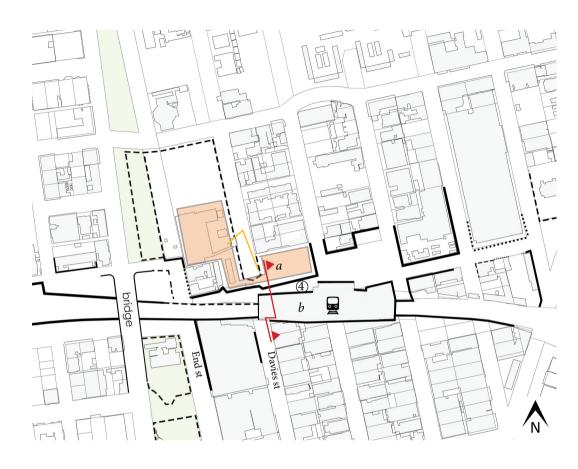
Figure 4-52: Site analyses - Key plan of Zone 4 (Author, 2019)
Figure 4-53: Site analyses - Section through Zone 4 (Author, 2019)

This space is very compressed and defined by the train station and a solid boundary wall enclosing an extended play area for the school children. This action by the school has also closed off the connection towards the north, further weakening the permeability within the urban blocks. Pedestrian movement has become secondary as they move through a narrow route, that is unlegible and unresponsive within its context

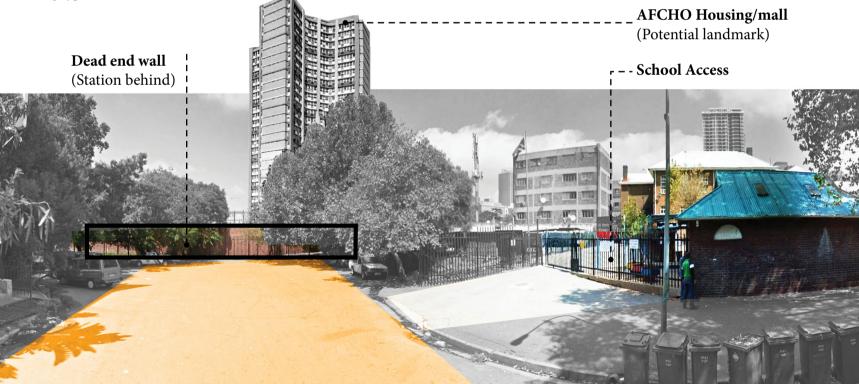
Figure 4-55: Site analyses - Photo analyses illustrating existing school entrance on Davies street and dead end that prohibits access to the station beyond (Author, 2019)

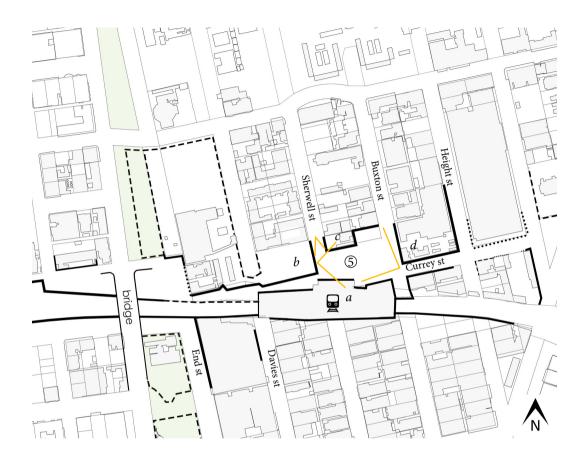
Figure 4-57: Site analyses - Photo analyses, corner of Currey street and Buxton street showing empty plaza, defined by low density buildings with dead edges (Author, 2019)

Small markets stalls have been incoperated around the station to allow space for informal traders. These spaces however seem empty and underutilised during the site visit.

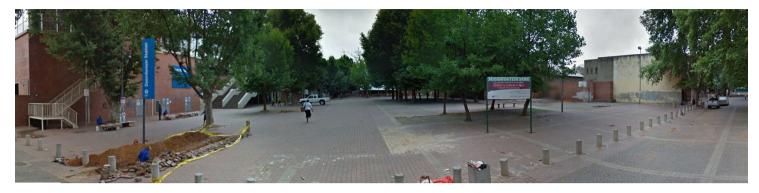
Figure 4-58: Site analyses - Photo analyses, view from Sherwell st. Informal market structures with little activity (Author, 2019)

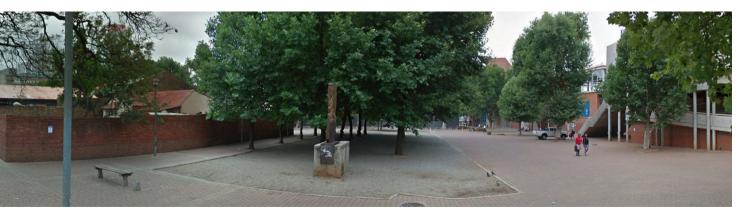
Figure 4-59: Site analyses - Photo analyses, looking west from station plaza, dead edges and low scale buildings define the plaza (Author, 2019)

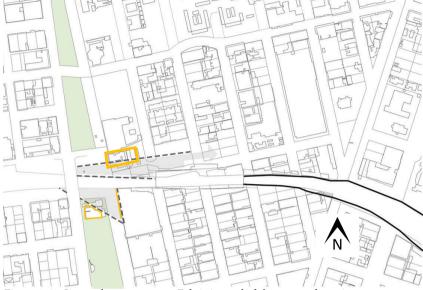
Figure 4-61: Site analyses outcomes - Fabric in need of change or adaptation (Author, 2019)
