SINKHOLE FORMATION DUE TO SUBSURFACE EROSION ABOVE UNDERMINED GROUND

A dissertation submitted in partial fulfilment of the requirements for the degree of

MASTER OF ENGINEERING (GEOTECHNICAL ENGINEERING)

December 2019

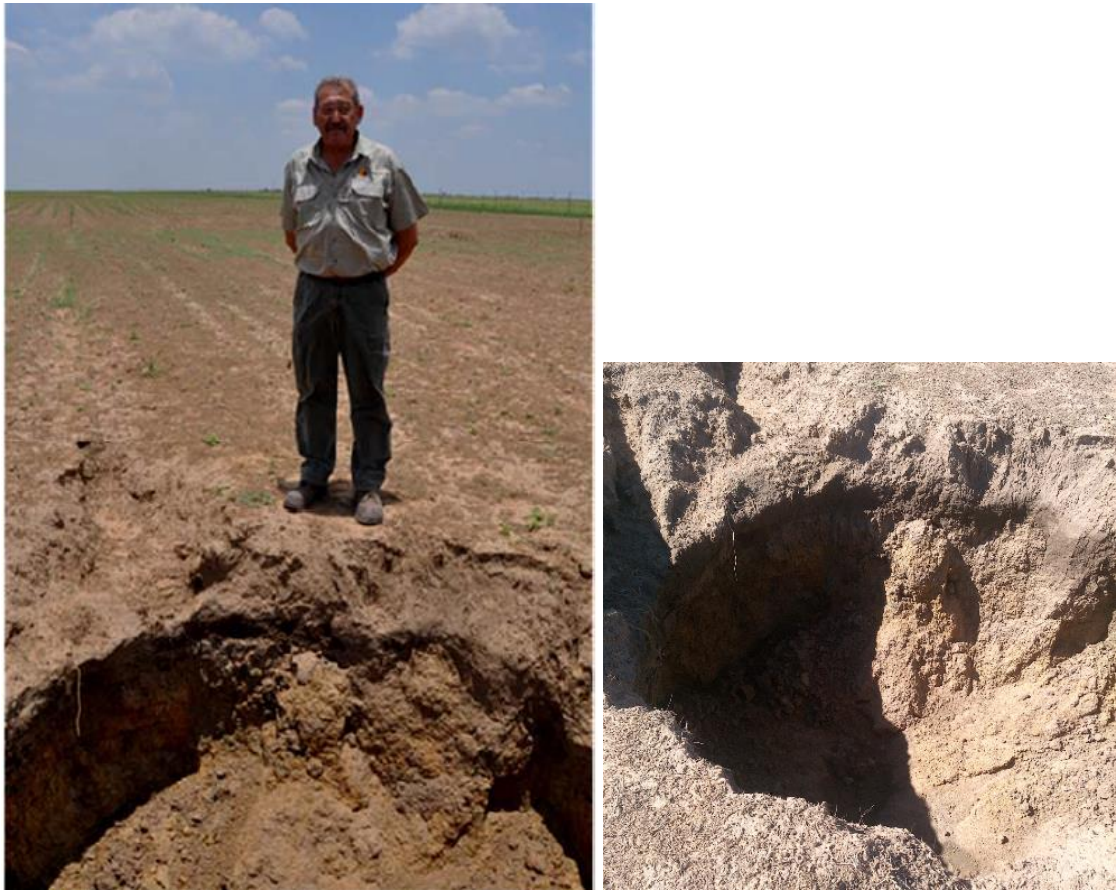
Figure 1-1: The largest sinkhole found in November 2016 (Van der Merwe, 2017a)

In November 2016, 38 sinkholes were noticed in a corn field on the farm Donkerhoek, located to the south-west of Sasolburg (Van der Merwe, 2017a). The largest sinkhole was 1,6m deep with a diameter of 1,5m as shown in Figure 1-1. At the time, the question was asked whether the sinkholes were the result of subsurface erosion due to undermining. Subsurface erosion is a process which occurs when material below natural ground level is transported to a deeper underlying cavity resulting in a shallow cavity below ground level. Once the cover of the cavity collapses, a sinkhole is formed. In this case, the deeper lying cavity could have been the result of undermining activity in the area.

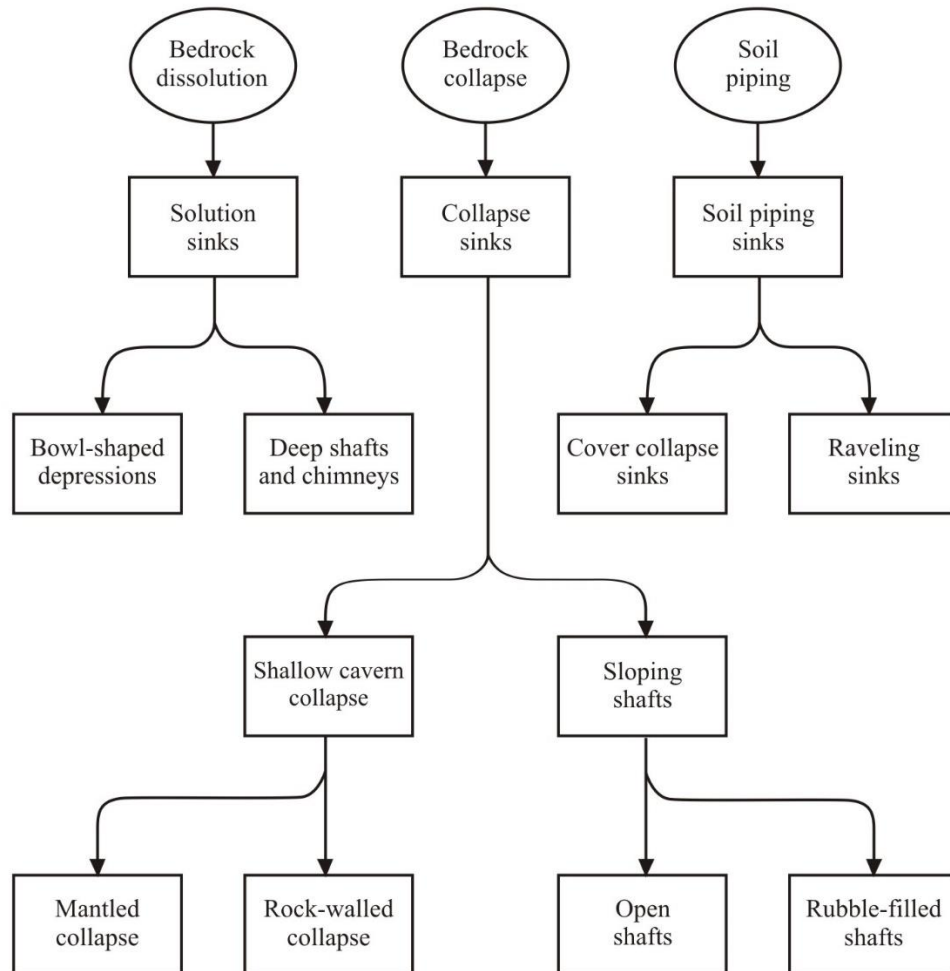
Figure 2-1: Classification scheme for sinkholes based on the predominant process of their formation (White and White, 1992).

caused by bedrock dissolution and bedrock collapse. Sinkholes from subsurface erosion fits into the third category and are referred to as “cover collapse sinks” or “ravelling sinks” caused by soil piping.

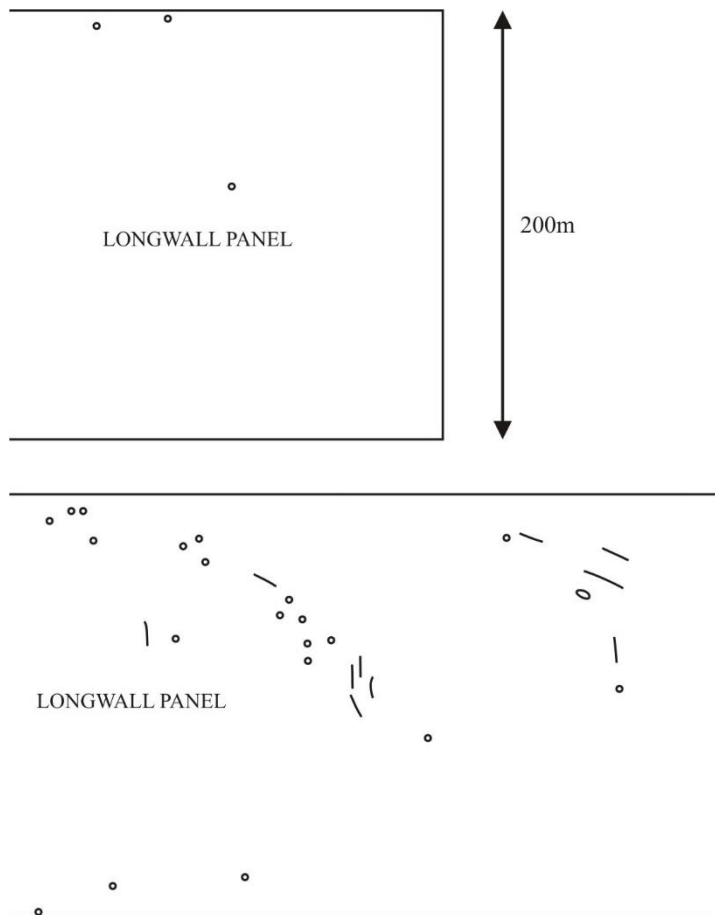
Figure 2-4: Positions of sinkhole features relative to longwall panels at Sigma Colliery (Adapted from Van der Merwe, 1990).

When the position of the first sinkholes was compared to the geometry of the underground mine workings, it was noted that the sinkholes appeared near the edges of a longwall panel, in the zone where tensile cracks were formed by subsidence due to the undermining. No mining had taken place in that area since 1978, meaning almost 8 years had passed before the sinkholes appeared (Van der Merwe, 1990).

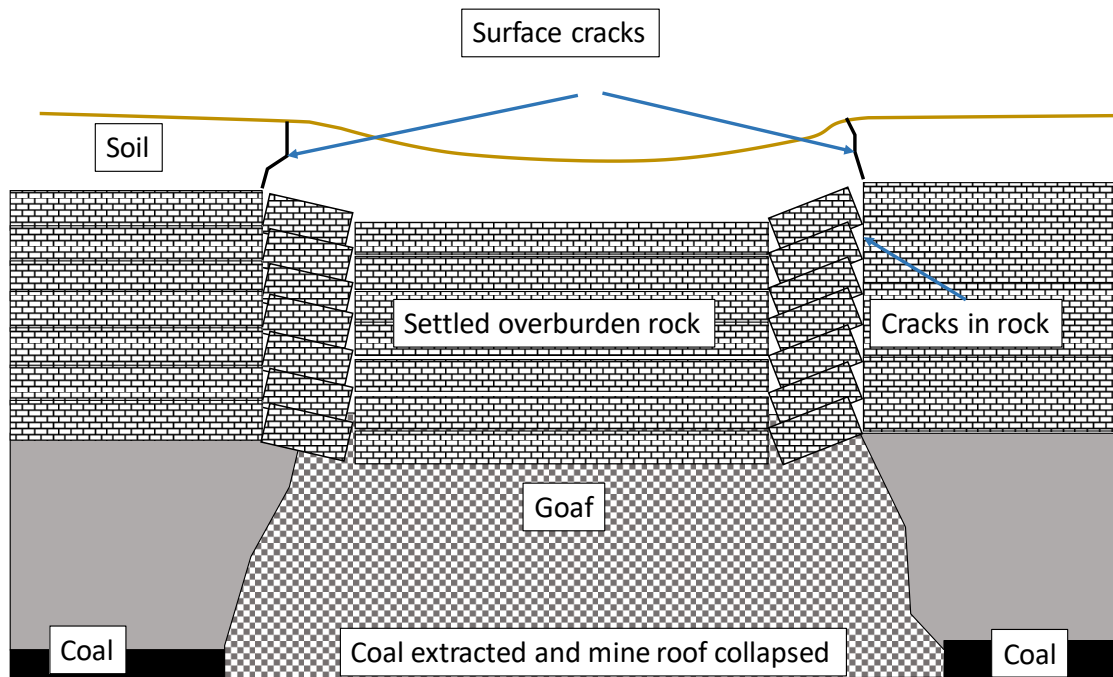
Figure 2-6: Cross section through longwall panel showing subsidence and surface cracks as adapted from Van der Merwe, 2017a.

The extraction of coal through longwalling or pillar extraction invariably leads to subsidence and crack formation, because the roof of the mined-out cavity is left unsupported (Van der Merwe and Madden, 2010). The formation process is illustrated in Figure 2-6, showing a typical cross section through a longwall panel with the width of the panel across the page and the length of the panel into the page. Typically, the longwall panels at Sigma Colliery are 200m wide and 1000m long; the typical mining height (height of the cavity once the coal has been removed) is 4m and the mining depth 120m (Scheppel, 2017b).

Although the maximum subsidence typically occurs in the centre of the panel as shown in Figure 2-6, the largest surface cracks appear along the perimeter of the panels where the tensile strain is the greatest (Van der Merwe and Madden, 2010). Examples of surface cracks are shown in Figure 2-7. Note the matchbox included in both photos for scaling purposes.

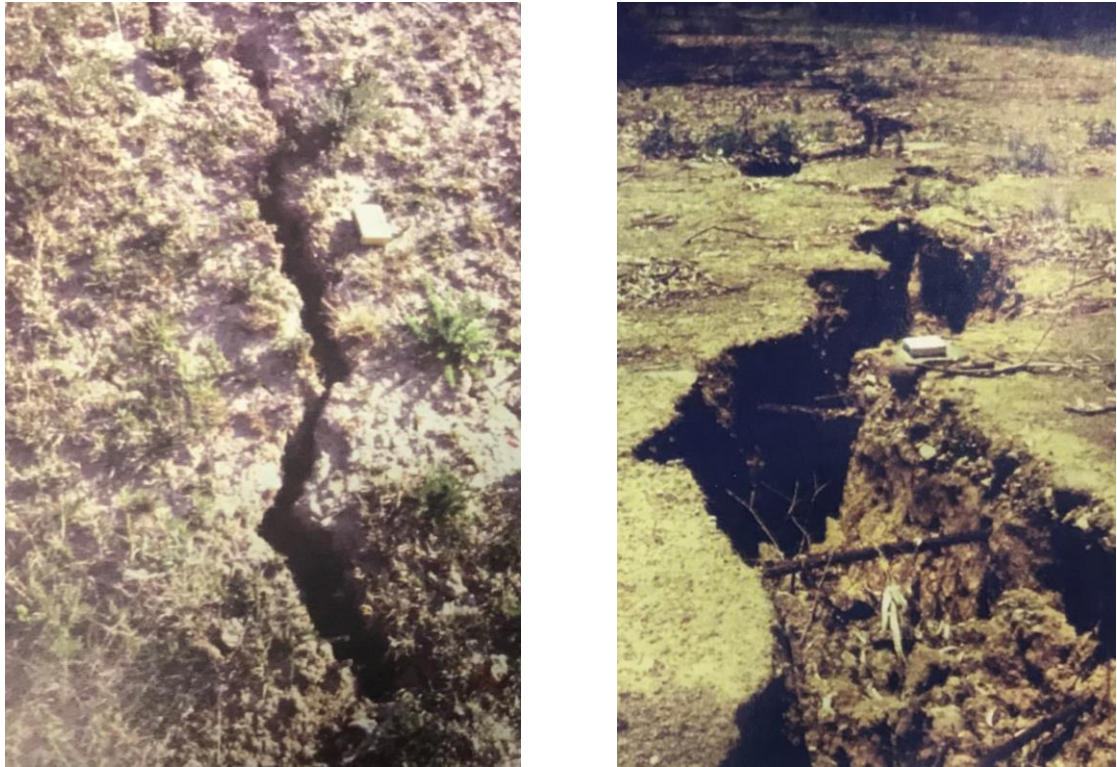
Figure 2-7: Surface cracks as a result of tensile strain shortly after mining (Van der Merwe and Madden, 2010).

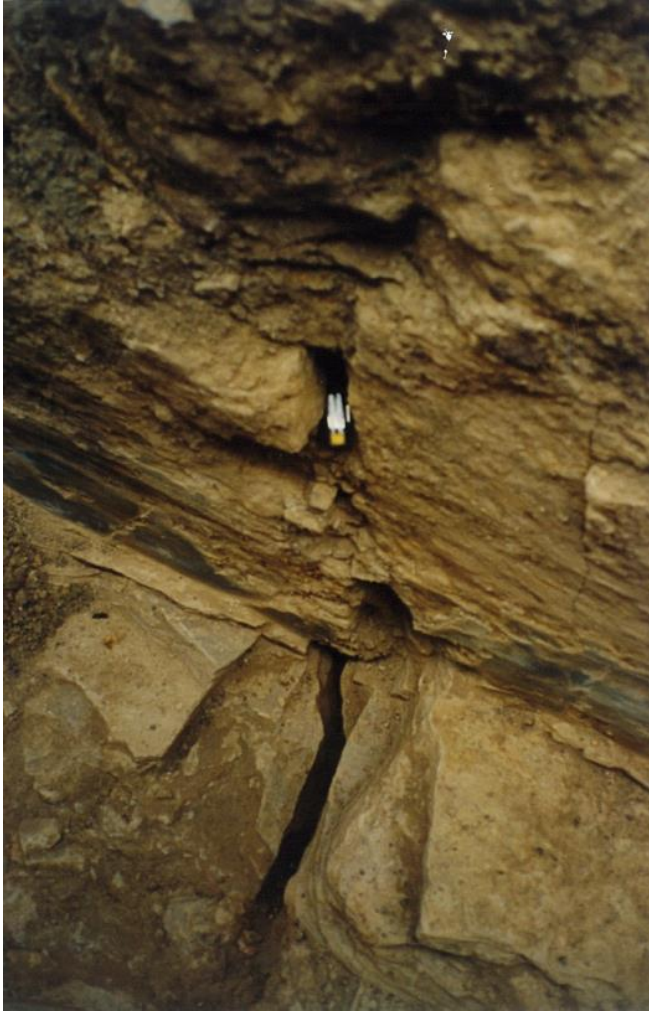
Figure 2-8: Displaced open crack in rock with no crack in soil above (Wagener *et al.*, 1990).

As far as the depth of the cracks into the underlying rock is concerned, Wagener *et al.* (1990) carried out an extensive investigation in the Secunda area and could not establish how far the surface cracks extended into the underlying rock. They mentioned that the possibility of the cracks extending all the way into the goaf could not be excluded. Van der Merwe (2018) pointed out that it is unlikely that the cracks will be continuous up to the goaf material, since horizontal displacement along the bedding planes occur, as is shown in Figure 2-8. Based on back calculations of the crack depth from observed sinkhole cavities, Van der Merwe (2018) recommended a continuous crack depth of 25m as reasonable for calculation purposes.

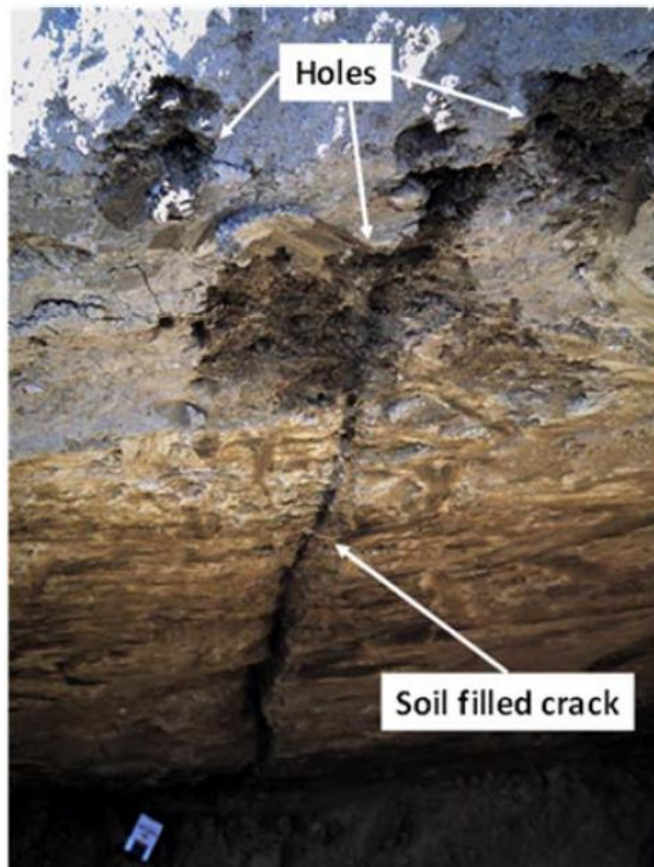
Figure 2-9: Cavities below ground surface with soil filled crack in rock below (Van der Merwe, 2018).

But where do the soil particles get eroded to? The answer to the *reservoir location* question has developed over time. Van der Merwe (1990) viewed the void filled goaf as the reservoir into which the soil particles are eroded and the subsidence cracks as the connection between the goaf and the soil being eroded. This point of view was based on observations made at Sigma Colliery at the time. When Wagener *et al.* (1990) excavated trenches perpendicular to the subsidence cracks in the Secunda area in 1990, the observation was made that the cracks themselves could also be the reservoir as shown in Figure 2-9. Van der Merwe (2018) referred to the trenches excavated near Secunda and stated that this is where the hypothesized process was visually confirmed. To date, this phenomenon (namely that the cracks act as the reservoir) has not been visually confirmed at Sigma Colliery (Van der Merwe 2017d).

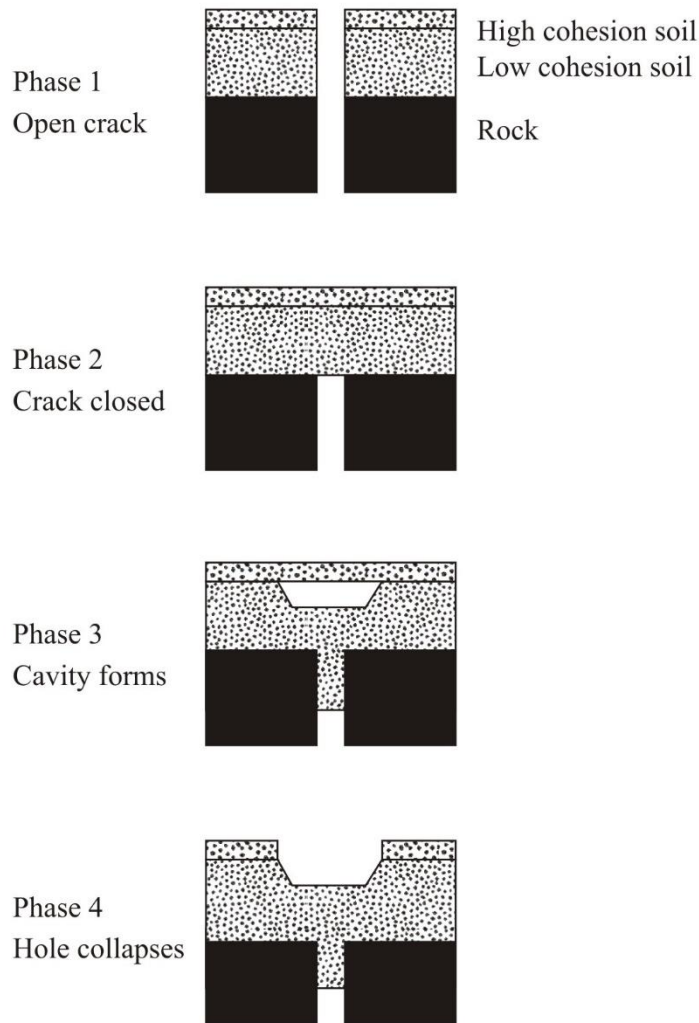
Figure 2-10: SSE schematic as found in Van der Merwe (2017a).

- Firstly, in Figure 2-10, material being eroded into the crack chokes in the crack, resulting in the entire crack not being filled up. In Figure 2-5, the material fills the crack from the bottom upwards.
- Secondly, in Figure 2-10, the cavity does not form directly above the rock, but rather at a shallower depth close to surface. By implication, no more material is eroded into the crack before the lid at the top collapses and at the time of collapse, the crack in the rock is not visible from surface. In Figure 2-5, the cavity forms directly above the rock and material is eroded into the crack in the rock until the lid collapses. Once collapsed, an open cavity is found all the way from surface to the crack in the rock.

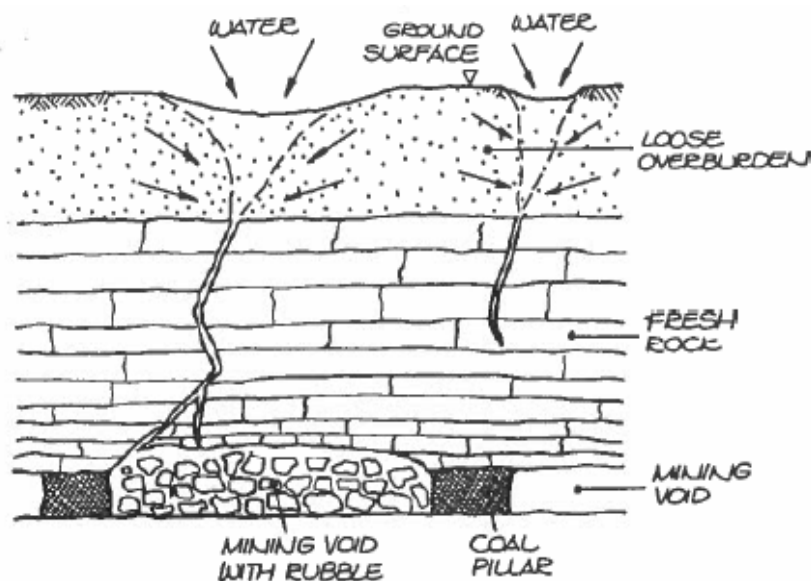
Figure 2-11: Development of local depression in homogenous profile (Wagener *et al.*, 1990).

As mentioned in the list of requirements at the beginning of this section, a critical requirement in the process is *stratification* in the soil profile, i.e. the upper portion of the soil profile must be less erodible than the underlying portion. Van der Merwe (1990 and 2017a) pointed out that if the soil profile is not stratified, i.e. if the soil profile is homogeneous, a sinkhole will not form and the soil will merely slump and be washed into the crack resulting in immediate subsidence on surface. The stronger the upper layer is, the wider the cavity underneath can grow before collapse (Van der Merwe and Madden, 2010). Wagener *et al.* (1990) agreed with the statements above and illustrated it as shown in Figure 2-11 and Figure 2-12.

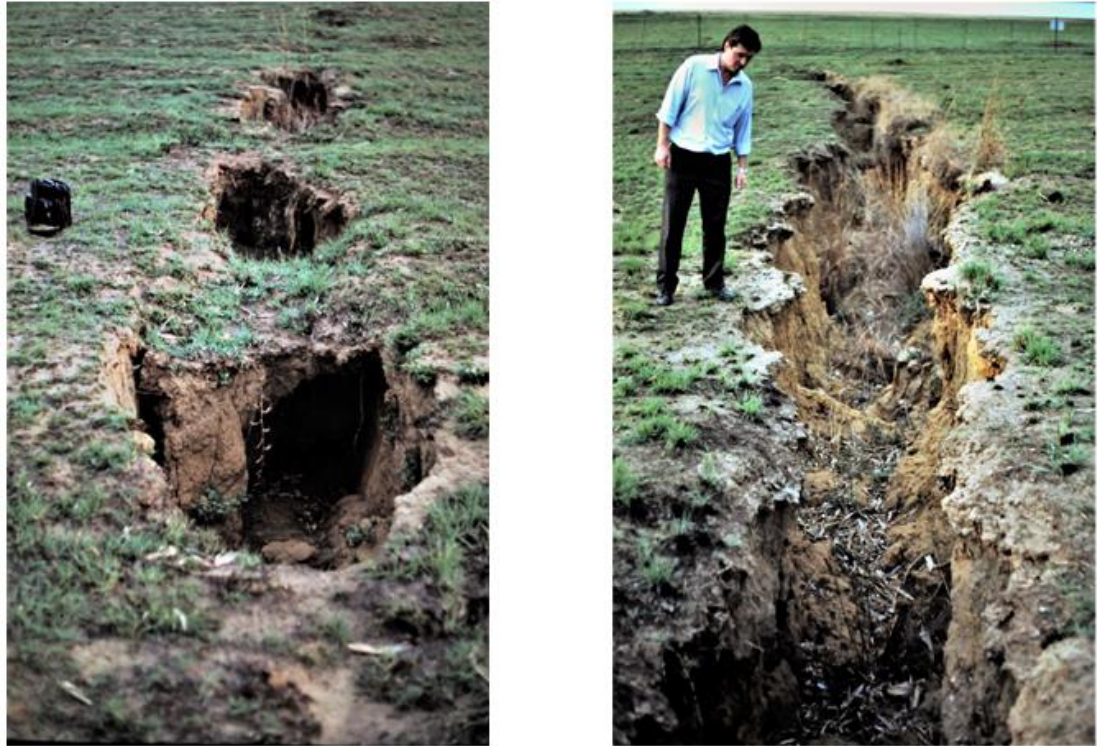
Figure 2-13: Progressive failure of the cover to the subterranean cavity (Van der Merwe, 2018).

In Figure 2-13 the final phase of the SSE and sinkhole formation process is shown, namely the collapse of the soil cover over the subterranean cavity resulting in sinkholes on surface. The photos were taken a few months apart and show the initial circular collapses on the left and the progressive failure on the right (Van der Merwe, 2018).

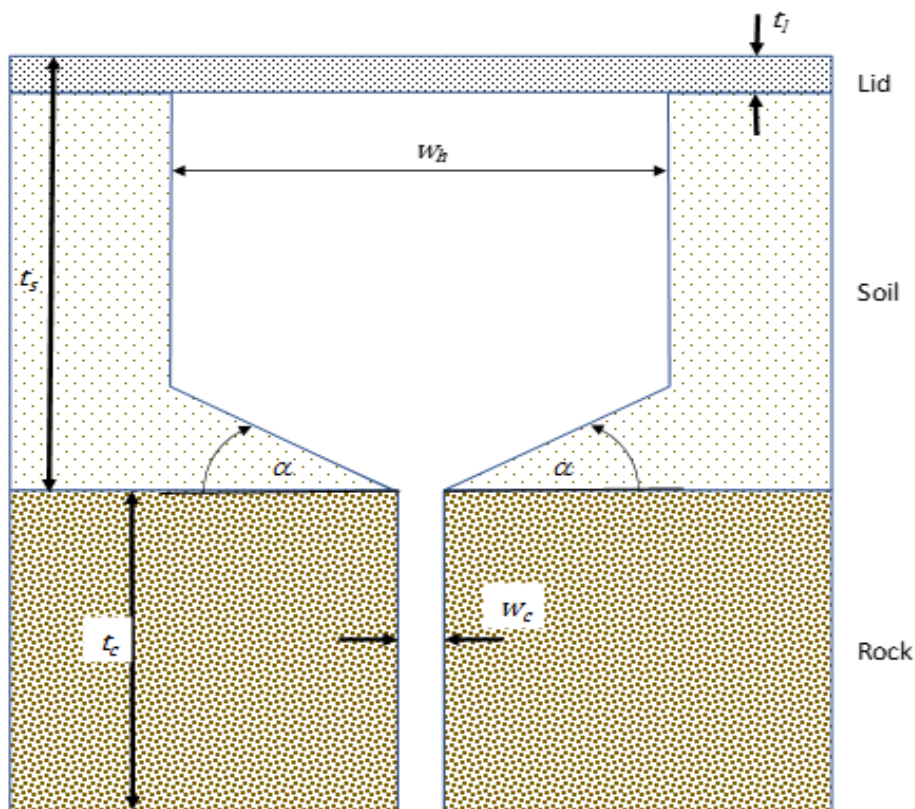
Figure 2-14: Cross section through SSE sinkhole (Van der Merwe, 2018).

A two-step process is followed as described below with reference to Figure 2-14.

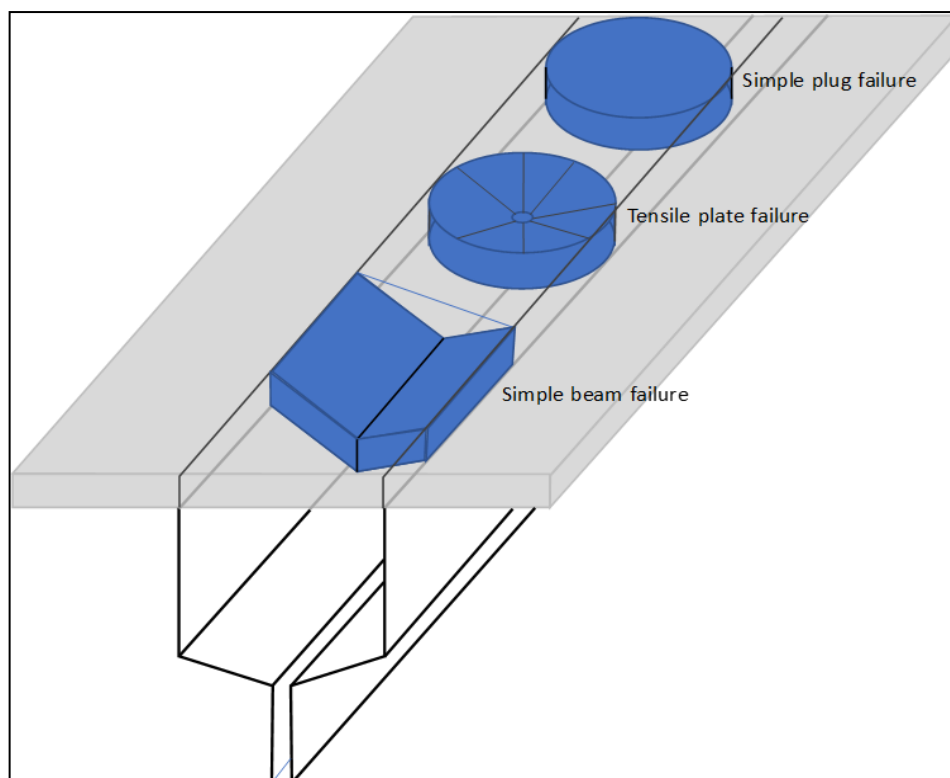
Figure 2-15: Sinkhole cover failure modes (Van der Merwe, 2018).

The second step is the evaluation of the capacity of the cover to span the calculated width of the cavity. Three failure modes were described by Van der Merwe (2018). These are depicted as circular tensile plate failure, simple beam failure and shear plug failure in Figure 2-15. Their respective equations are set out below.

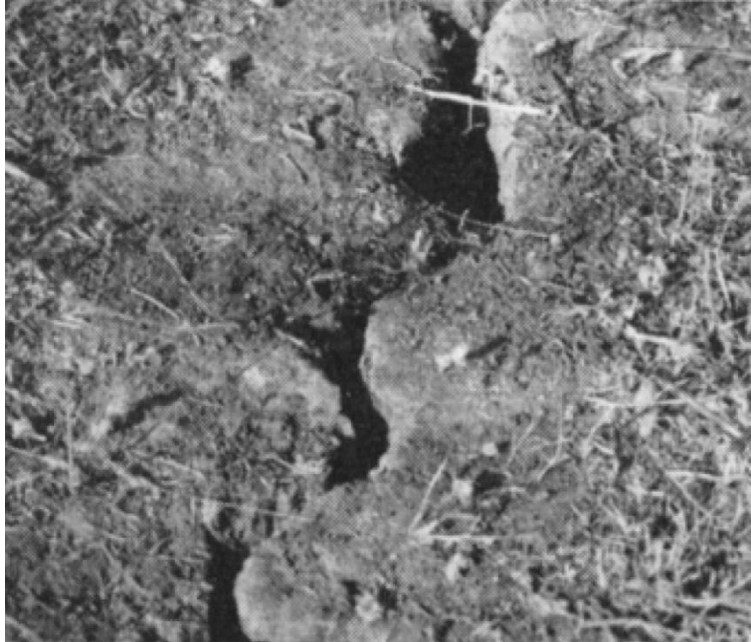
Figure 2-17: Shrinkage crack in cultivated field (Marr, 1955).

If the water cannot penetrate into the soil layer beyond the surface, no piping will take place. Apart from the animal burrowing and ploughing referred to above, *desiccation cracking* (shrinkage cracking) within the upper soil layers is one of the largest factors influencing soil piping as reported by Jones (1981), Dunne (1990), Marr (1955), Beckedahl (1998), Higgins and Schoner (1997) and García-Ruiz *et al.* (1997). An image of a shrinkage crack in a cultivated field is shown in Figure 2-17.

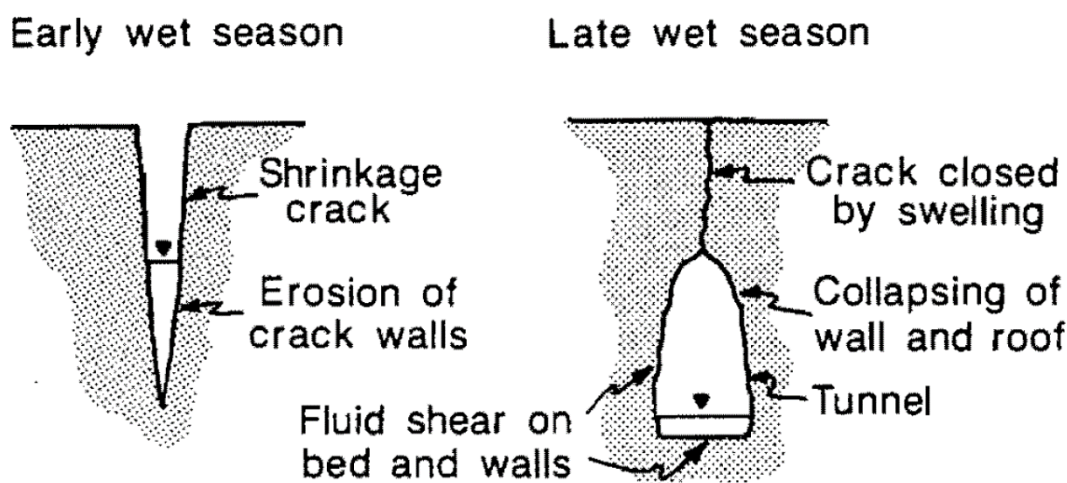
Figure 2-18: Enlargement of shrinkage crack by tunnel erosion (Dunne, 1990).

Dunne (1990) provided a detailed description of the seasonal enlargement of a shrinkage crack through *tunnel erosion* as depicted in Figure 2-18. With the first rains after a dry season, the desiccation cracks are open and surface water flowing into the crack will have sufficient energy to erode particles from the bottom of the crack. Towards the end of the rainy season, as the moisture content increase causing swelling and closure of the crack, a tunnel is formed which is enlarged by further erosion. As this process is repeated over consecutive wet and dry seasons, a network of tunnels can form, bridged by an arch of cohesive soil.

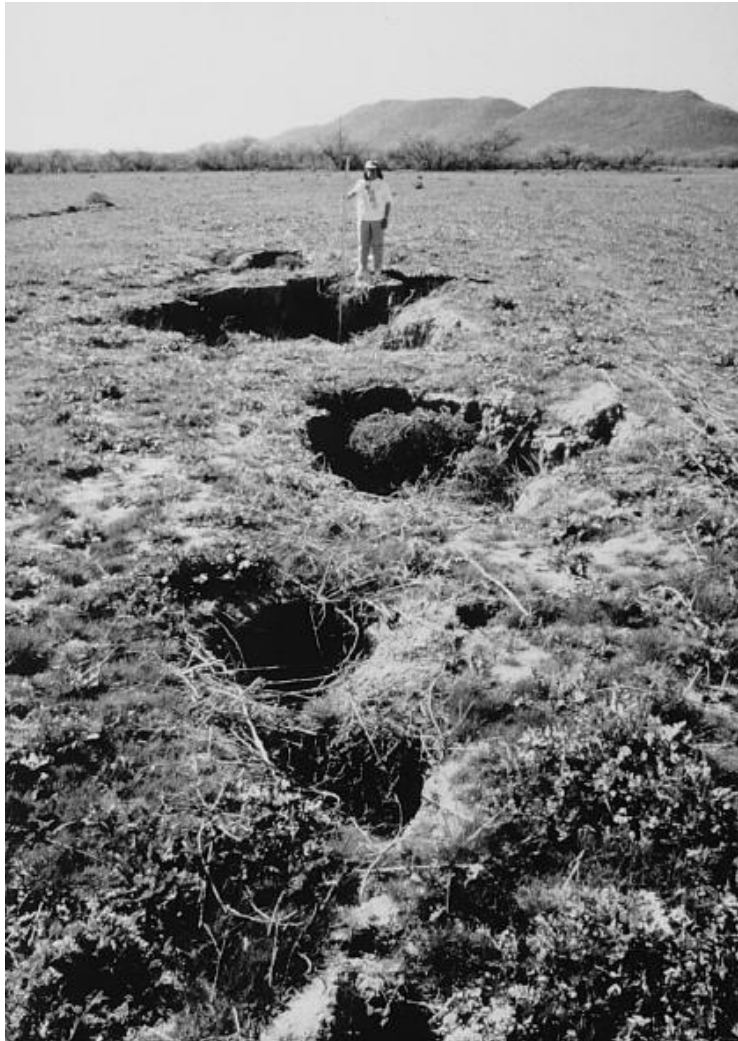
Figure 2-19: Sinkholes due to SSE in Arizona, USA (Hoffmann *et al.*, 1998).

Sinkholes often appear in *clusters* as reported by Zhou *et al.* (2014) and Hoffmann *et al.* (1998) as shown in Figure 2-19, which could be influenced by the connection of underground cracks and tunnels discussed in section 2.4.2.

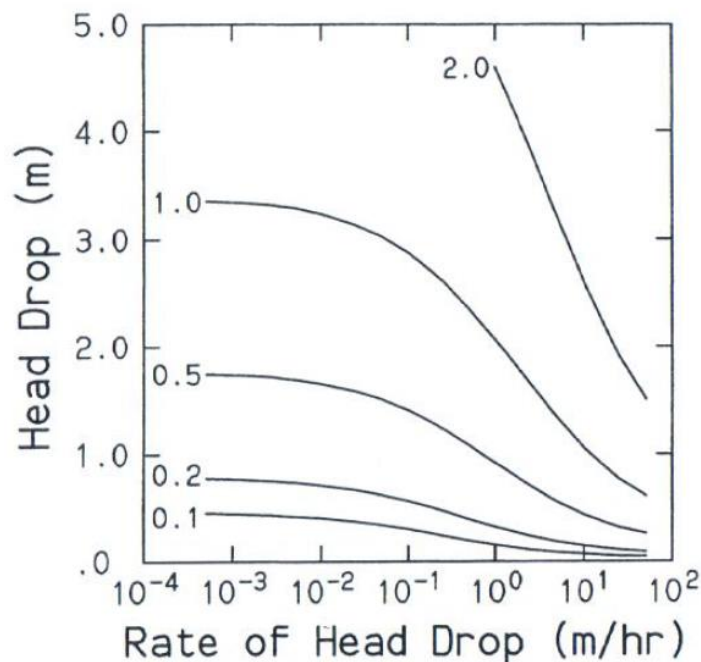
Figure 2-21: Head drop for hydraulic fracture vs rate of head drop (Tharp, 2003).

The effect of the rapid drawdown of the water table was further discussed by Tharp (2003) as shown in Figure 2-21, which shows the head drop required for hydraulic fracture versus the rate of head drop. The different graphs reflect a parameter “d” which Tharp (2003) related to the soil cohesion. The modelled dome shaped cavity has an initial radius of 0,1m and the thickness of the soil overlying the cavity is 5m. From the graph it is clear that for an increased drawdown rate, a smaller head drop is required. Also, soils with more cohesion required either larger head drops or quicker head drops for hydraulic fracture and sloughing.

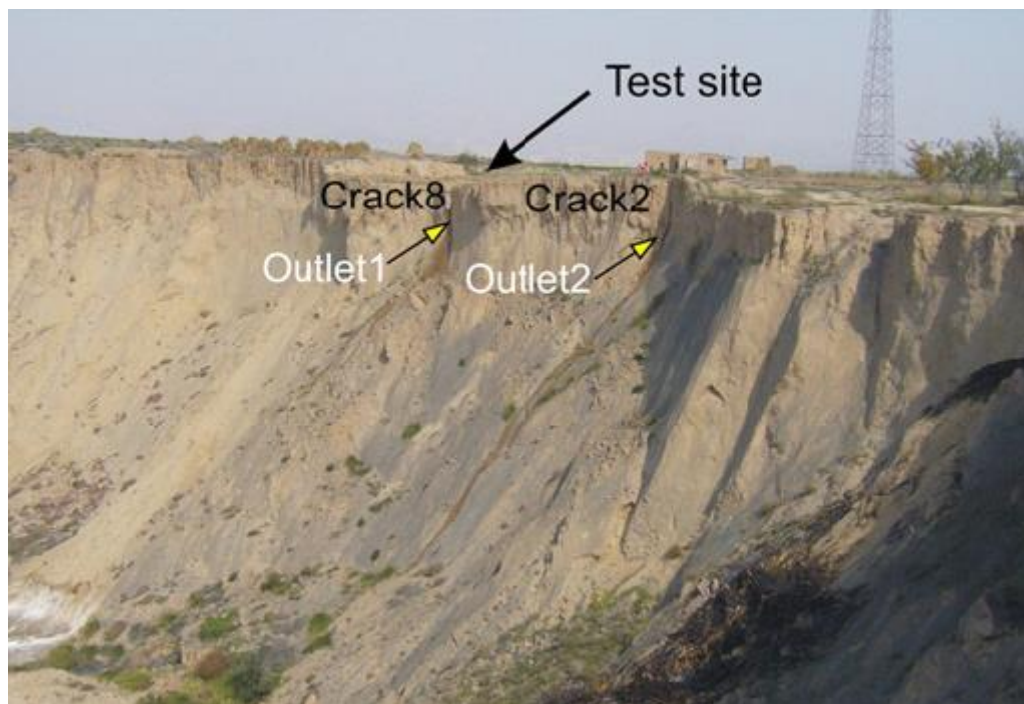
Figure 2-22: Location of some of the crack outlets in the hillside slope (Xu *et al.*, 2011)

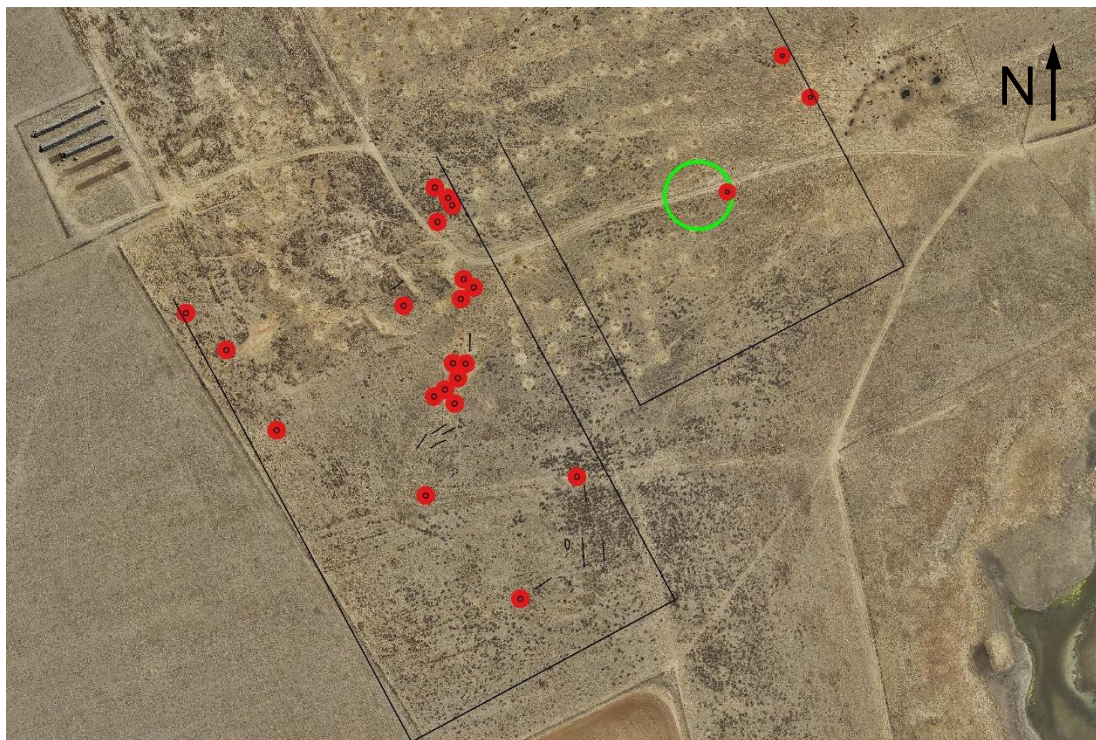
Figure 3-3: Location of sinkholes on De Pan farm.

On De Pan farm, the only sinkhole records found in literature are those shown in Figure 3-3. Included, and re-orientated, are the sinkholes shown in Figure 2-4 (recorded before 1990 and shown by the red dots) and sinkholes found in 2006 within the green circled zone as scaled from Van der Merwe (2017a). Refer to Figure 3-1 for the general location on De Pan farm.

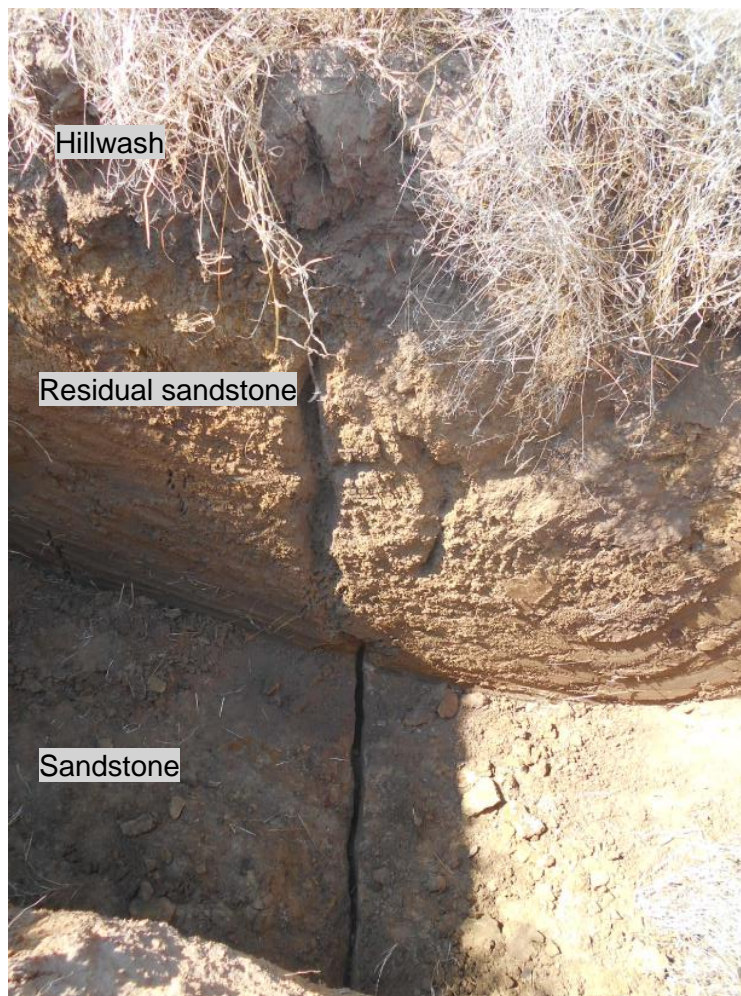
Figure 3-11: Looking downwards into TP01 showing the infilled cracks in the residual sandstone and rock below.

geological pick. The upper portion of the residual sandstone layer had a micro-shattered appearance with a dense network of fissures.

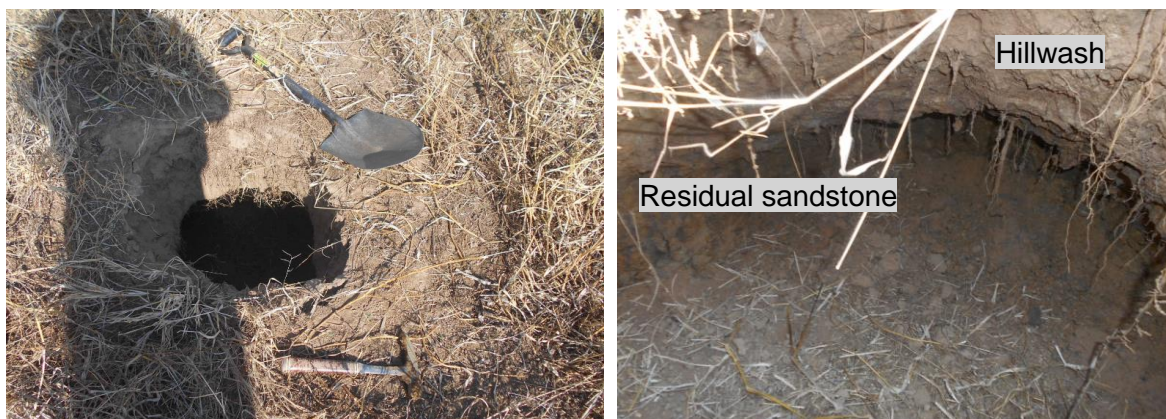
Figure 3-12: The partially collapsed sinkhole at TP02.

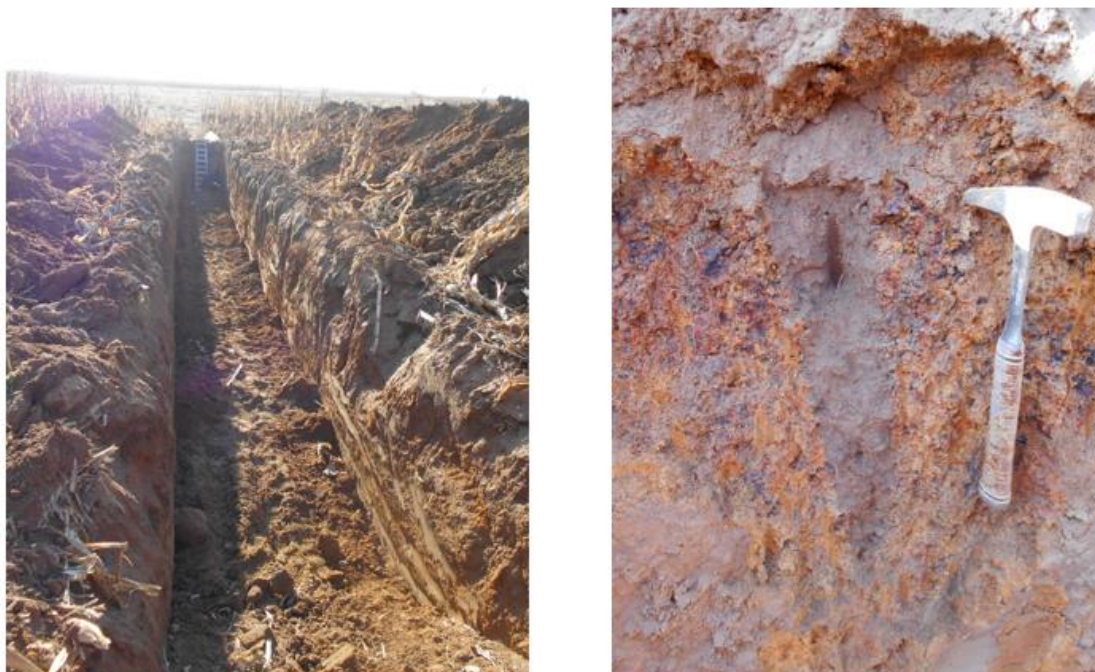
Figure 3-17: Trench in Area 2 at TP10 and hillwash infilled crack in the residual sandstone.

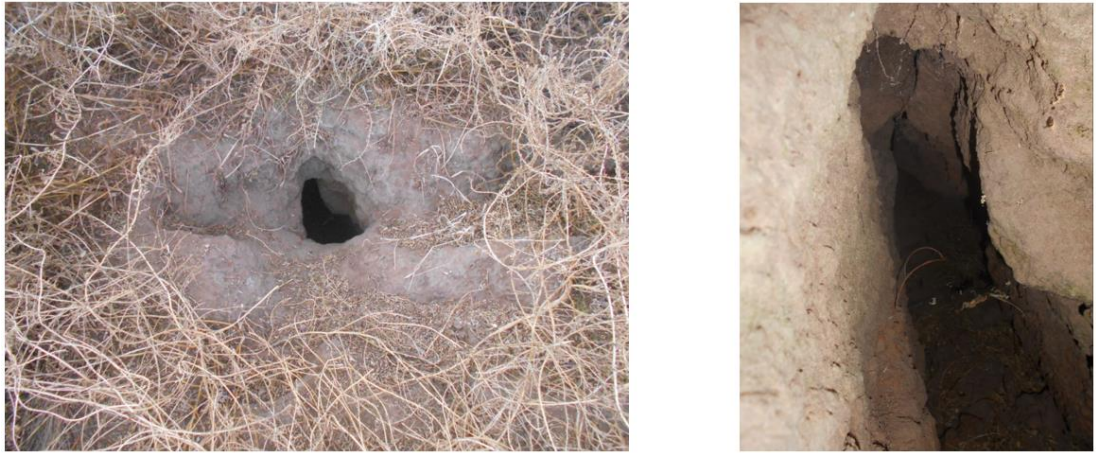
Figure 3-19: Typical sinkhole (0,3m diameter) in Area 3 and subterranean tunnel (0,45m deep).

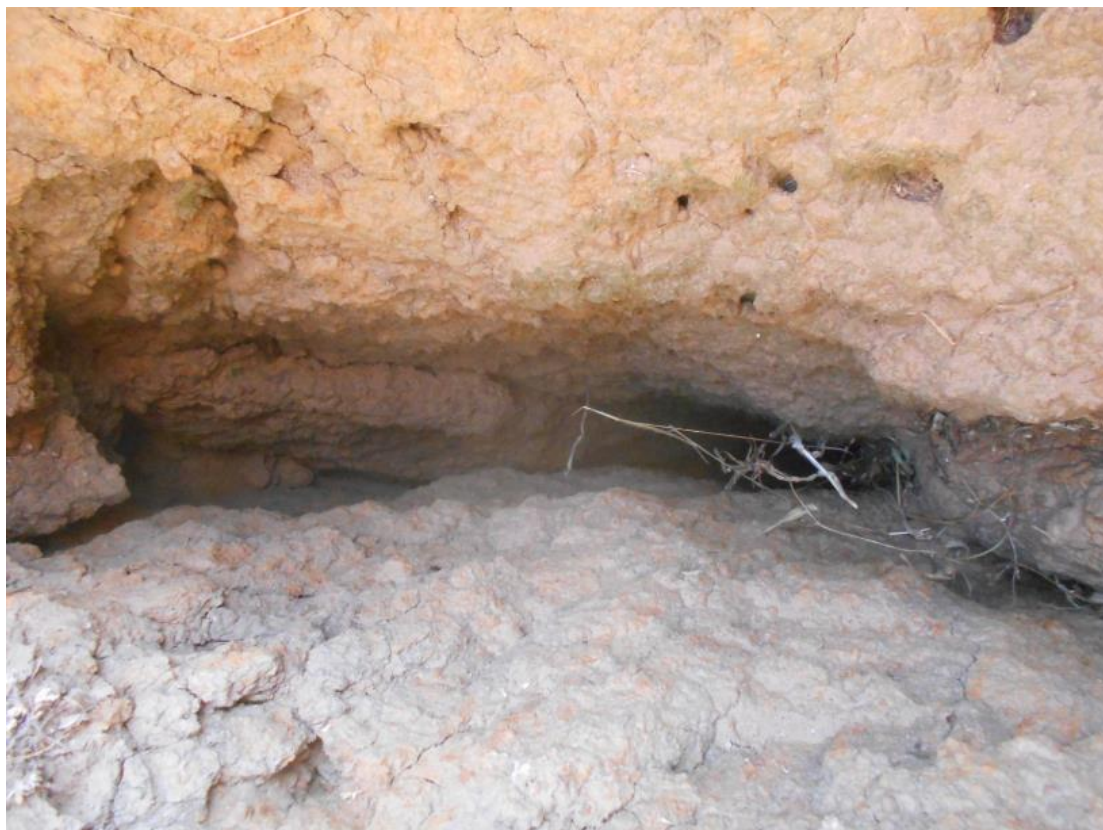
Figure 3-21: Looking down into the empty V-shape of the sinkhole at TP06.

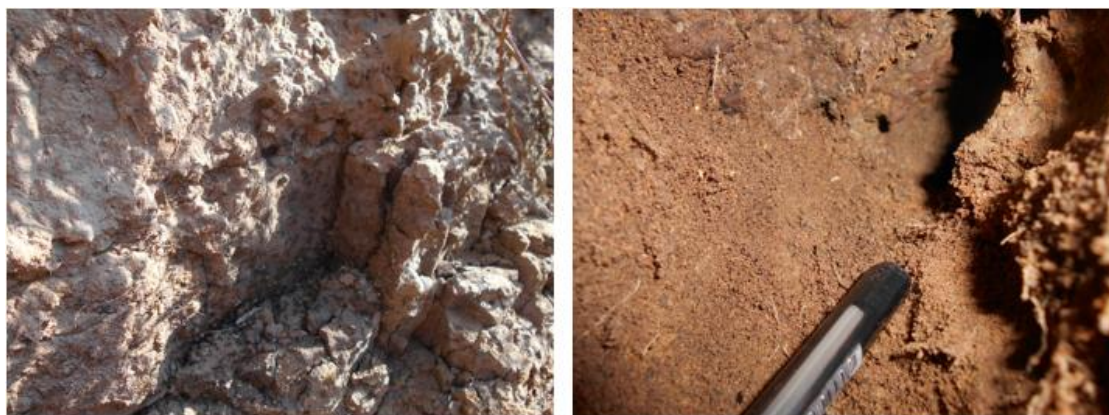
Figure 3-23: Termite activity in the side of sinkhole DSC109 (left) and TP10 (right).

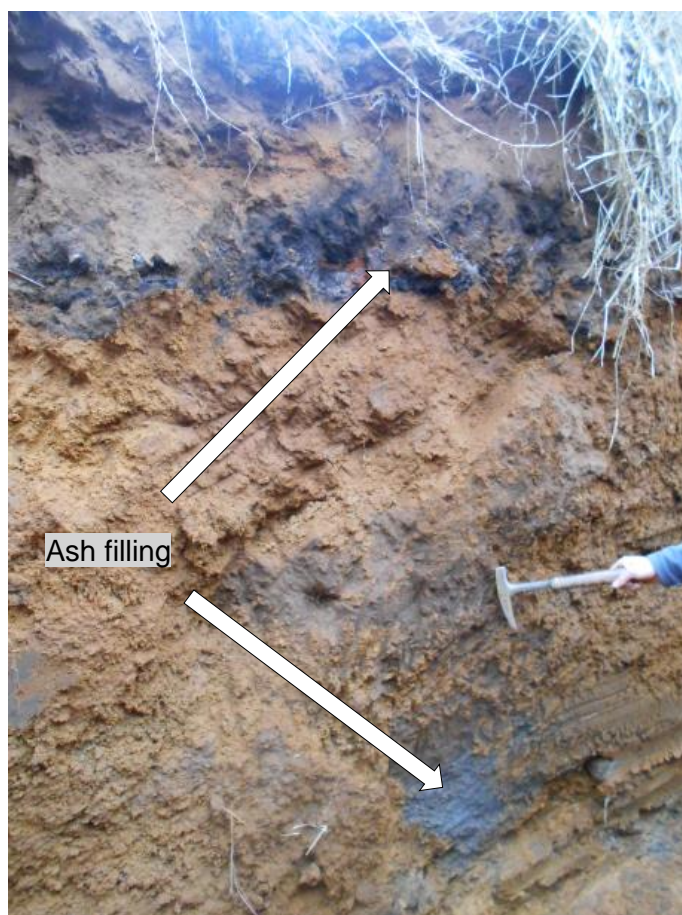
Figure 3-24: Historical sinkhole backfilled with ash (TP15).

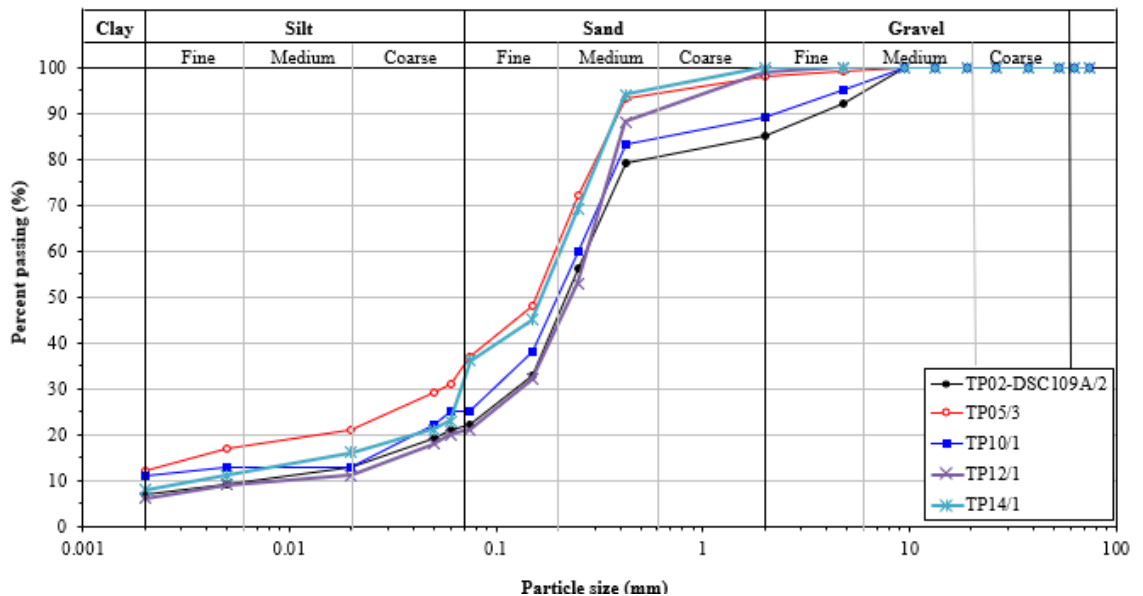
Figure 4-1: Grading curves for hillwash in Area 1, 2 and 3 and two test pits on De Pan.

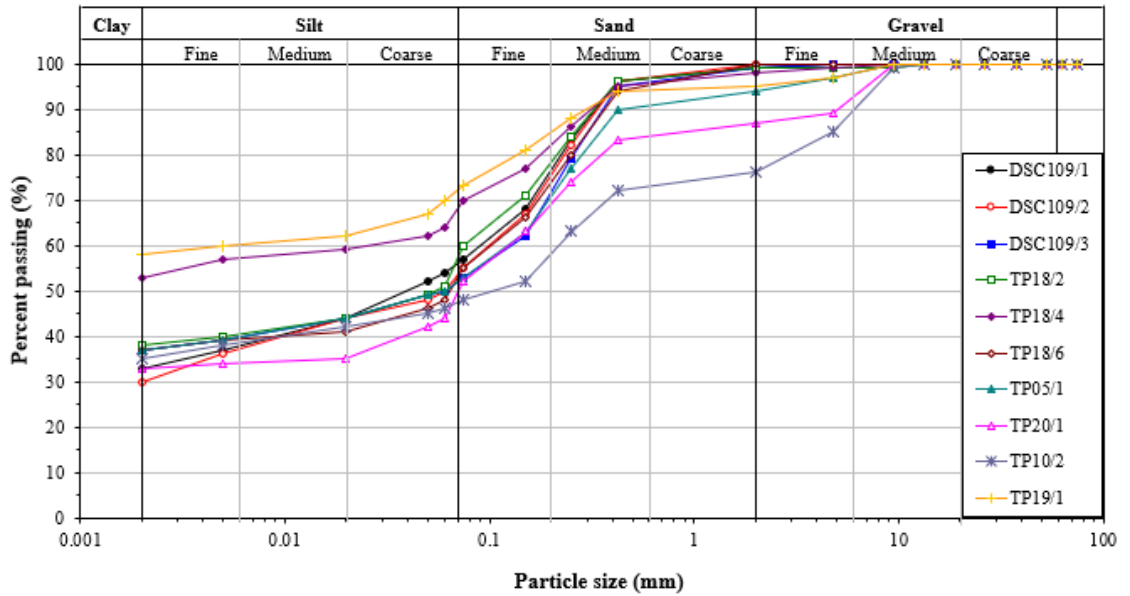
Figure 4-2: Grading curves for residual sandstone in Area 1, 2 and 3.

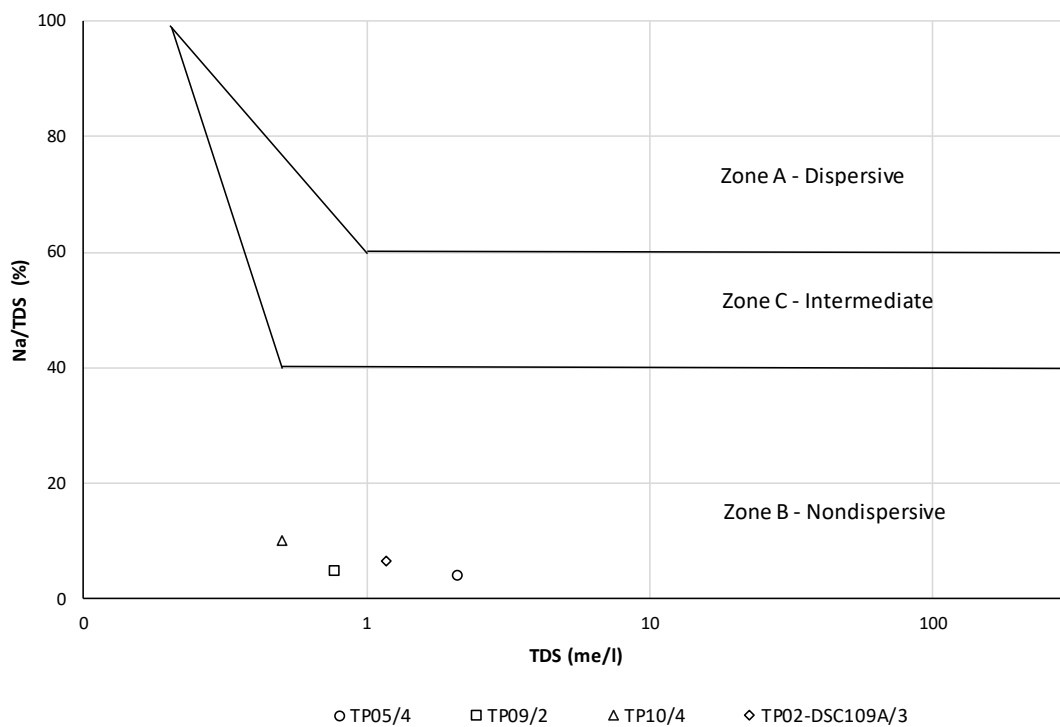
Figure 4-4: %Na versus TDS for hillwash samples.

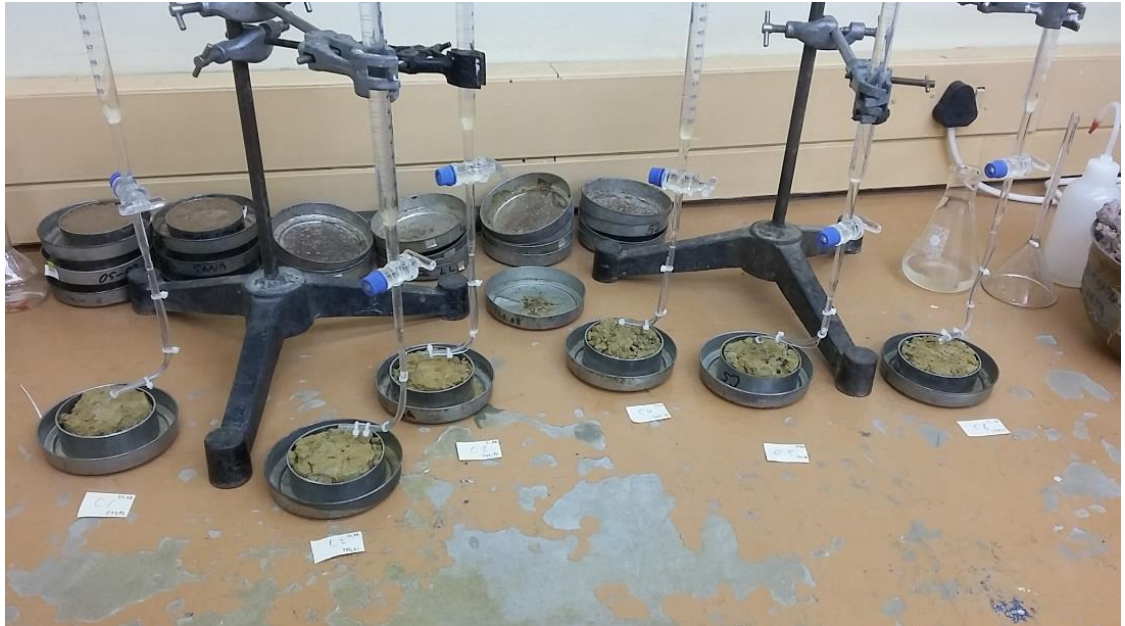
Figure 4-8: Wetting of specimens to target moisture content.
