SINKHOLE FORMATION DUE TO SUBSURFACE EROSION ABOVE UNDERMINED GROUND

A dissertation submitted in partial fulfilment of the requirements for the degree of

MASTER OF ENGINEERING (GEOTECHNICAL ENGINEERING)

December 2019

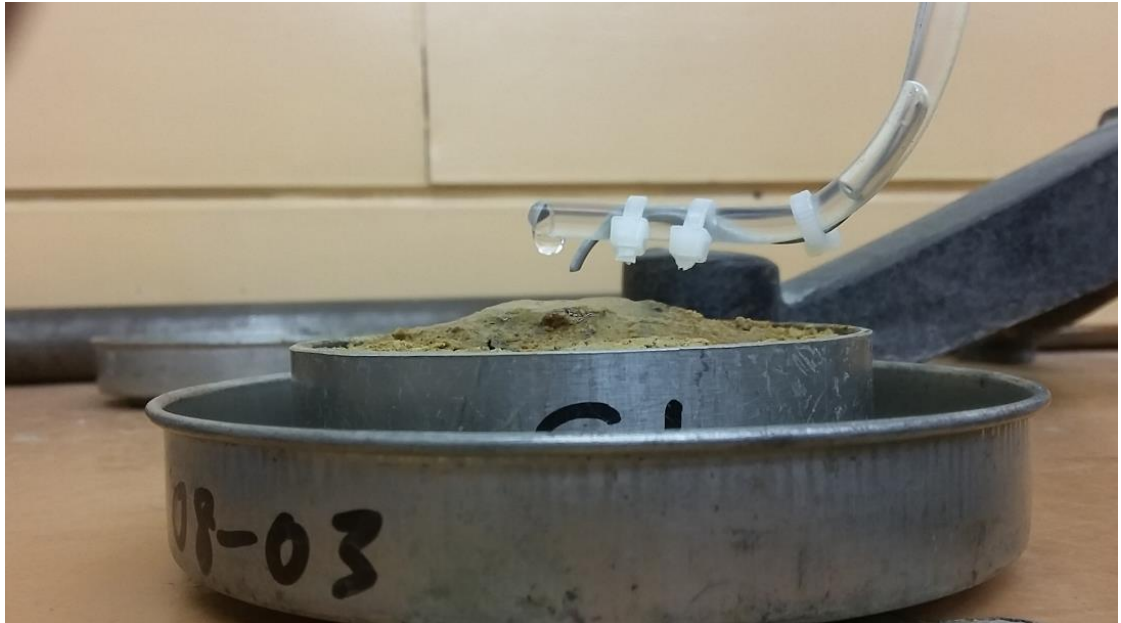
Figure 4-9: Swelling of the specimen upon wetting.

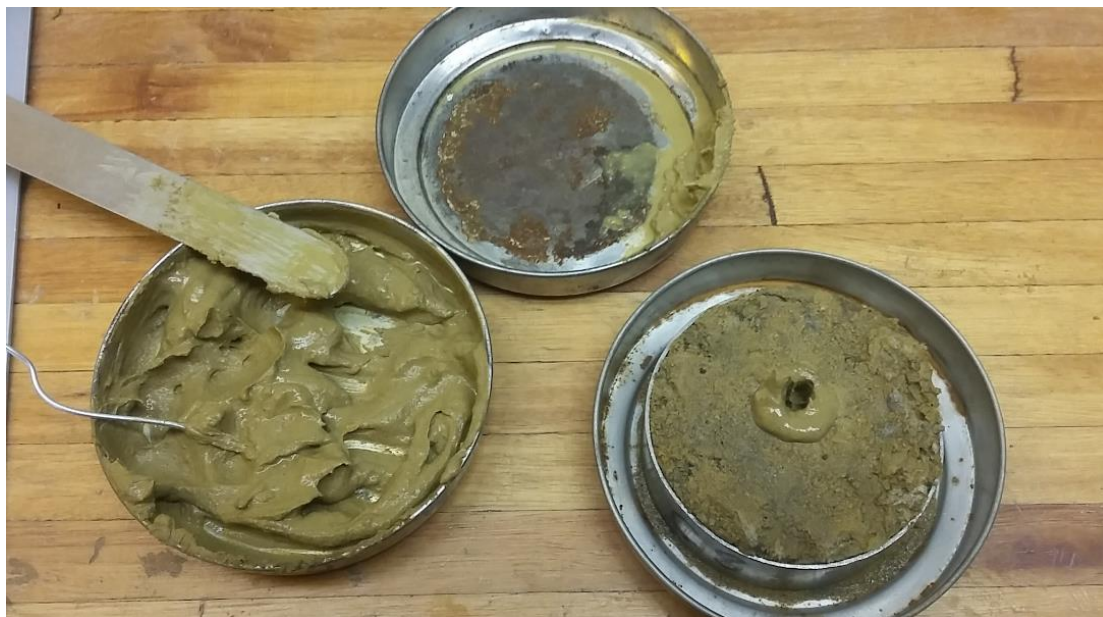
Figure 4-16: Slurry paste used to seal tensiometer into drilled hole.

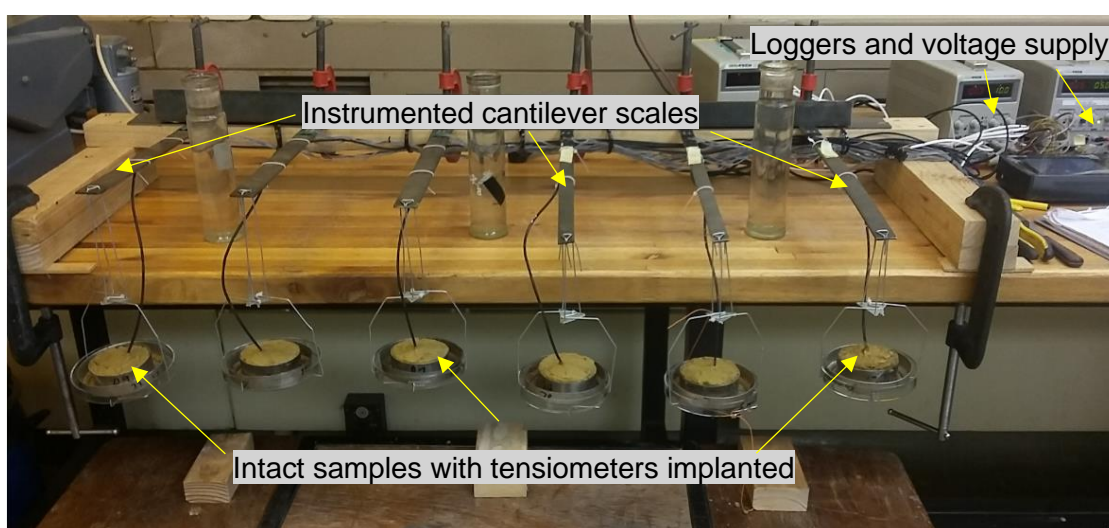
Figure 4-17: Experimental set-up to measure primary drying curves with tensiometers.

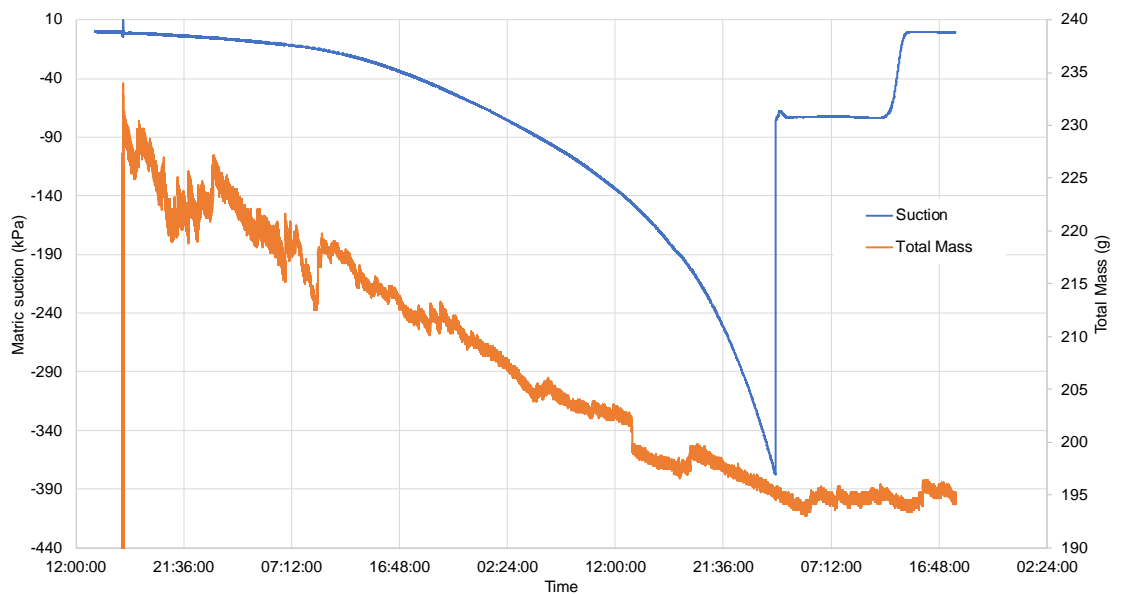
Figure 4-18: Matric suction and total mass change for specimen C6 (Area 2).

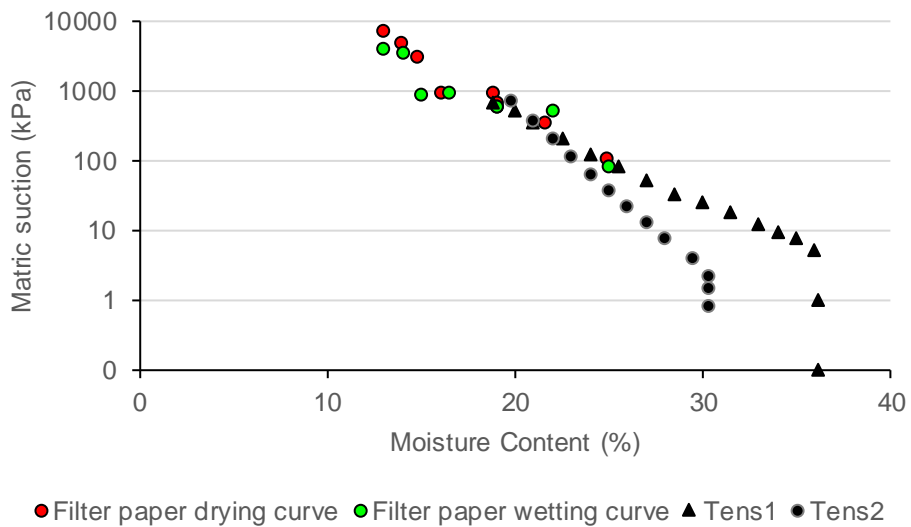
Figure 4-19: Primary drying curve from tensiometer data with filter paper results for Area 1.

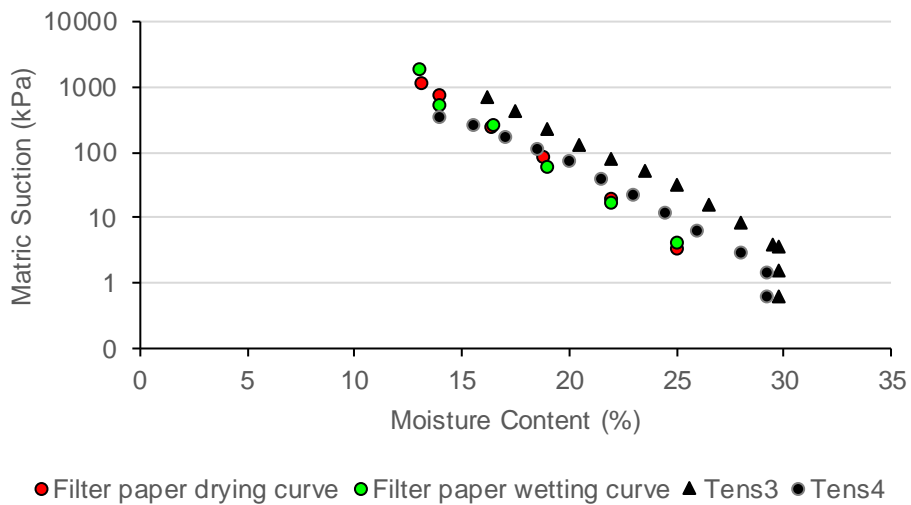
Figure 4-21: Primary drying curve from tensiometer data with filter paper results for Area 3.

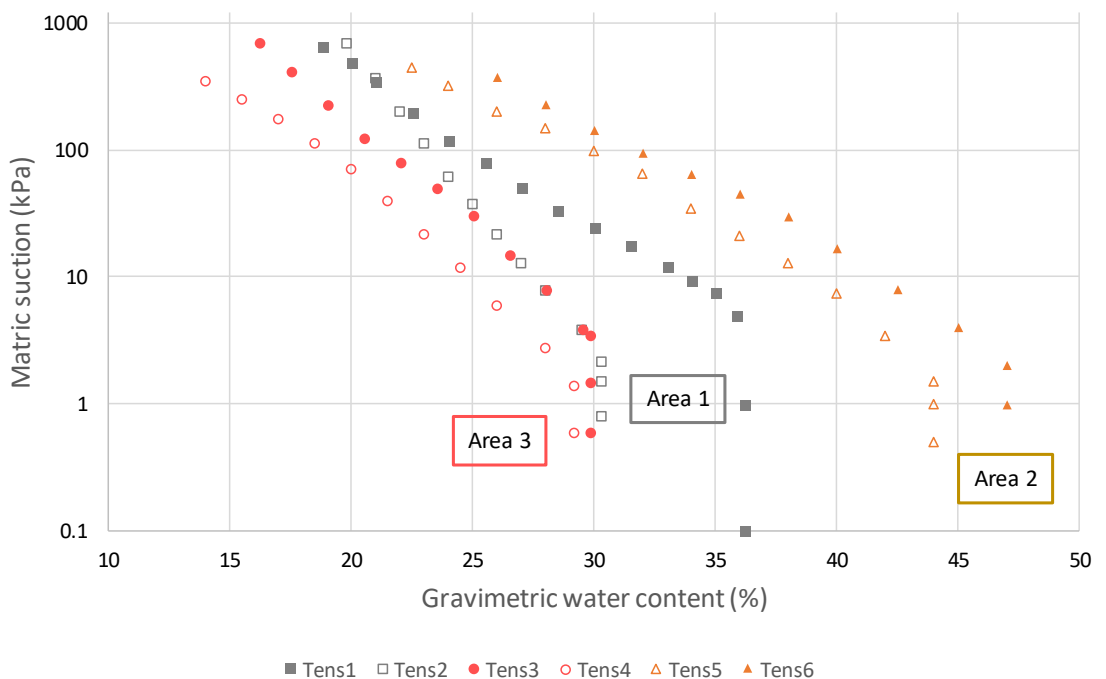
Figure 4-22: All primary drying curves from tensiometer tests combined.

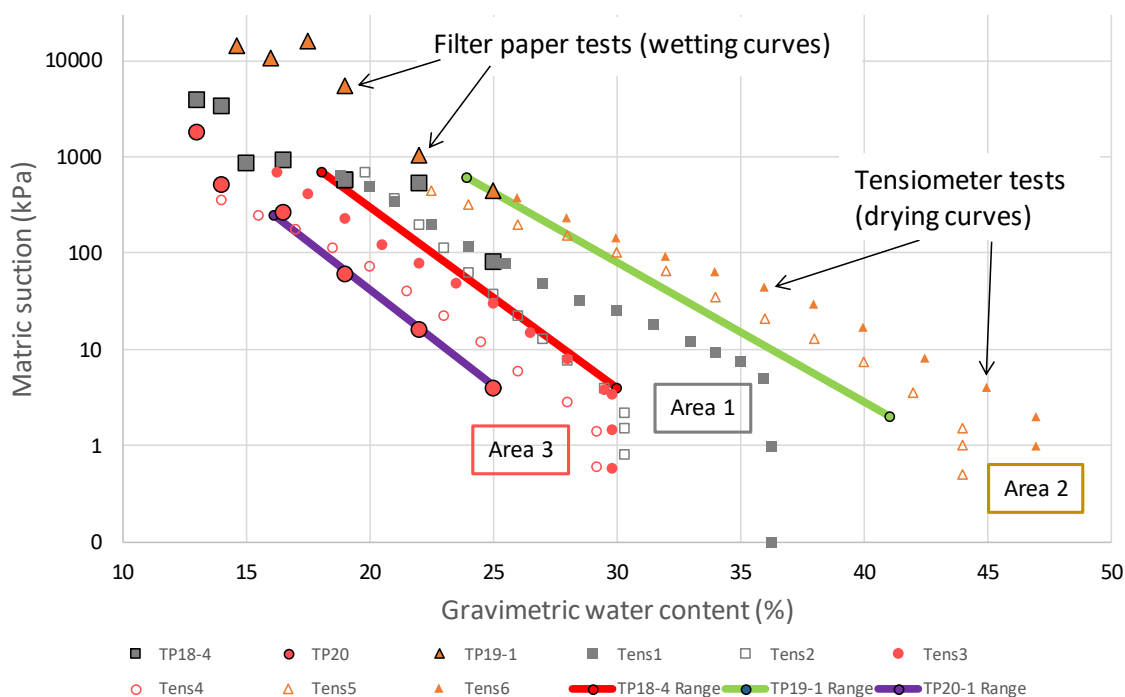
Figure 4-23: Tensiometer PDCs with filter paper PWC and moisture content variation added.

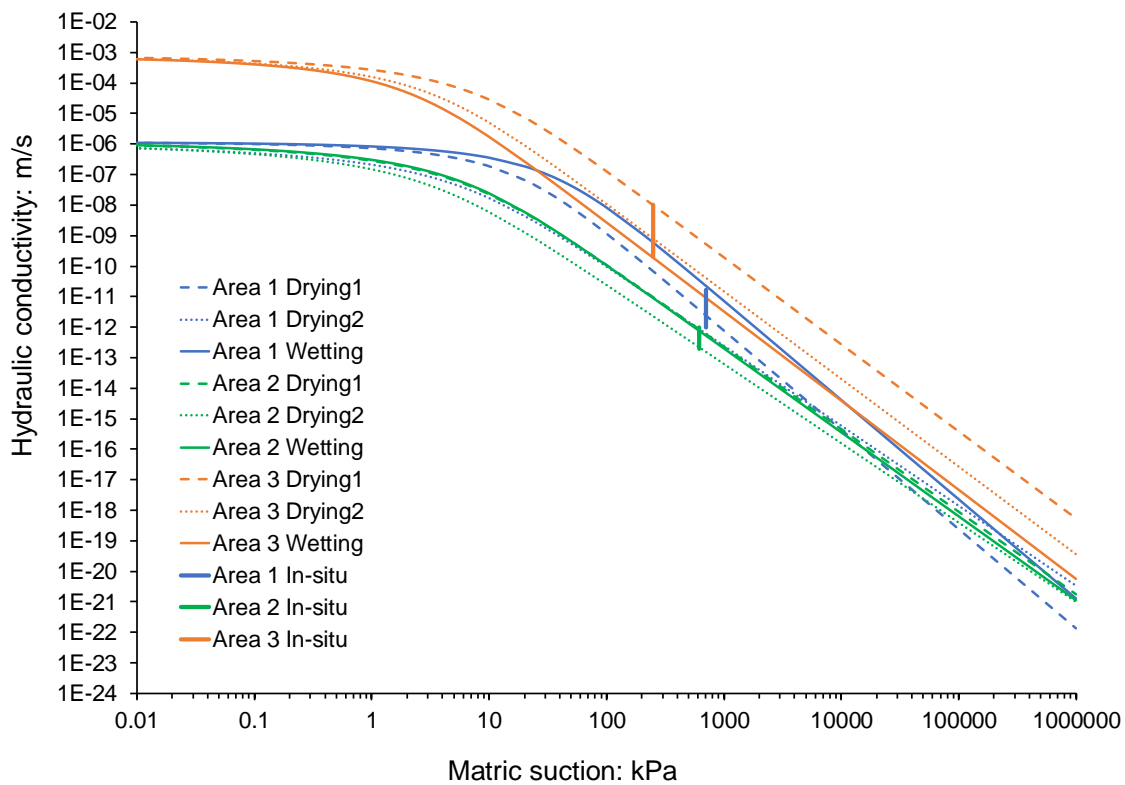
Figure 4-24: Hydraulic conductivity for change in matric suction for the three study areas.

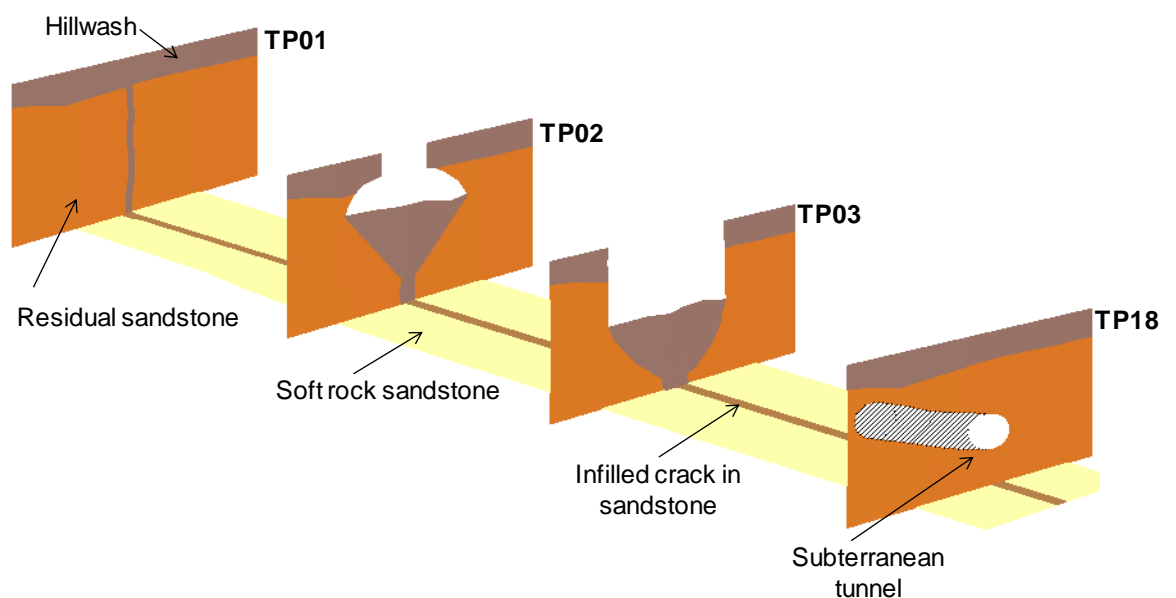
Figure 5-1: Cross sections through each test pit in Area 1.

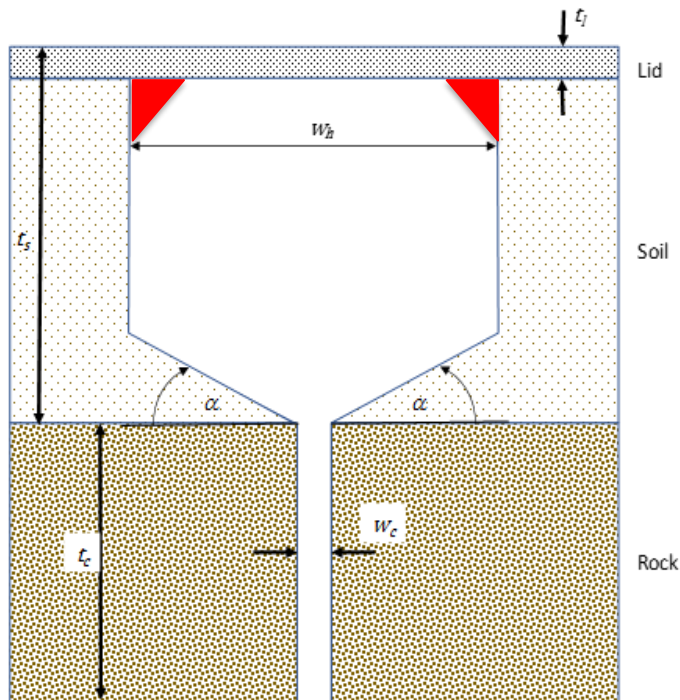
Figure 5-2: Arching support along the perimeter of the lid.

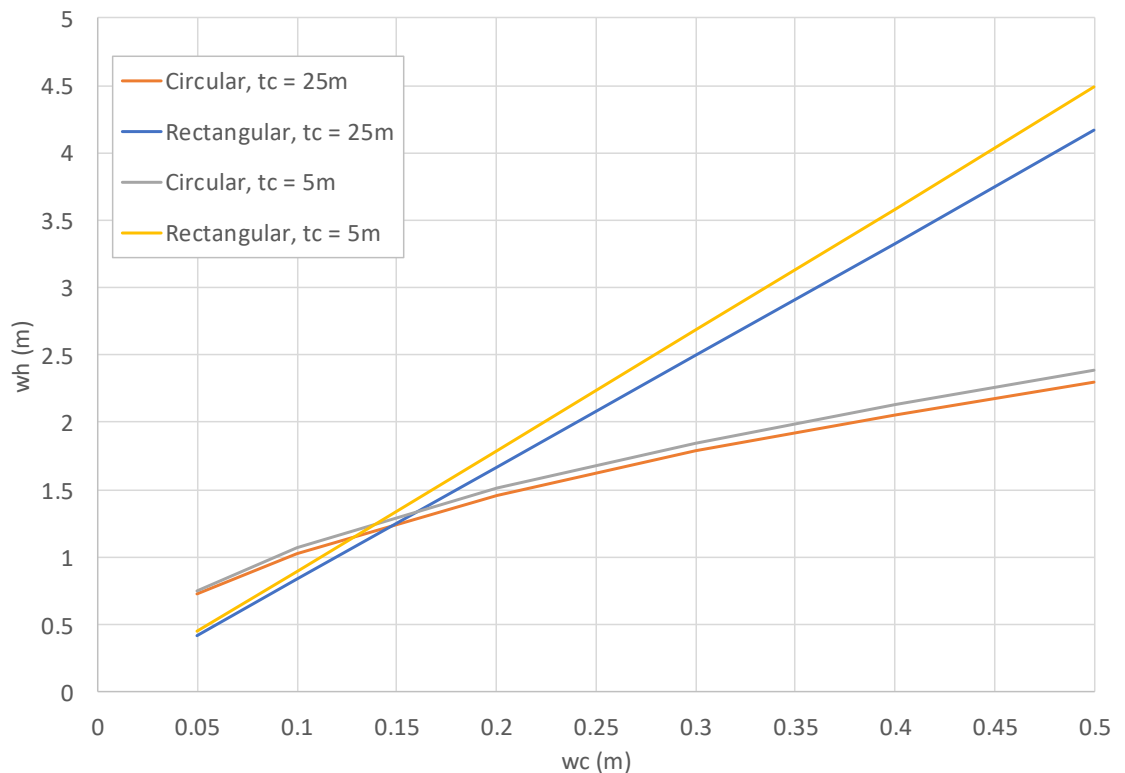
Figure 5-3: Sinkhole width for circular and rectangular shapes for varying crack width

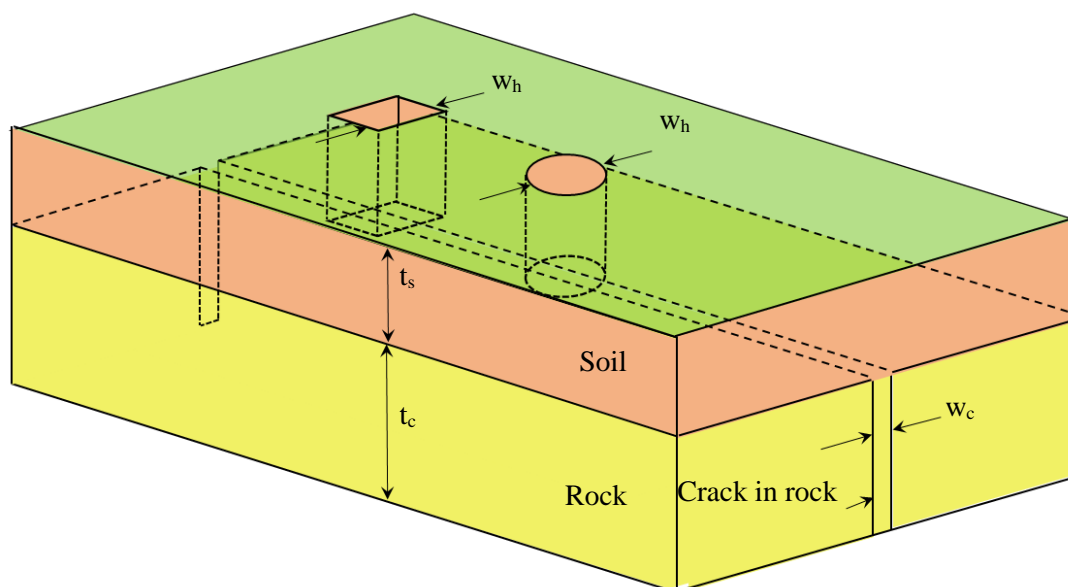
Figure 5-4: Rectangular and circular shape of sinkhole formation.

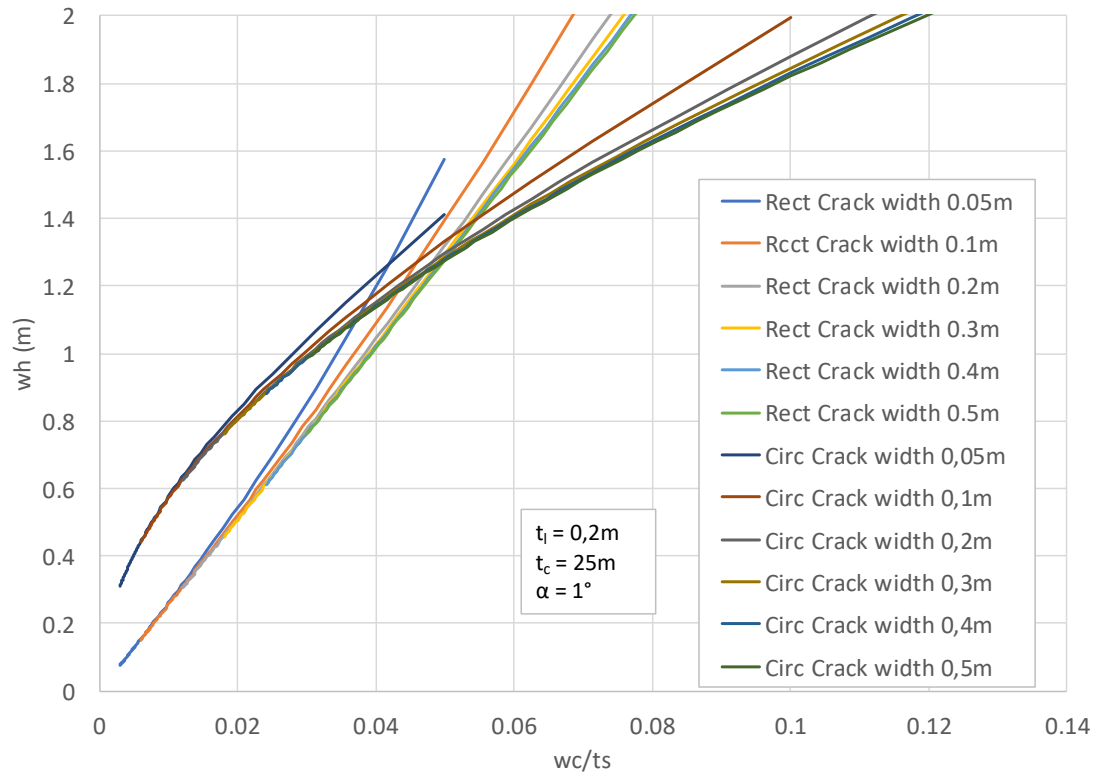
Figure 5-5: Relationship between w_h and w_c/t_s for rectangular and circular cavities for a crack depth of 25m.

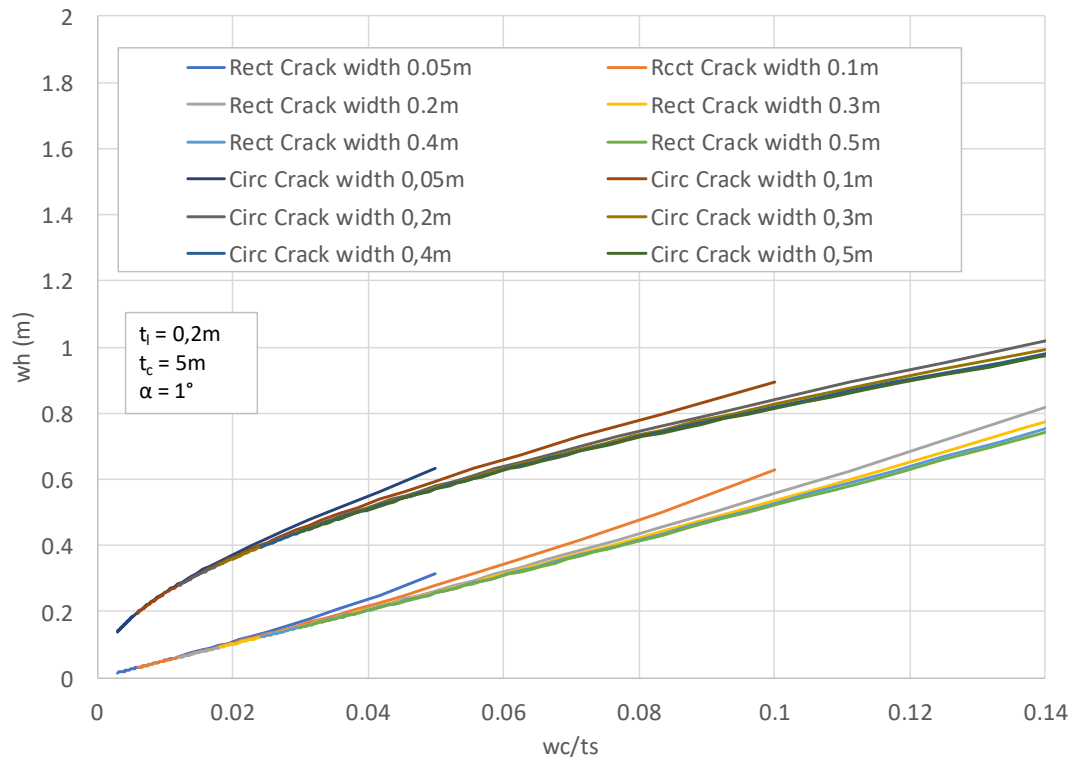
Figure 5-6: Relationship between w_h and w_c/t_s for rectangular and circular cavities for a crack depth of 5m.

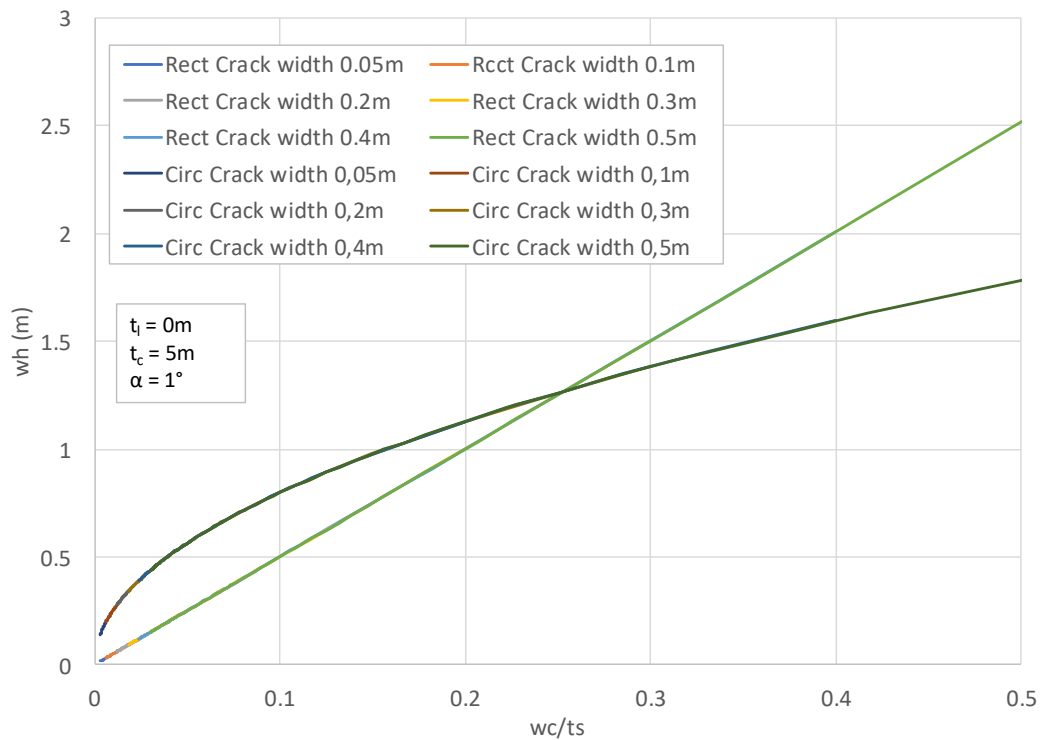
Figure 5-7: Relationship between w_h and w_c/t_s for rectangular and circular cavities for a crack depth of 5m and lid thickness equal to zero.

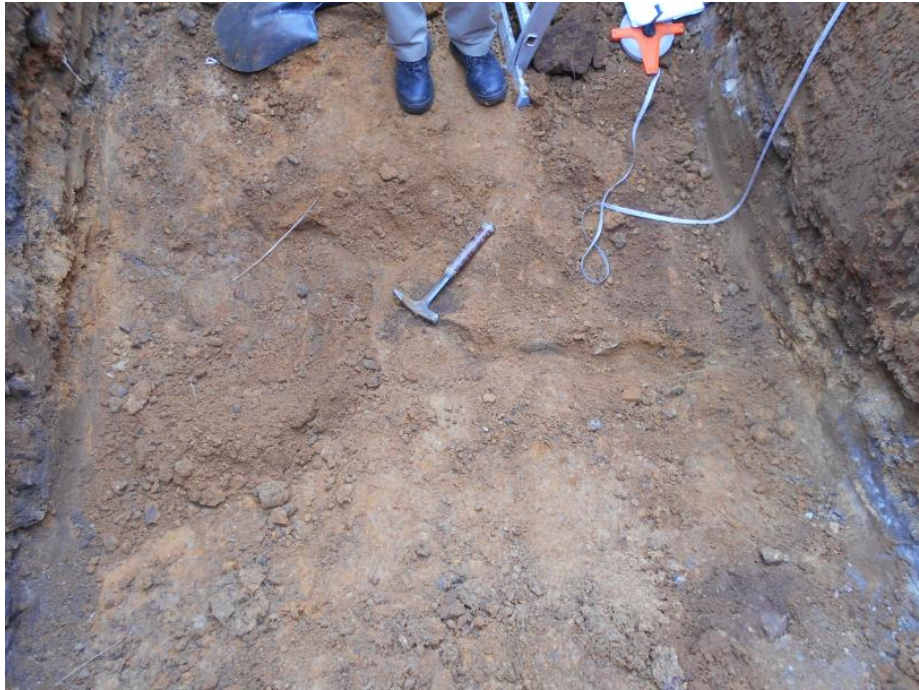
Figure 5-12: The fracture zone at the bottom of TP15.

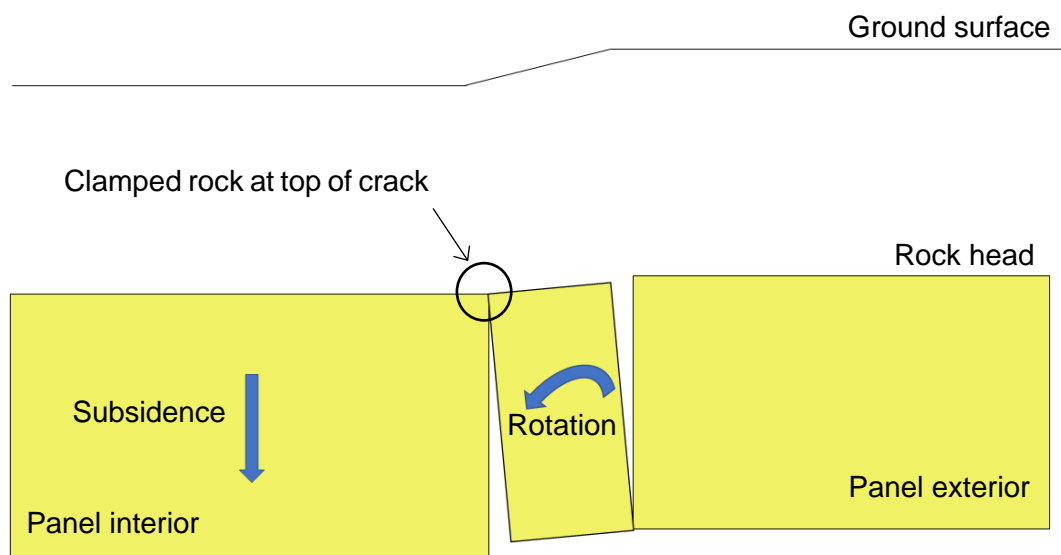
Figure 5-13: Possible mechanism for clamping of rock fragment in top of crack.

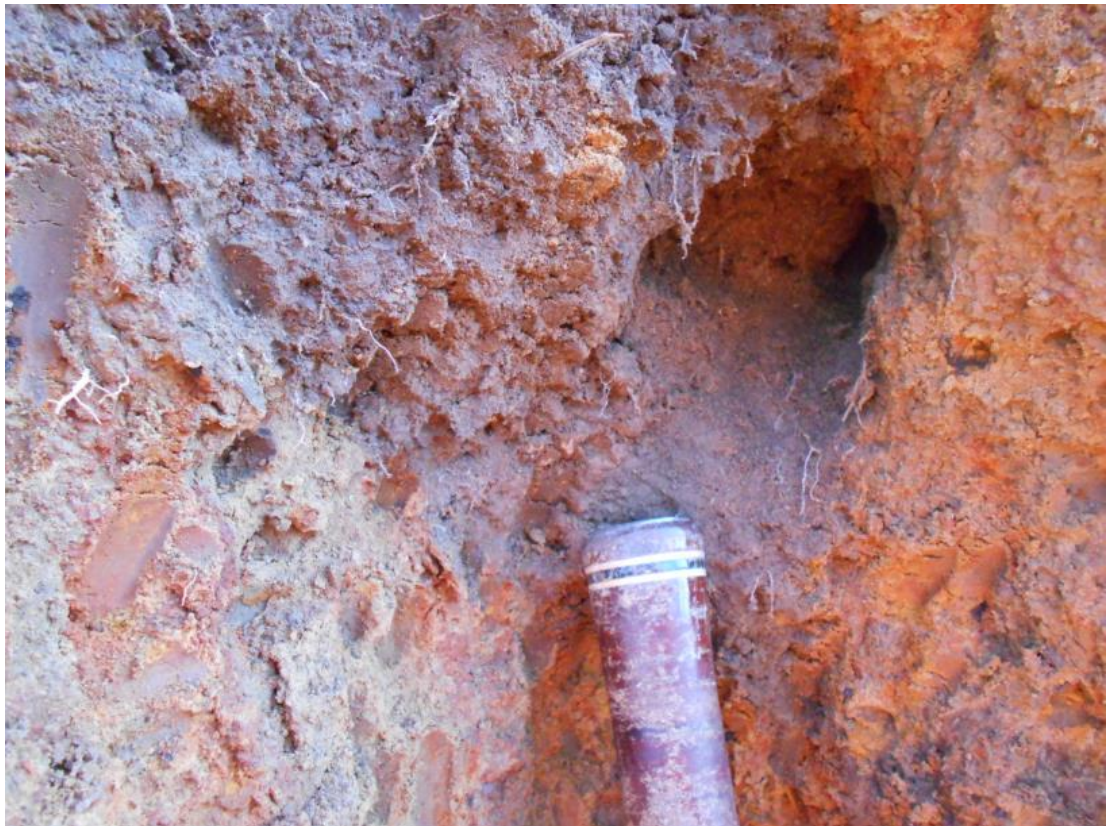
Figure 5-14: Termite activity within hillwash infilled crack in residual sandstone at TP10.

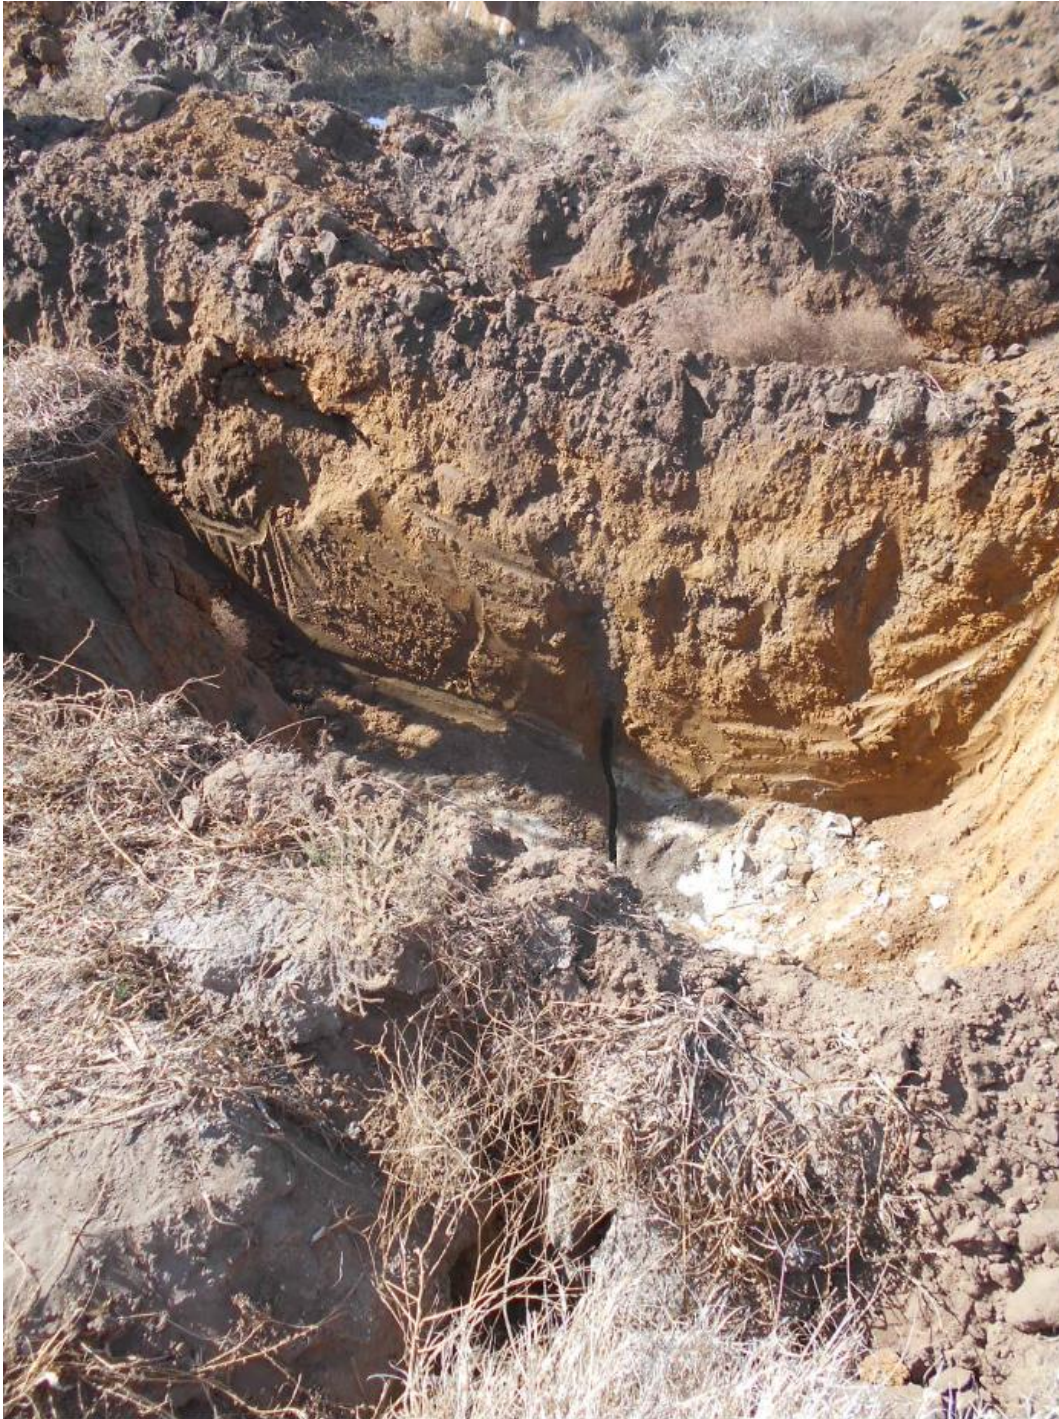
Looking east across TP04 and TP05, showing the excavated crack in the rock, infilled V-shape and small sinkhole on surface in the foreground.

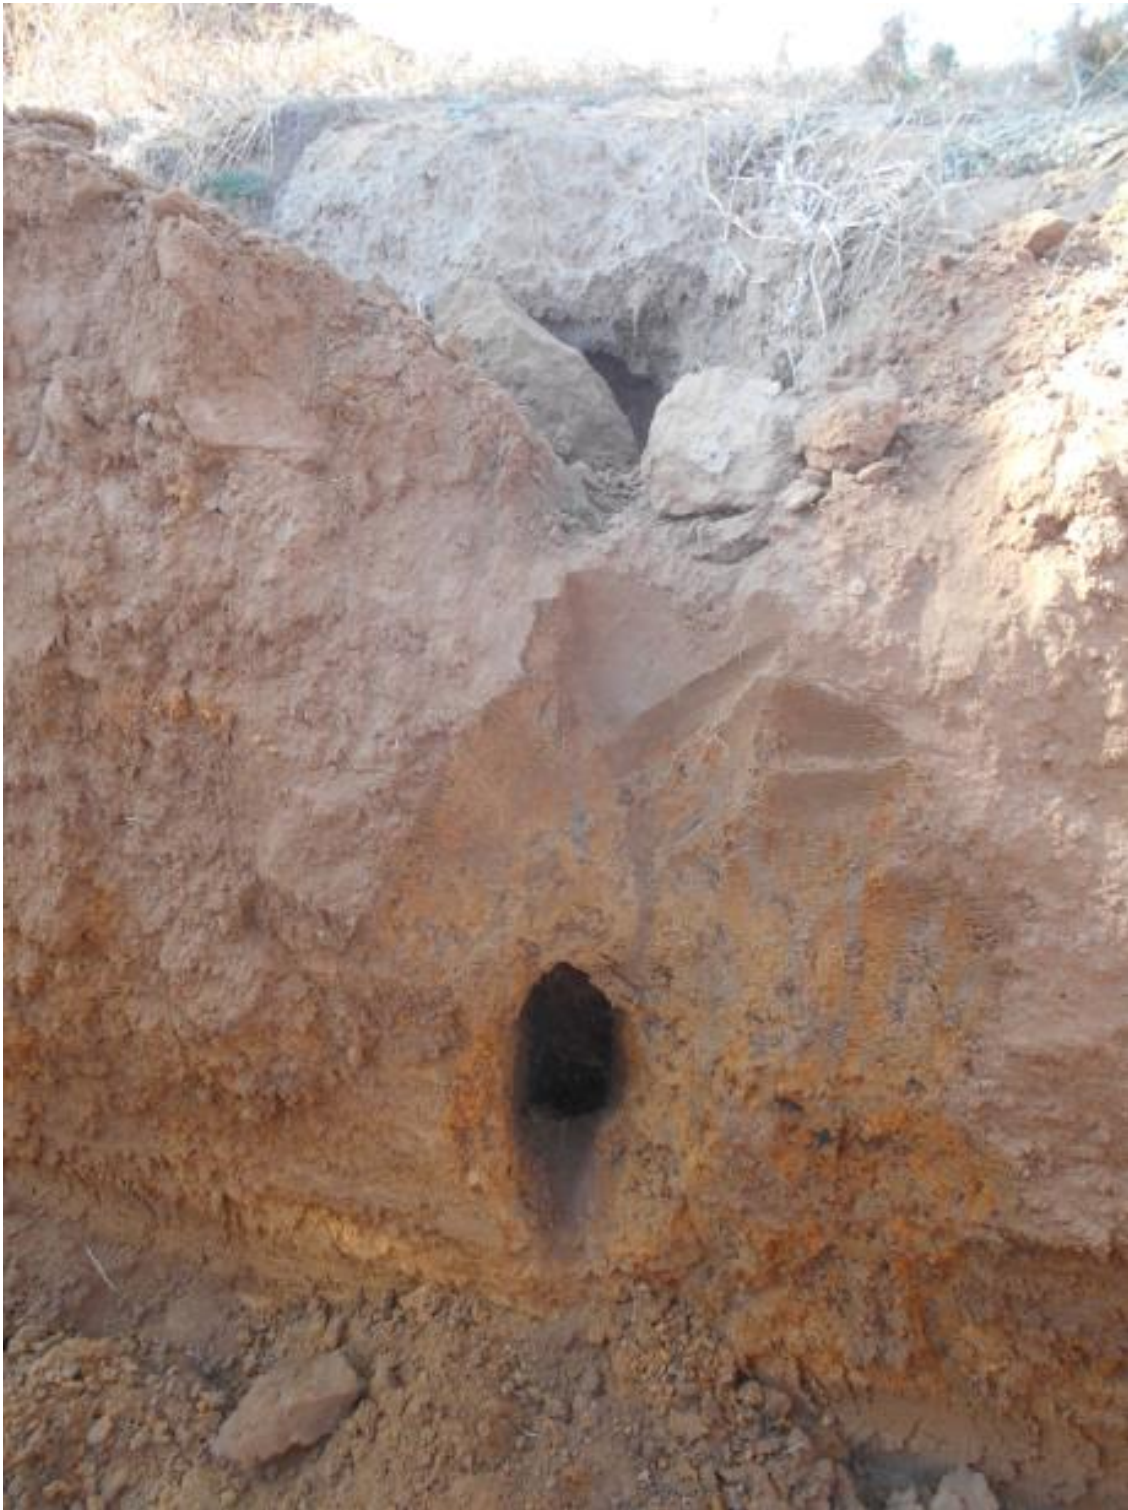
Start of the excavation at TP06, showing the sinkhole on surface and the intersected subterranean tunnel below.

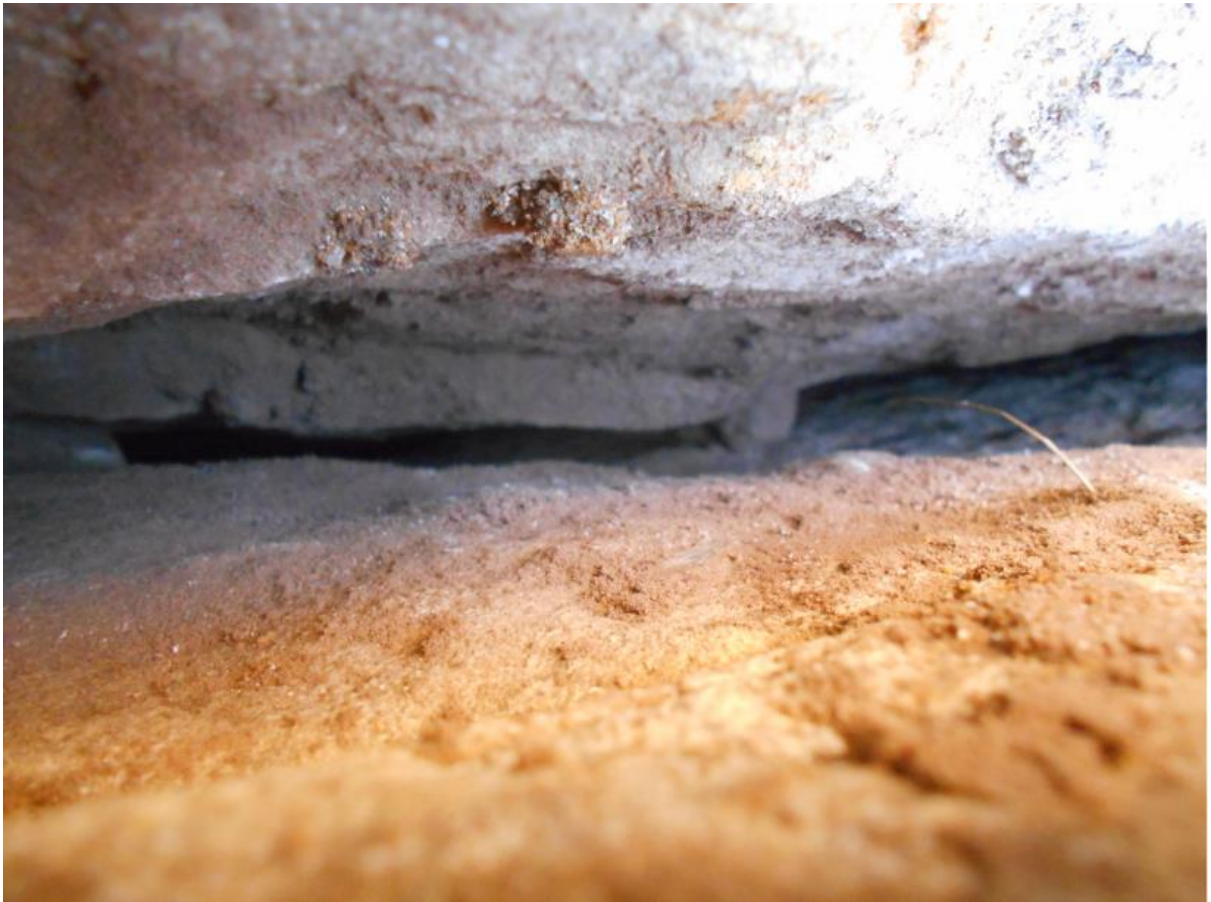
Looking down into crack in the rock at TP06. Note the staining on the rock surface.

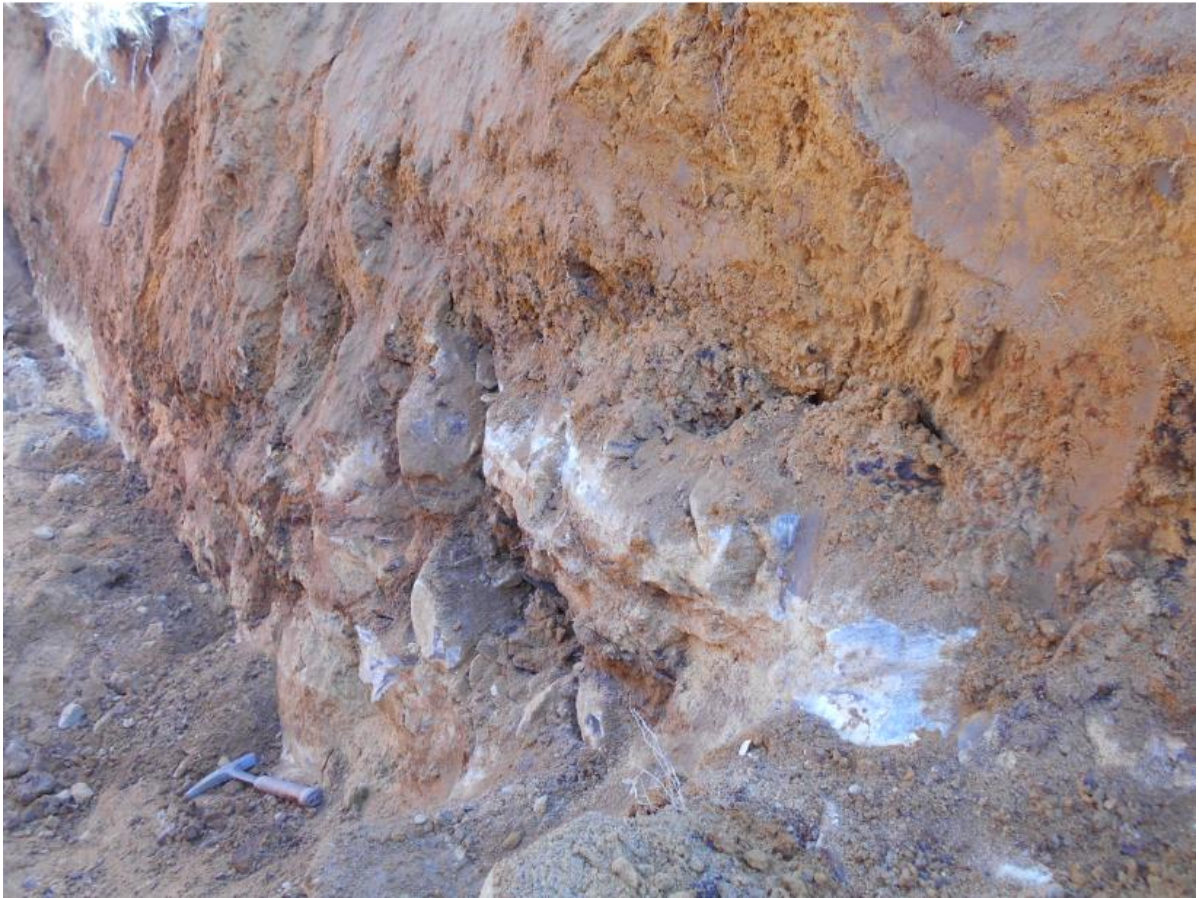
Vertical displacement across fracture zone at edge of subsided area exposed in TP11.

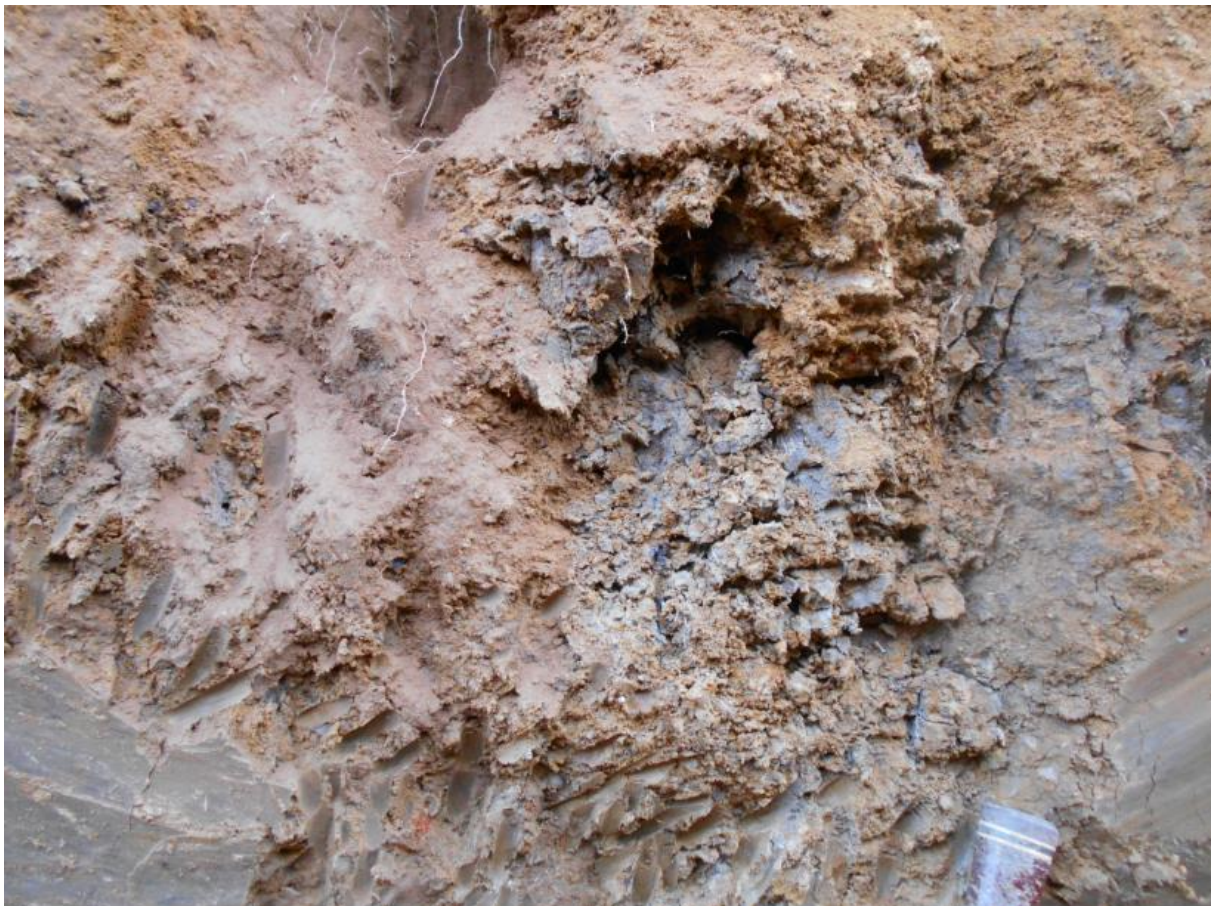
Clockwise from top left: Infilled V-shape at TP14, excavated V-shape and apparent “leached zone” at bottom of V-shape which is the presumed collapsed subterranean tunnel.

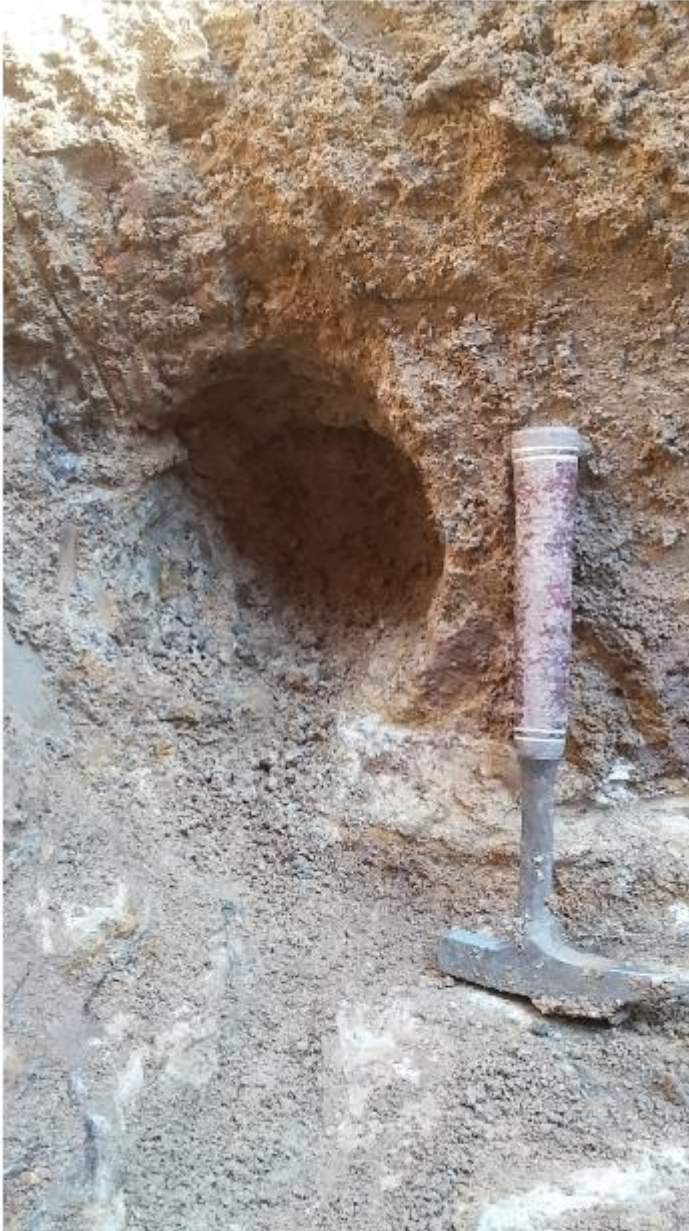
Loose material of collapsed sub-terranean tunnel excavated at bottom of TP18 above infilled crack in rock.

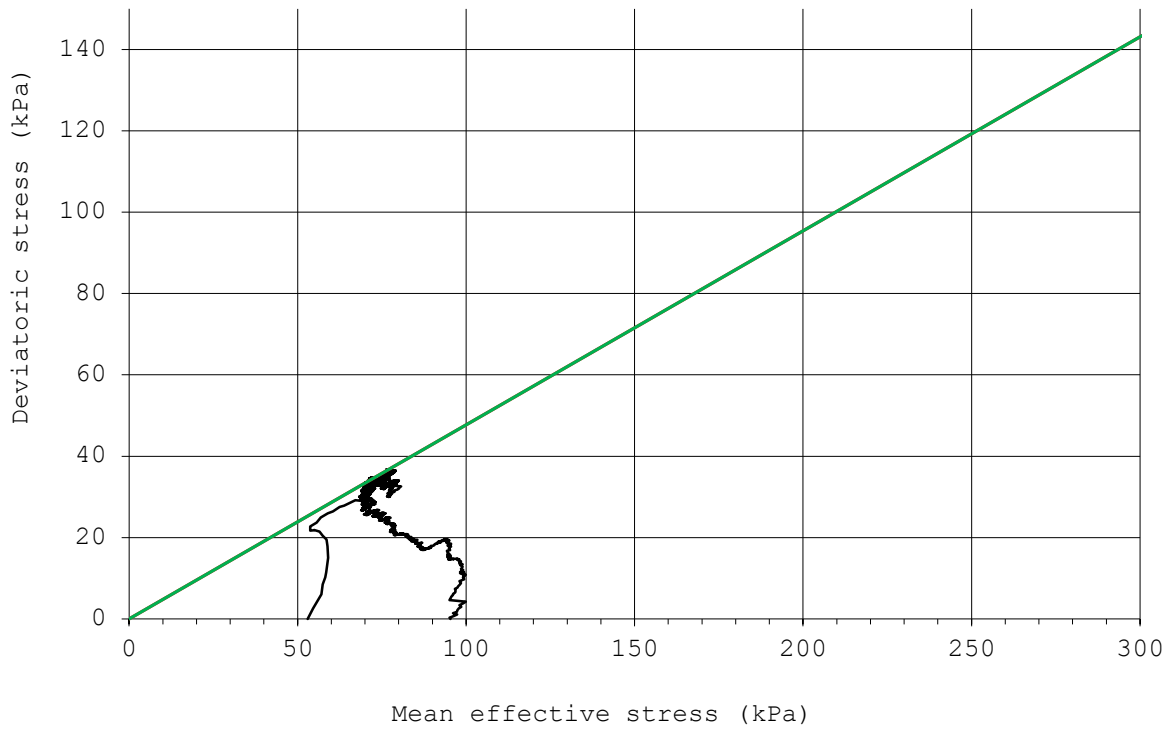
CONSOLIDATED UNDRAINED TRIAXIAL TEST
WITH BASE PORE PRESSURE MEASUREMENT

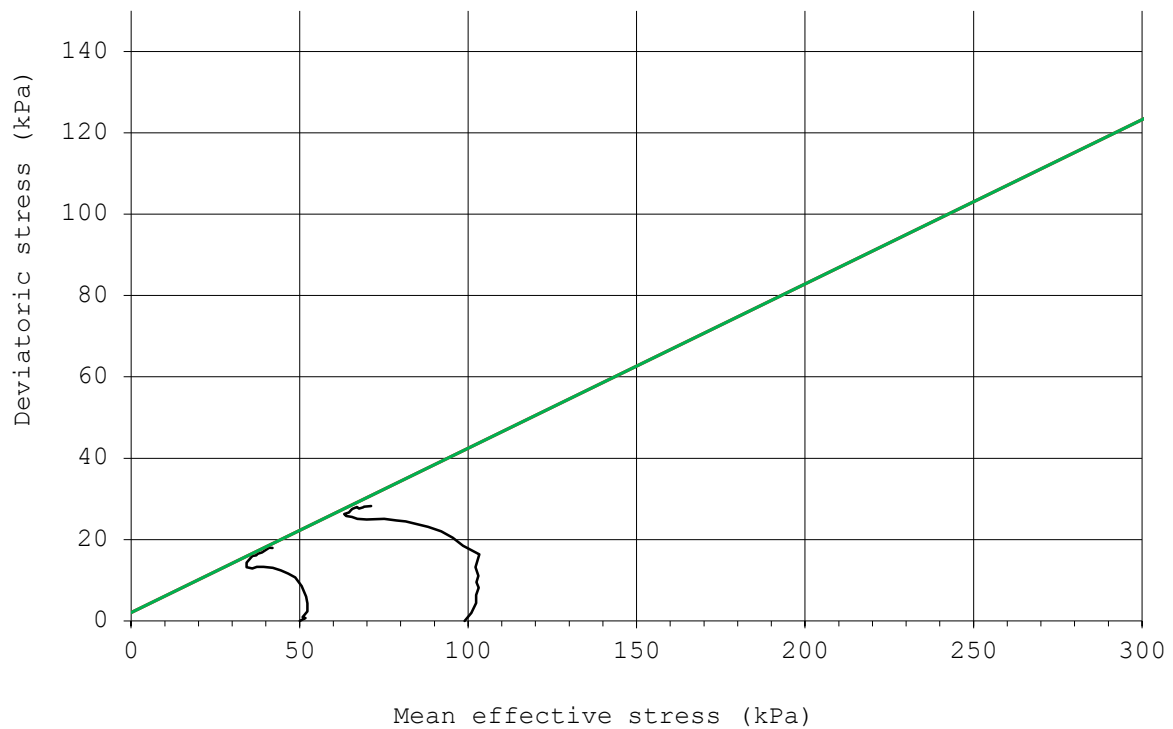
CONSOLIDATED UNDRAINED TRIAXIAL TEST
WITH BASE PORE PRESSURE MEASUREMENT
