SINKHOLE FORMATION DUE TO SUBSURFACE EROSION ABOVE UNDERMINED GROUND

A dissertation submitted in partial fulfilment of the requirements for the degree of

MASTER OF ENGINEERING (GEOTECHNICAL ENGINEERING)

December 2019

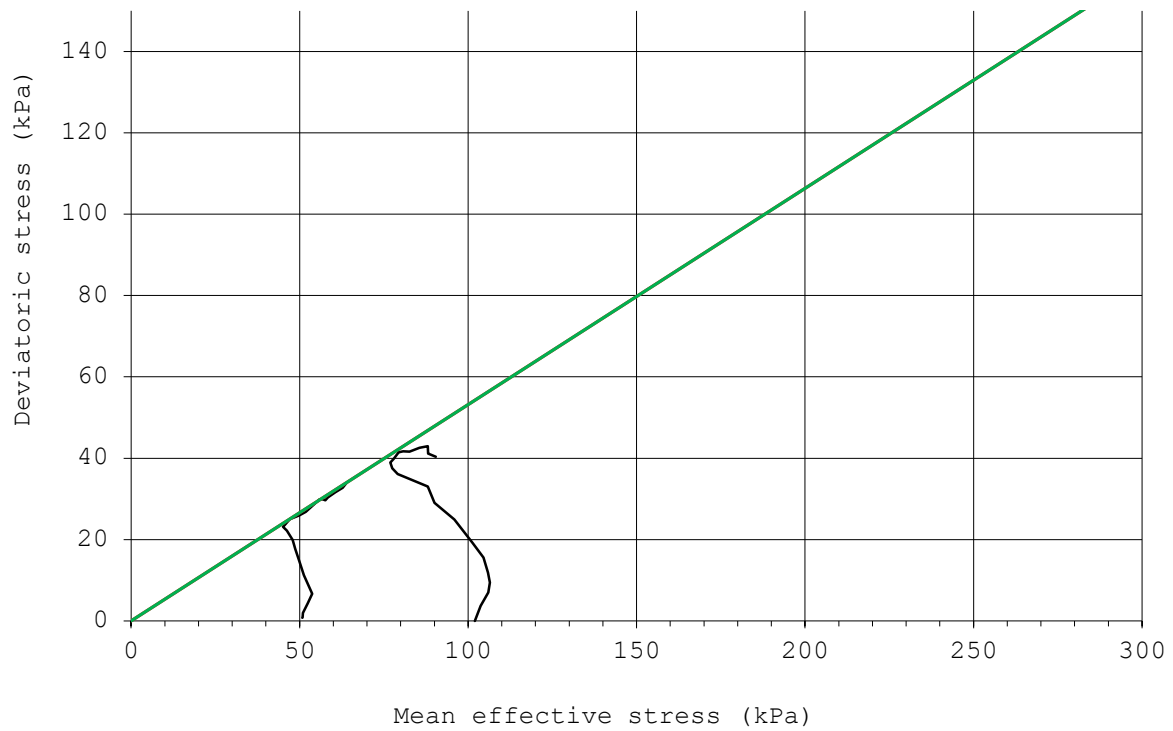
CONSOLIDATED UNDRAINED TRIAXIAL TEST
WITH BASE PORE PRESSURE MEASUREMENT
