THE EFFECTIVENESS OF CONTROL OF SPEED BY ILLUSION LINES (COSBI LINES)

J VAN DER SPUY* and M SCHRÖDER**

Royal HaskoningDHV (Pty) Ltd, Tygerberg Office Park, 163 Uys Krige, Platteklouf, 7500

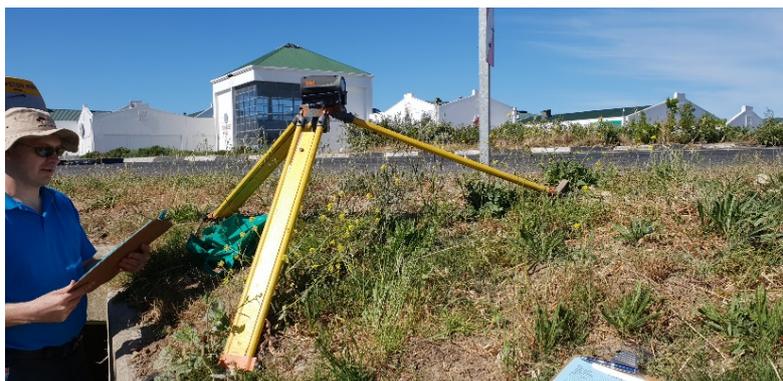
At the LHS Culvert, the radar gun was set up at an approximate height of 500 mm. With the radar gun set up at a low height and next to a hazard plate was being partially hidden from for the driver. Figure 2 shows the position of the radar gun at the LHS Culvert location set up next to a hazard plate. At this position, a 5% correction factor had to be factored in because the radar gun was not set up in a direct line of sight with the vehicles being measured. The readings were taken at a slight angle. This is called the Cosine Effect. A total of 338 vehicle's speeds were recorded over a period of 1-hour (09:00 am to 10:00 am). Table 1 shows the average speeds that was recorded at this location. The reading was taken when the vehicles were between 50 and 80 m from the measuring points.

Figure 2: Radar Gun set up at LHS Culvert

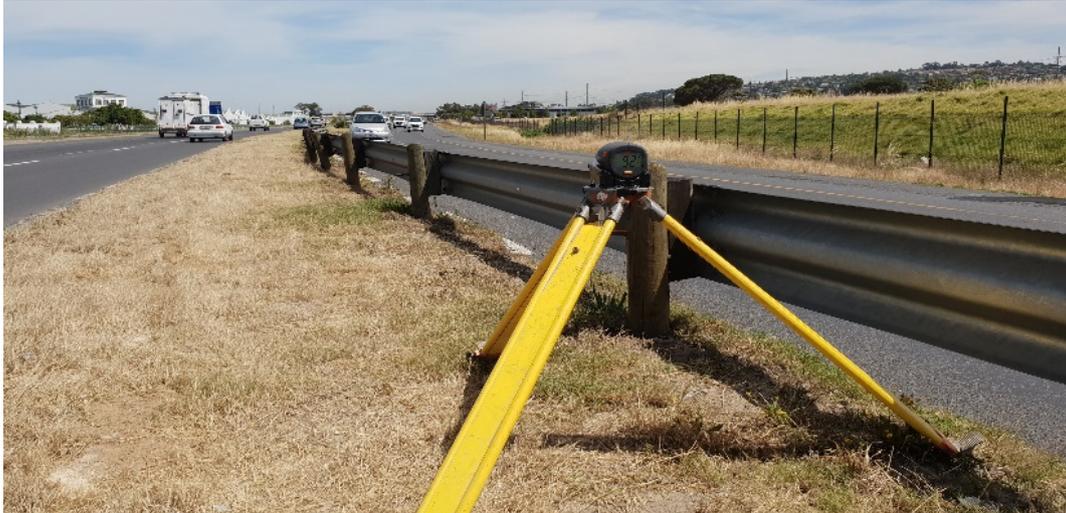
At the median, the radar gun was set up at an approximate height of 800 mm. With the radar gun set up at this height it was just above the guardrail. This would make it less visible to the motorist as the approach the radar gun. Figure 3 shows the setup of the radar gun behind the guardrail in the Median. At this position the reading was accurate as the radar gun was in the direct line of travel. A total of 529 vehicle speeds were recorded over a period 10:37 am to 12:00 pm). Table 1 below shows the average speeds that was recorded at this location. The reading was taken when the vehicles were between 50 and 80 m from the measuring points.

Figure 3: Radar Gun set up behind Guardrail in the Median

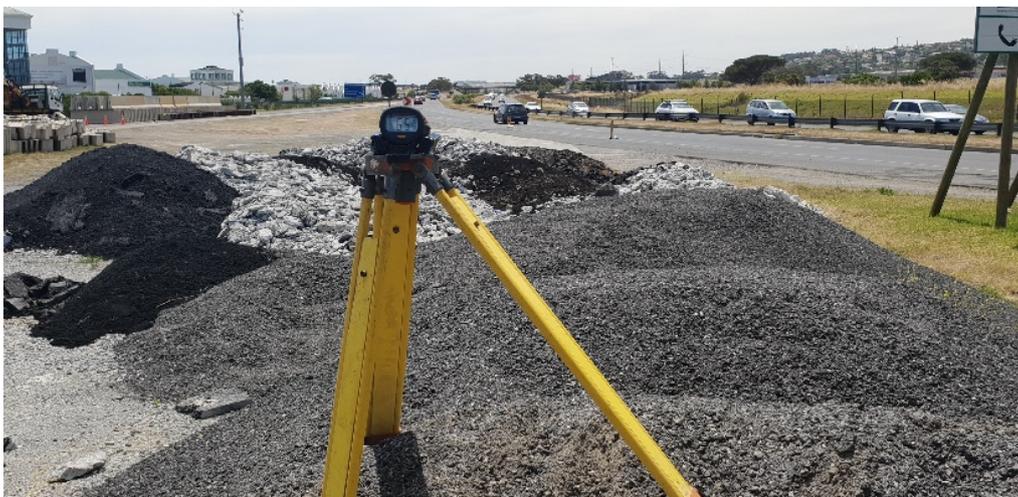
At the site camp, the radar gun was set up at an approximate height of 1100 mm. With the radar gun set up at this height it could sight the vehicle over two lanes of opposing traffic and the median island. Figure 4 shows the setup at the site camp and the line of sight over the two opposing lanes and median island. At this position the reading was accurate as the radar gun was in the direct line of travel, however the reading was more difficult to take due to the distance to the oncoming traffic.

Figure 4: Radar Gun set up at Site camp

The speed measurements at this location were taken when there was a gap in the west-bound traffic and a clear line of sight towards the oncoming east-bound traffic. A total of 528 vehicle speeds were recorded over a period 13:35 pm to 15:30 pm. Table 1 below shows the average speeds that was recorded for this section. Observations were taken at the site camp and where vehicles being measured has just gone over the COSBI lines.

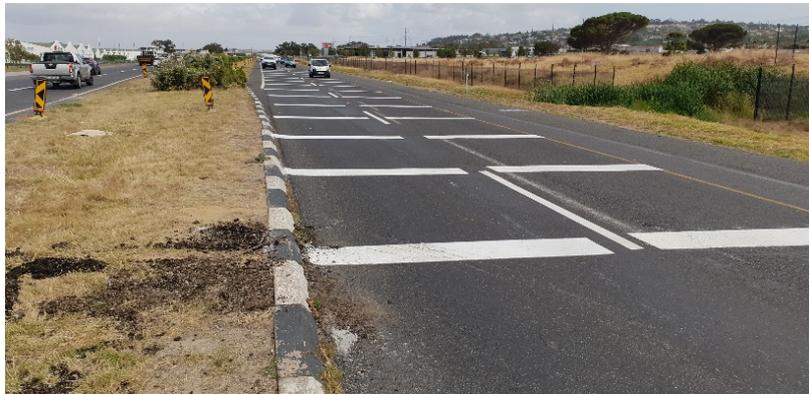
The COSBI lines were painted on 12 December 2018. Retro-reflective road marking paint was used for this case study. The 14 bars would be applied as the secondary set of bars with the spacing calculated in Table 2. A primary set of three bars was painted using the same bar spacing as the first bar, for a total of 17 bars. Figure 5 shows the COSBI lines as painted.

Figure 5: COSBI Lines applied
