# A multidisciplinary forensic analysis of two lightning deaths observed in South Africa

Hugh G.P. Hunt<sup>a,\*</sup>, Ryan Blumenthal<sup>b</sup>, Ken J. Nixon<sup>a</sup>, Chandima Gomes<sup>a</sup>

<sup>a</sup> The Johannesburg Lightning Research Laboratory (JLRL), School of Electrical & Information Engineering, University of the Witwatersrand, Johannesburg, South Africa

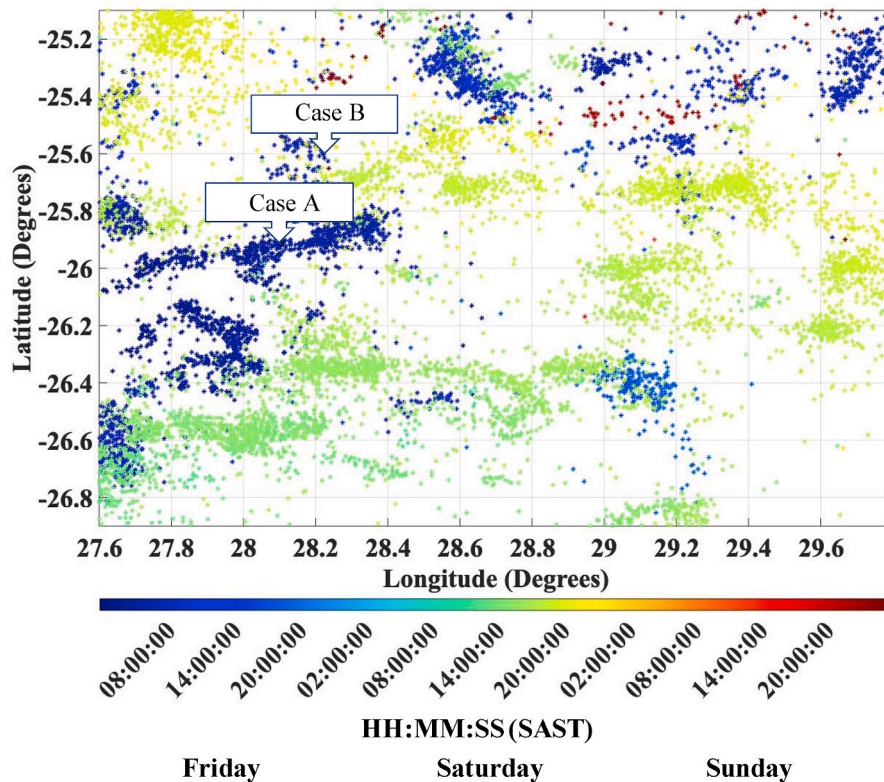
Fig. 2. South African Lightning Detection Network (SALDN) flash location reports for the weekend in February 2020 in the Gauteng area, South Africa. The location of Case A and Case B are indicated on the figure and the colour bar indicates progression in time of the storm.

passed over the location of Case A. It is also clear from the figure (indicated) that the storm on the Friday had many lightning events reported very close to the location of Case A at approximately 14:00:00 SAST. 6 Flashes were reported within 1 km of the location.

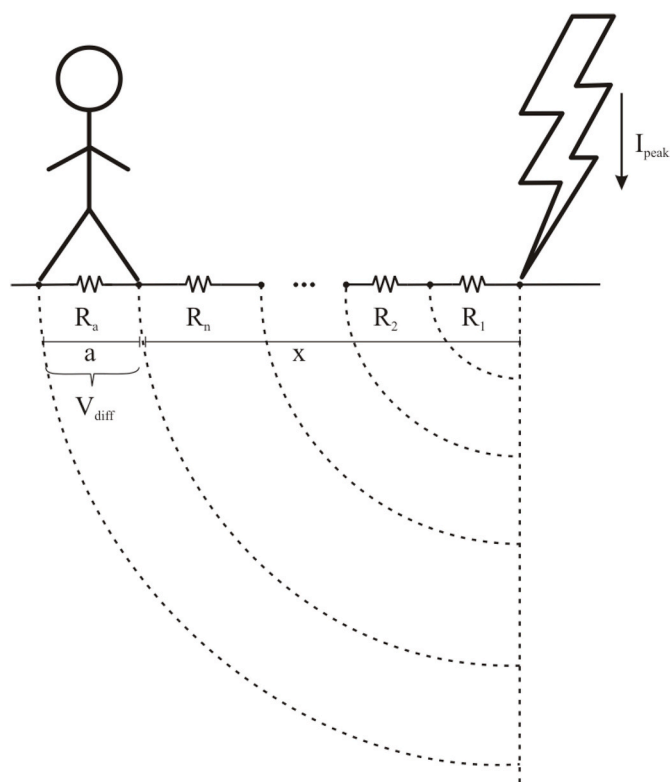
Fig. 3. Description of step potential injury mechanism and the estimation of the voltage developed between the feet of a person due to a nearby lightning strike.

$$V_{diff} = \frac{\rho I_{peak}}{2\pi} \left( \frac{1}{x} - \frac{1}{(x+a)} \right) \quad (1)$$

$I_{peak}$  is the peak current of a stroke,  $\rho$  is the soil resistivity,  $x$  the distance of the strike point from the victim and  $a$  is the distance between their legs, typically set at 1–0.5 m. This equation relies on the assumption that the soil is homogeneous and that current flows radially outwards equally from the strike point. Any irregularities in the soil, or the presence of any conductive materials (piping, cabling etc.) in or on the surface of the ground may change the situation, leading to equation (1) estimating the voltage incorrectly. Therefore, if we consider a step potential voltage of 1 kV and a human body resistance of 1000  $\Omega$ , we calculate a current of 1 A. We estimate that the heart would be exposed to at most 4% of this ie.

40 mA. If we consider a lower estimate of human body resistance (say  $600 \Omega$ ), this becomes 66 mA - current magnitudes that could result in death, depending on the duration of the lightning stroke.

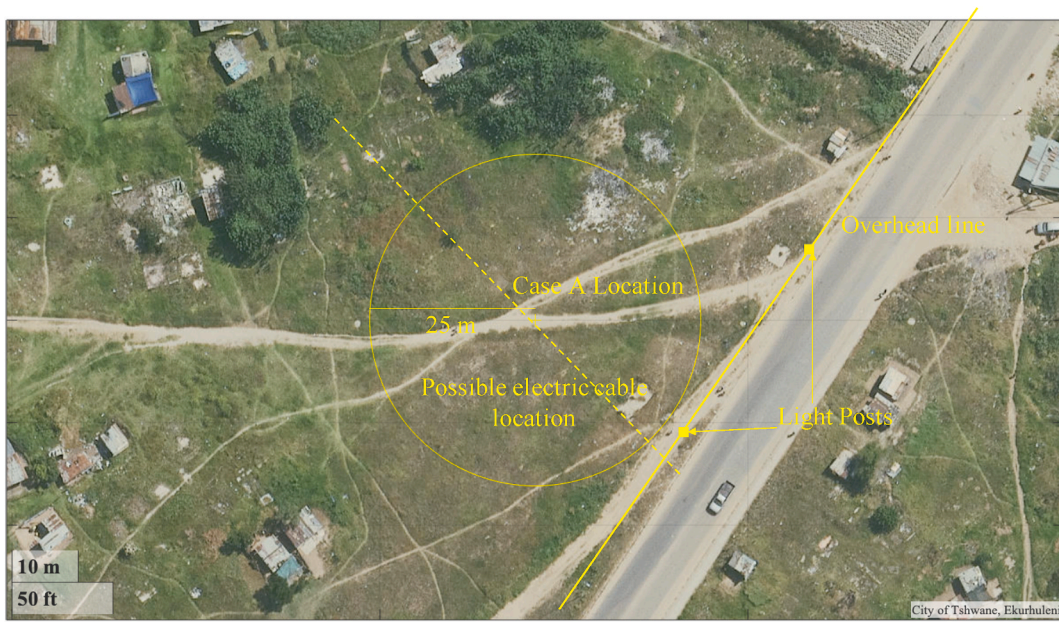
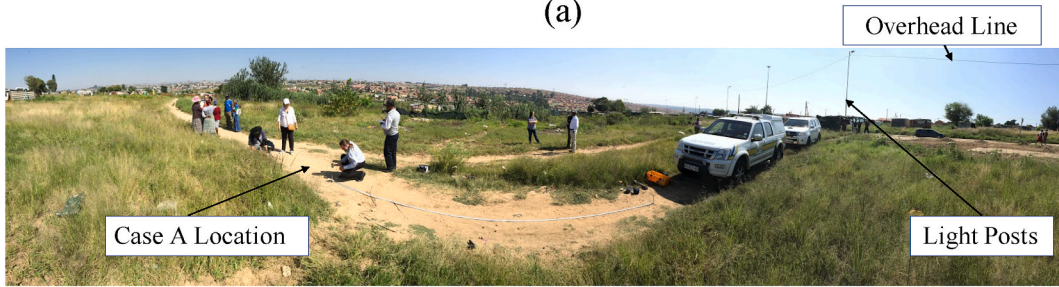
**Fig. 4.** Site description (a) site location of Case A with a 25 m radius indicated. Locations of the light posts, overhead line and the possible electric cable location are shown. (b) Panoramic photograph of site location while soil resistivity measurements are being conducted. Note the open area with the light posts (approximately 25–30 m from the body location) being the only tall structures in the vicinity. (c) Soil resistivity plot.

The deceased was found in an open area of an informal settlement on a dirt road without any large structures in the immediate vicinity. The only tall structures nearby were light posts approximately 25–30 m from the location where the body was found. An overhead line was seen strung between the light posts. Fig. 4a shows an aerial view of the scene

with the location where the body was found indicated as well as the relative position of the tallest structures - the light posts and the overhead line. The figure also indicates the supposed location of the electric cable that was possibly running across the ground at the time. Fig. 4b shows a panoramic photograph of the scene where we can see the open nature of the area. The light posts are indicated in the photograph as well.

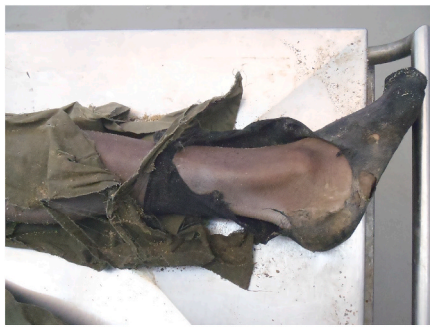
(a) Tearing-and-tattering of trousers and socks.

The victim was an adult black male. At the outset of the examination, the anterior aspect of the body was covered with sand and the clothing was wet. Observations made during external examination of the victim are shown in Fig. 5a–e. Observations regarding the clothing are as follows: light-brown trousers with multiple pockets (the right side of the trousers was torn-and-tattered) (Fig. 5a). The victim was wearing footwear and both showed signs of damage although neither shoe showed signs of entry on the underside. The right leather shoe was almost completely ruptured. The left leather shoe showed rupture; although to a lesser extent (Fig. 5b). Blue shorts (the white drawstring showed scorching, and there were tear-and-tatter marks anterior over the crotch region) (Fig. 5c). An orange-and-black golf shirt, with 2/3 lower buttons fastened (there was a  $6 \times 2$  cm 'tear' of the upper neck region anterior, there were also tear-and-tatter marks and scorch marks, posterior). There was a brown leather belt, the  $3 \times 3$  cm buckle showed signs of 'metalization'. Black socks were present, the left sock showed a  $7 \times 4$  cm 'tear' on the dorsal aspect, the right sock showed a tear overlying the big toe region.

clothing (Fig. 5a), shoes showed signs of rupture (Fig. 5b), the presence of pneumomediastinum [31] (Fig. 5f), and the singeing of the pubic hair suggestive of open-flame or heat effect (Fig. 5d).

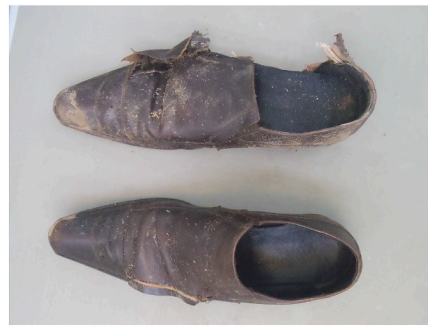
(b) Rupture of the shoes.

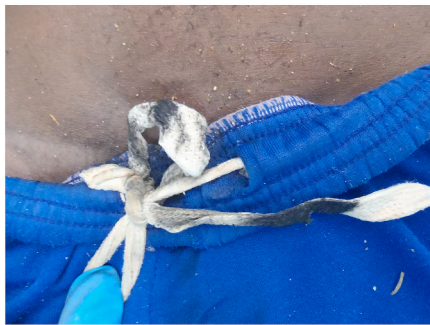
(c) Scorching/singeing of the white drawstring.

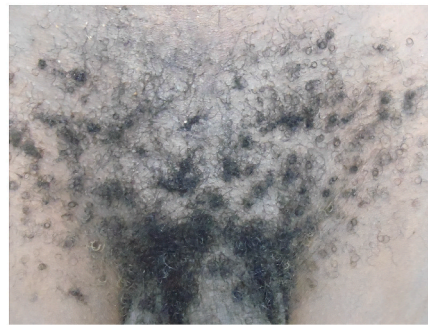
(d) Singeing of pubic hair.

On the body, the following observations were made: there was singeing of the pubic hair suggestive of open-flame or heat effect (Fig. 5d). There was a  $3 \times 2$  cm fresh laceration located below the chin, most likely from a fall (blunt force trauma - a secondary effect). There was a  $2\text{cm}$  horizontally orientated laceration located below the lower lip and examination of the inner aspect of the lower lip showed a  $3 \times 2$  cm fresh laceration both of which were also most likely due to blunt force trauma from the fall. Also observed externally was a rupture of the left ear drum (Fig. 5e). No exit or entry wounds were found on either the upper or lower parts of the body, or any external injury marks or Lichtenberg figures. There were no injuries noted on the underlying skin and no exit or entry points were found on either of the feet or upper body area.

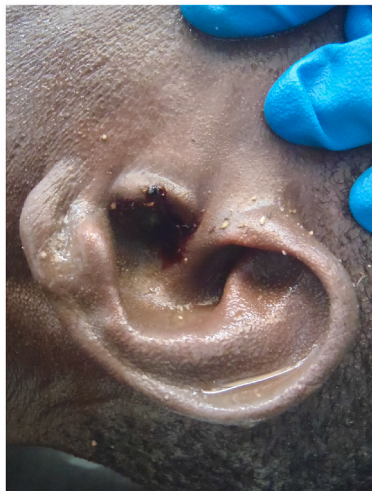
(e) Rupture of the left eardrum

The chief findings were in keeping with that of a direct lightning strike: rupture of the left ear drum [43] (Fig. 5e), torn-and-tattered

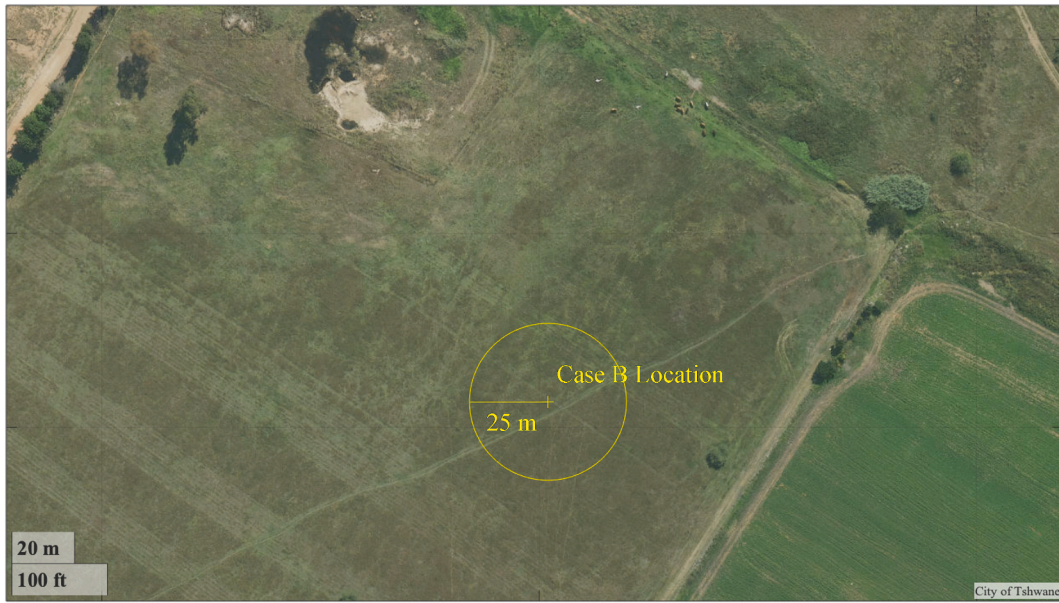
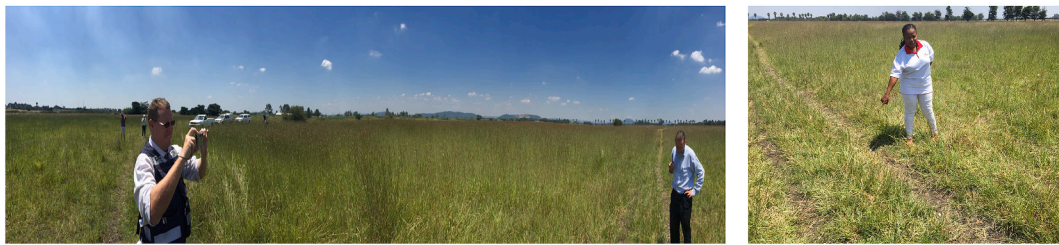
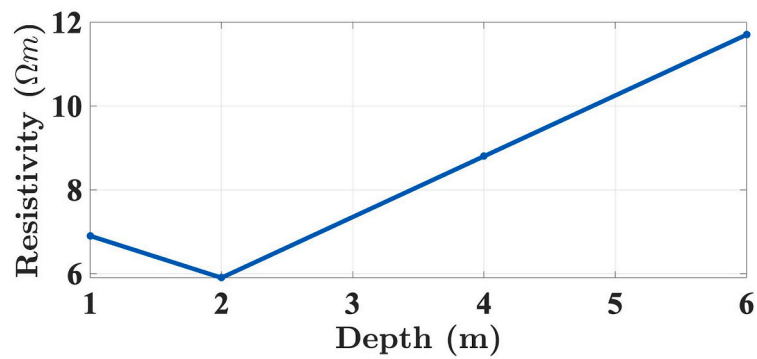
**Fig. 9.** (a) Site location of Case B with a 25 m radius indicated. (b) Panoramic photograph of site location (note the open area with no tall structures in the vicinity) and the location where the body for Case B was found (c) Soil resistivity plot for the area.

The location where the body was found was an open field in a sparsely constructed area off of a main road. Fig. 9a shows an aerial view of the area. The location where the body was found is indicated and a 25 m radius around this location is shown. As can be seen, no structures, trees or any tall objects are within this radius with the only such objects being trees found over 50 m away. Fig. 9b shows a panoramic photograph of the field taken from the location where the body was found - clearly showing no tall structures/objects in the area. A photograph of where the deceased was found is also shown.

An analysis of the soil resistivity was conducted following the same procedures as described in above sections, and the results of the measurements are shown in Fig. 9c. The soil was noted to be soft and clearly with high moisture content. As can be seen, the measured soil resistivity in the area was much lower than 25 Ωm, ranging between 6 and 12 Ωm in depth. This indicates highly conductive soil, dissipating lightning currents well and leading to less step voltages being developed. The decrease from 1 m to 2 m is likely due to the surface of the area drying slightly as the storm in the area occurred a number of days before the measurements were taken.

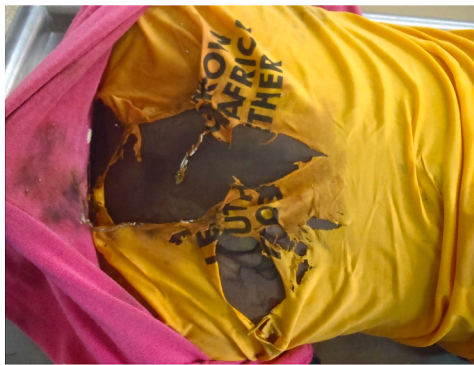
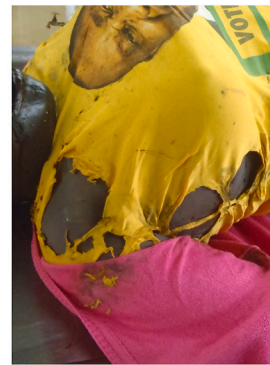
(a) Tearing and scorching of the yellow t-shirts.

(b) Tearing and scorching of the yellow t-shirts.

and almost the entire back of the t-shirt (Fig. 10a and b). The sneakers had metallic zippers instead of laces and eyelets, which showed no abnormalities. The right sneaker was ruptured on the heel region and lateral aspect of the material (Fig. 10c). No rupture was found on the left sneaker. There was scorching of the left lateral side of the petticoat (Fig. 10d). Interestingly, the pink jersey and skirt were intact. There was some soot deposition on the back of the jersey and on the anterior and posterior aspect of the t-shirt (suggestive of open-flame, or heat effect). A red cotton traditional string was wrapped around the left wrist which showed no damage. A set of metallic keys were present in the palm of the hand which were attached to the string, which showed no damage.

The chief findings were suggestive of a direct lightning strike: The synthetic t-shirt and petticoat were singed (scorched-and-melted), chiefly overlying the left shoulder region, right upper aspect chest region and almost the entire back of the t-shirt (Fig. 10a and b). There was soot deposition on the back of the jersey and on the anterior and posterior aspect of the t-shirt (suggestive of open-flame, or heat effect). The rupture of only the right sneaker is shown in Fig. 10c. There was scorching of the left lateral side of the petticoat (Fig. 10d). The findings on the left hand and right side of the face were suggestive of electrothermal-type injuries. As such, we are able to confirm lightning as the cause of death in Case B and that the flash was suggestive of a direct

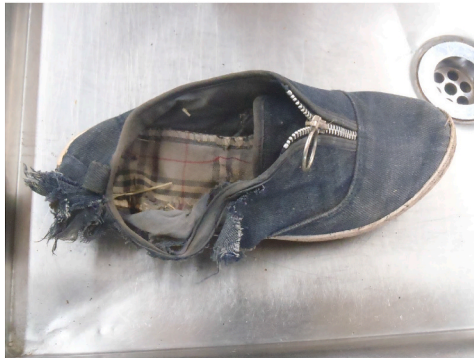
(c) Rupture of the right shoe.

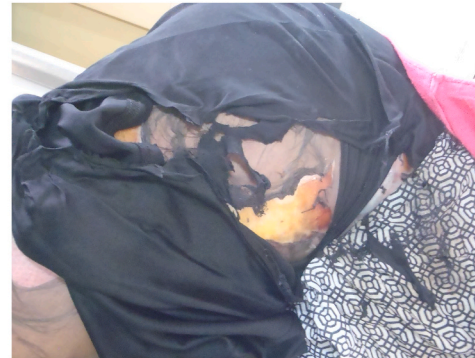
(d) Rupture of the right petticoat.

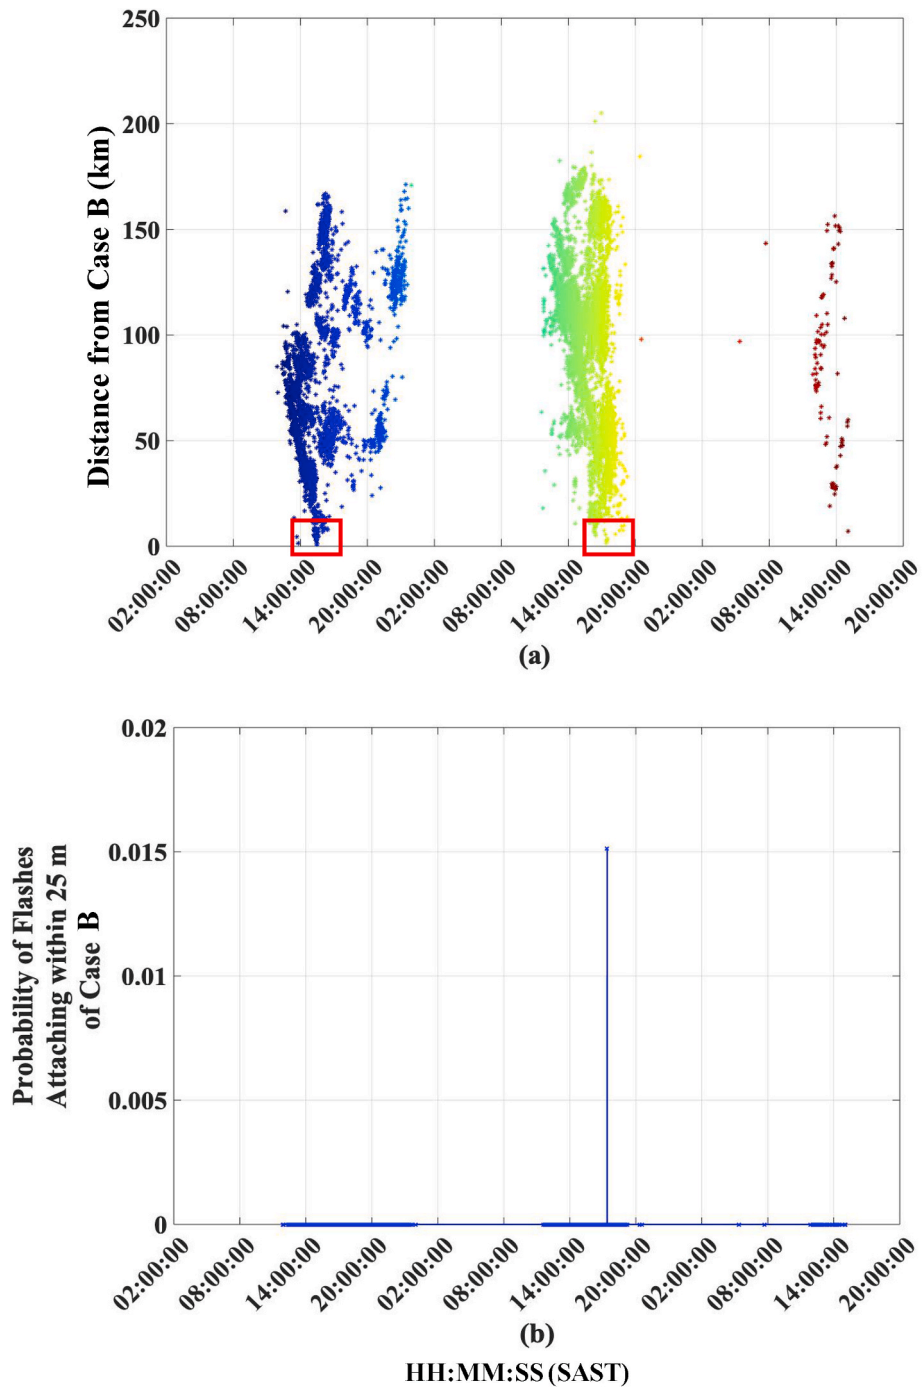
**Fig. 11.** South African Lightning Detection Network (SALDN) flash location reports for a weekend in February 2020 in the area plotted as (a) distance from Case B location and (b) probability of flash attaching within a 25 m radius of Case B against time.

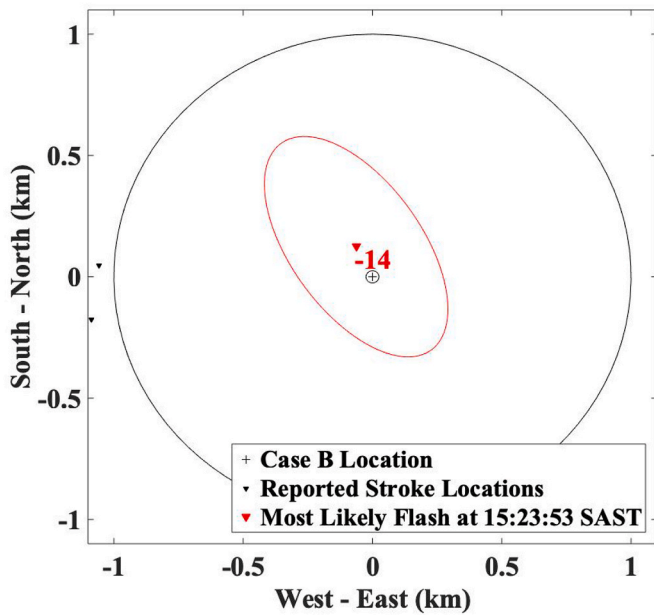
Fig. 12. Reported locations of SALDN detections in a 1 km area around Case B with the most likely flash indicated. Peak currents and 99% confidence ellipses are also indicated.
