**Non-compliance assessment and law enforcement efficacy in the eMalahleni
Local Municipality Mpumalanga**

**Mini- dissertation Submitted in partial fulfilment of the requirement for
the degree**

Masters Water Resource Management

University of Pretoria

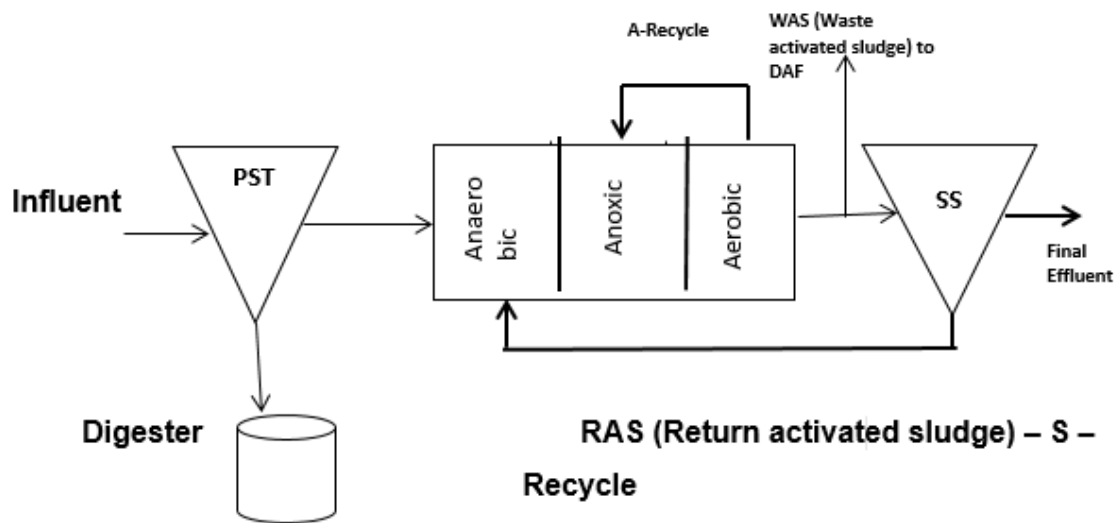
Figure 1: Municipal wastewater treatment work configuration, Naauwpoort WWTP. Typical Plant flow diagram

Plant A, Naauwpoort WWTP in eMalahleni Local Municipality has a 3 -stage Phoredox system commonly known as Biological Nutrients Removal system (BNR). This wastewater treatment system with 10ML design capability requires enough Oxygen, *Acinetobacter*, *Nitrobacter* and *Nitrosomonas* bacteria to play a role in the treatment processes that differ from the environment appropriate for their survival. The key to the treatment is to maintain the condition that the bacteria are active and able to function as intended. The plant discharges its final treated effluent into the Naauwpoortspruit stream, final destination being the Witbank dam.

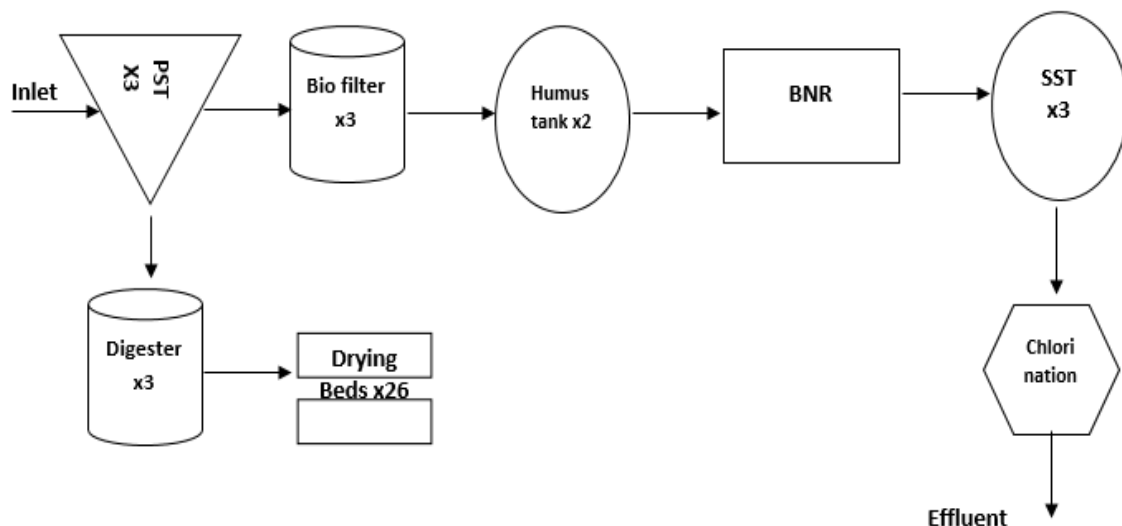
Figure 2: General Municipal wastewater treatment work configuration, plant B-Combination of Bio -filter and BNR system.

Whereas Plant B, Riverview WWTP is a combination of Bio-Filter and Biological Nutrient Removal System with a design capacity of 11ML per day. Oxygen is the engine driver of the two processes for the effective treatment of sewage and the generation of compliance effluent. Treatment works applies the General Authorization Standards and discharge thru small canal that flows into the Olifants River.

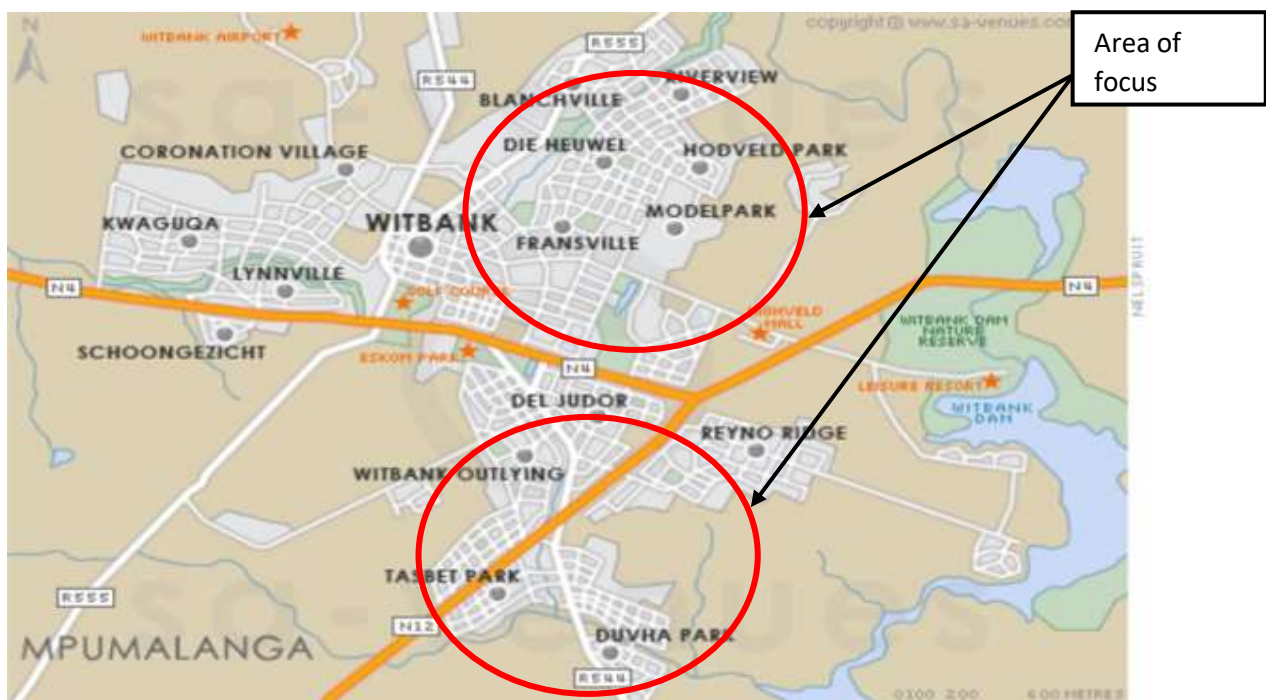
Figure 5: Area served by Naauwpoort WWTP and Riverview WWTP

The two wastewater treatment works are allocated at the urban area and situated few kilometres from water resources, where both discharge the final treated effluent into. Naauwpoort WWTP discharge into the Naauwpoortspruit which flows directly into the Witbank dam, while Riverview WWTP discharge into the Olifant River (Zitha Goldswain, 2014). Witbank dam is used as the abstraction source for the eMalahleni drinking water treatment plant that supplies most part of Witbank area. eMalahleni Local Municipality, the statutory local water service authority for Witbank, has already surpassed its 90 ML/d permission for Witbank Dam by 11 ML/d (Gunther et al., 2006).

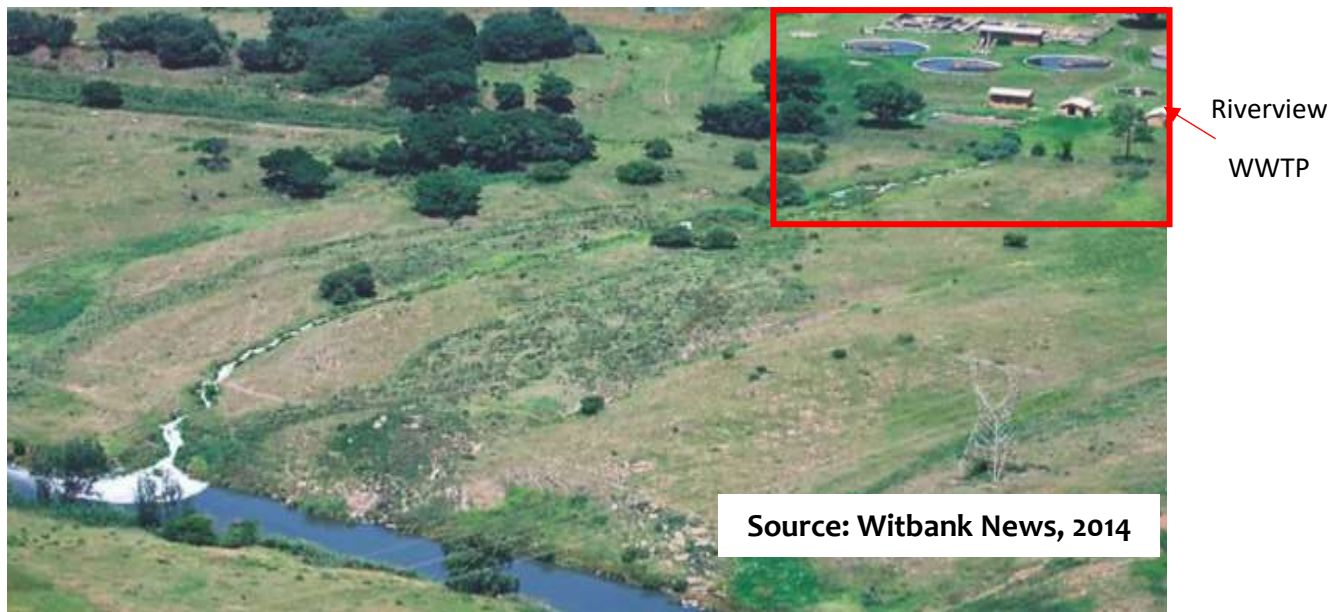
Figure 7: This is a picture regularly seen, white foam coming from Riverview Wastewater Treatment plant and running into Olifants River.

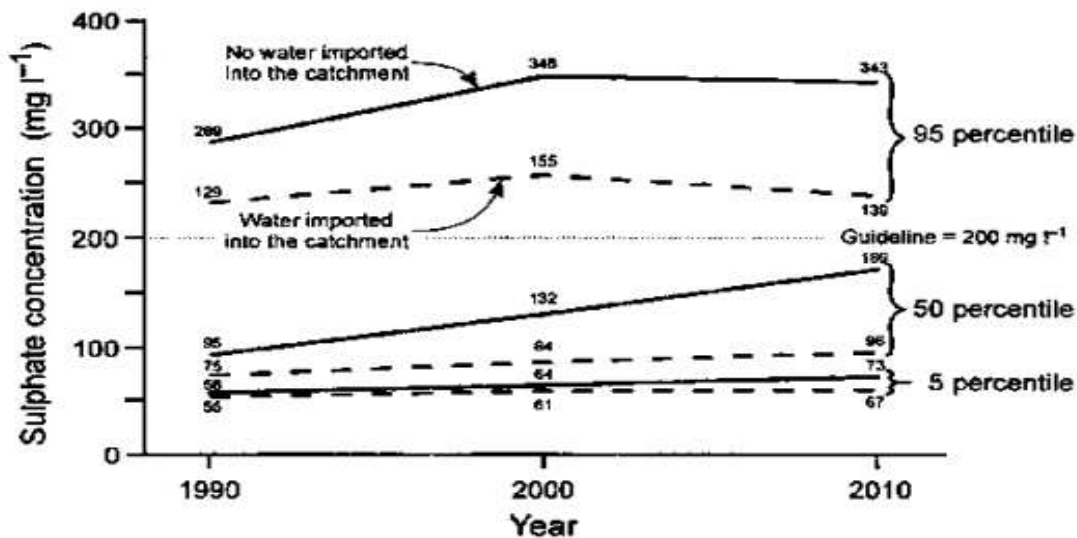
A variety of streams are present in the catchment area, along with elevated levels of compounds harmful to the natural aquatic ecosystem. These chemicals are predominantly metals and ammonia. Acid mine drainage linked with coal mining is mobilizing metals. Aluminium, iron and manganese are the primary metals of concern. Ammonia originally comes from wastewater effluent (Waters, Meiring and Barnard, 1993).

Figure 8: The present and predicted sulphate concentrations in Witbank Dam

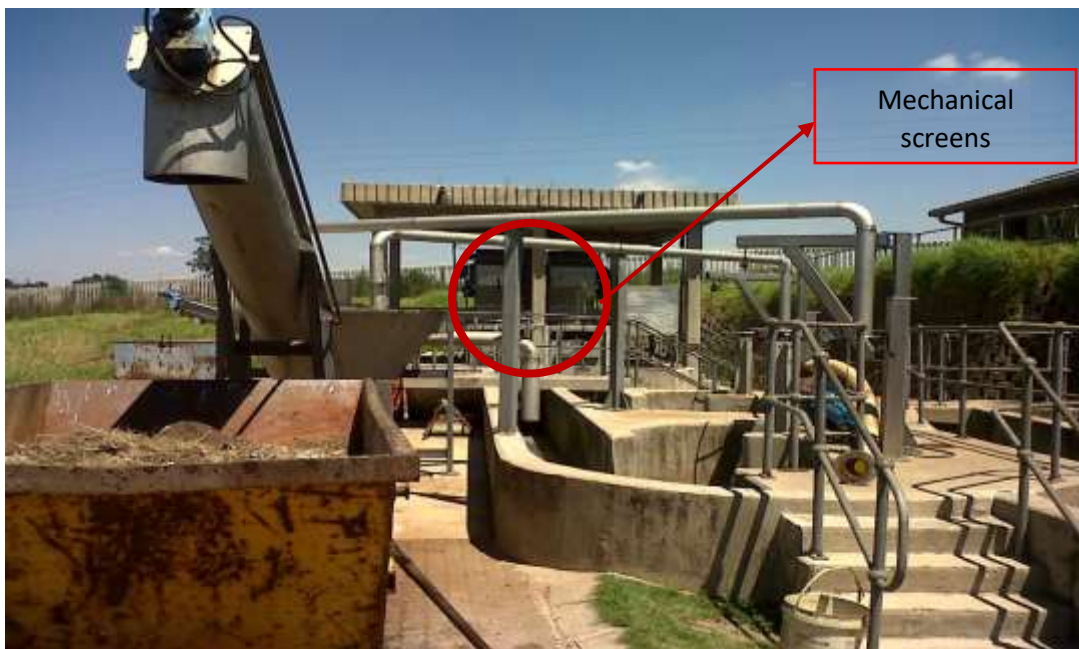
Figure 9: Naauwpoort WWTP Inlet works

Both Wastewater treatment plants operates 24 hours with two shift cycle. Sewage enters Inlet works where debris is removed either by mechanical screen or hand rake. During site visits a Process of debris removal was done to prevent the clogging of pumps. The removed debris were stored in the waste bin allocated, which is then removed by the municipal waste department and dumped at the municipal landfill.

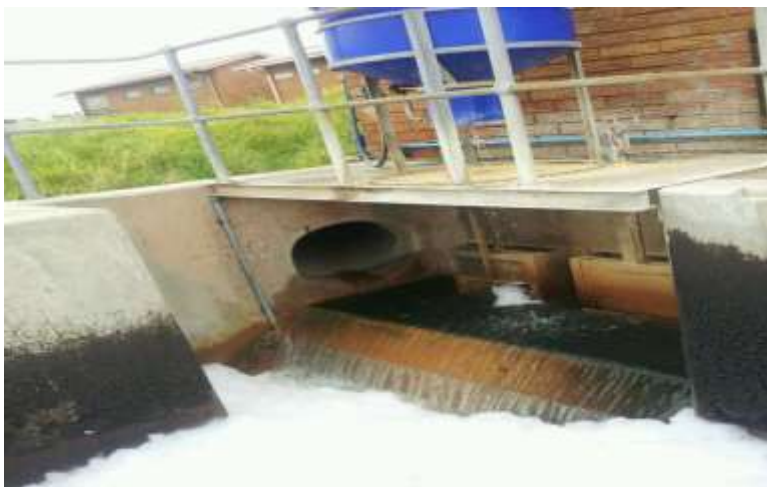
Figure 10: Dosing chamber

Effluent from Secondary clarifiers is then chlorinated with Hth (Calcium Hypochlorite) pills or chips. Final effluent is discharge to Olifants River and Naauwpoortspruit stream that feeds the Witbank dam.

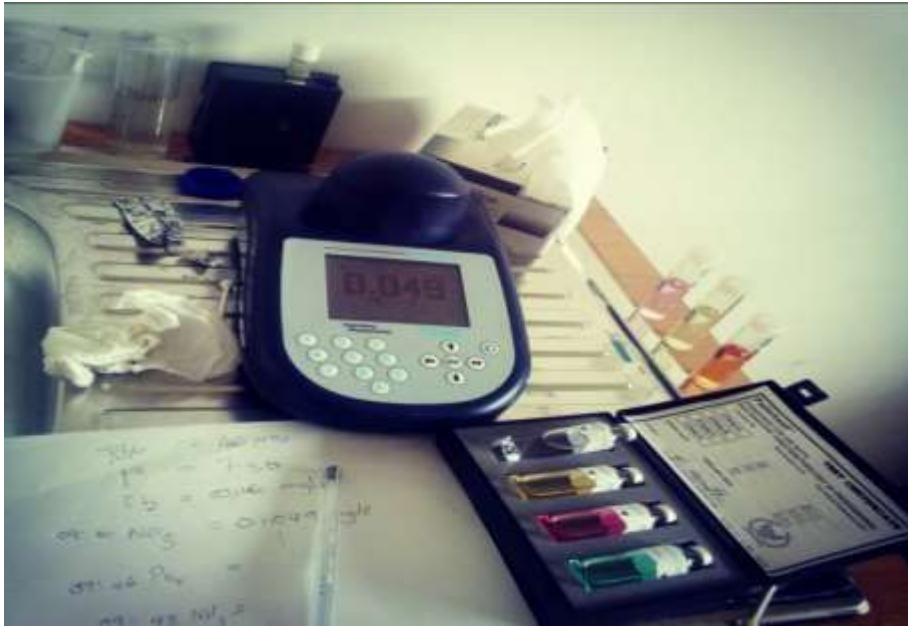
Figure 11: photometer 7500 Bluetooth –palintest

The Palintest Photometer 7500 Bluetooth is a direct reading, waterproof photometer used to determine key water quality parameters for drinking water, wastewater and process water samples. Optical absorbance techniques rely on the use of Palintest (spectro) photometric reagents, producing visible colours with complex reaction analysis. The strength of the emitted colour is measured with the Photometer 7500 and the data are measured against the stored calibration data to deliver the final result.

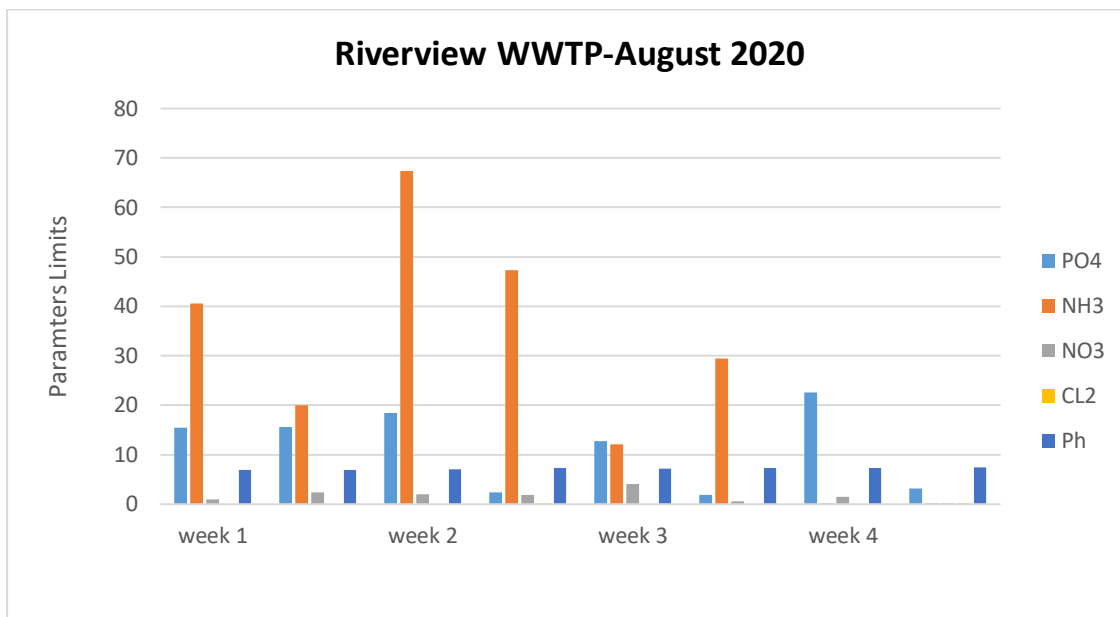
Riverview WWTP did not comply with Phosphates (PO₄) and Ammonia (NH₃) during analysis weeks. The concentrations of this two parameters was relatively high. Effluent is discharged into the Olifants River which is near the plant. The plant was also not dosing during week 1 and 3, chlorine Hth was not available. There was inflow containing oil getting into the plant, it was suspected it comes from the

industrial area. This plant is under pressure, due to developments in the area and is currently over capacitated and the treatment process retention time is not enough, resulting in poorly treated effluent at discharge.

Figure 13: Riverview WWTP compliance graph

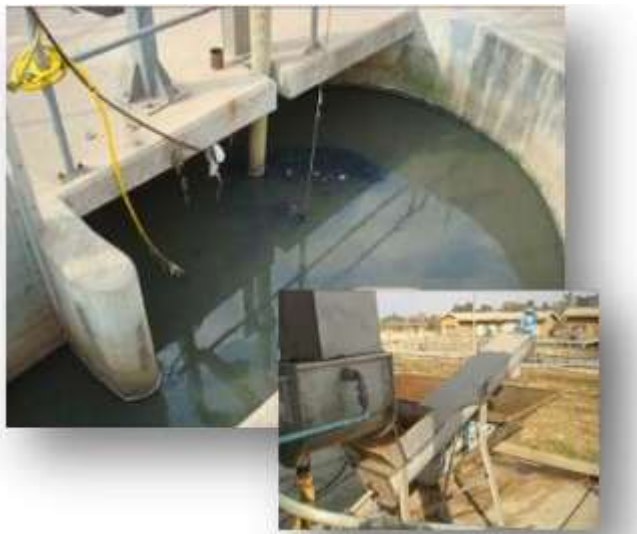
Naauwpoort WWTP was under renovation, which prevented a fair statement on the condition of the plant during the Green Drop assessment in 2011, and some negative results were concluded and reported during the assessment of the plant. Below are true evident of poor plant maintenance and management found;

- The inlet work was functional, but the screenings made their way into the biological nutrient removal plant.
- Grit removal was badly impaired by pump blockages (damages) and hardened grit accumulation visible in the grit canals, the Grit classifier was not working.
- Five aerators were not functioning at the Biological Nutrient Removal Facility.
- no process control available
- There poor sludge characteristics evident
- There was disinfection, but the effectiveness of disinfection was not verified
- Sludge drying beds have not been maintained and are not well managed for sludge disposal.

Figure 16: The condition of inlet area, Naauwpoort WWTP during 2010/2011 NGDA

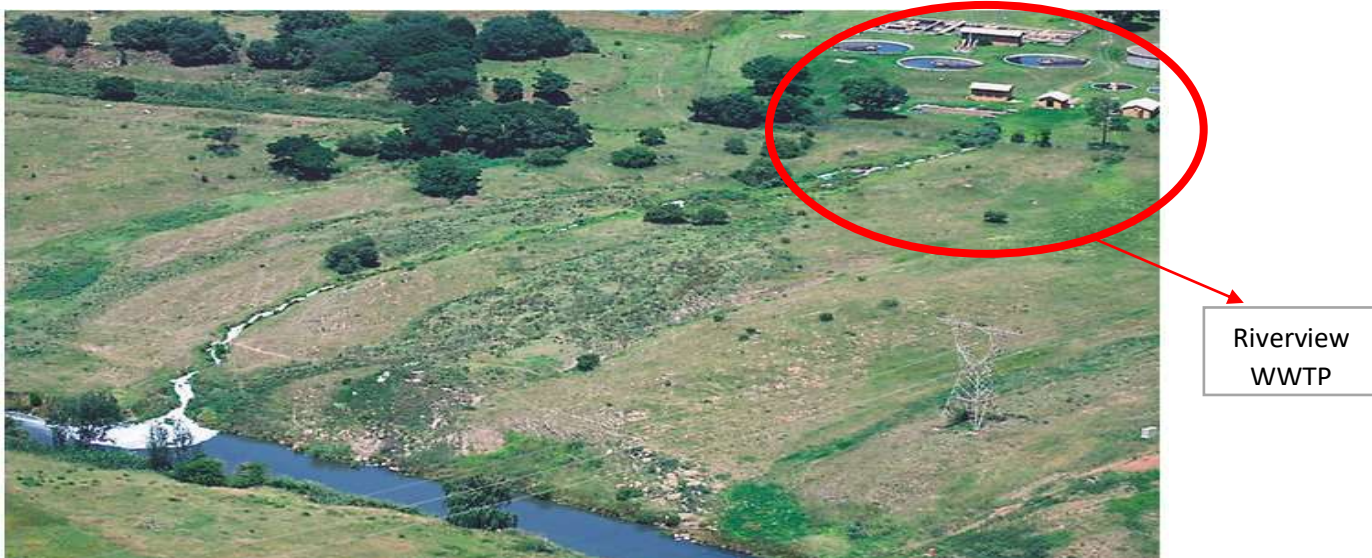
Figure 17 : This is a picture regularly seen, white foam coming from Riverview wastewater treatment works and running into Olifants River. (Witbank News, August 13, 2014)

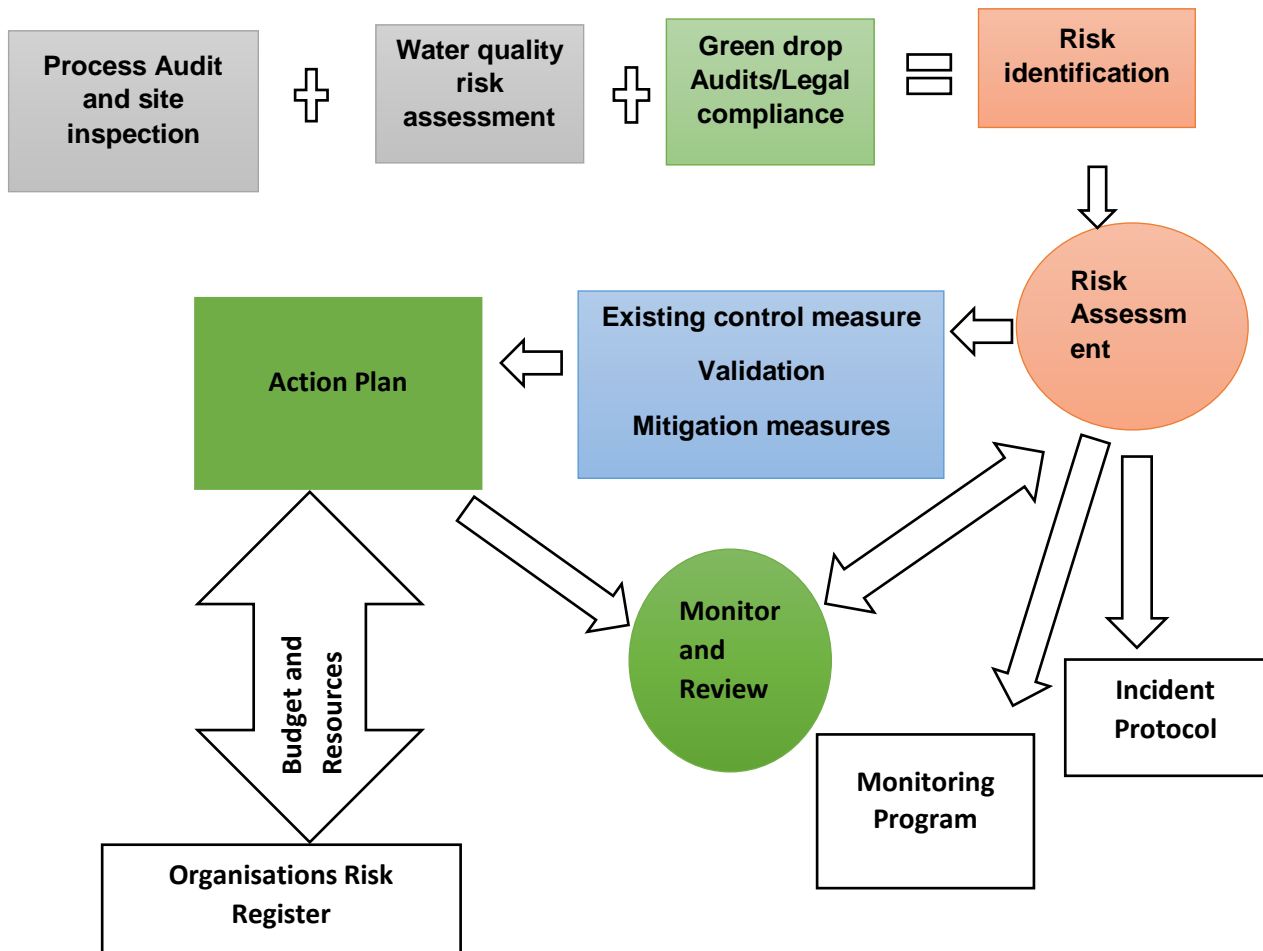
Figure 19: Risk assessment flow diagram

The following **overall Risk management process** must be implemented for effective operations;

Should the above overall risk management process not be implemented and not considered and the non-employment of people with right expertise, together with monitoring and maintenance of the wastewater plants amongst other required factors persist and without effective motivation, complying effluent at discharge will not be successful and will remain a dream.
