LOW COST HIGH BENEFIT IMPROVEMENTS TO BEN SCHOEMAN FREEWAY

Mrs AC Hanekom (BKS), Dr PJ Strauss (BKS), Mr PG Wilken (BKS)
and Mr HJ Kotze (SANRAL)

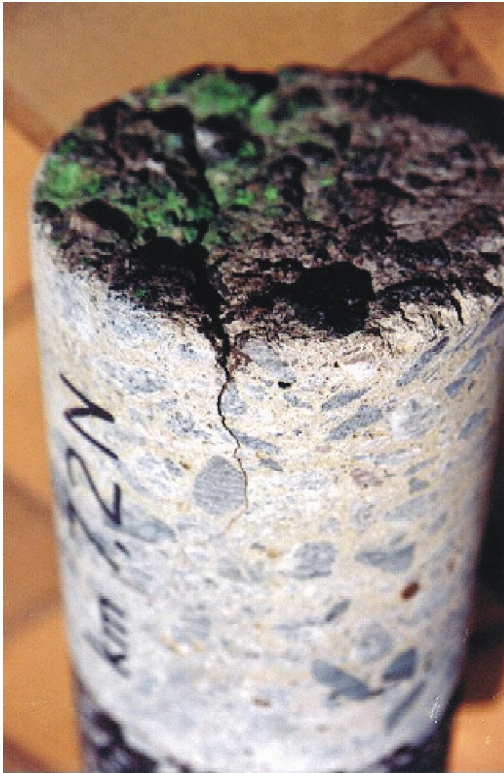
The first core was drilled at N1/21 km 7,2 on the northbound carriageway. During road construction, problems had been experienced at this specific position, due to excess slagment in the concrete mix. Although the surface had weathered considerably more at this point than the rest of the road and the core was drilled on a transverse crack, the concrete proved to be structurally sound, with the crack feathering out about two-thirds of the depth of the core (**Photo 1**).

Photo 1: km 7,2 N - Surface weathering due to high slag content

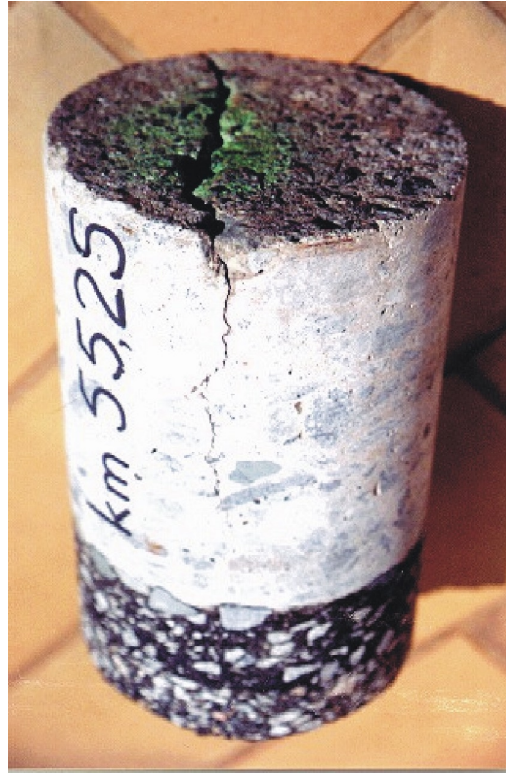
The second core was drilled at N1/20 km 55,2 on the southbound carriageway. Once again, the core was drilled across a transverse crack that apparently showed signs of pumping. Although the crack was approximately 5 to 10 mm wide on the road surface, it also feathered out, about two-thirds through the depth of the core (**Photo 2**).

Photo 2: Transverse crack showing signs of "pumping"

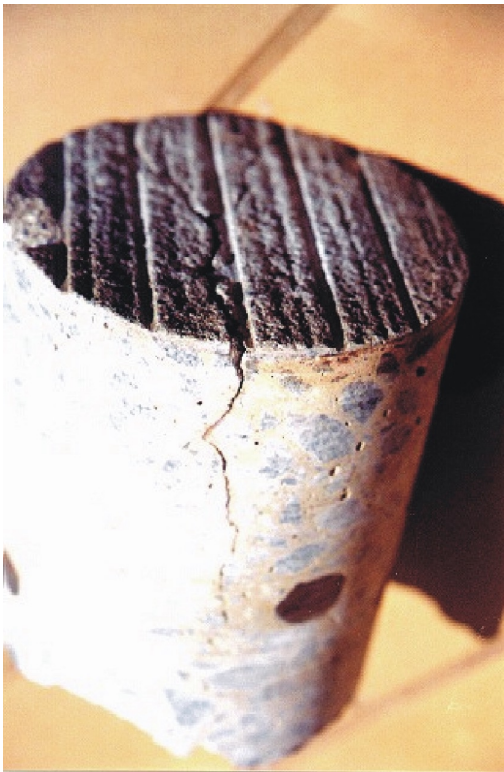
Finally, in an attempt to obtain a core that is cracked right through, a position was chosen at N1/21 km 3,8 on the southbound carriageway, where a transverse and random crack met and where pumping was also observed, (**Photo 3**). Unfortunately, the core had to be broken off, as the drilling process was slow due to the high strength of the concrete and the fact that reinforcing steel was encountered.

Photo 3: Intersection of transverse and random cracks with "pumping"

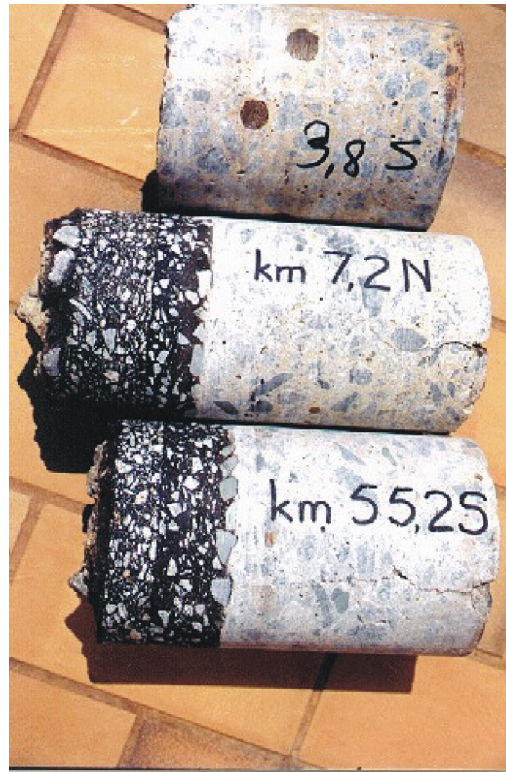
The above three cores led to the conclusion that the existing pavement was structurally sound and that no further drilling of cores was necessary. The cores also showed that there was no ingress of water into the asphalt beneath the CRCP at transverse cracks, since no stripping of asphalt was evident. Nor was there any movement of the CRCP relative to the asphalt, as there were no gaps between the CRCP and the asphalt (**Photo 4**). Signs of pumping on the surface were therefore defined as stains originating from an unknown source.

Photo 4: Good adhesion between asphalt and concrete

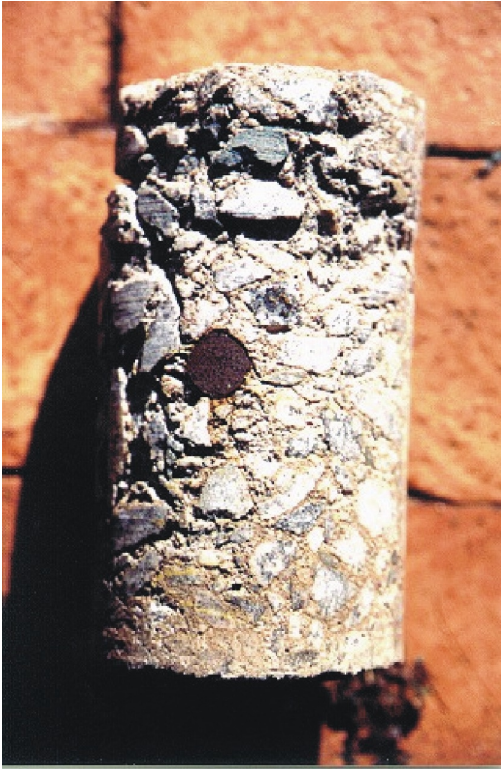
During construction of the CRCP in 1987/8, inadequate mixing of the cement and slagment did occur at times. The relevant sections of concrete were removed, but cores were taken from these sections prior to their being broken out. **Photo 5** shows to what extent one of these cores has weathered after 10 years of exposure to the elements.

Photo 5: Weathering of concrete containing badly mixed cement/slagment mixture, after 10 years' exposure to elements
