## mapping the potential

### SITE POSITION & MESO-CONTEXT

## IDENTIFYING EXISTING ARCHITECTURE

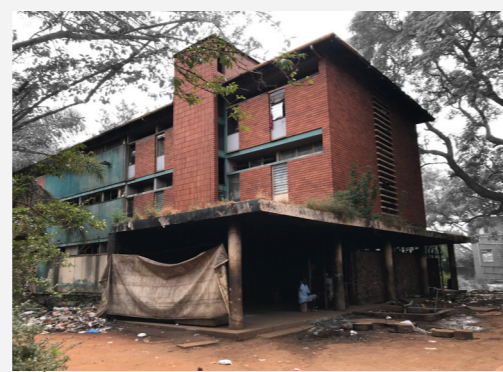
#### 1960s/70s Building:

**Moderate-high significance**  
(Possibly a heritage building, exemplary of a functional regionalist style)

**Condition:** Fair. Some surface damage and vandalism. In relatively good condition compared to other non-heritage buildings on site. Occupants have seemed to take ownership.

**Materiality:** Face brick, concrete frame structure and metal roof sheeting.

**Other:** Three storeys. Exemplary of a functional regionalist style as a variant of the Modern Movement, with evidence of climate considerations and material articulation.

**Proposed Action:** To be retained, adapted and treated with similar sensitivity as a heritage building.

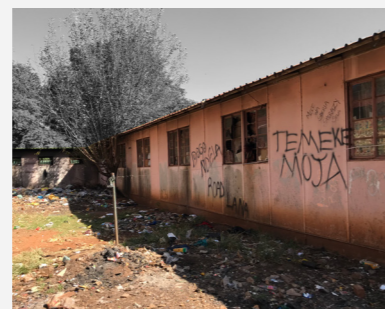
#### Pre-fabricated asbestos structures:

**Lowest significance**

**Condition:** Very poor. Damaged asbestos – hazardous and uninhabitable.

**Materiality:** Asbestos and steel structure and metal roof sheeting.

**Other:** One storey. These five structures are all placed on the site with little consideration of the overall site layout. Their elongated “dead” facades provide little to no interaction with the spaces adjacent, especially the narrow leftover spaces between the structures to the south, which are predominantly used as dumping sites. The asbestos presents health risks and the exteriors provide little thermal comfort to the narrow interiors.

**Proposed Action:** To be removed/demolished.

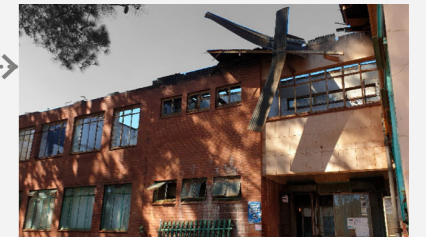
#### North Brick Building:

**Low significance**

**Condition:** Very poor. Severe structural and surface damage caused by neglect and fires. Sanitation equipment and piping removed. Parts of the building are used for housing by occupants.

**Materiality:** Face brick, suspended timber floors and metal roof sheeting

**Other:** Two storeys. Impermeable, elongated form cuts site off from surroundings. Minimal architectural contribution in terms of style, craftsmanship and architectural value. Positioned extremely close to 1927 Hostel, creating a narrow, dead passage between the two buildings.

**Proposed Action:** To be demolished.

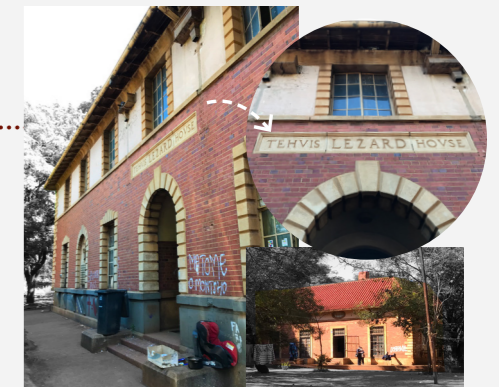
#### “Lezard” Hostel, Dining Hall & Staff Quarters:

**Highest significance**  
(Heritage buildings by a significant architect)

**Condition:** Fair. Some surface damage and graffiti. In relatively good condition. Occupants have seemed to take ownership of the buildings by cleaning and appropriating them for housing.

**Materiality:** Red (presumably Kirkness) face brick in English bond with sandstone accents and rustication; parquet and vinyl floor finishes; pressed steel and asbestos ceilings; and clay roof tiles.

**Other:** Hostel – two storeys; dining hall and staff quarters – one storey. Exemplary of Gordon E. Leith's

classicalist “traditional style” (Artefacts.co.za n.d. (2)) with its symmetry, vaulted foyer and arched openings. Showcases an important architectural contribution and craftsmanship attributed to Gordon Leith's works.

**Proposed Action:** To be retained and adapted with sensitivity (specifically the hostel and dining hall).

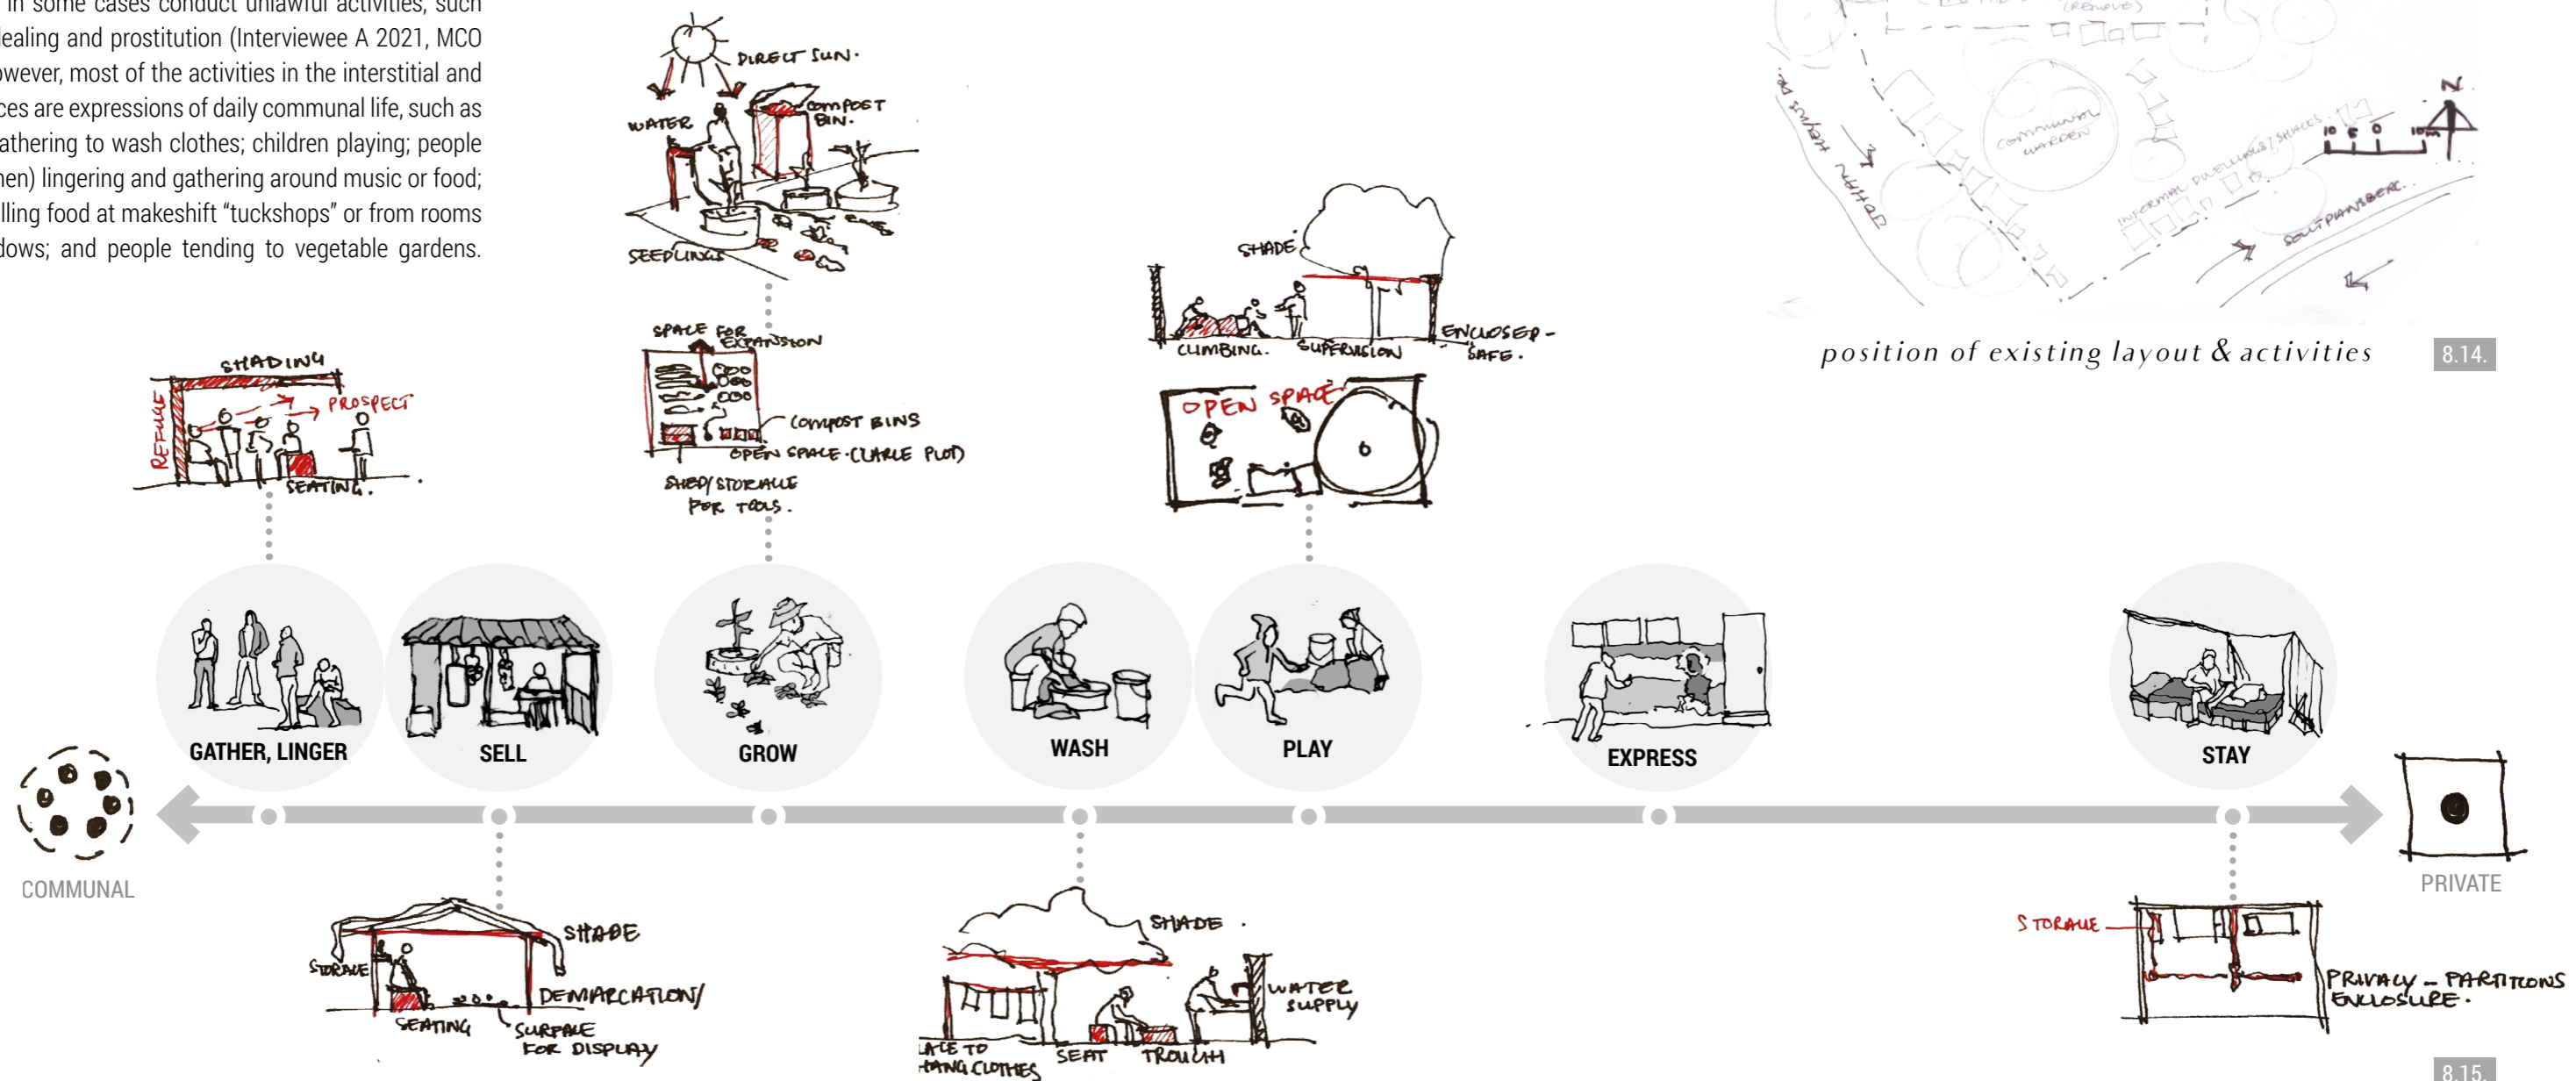
Fig. 8.15. Below: Identified activities are unpacked briefly in terms of their spatial, physical and functional requirements. Most of the activities happening between buildings and in the outdoor spaces are communal in nature (Author 2021).

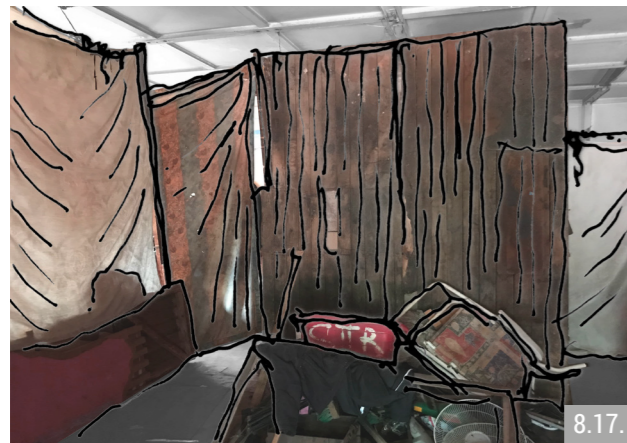
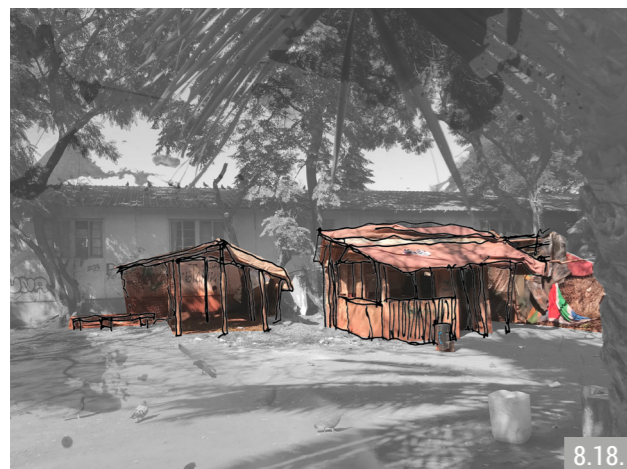
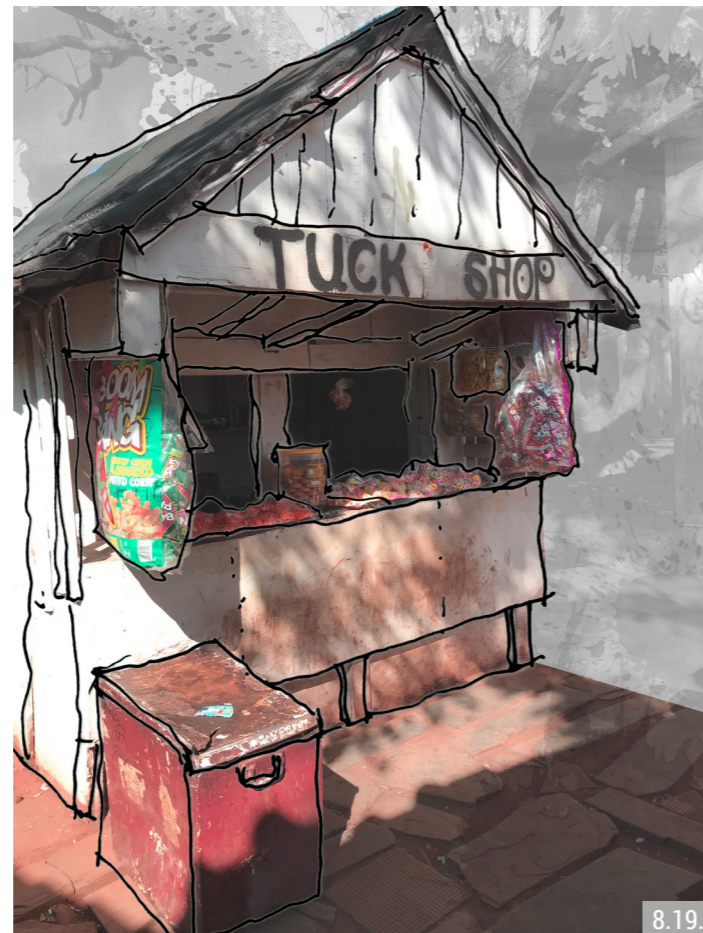
Fig. 8.17.–8.19. Bottom left: Photographs of structures and materials of appropriation on site, revealing the temporal and collaged materiality of the additions.

The identified activities are viewed as anchor points and programmatic catalysts in the development of interlinking event-driven spaces for the programme and intervention strategy to follow (see Figure 8.16.). The evolving, transient nature and the tectonic, adaptable materiality of the “makeshift” structures, room partitions and enclosures that inhabitants have added over time inform an incremental, flexible and adaptable approach to programme, design and even materiality that accommodates, acknowledges and celebrates this ongoing process of appropriation (see Figures 8.17.–8.20.). The existing appropriation and activities also indicate the “bare minimum” or essence of what is required practically and spatially for certain quotidian rituals (see Figure 8.15.). This flexibility and transience should, however, also be balanced by aspects of permanence that anchor the programme and materiality and reference the presence of past layers. Thus, the conceptual approach should negotiate between the existing tensions on site between old and new; informal and formal; social and heritage issues; solid and void; communal and private space; permanence and transience (see Figure 8.21.).
