Double Death Electrocution in the Bathtub

CASE SUMMARY

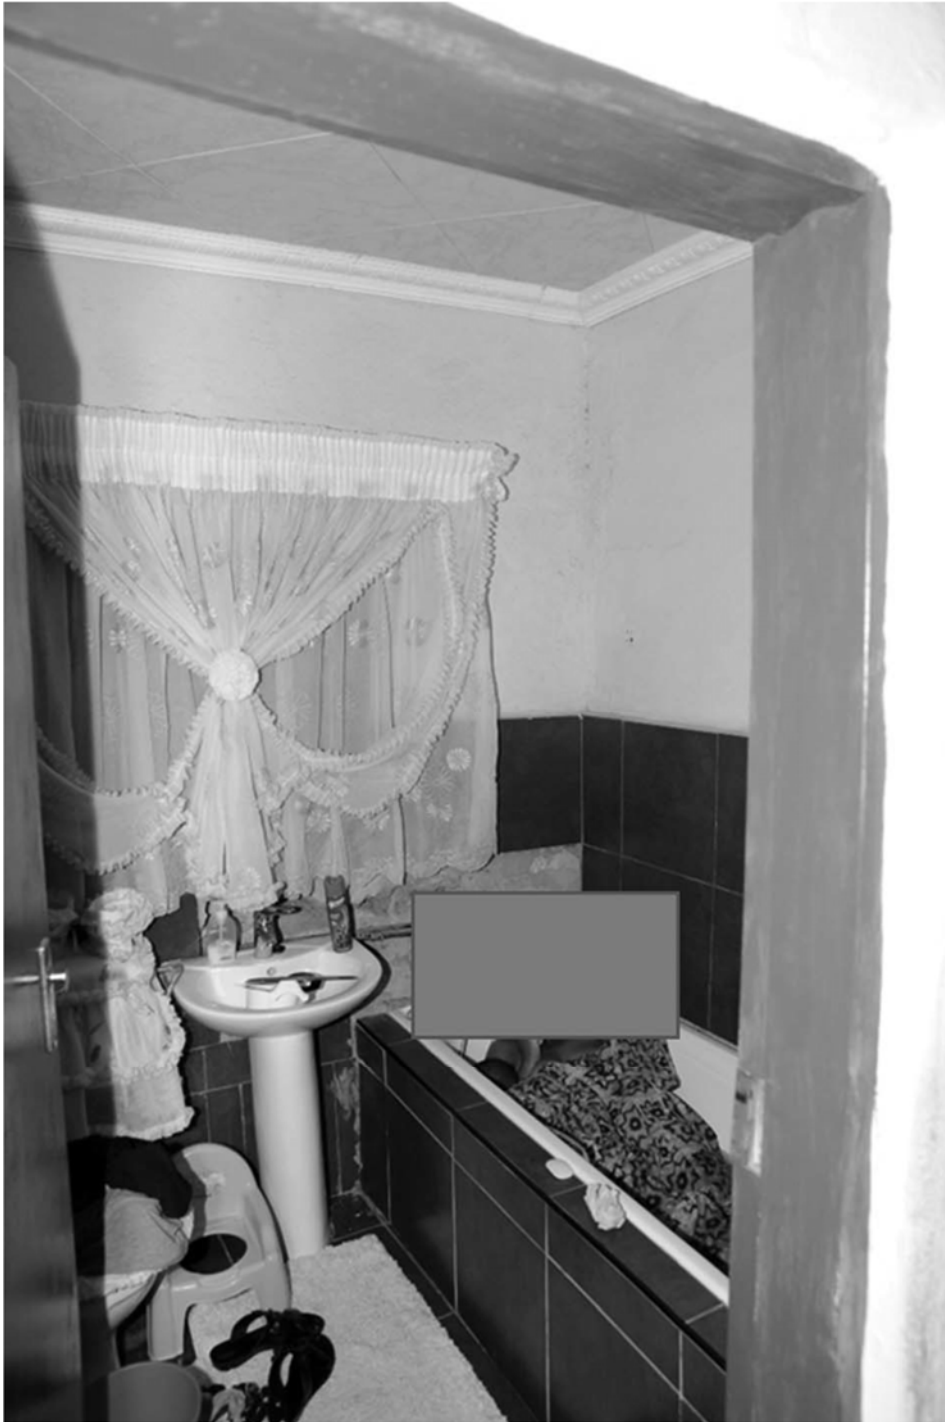
FIGURE 1. A 25-year-old woman and her 3-year-old son who were found dead in the bathtub because of electrocution (photographs courtesy of Captain Thierry Werner Beheydt, Provincial CSI, Gauteng, and Dr Bathabile Soul).

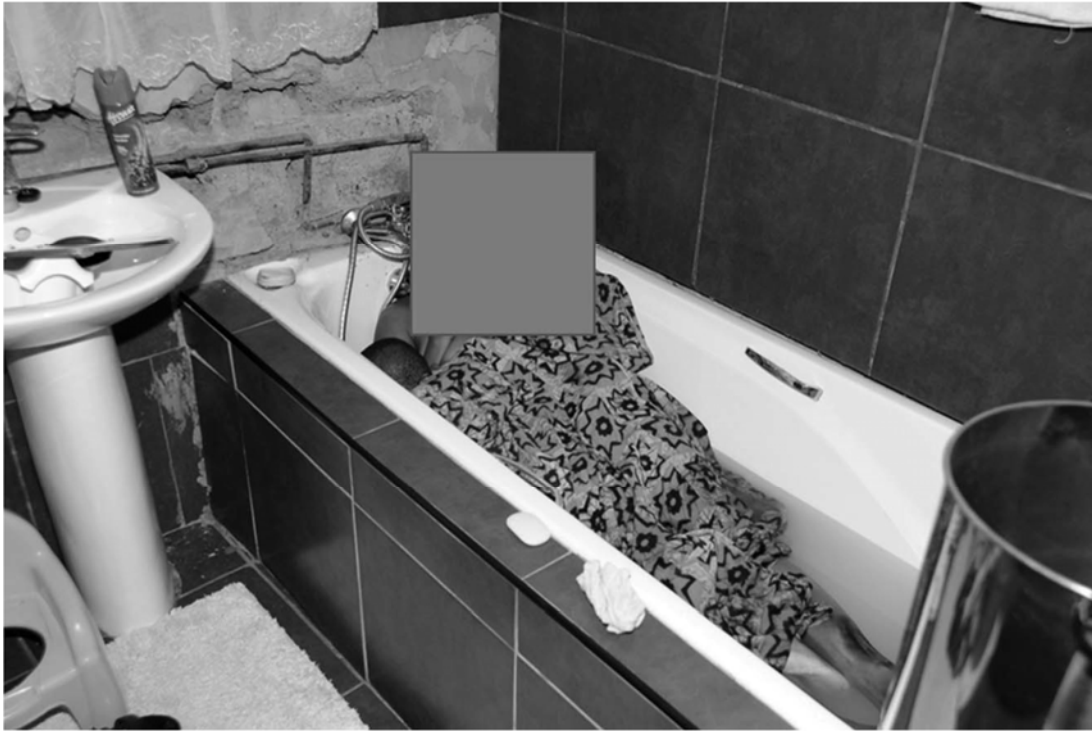
FIGURE 2. Upon inspection, naked bodies of a woman and a boy were observed inside a water-filled bathtub. At the outset of the examination, both bodies were covered with a blanket (photographs courtesy of Captain Thierry Werner Beheydt, Provincial CSI, Gauteng, and Dr Bathabile Soul).

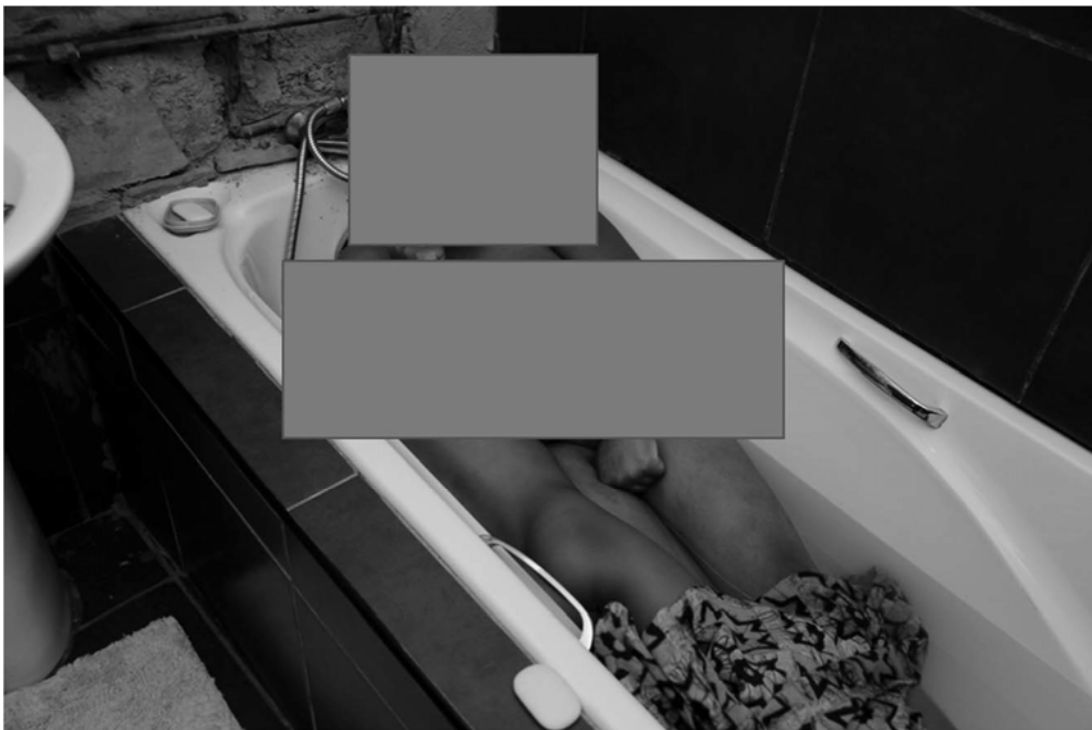
FIGURE 3. The woman was observed lying supine along the length of the bath with the posterior region of the body submerged in the water, and a defined water level line and hypostasis were observed. The body of the boy was also present inside the bathtub lying longitudinally prone between the one free wall of the bathtub and the right side of the body of the woman (photographs courtesy of Captain Thierry Werner Beheydt, Provincial CSI, Gauteng, and Dr Bathabile Soul).

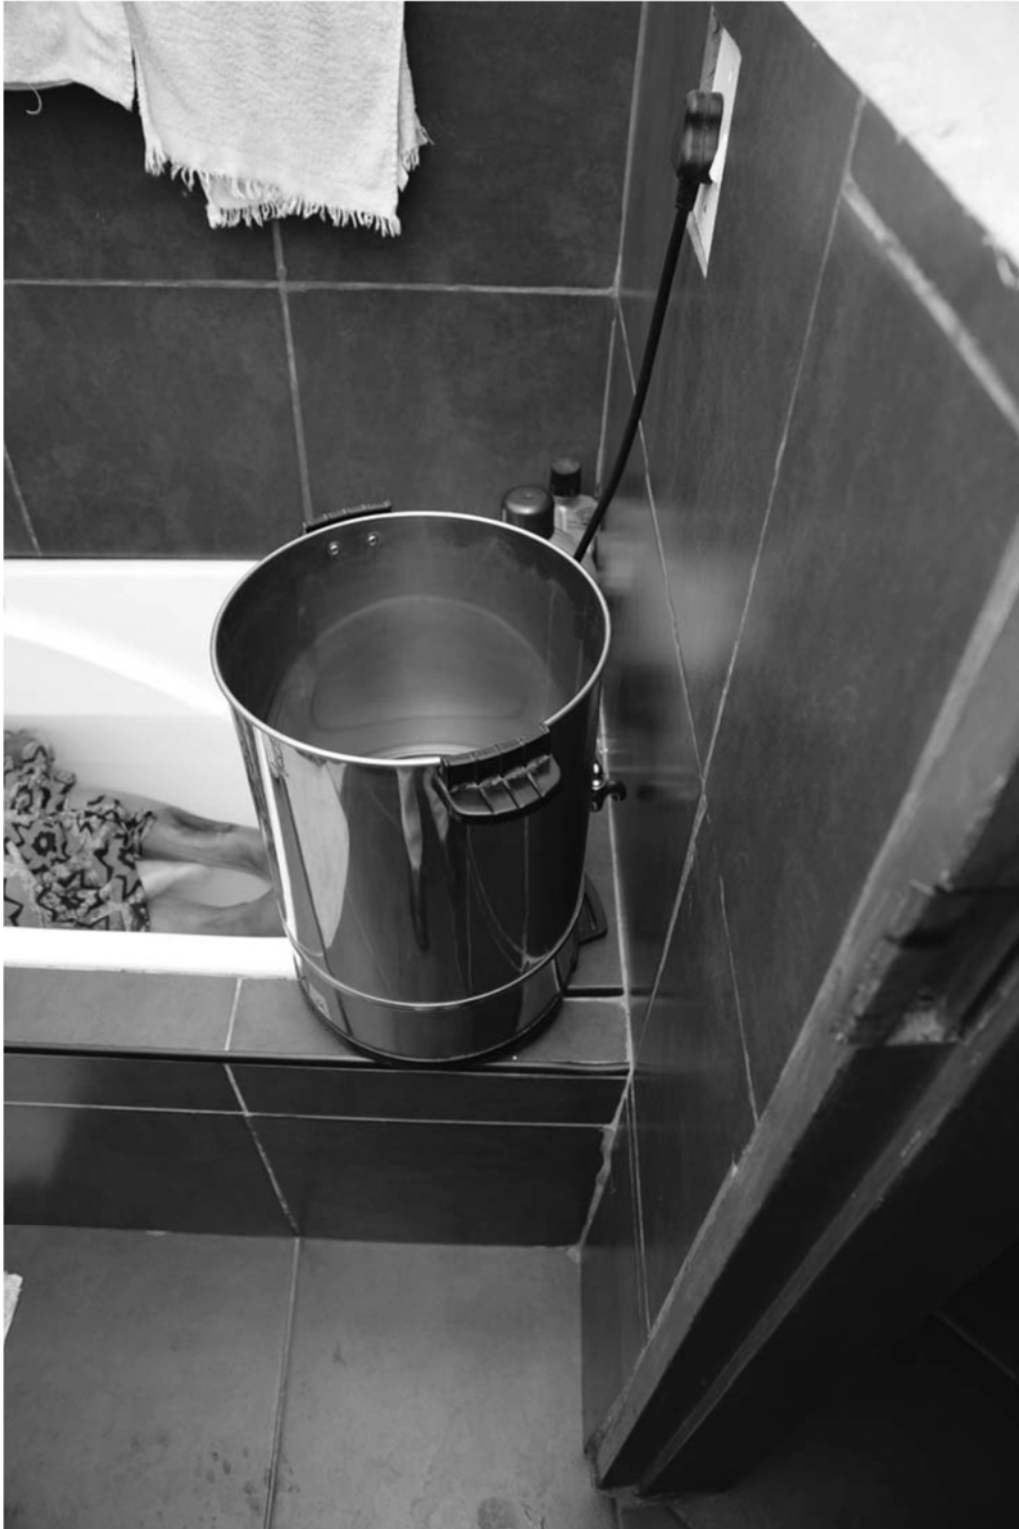
FIGURE 4. An electrical urn was used to heat the bathwater. The urn was plugged into the mains and apparently fell into the water (photographs courtesy of Captain Thierry Werner Beheydt, Provincial CSI, Gauteng, and Dr Bathabile Soul).

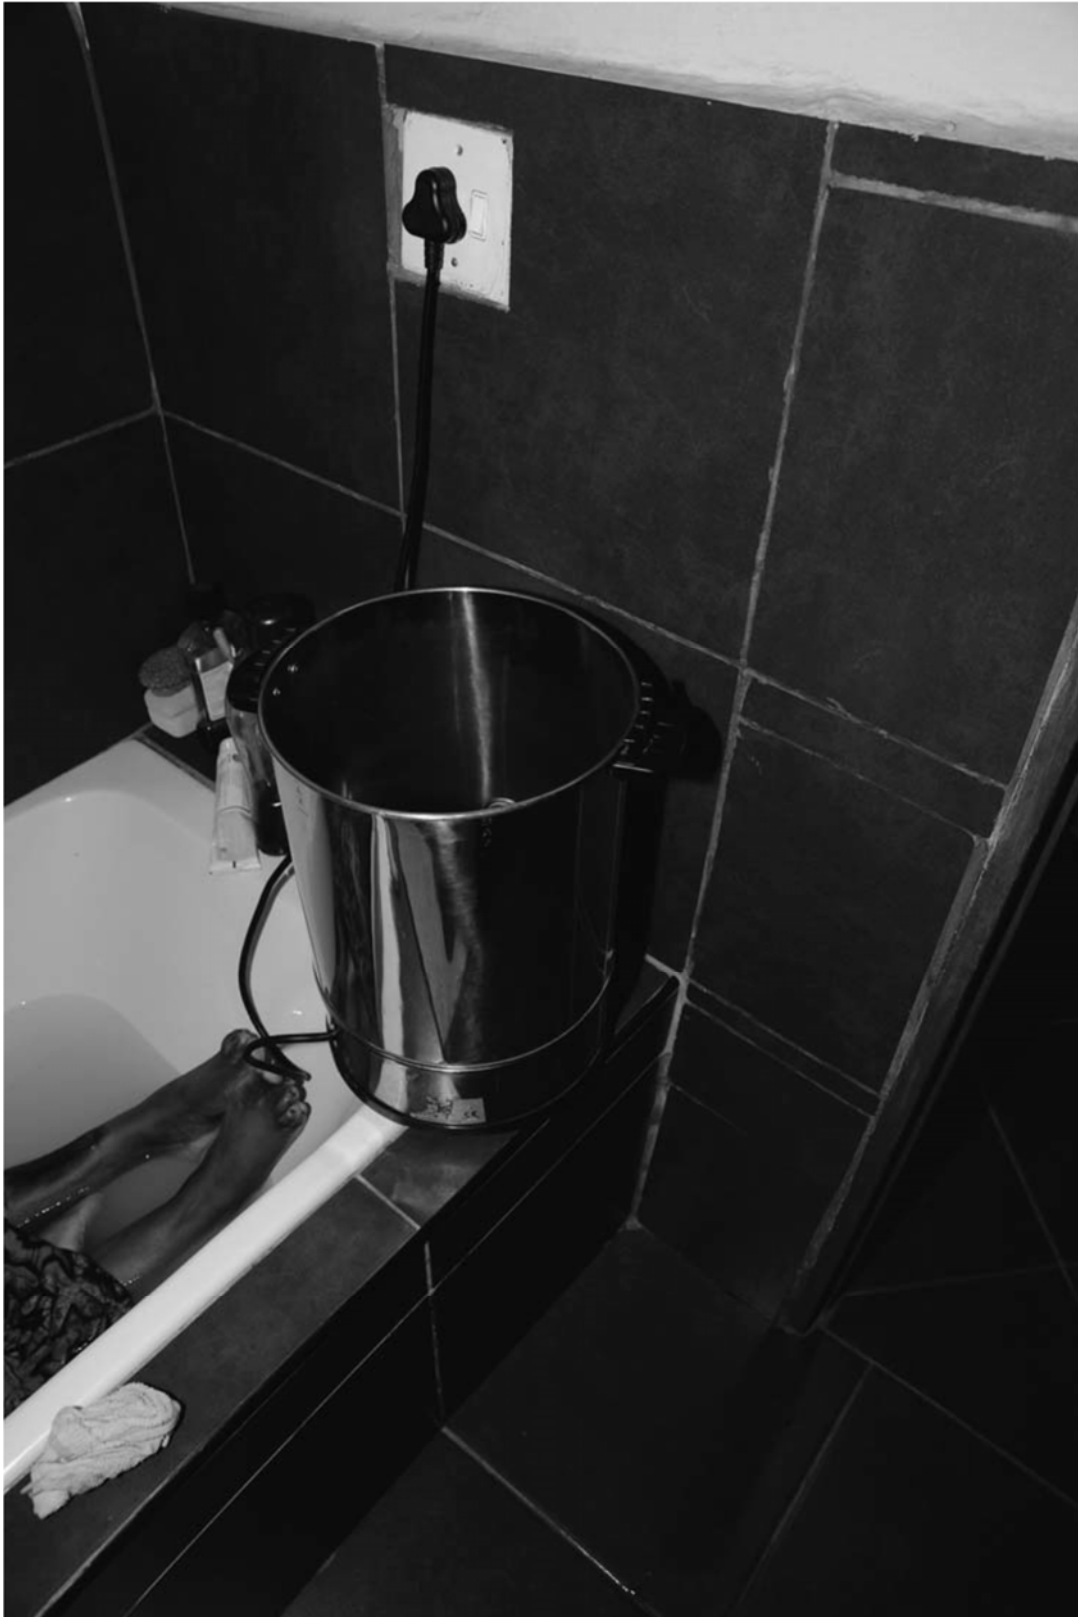
At the scene, inside the bathroom of a suburban house, 2 bodies lying side-by-side were present. Initially, the bodies were covered with a blanket by the next of kin. An electric metal urn, containing minimal water, was noted on the edge of the bathtub plugged into a plug point installed inside the bathroom.

FIGURE 5. Inside the bathroom, a metal urn containing minimal water was noted on the edge of the bath plugged into a plug point installed inside the bathroom (photographs courtesy of Captain Thierry Werner Beheydt, Provincial CSI, Gauteng, and Dr Bathabile Soul).

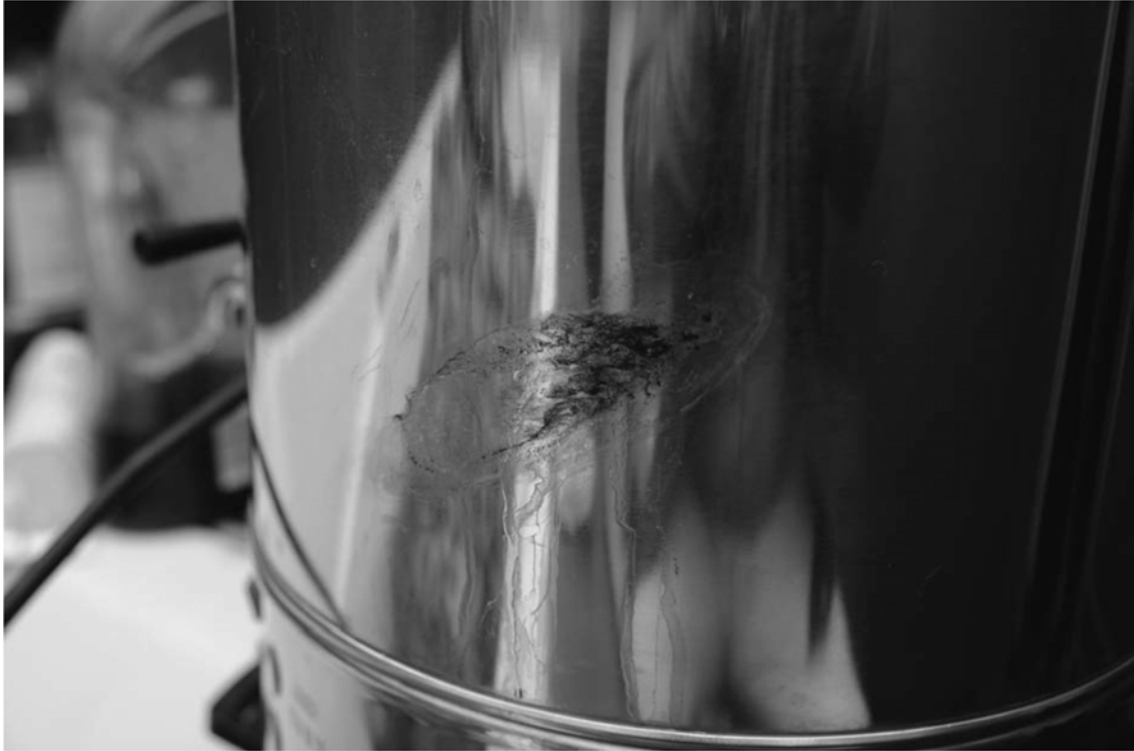
FIGURE 6. An injury consistent with an electrothermal injury was observed on the left leg. A mark corresponding with this injury was observed on the side of the urn (photographs courtesy of Captain Thierry Werner Beheydt, Provincial CSI, Gauteng, and Dr Bathabile Soul).

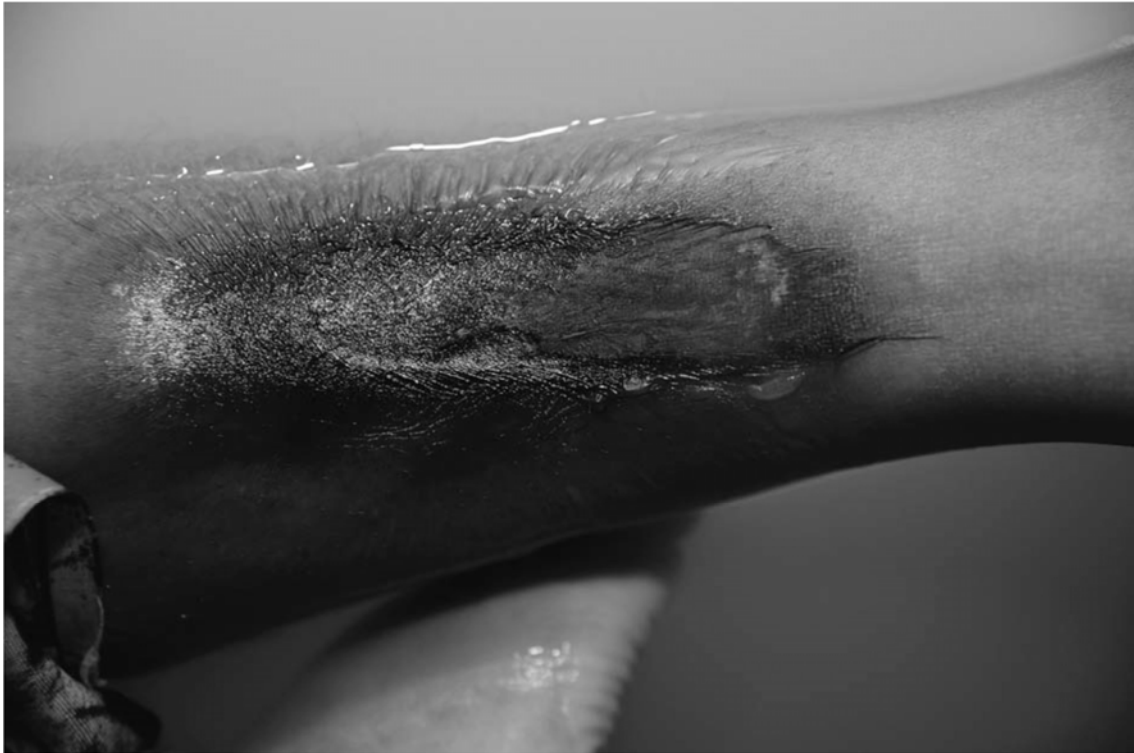
FIGURE 7. An injury consistent with an electrothermal injury was observed on the left leg. A mark corresponding with this injury was observed on the side of the urn (photographs courtesy of Captain Thierry Werner Beheydt, Provincial CSI, Gauteng, and Dr Bathabile Soul).

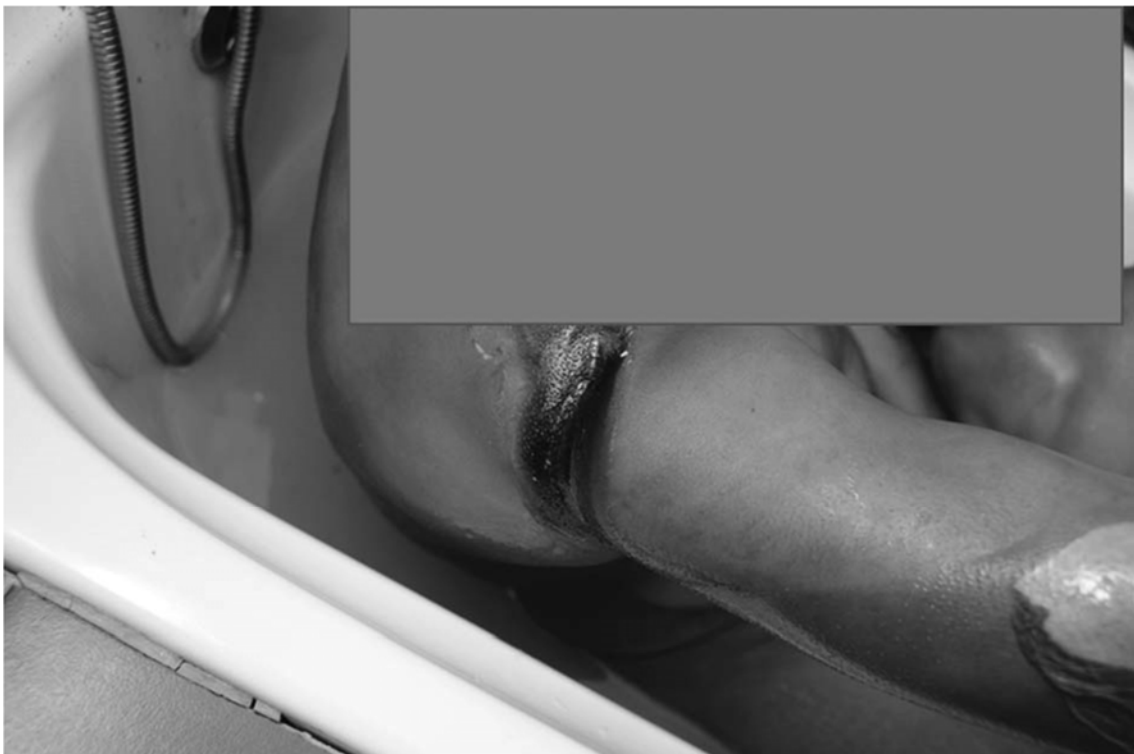
The female body was lying supine with the back of the body submerged in the water. A well-defined water level mark with lividity/hypostasis was observed on the posterior aspect of the body. The head was above the water with the right ear and right shoulder in contact with the chrome metal tap. A plume of white froth was present at the nostrils. Electrothermal injuries were observed on the left leg, which corresponded with a mark on the one side of the electrical urn. Electrothermal injuries were also observed on the right ear and right shoulder. No other external injuries were observed upon initial inspection of the body (Figs. 7–9).

FIGURE 8. Electrothermal injuries were observed on the right ear and right shoulder (photographs courtesy of Captain Thierry Werner Beheydt, Provincial CSI, Gauteng, and Dr Bathabile Soul).

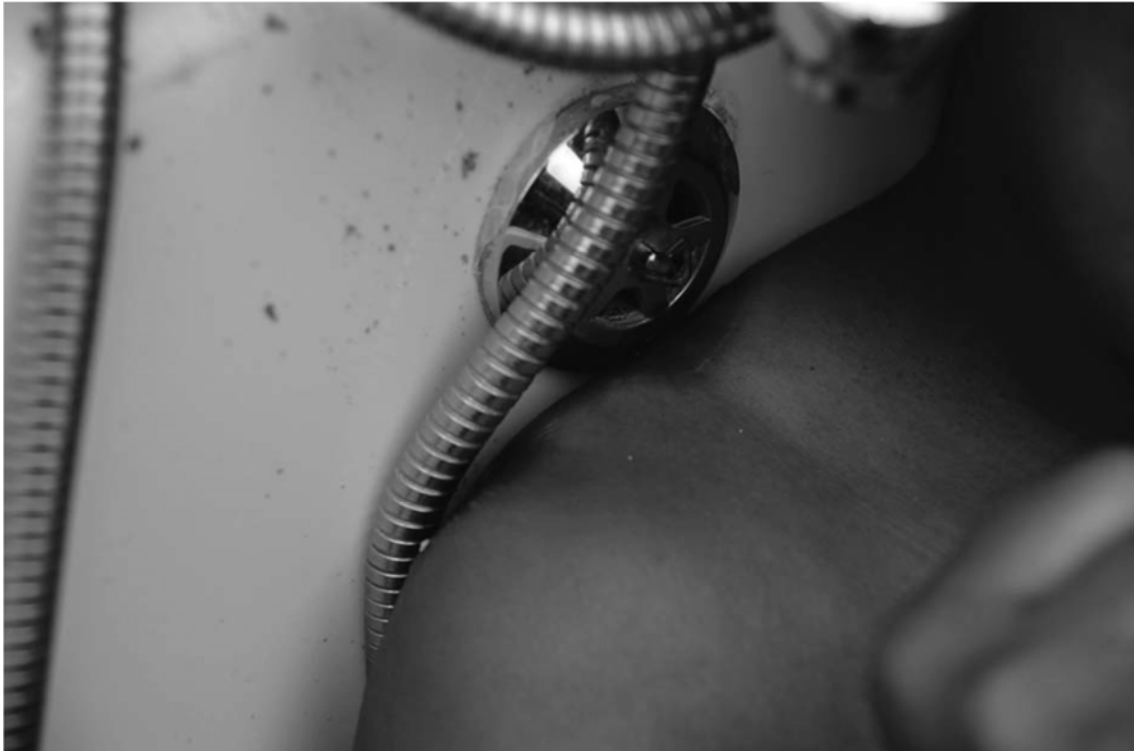
FIGURE 9. Electrothermal injuries were observed on the right ear and right shoulder (photographs courtesy of Captain Thierry Werner Beheydt, Provincial CSI, Gauteng, and Dr Bathabile Soul).

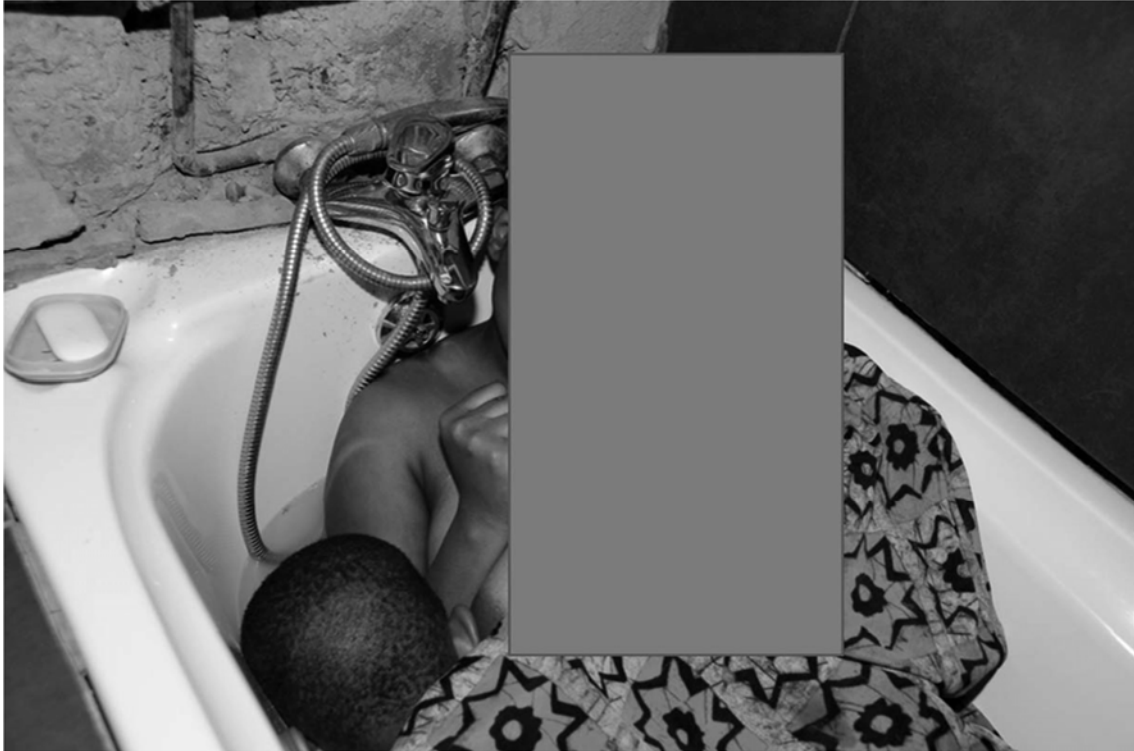
The body of the boy was wedged between the one freewall of the bathtub and the right side of the body of the woman. The boy's face was fully submerged within the water with a plume of blood tinged froth noted within the nostrils and mouth. A clearly defined water level mark with fixed lividity/hypostasis was observed on the anterior aspect of the body. Initial cursory examination at the scene showed an electrothermal burn wound on the right foot. No other injuries were observed upon initial external examination of the body (Fig. 10).

FIGURE 10. The body of the boy was also present inside the bathtub lying longitudinally prone between the one free wall of the bathtub and the right side of the body of the woman. The deceased's face was fully submerged within the water with a plume of blood-tinged froth noted within the nostrils and mouth (photographs courtesy of Captain Thierry Werner Beheydt, Provincial CSI, Gauteng, and Dr Bathabile Soul).

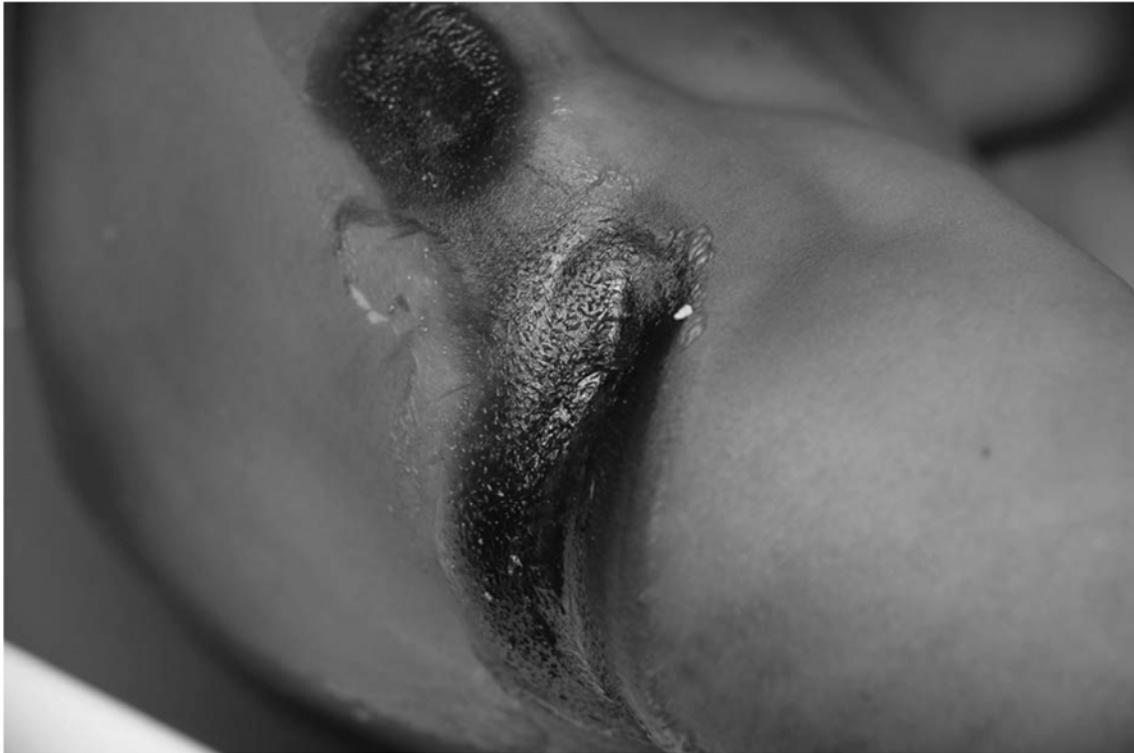
Autopsies were performed the following day (within 24 hours). The female body showed electrothermal, contact burn wounds on the right side of the face, right upper limbs, and left lower limbs (Fig. 11). Features were suggestive of “grounding” injuries. A well-defined water level mark with fixed lividity/hypostasis was distributed on the back of the body. The lungs were congested and edematous (the left and right lungs weighed 430 g and 522 g, respectively). Internal findings were nonspecific (asphyxial findings).

FIGURE 11. At the scene, the woman showed electrothermal, contact burn wounds on the right side of the face, right upper limbs, and left lower limbs. The chief pathology was found on the external aspects of the body consistent of electrothermal burn wounds at areas of “grounding” (photographs courtesy of Captain Thierry Werner Beheydt, Provincial CSI, Gauteng, and Dr Bathabile Soul).
