LESSONS LEARNT FROM IMPLEMENTATION OF NANO MODIFIED EMULSION TECHNOLOGY ON STREET REHABILITATION ON A RECENT SANRAL FUNDED COMMUNITY DEVELOPMENT PROJECT

E HORAK¹*, J KABALE¹, Z NDODANA¹, <u>F Le ROUX</u>², T MATHEBULA³ and R OERLEMANS³

¹Ndodana Consulting Engineers (Pty) Ltd; *E-mail: <u>emileh@global.co.za</u> ²Nyeleti Consulting Engineers (Pty) Ltd ³SANRAL Northern region, SANRAL (SoC)

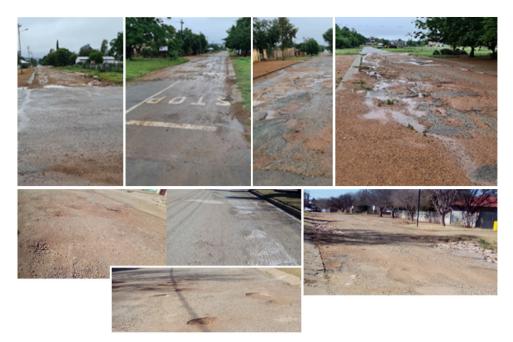
Figure 2: Collage of typical worst case street condition illustration

Like various rural towns in South Africa, other bituminous surfaced streets in Wolmaransstad, as well as Leeudoringstad, fell into severe disrepair over time, became dysfunctional due to lack of basic maintenance and clearly are in need of urgent rehabilitation. Typical forms of distress observed were potholes, loss of bituminous surfacing and in some cases even washaways of the base and surfacing. The distress forms were mostly severe and extensive over the whole street length of these towns. The various forms of distress observed are portrayed by the collage of images in Figure 2 from Wolmaransstad streets directly after seasonal rains. It is clear an innovative solution to the restoration of the street network was needed.

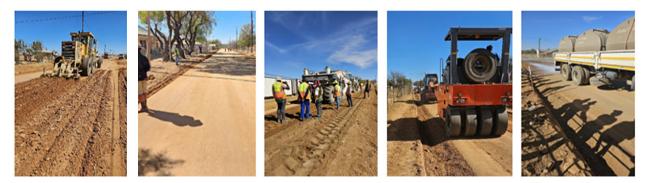
Figure 4: Witpoort gravel preserved street: Grader preparation before hand, compaction before recycling, recycler trainn mixing in 75mm thickness NME, compaction with heavy vibratory roller and pneumatic, Clearspray with water cart

The construction of the NME treated streets was preceded by initial trails on the Witpoort streets. These streets are close to the construction site offices. This close proximity made communication, sample moisture contents, NME mix preparation, and equipment adjustment easier. The streets in Witpoort are all gravel streets and as previously reported only gravel preservation measures were implemented on these streets (Horak et al., 2024). In Figure 4 a collage of images illustrates aspects of the construction on such streets in Witpoort. Preparation work was done with a grader by ripping and blading of 150mm thickness of base material, compaction. The lowest form of gravel preservation was to then spray with Clearseal as the most basic treatment for the very low traffic volume streets (eg <5vpd). Figure 4 also shows some streets in Witpoort where after the top 150mm being ripped and recompacted the NME was mixed into the top 75mm, compacted and afterwards also receiving Clearseal surface application via a converted watercart. These are all defined as low cost gravel preservation and mobility measures for gravel streets (Horak et al., 2024)

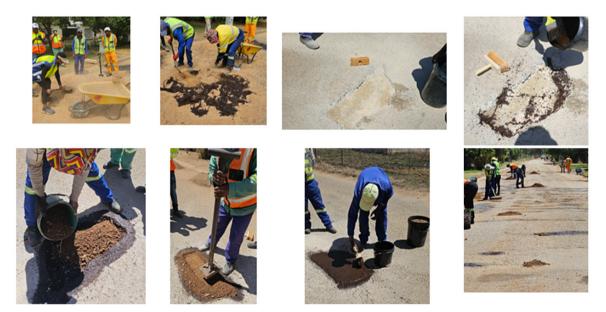
Figure 6: Clockwise, Ease of hand mixing G5 and NME demonstrated, pothole cleared of all loose material, sides and bottom painted with NME, mixed G5 with NME placed in pothole with lips also painted with NME, compacted with tamper, NME painting on top after compaction and large scale production with local labour on Smit Street, Wolmaransstad

Pothole patching was the most labour friendly utilisation of local unskilled labour. Unskilled labour could also be used with the required traffic accommodation. A natural gravel G5 was used to mix with the NME on site (literally on the street surface) and mixed in by hand to form the pothole premix used with the pothole filling. This on site mixing process is demonstrated in Figure 6.

The pothole is cleared of loose material, painted with tack coat on the sides, bottom and rim with NME as demonstrated in Figure 6. Hereafter the G5 and NME pothole fixing premixture is placed in the prepared pothole, compacted to refusal density with a hand tamper and the top painted with NME to ensure a black surface matching surrounding asphalt is provided.

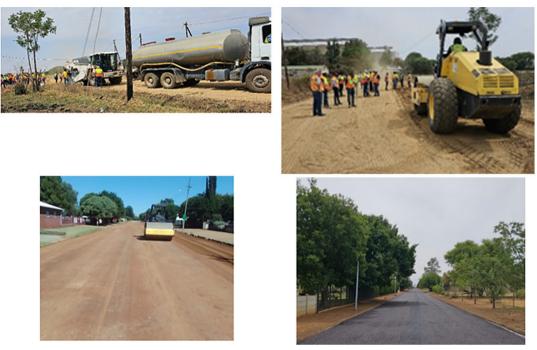
Figure 7: Images Clockwise. West street linking to silos Leeudoringstad, compaction behind recycler, completed Botha street with slurry finish

Where deeper recycling treatment depth (150mm) was required, such as South and West streets in Leeudoringstad, the recycler preprepared the street by ripping, grading and compacting to correct level. This was then followed by the recycler train with correct water

quantity and NME dosage mixed in. This is directly followed with a smooth wheel heavy vibratory roller and finished off with a pneumatic roller. It was noted on other projects a grid-roller was also applied (Jordaan et al., 2023), but it was not deemed necessary on this project. The process on West and South streets where 150mm deep NME was mixed in the existing base and surfacing are illustrated in Figure 7.

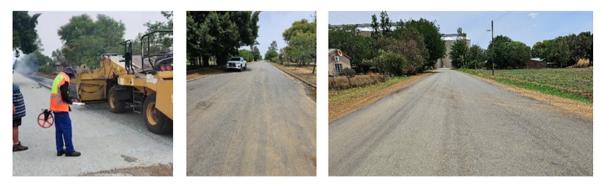
Figure 8: Botha street in Leeudoringstad chip spreading and final surface with slurry show good surface on Botha as well as for West street (link to silos)

The tack coat applications varied from straight SS60 anionic emulsion and various percentages of NME dilution. In the end the 50% NME dilution gave the best penetration. The original design was a standard tack coat, but this did not work as well as the NME tack coat. In Figure 8 the typical surfacing application of the 10mm seal application is shown in Botha street (Leeudoringstad) and after the slurry application and on the right hand side also West linking to the Silos are shown with a smooth new 10mm Cape-seal application.
