TALES FROM THREE CONSTRUCTION SITES: A QUALITATIVE INVESTIGATION INTO WORK ZONE SAFETY

K MOKGATLE^{1*}, L NEMAULUMA^{1}, M MIYAMBU^{1***}, WA VAN GRUTING, A JUBA, B MASOMBUKA, J LOWE, J SAMPSON, A MENON, J BEN-EDIGBE, E DE BEER and K VENTER²**

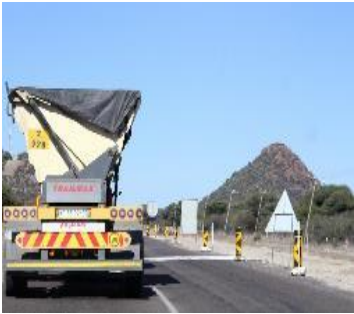
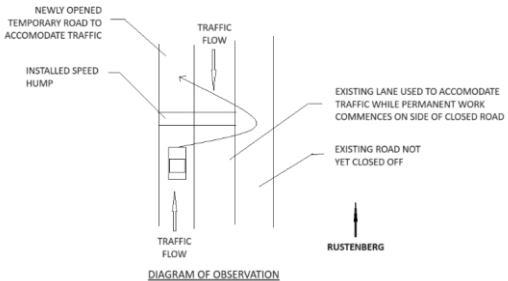
| Road | Activity | Observation | Number of observations | Safety implication and mitigation measures |
|---|---|--|---|---|
| Class R2 (section 1) | To reduce speed, traffic calming devices (speed humps) were erected across the construction section. The speedhumps were well marked, and solar road studs used to make them more visible at night. Speedhumps erected across the new temporary road (single lane) and lane where traffic is shifted during construction of permanent layer works commenced on opposite side. | The open lane without the speedhump gives motorists the space to circumnavigate the speedhump by driving on the construction area. | 1 | Drivers must pass the oncoming traffic lane twice in doing so increasing the risk of head-on collisions. The problem was addressed the same day by shifting delineators to barricade motorists from driving in the open lane. Barriers were later placed for the deep excavations as a safety precaution. |
| Law enforcement and awareness | <ul style="list-style-type: none"> • No active law enforcement • Traffic calming warning signs erected next to speed humps. • Speed humps fitted with road studs to increase awareness at night | | | |

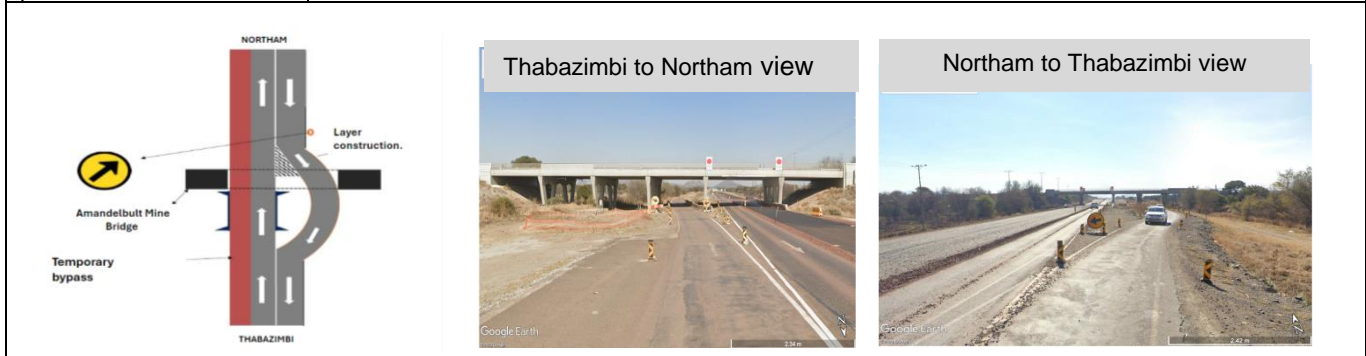
| Road | Activity | Observation | Number of observations | Safety implication and mitigation measures |
|---|---|--|---|---|
| Class R2 (section 2) | To widen the bridge there was not enough space to accommodate two lanes. The solution was to build a bypass that would accommodate one lane of traffic. | Drivers would avoid the bypass and drive in the oncoming traffic lane. | 1 | Head-on collisions and putting construction workers at risk, disruption of construction works. To mitigate the errant driver behaviour, additional flag personnel were added to alert and channel drivers to make use of the bypass. |
| Channelling and protection | <ul style="list-style-type: none"> Concrete barriers and delineators to channel traffic | | | |

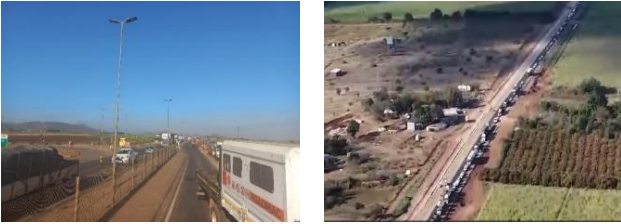
| Road | Activity | Observation | Number of observations | Safety implication and mitigation measures |
|---|---|--|---|--|
| Class U1 | Closure of the east bound 60 km/h lane for the asphalt pavement rehabilitation. | Drivers grew impatient as traffic backed up to 10-20 km. | 1 | Drivers make illegal and unsafe turns to avoid the construction area. The construction work was stopped, and the work replanned. |

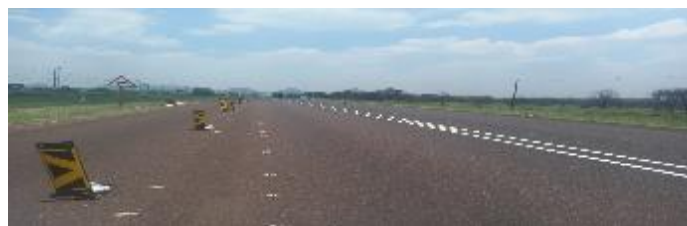
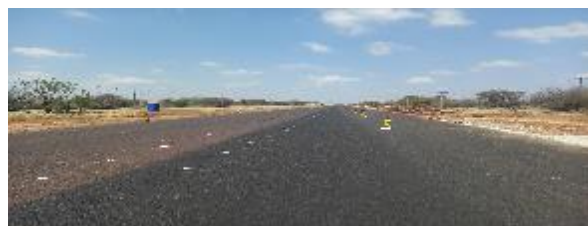
Table 7: Construction related practices and construction personnel

| Road | Activity | Observation | Number of observations | Safety implication and mitigation measures |
|---|---|---|---|--|
| R2 Section 2 | Changing phases of construction affect the previous phases of road marking. | Temporary road markings still visible | 4 | Still visible road markings on old construction area confuses motorists. |

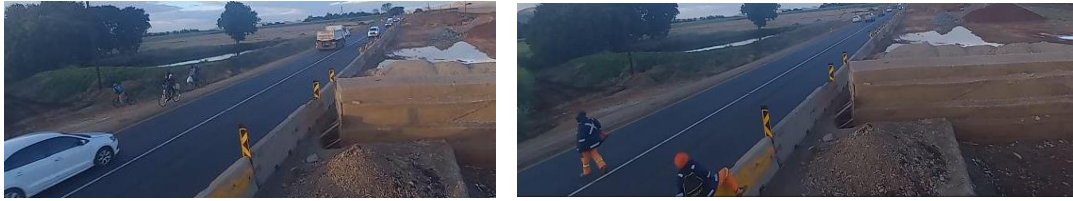
Table 8: Accommodation of NMT

| Road | Activity | Observation | Number of observations | Safety implication and mitigation measures |
|--|---|---|---|---|
| U1 | Shoulder Closure Prior to construction, local farm workers on either side of the U1 road would wait for the bus on the existing gravel shoulder. Upon construction activities commencing, this resulted in no shoulder during the duration of the project on the north side of the contract. | Pedestrians crossing the N4 at an informal bus stop adjacent to the construction work zone. | Multiple | This resulted in the bus stopping in the middle of the road on the westbound carriageway when dropping off the farm workers. During afternoon peak hours in the afternoon, the workers were subjected to cross the national road to the wait for the bus. This however is not a formalised bus stop nor safe crossing zone. The engineer consulted the public transport company and proposed alternative stopping places for the public transport vehicles. |
