# PEDESTRIAN CROSSING BEHAVIOUR ALONG A PRIMARY ACCESS CORRIDOR IN STELLENBOSCH

A ROUX and M SINCLAIR

## ABSTRACT

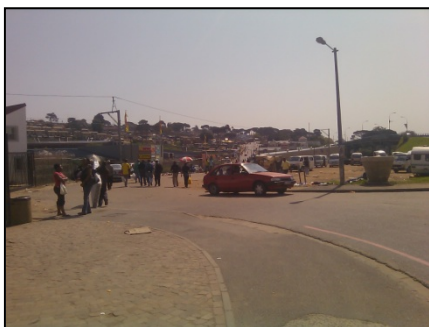
**Figure 2: Pedestrian access into Bird Street**

Along Bird Street, there are no formal crossings in the northern Kayamandi section of the road between the R304 bridge exit and R44 to accommodate pedestrians. This stretch is also the location of a pedestrian access connecting Kayamandi to Bird Street (Figure 2) which sees increased pedestrian crossing movement into and out of the area. This lack of crossing points is in stark contrast to the southern CBD section of the road between Alexander and Church Street which incorporates a total of six formal pedestrian crossings as located in Figure 1.

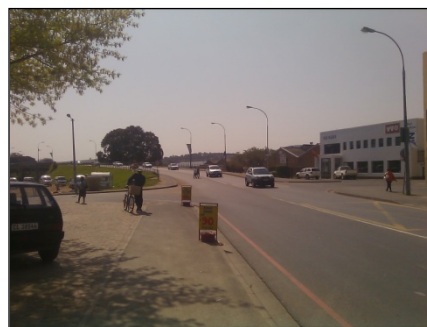
**Figure 3: R304 Bridge entrance adjacent to pedestrian access**

As a result of the high volume of vehicles entering and exiting Bird Street from the R304 bridge (Figure 3) , pedestrians were observed having to wait significant periods of time to find sufficient gaps to cross the road, resulting in pedestrians running across the road and/or waiting midway for traffic breaks. The dangers of pedestrians running over the road were exacerbated by the pedestrian committing him/herself to making the crossing manoeuvre with less time to pick up all visual information. Crossing behaviour was observed on two midblock sections in the region and showed running to occur on 17 of 65 crossings observed on the Bell// R44 midblock and 22 of the 115 crossings observed on the R44 Bridge exit midblock crossing. Running had been identified as a factor in 13% or eight casualty collisions involving pedestrians on this section of road, which underlines the risks associated with this behaviour.

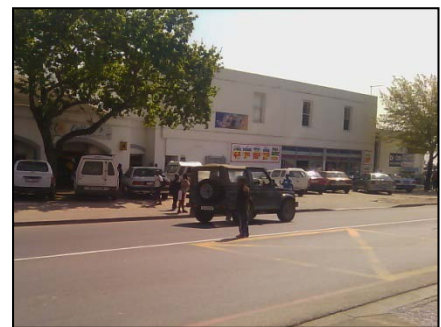
**Figure 4: Child pedestrian waiting midway to cross the road**

Pedestrians stopping midway between two flows of traffic find themselves in close proximity to incoming vehicles as can be seen in Figure 4, especially heavy vehicles. This crossing behaviour is prevalent on the road of study and was observed to occur on 25% (16 cases) of the crossings observed on the Bell// R44 midblock. At certain times, lower volumes of traffic created opportunities for pedestrians to cross diagonally over the road directly to their desired location and also specifically to and from the access walkway into Kayamandi. This diagonal crossing manoeuvre exposes the pedestrian to traffic for extended periods of time with his/her back to incoming traffic. A higher incidence of diagonal crossing was seen to occur across the pedestrian access area in Kayamandi, with 21 and 18% of pedestrians observed taking the shortest route to their destination.

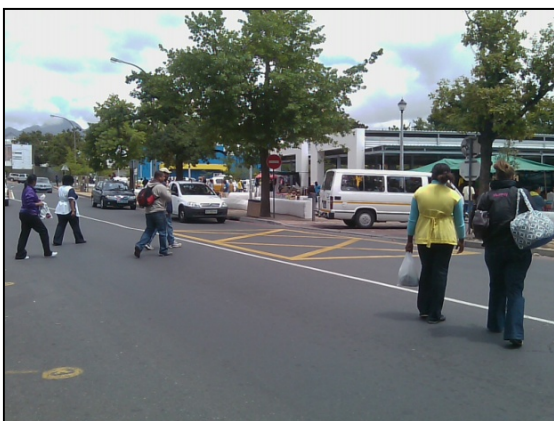
**Figure 5: Pedestrians crossing to formal taxi rank**

This section of the road is located within the CBD and maintains high volumes of pedestrians and vehicles throughout the day. Observational studies were conducted on the Merrian// Crozier midblock section that is located along a formal taxi rank, the Bergzicht Taxi Rank, and low cost retail centres (Figure 5 and 6). This midblock section was identified as having the highest number of casualties with 17%, (or ten) of reported casualties having occurred here.

most prevalent in this area, occurring on 63 of the 224 crossing observed. An interesting distinction here was that where, in the northern section, pedestrians crossed individually or in small groups, in the southern section bigger groups of pedestrians (up to ten) were seen to cross at the same time, resulting in clusters of pedestrians waiting midway for traffic to pass before proceeding to enter the taxi bus entrance for the taxi rank as shown in Figure 5.

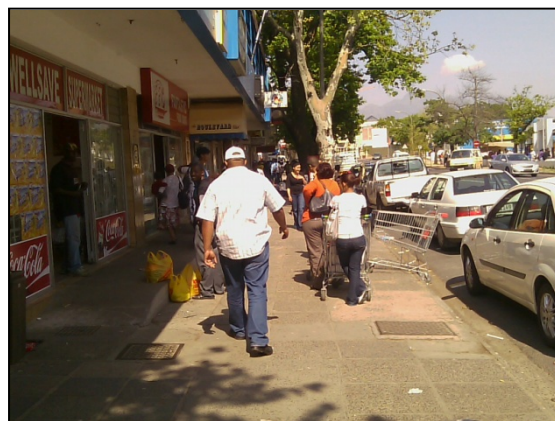
**Figure 6: Retail centres along midblock section**

This midblock section also provides parking spaces on the side of the road as shown in Figure 6, which, when occupied by parked vehicles, were seen to obstruct the drivers' view of pedestrians crossing in front of or behind them.

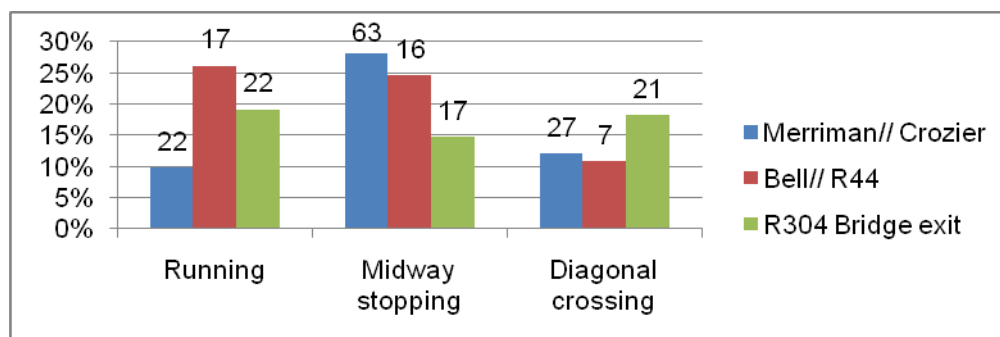
Figure 7 below illustrate the predominant types and frequency of behaviour witnessed on three key informal crossing locations within similar weekday conditions.

**Figure 7: Crossing behaviour at informal midblock crossings**

Similar crossing behaviour witnessed in the northern region was seen to take place within these midblock crossing locations. These include running, midway stopping and diagonal crossing occurring frequently. As in the northern section long waiting times for pedestrians crossing the road were observed. From Figure 7 it can be seen that midway stopping was

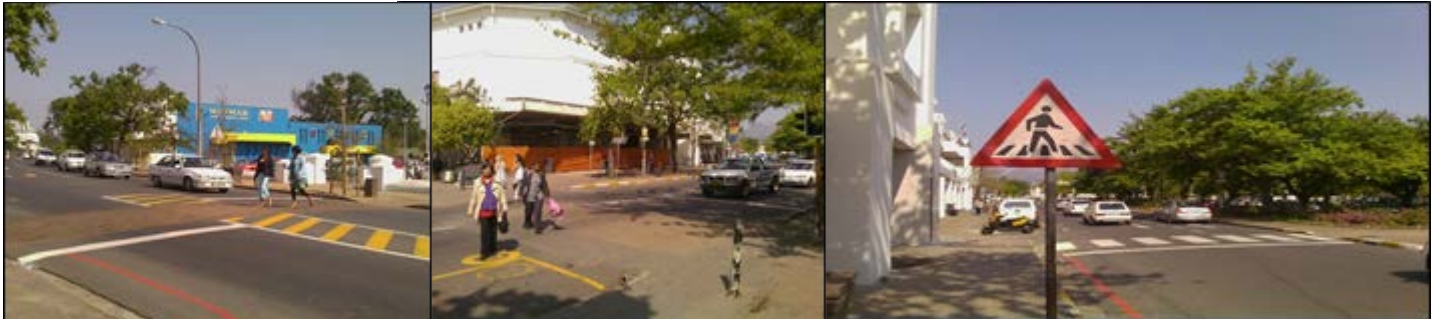
Formal crossings along Bird Street differ in their appearance and design with three types of crossings found within 280m of the road section within the CBD as can be seen in Figure 8, 9 and 10. This adds to further confusion to the purpose or use of the facilities for both motorist and pedestrians.

**Figure 8: Merriman// Crozier midblock formal crossing**

**Figure 9: Raised and signalised crossing within CBD**

**Figure 10: Zebra crossing within CBD**

The formal crossing near the taxi rank (Fig.7) experienced a high number of peripheral use (pedestrians crossing outside its boundaries and also diagonally). Pedestrians were also seen to dawdle, causing frustration for motorists. Vehicles were observed frequently not stopping for pedestrians waiting to cross. The signalised crossing at Eikestad mall (Fig. 9) evidenced confusion over the right of way, with vehicles often not stopping when the green man was green, and pedestrians crossing when it was red. There appeared to be a high degree of confusion as to whether this was a demand stop or whether pedestrians always had right of way. Little diagonal or peripheral crossing was observed.

The midblock Eikestad mall crossing was well marked and the highest level of pedestrian compliance was observed here.

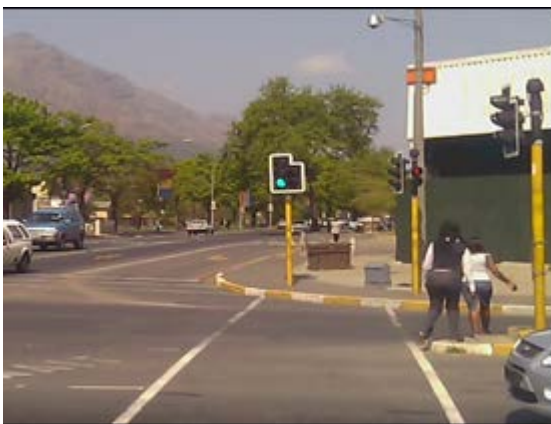
**Figure 12: Pedestrians using median at R44 intersection**

Similar dangerous crossing behaviour as associated with midblock crossings (such as running and midway stopping) was seen to occur on signalised intersections. Midway stopping was more prevalent over the R44 intersection with 30% of the 128 pedestrians observed stopping midway on the raised median compared with 13% of the 155 pedestrians observed stopping midway on the Merriman intersection (with no raised median). The R44 median is, however, too narrow for groups of pedestrians and does not stretch over the designated pedestrian walkway in front of stopping vehicles (Figure 12). This in turn could explain the higher occurrence of pedestrians crossing within the road (21% vs. 14%) and up to ten meters behind the designated walkway lines. When pedestrians cross outside the designated walkway lines provided at signalised intersections, they become vulnerable to the same dangers associated with informal midblock crossing locations and could also catch oncoming vehicles of guard.

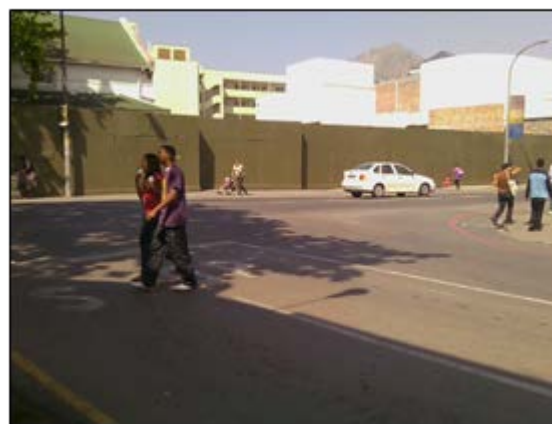
**Figure 13: Pedestrians crossing Du Toit street T-intersection**

Data was collected over a one hour period for 121 crossing pedestrians on the Du Toit Street T-intersection located within the CBD (Figure 13). This intersection makes use of a stop control for vehicles crossing into Bird Street and has no formal pedestrian facilities. The percentage of pedestrians looking backwards for turning vehicles crossing in both directions

is comparable with 47% of the pedestrians looking backward for turning vehicles when crossing from the left to right lane and 41% looking backwards walking from the right to left lane. In total, four near conflict situations were observed between vehicle and pedestrian as a result of the side swipe action from turning vehicles

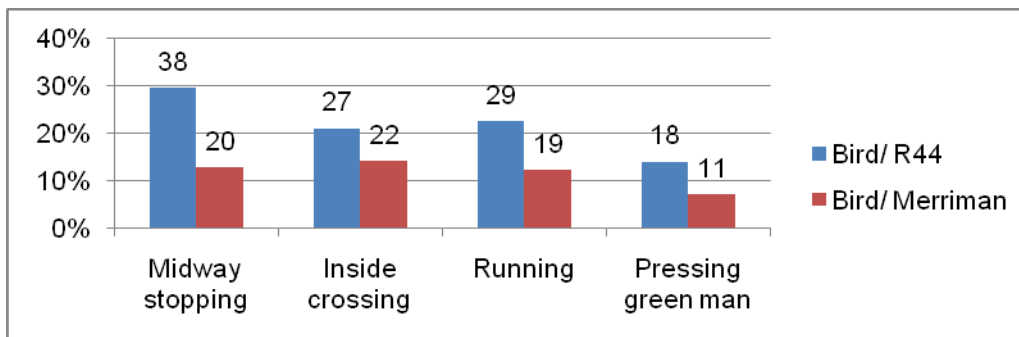
Figure 14 shows predominant dangerous crossing behaviour and frequency witnessed to occur on the two major signalised intersections crossing Bird Street within similar time and weekday conditions.

**Figure 14: Crossing behaviour at signalised intersections**

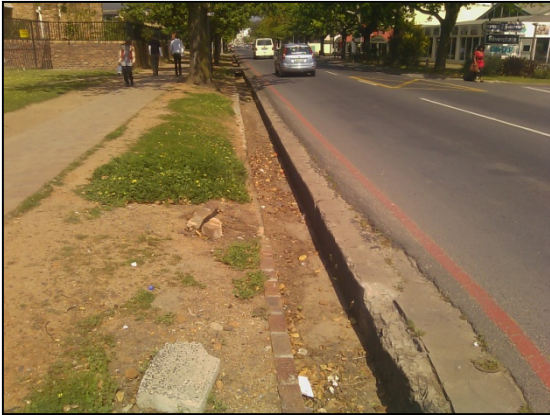
**Figure 15: Gutter on side of road along Bird Street**

Walkways on both sides of the road are too narrow for safe cyclist and pedestrian use and the road offers minimal shoulder width for cyclist to ride on. Furthermore, the presence of wide gutter and scarce refuge zones (Figure 15) makes the journey only more hazardous. Further investigation into the casualty data found that the majority - nine of the sixteen cyclist casualties – had been a result of side swipe action with a turning vehicle with eight of these side swipe casualties occurring on T-intersections.
