CHAPTER 2  
ROAD SURFACE ROUGHNESS  
MEASUREMENT SYSTEMS

## 2.1 INTRODUCTION

## 2.2 MAYSMETER

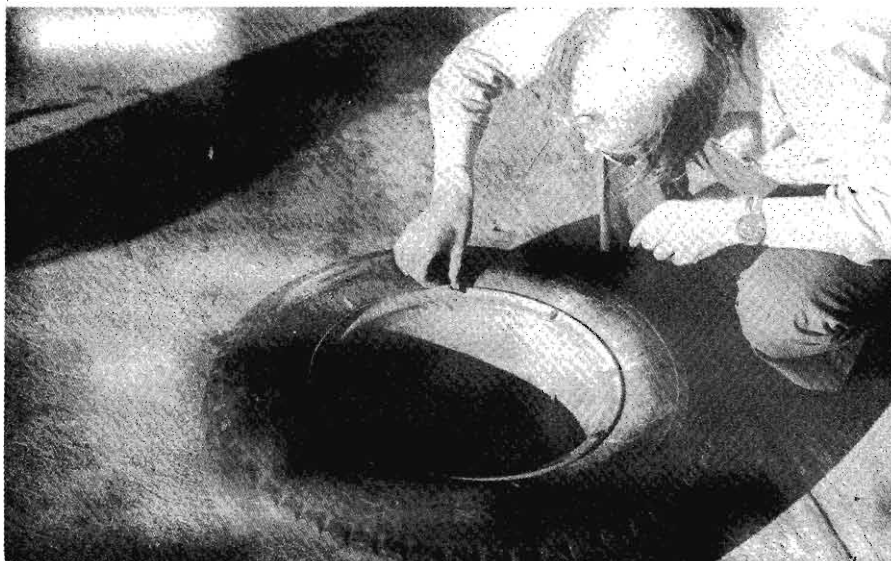
FIGURE 2.8 - INSTALLATION OF MAGNETS ON TIRE RIM

The summation device uses an electronic distance measuring instrument (DMI) to measure the distance of each road subsection under study. The DMI senses the passage of 8 target magnets fixed to the inner rim of the vehicle's left front wheel, which are shown being installed in Figure 2.8. The DMI then scales the number of magnets sensed to produce an output display and signal which is proportional to an operator adjustable distance measurement unit, e.g., miles, feet, meters, etc.

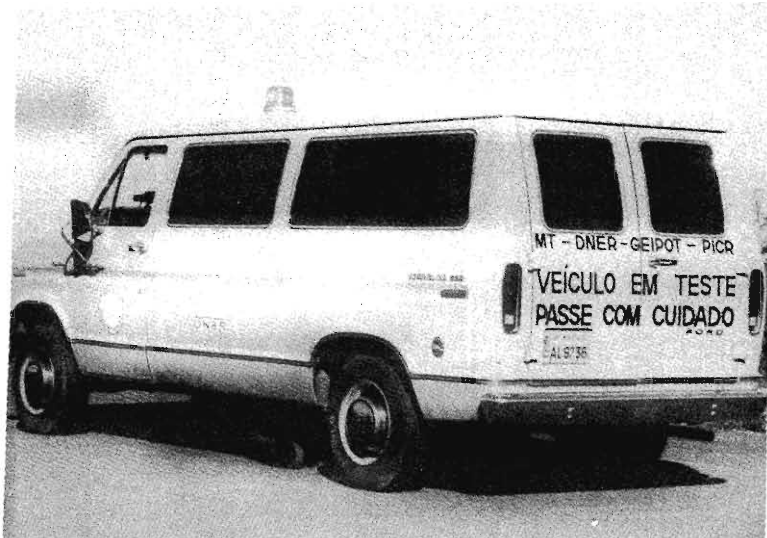
FIGURE 2.9 - PROFILOMETER IN OPERATION ON A TEST SECTION

The General Motors road surface dynamics Profilometer (Figure 2.9), manufactured under licence by K. J. Law Engineers Inc., was acquired to provide a reliable standard against which the Maysmeter results could be compared, to facilitate correlation among the seven Maysmeters. The Profilometer was thus used to establish and to monitor periodically the control sections used in the calibration of the Maysmeters. The correlation technique between Profilometer and Maysmeter was based on Walker and Hudson (1973).
