The design of stable pillars in the Bushveld Complex mines: a problem solved?

by D.F. Malan* and J.A.L. Napier†*

Synopsis

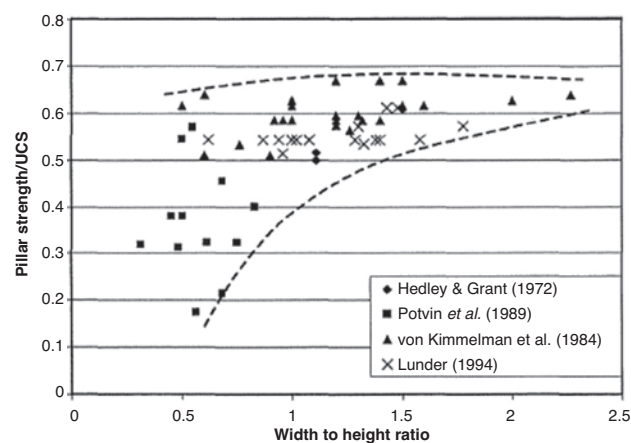
Figure 2—Pillar stability graph showing examples of failed pillars from hard-rock mines (after Esterhuizen⁴)

Esterhuizen⁴ conducted an evaluation of the strength of slender pillars. Figure 2 illustrates published case histories of failed pillars from hard-rock metal mines. This figure illustrates that the pillar strength becomes highly variable as the width to height ratio decreases. For a ratio of 1, the pillar strength is not expected to exceed 65% of the laboratory

strength (but it can also be significantly lower than this value). Esterhuizen⁴ suggests that a larger factor of safety is required for these pillars to account for the increased variability in strength. Numerical modelling indicated that for slender pillars, the difference between the pillar load at the onset of spalling and the ultimate pillar strength can be small. This implies that slender pillars are at or near the point of failure at the onset of brittle spalling.

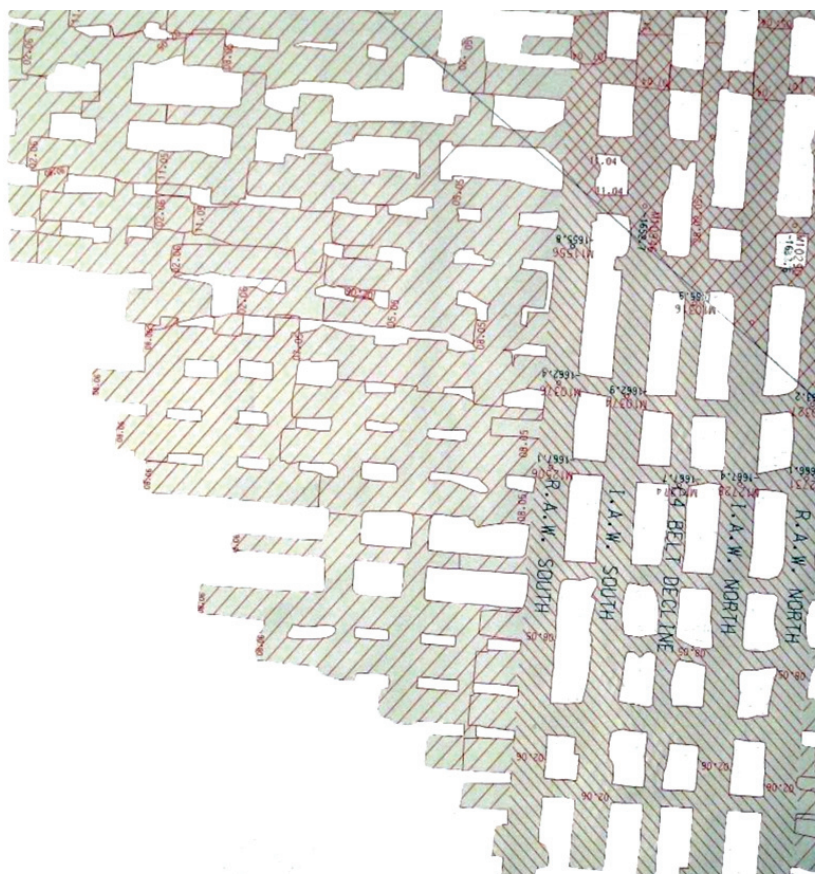
Figure 4—An example of poor pillar cutting in a platinum mine in the Bushveld Complex

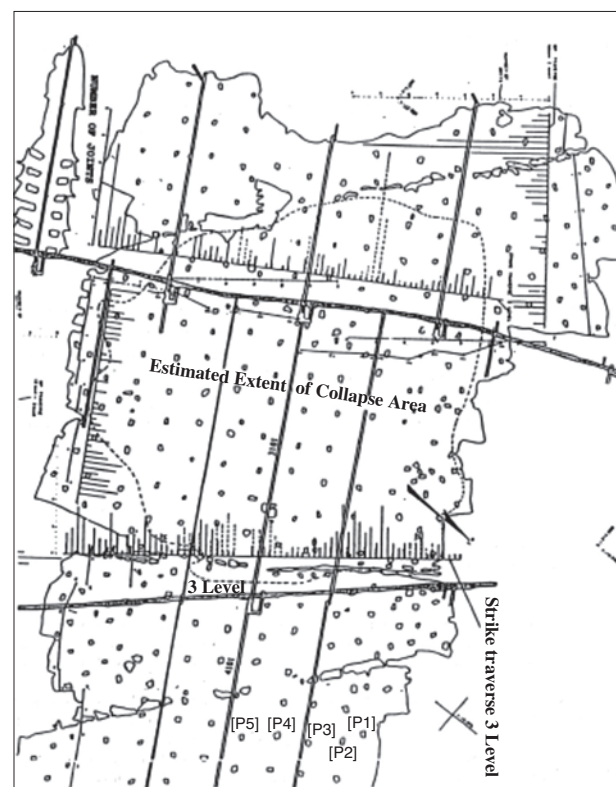
Figure 5—Extent of the collapse (dotted line) at No 6 Shaft, Bafokeng North mine

depth of the overburden was 58 m. The extent of the collapse was of the order of 350 m on strike and 350 m on dip, and the outline of the collapsed region is shown in Figure 5. The upper and lower limits of the fall were bounded by two faults. Up to the time of the collapse there were no signs of pillar scaling and no timber poles were broken, suggesting that conditions were indeed stable. This condition, however, changed overnight with the entire rock mass to surface moving down between the two faults shown in Figure 5. No doubt this observation resulted in the hypothesis given by Gay *et al.*²⁰ that the presence of and shear along near vertical faults can change the loading condition from a stiff displacement controlled system to a soft load controlled system. Kotze²¹ used numerical modelling and stress measurements conducted by the CSIR in 1975 in pillars adjacent to the collapse area to estimate a Merensky pillar strength of 75 MPa (for a pillar with an effective width of 4.3 m). This value is of course applicable only to the particular width to height ratio of the pillars (the pillar height was given by Kotze²¹ as 1 m).

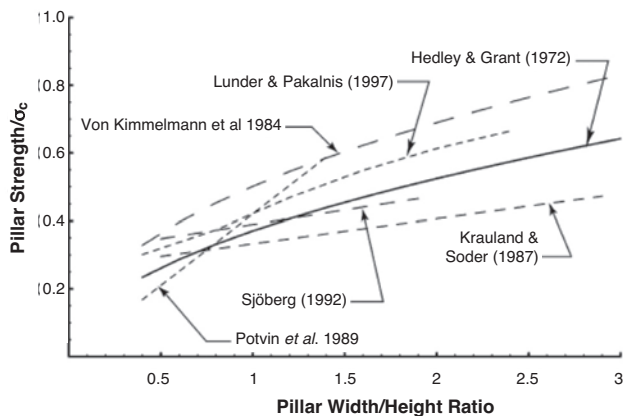
Figure 6—Comparison of empirical pillar strength formulae (after Martin and Maybee²²)

Martin and Maybee²² give a very good overview of the different empirical strength formulae that were developed to predict pillar strength. A comparison of these formulae is given in Figure 6. These curves were calculated for a pillar height of 5 m.

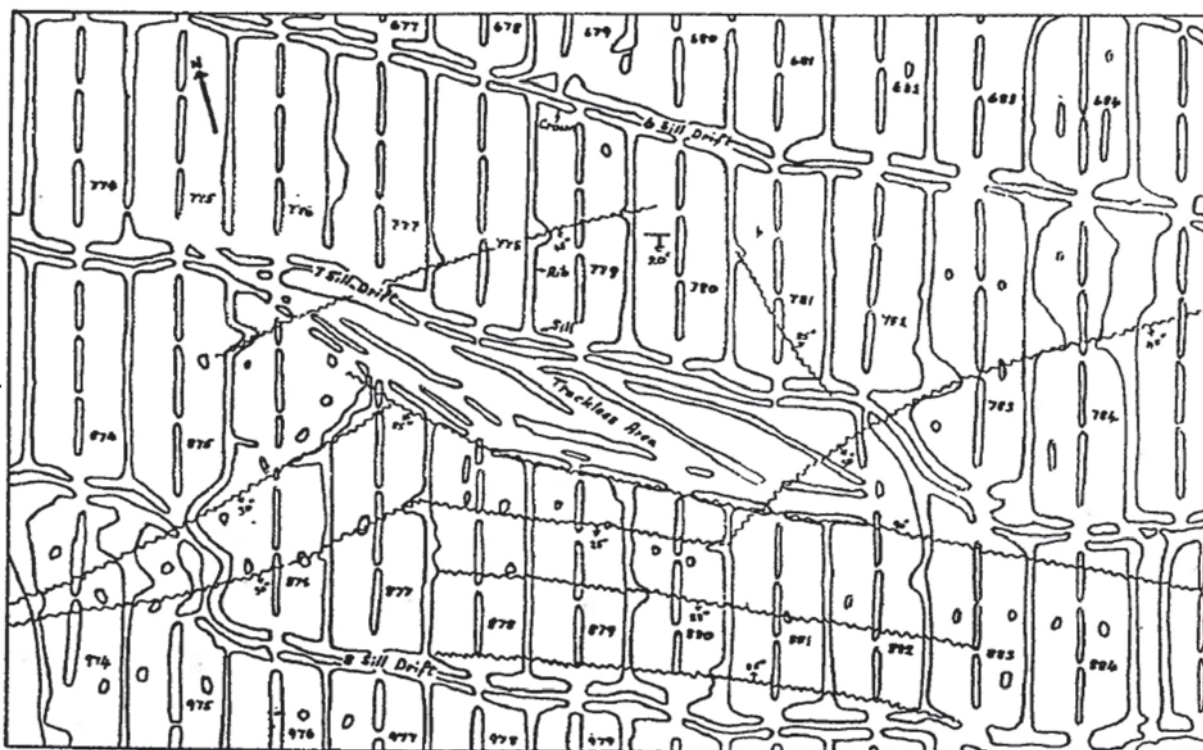
Figure 7—Typical layout of a mine in the Elliot Lake district (after Hedley, Roxburgh and Muppalaneni²⁴)

The uranium mines in the Elliot Lake area used a stope and pillar layout to mine the orebody. Narrow pillars about 250 ft (76 m) long were left along dip (see Figure 7). The pillars which were chosen for analysis were typically conducted 10–20 ft wide (≈ 3 –6 m) and 8–20 ft high (≈ 2.5 –6 m). The width to height ratio of most of the pillars was close to 1 and only a very few (3 in the database) had a width to height ratio of 2.5. It is clear that this original formulation was derived for slender rib pillars and it can be questioned whether it is applicable to square pillars with a width to height ratio greater than 2.5. The original data used by Hedley and Grant is reproduced in Table I. It is immediately obvious that the dataset used was very small (28 pillars). This should be compared to the coal database of Salamon and Munro¹⁰, which included 125 pillars of which 27 were collapsed. The width to height ratio of the failed pillars varied from 1.1 to 1.5. Only 3 of these pillars were ‘crushed’ and 2 were ‘partially crushed’. Of further concern is that it is stated in the paper that: ‘The information on complete pillar crushing was obtained second-hand because it happened in mines which are closed.’ This work was conducted in the days before computer-based numerical modelling could be used to determine pillar stress. The approach followed was therefore to use tributary area theory, which relates the pillar stress to the pre-mining stress and the extraction ratio by:

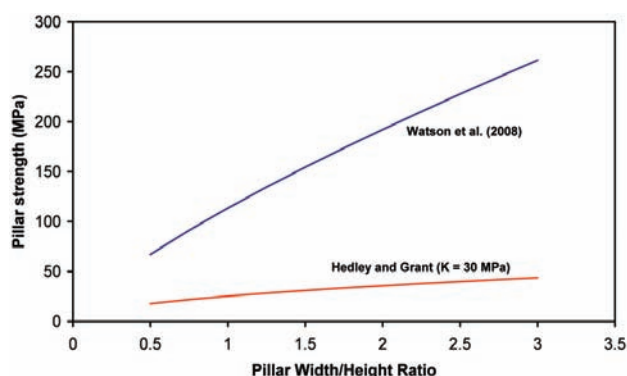
Figure 8—A comparison of the Merensky pillar strength predicted by the new Watson formula and the traditional Hedley and Grant using a K -value of 30 MPa (a third of the average UCS obtained from laboratory tests of Merensky Reef samples from Impala 2A Shaft)

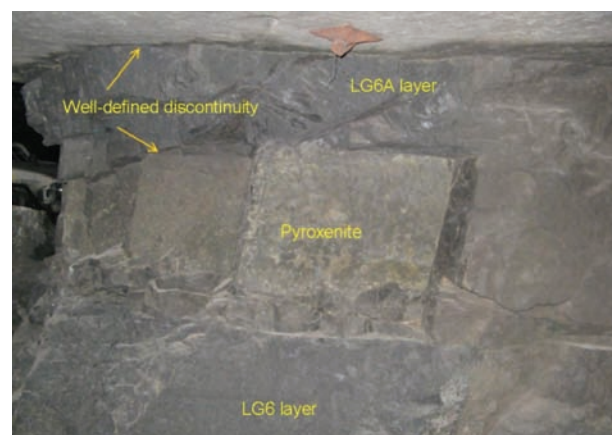
Figure 9—Typical multi-layer composition of pillars in the Bushveld Complex mines exploiting the LG6 and LG6A chromitite layers

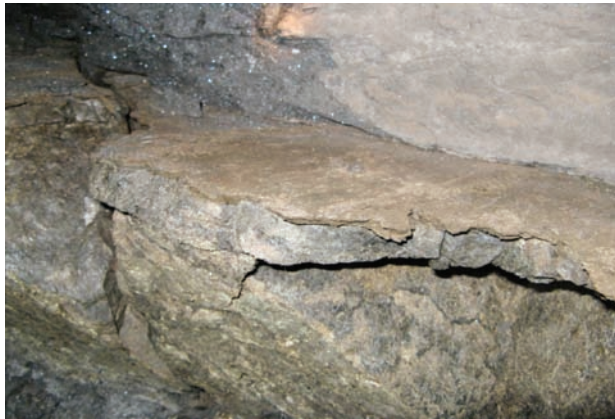
Figure 10—Presence of weak clay layers in the pillars at Wonderkop Mine. This photograph illustrates the presence of a clay layer between the LG6A chromitite and the pyroxenite below it

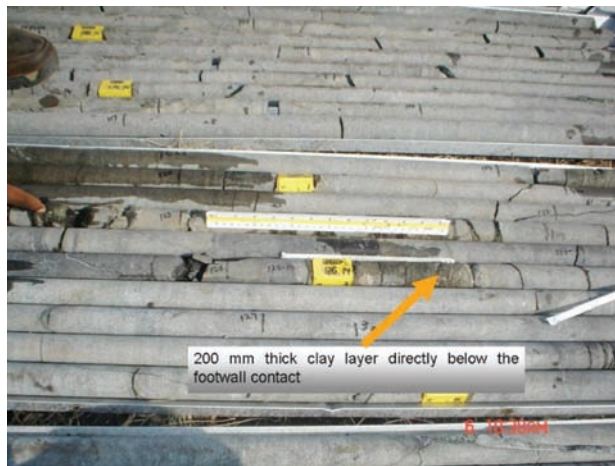
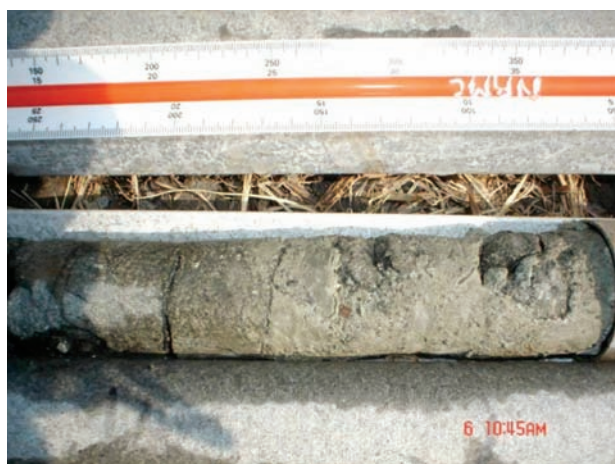
Figure 11—Presence of weak clay layers in proximity to the LG6/LG6A chromitite reefs at Wonderkop Mine

Spencer³⁵ reported on the failure of the pillar system and the subsequent closure of the Wonderkop Chrome Mine in May 1998 (stopping commenced only in September 1996). The mine is located close to Rustenburg and exploited the Lower Group chromitite seams, namely the LG6 and LG6A. An internal pyroxenite waste band is found between these two reefs and this results in the pillars having a multi-layered appearance (Figure 9) wherever these two reefs are mined. The Wonderkop Mine was the most easterly situated LG6 mining operation in the Rustenburg area and was situated adjacent to the Spruitfontein dome (an upfold structure which separates the Rustenburg section from the Marikana section). Its close proximity to the Spruitfontein dome has influenced the structure of the LG6 and LG6A seams and this has resulted in thick clay layers (up to 300 mm in some places) traversing the pillars in some areas (Figure 10). The position and thickness of this weak layer is highly variable (e.g. see Figure 11).

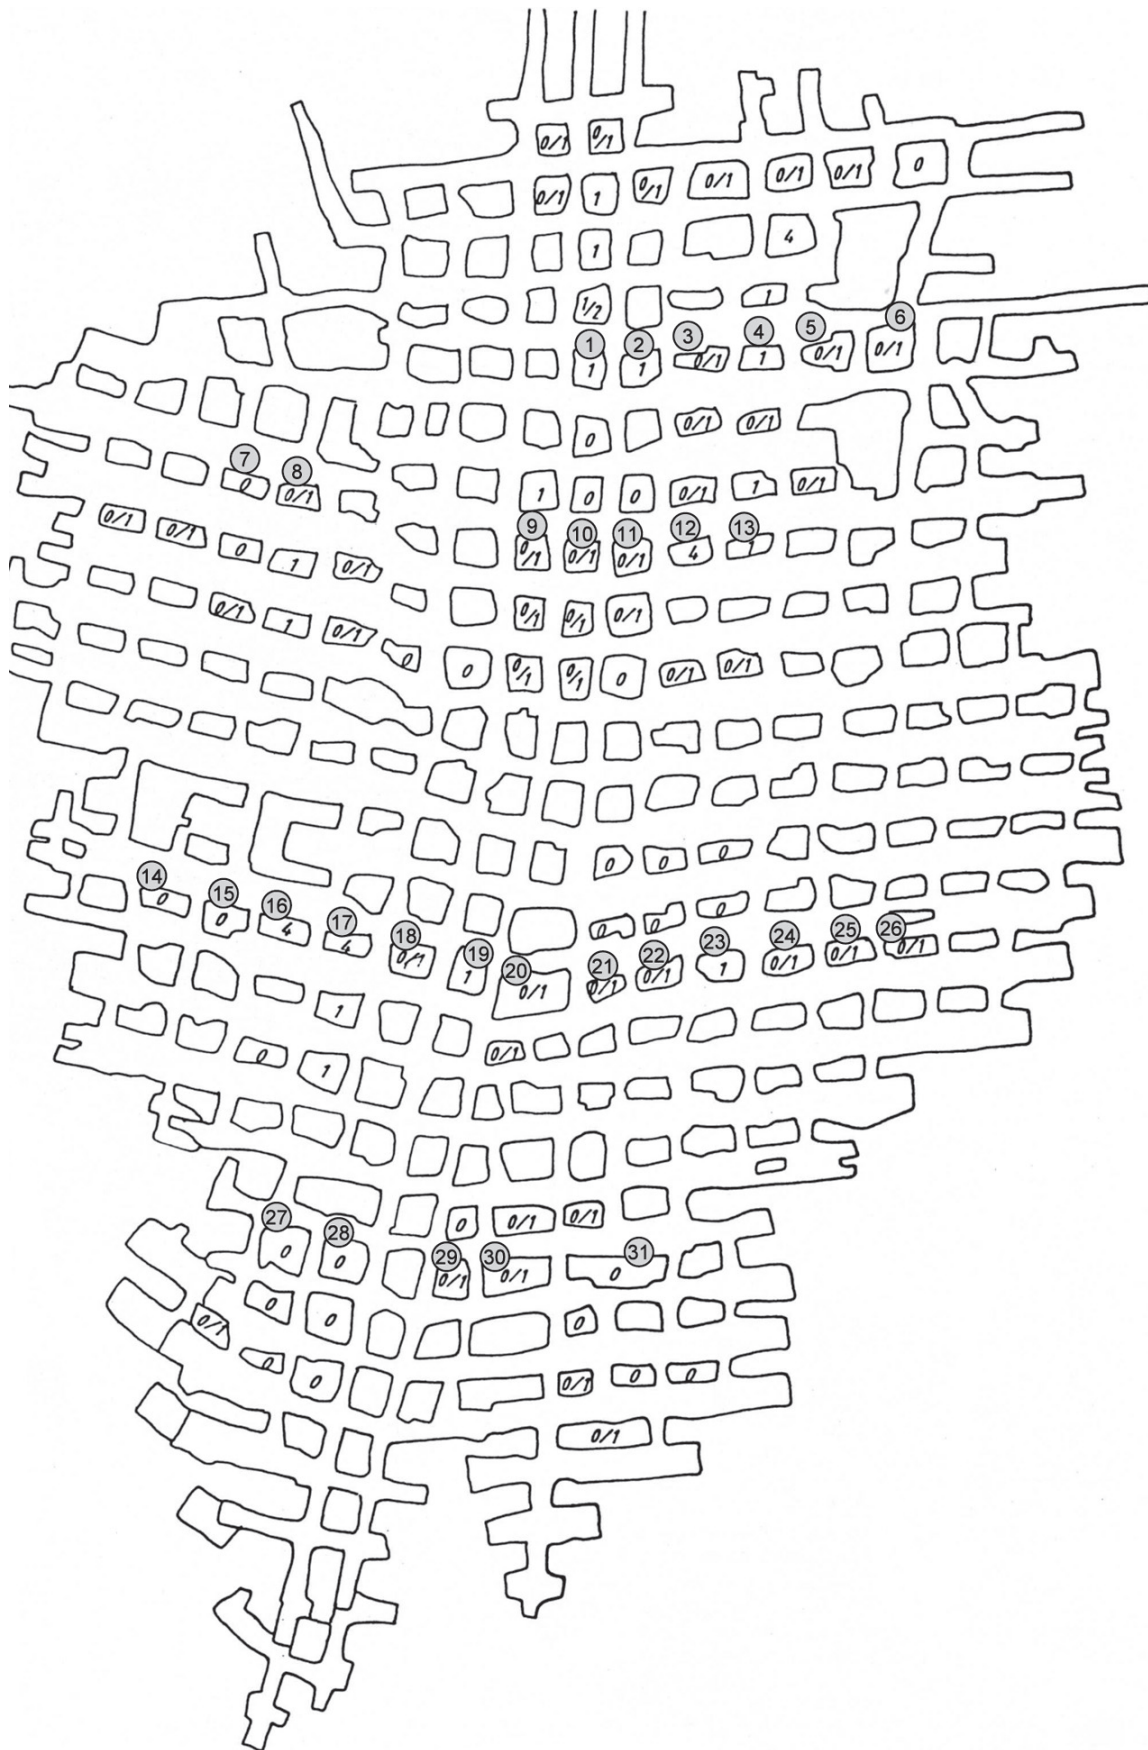
Figure 12—Failure condition of the pillars and the extent of mining during July 1997 (after Spencer³⁵). The failure codes used in this figure are as follows: 0 - No failure, 1 - opening of joints at the corners, 2 - opening of joints at the corners and along the sides, 3 - material slabbing off the corners and sides, 4 - horizontal movement occurring along the clay layer

The first underground inspection of the pillars by the consulting rock engineer was conducted in July 1997. During this visit it was noted that some joints were beginning to open at the corners of some pillars. Some joints were also opening up at the sides of the pillars and in a few cases

sliding along the clay layer was noted. Figure 12 illustrates the layout and the positions where pillar failure was observed. Following these observations, steps were taken to introduce a system of barrier pillars (Figure 13) with a width to height ratio of at least 10 (it is generally believed that at this ratio the pillar becomes indestructible). During the following nine months, the condition of the pillars continued to deteriorate. To strengthen the pillars along the main dip belt and road declines, two strategies were adopted; namely waste stowing between the pillars and mesh and lacing of the pillars. The success of the mesh and lacing of the pillars appeared to be doubtful, as the drilling process introduced additional water into the clay which probably weakened the pillars further. During April 1998, the failure process accelerated and the rate of closure in some areas increased to 1.8 mm/day. Numerous falls of ground occurred and management decided to cease operations at this stage. Recently, a back analysis of this pillar failure was conducted by the authors using the TEXAN boundary element program³⁶, which can explicitly simulate the individual pillars and calculate the stresses on these pillars relatively accurately. The results are shown in Figure 14. Two face positions were simulated; namely July 1997 (Figure 12) and July 1998 (Figure 13). From this study, the Hedley and Grant formulation was used to back-calculate the K -value for the pillars. A value as low as 6 MPa was obtained, which is in agreement with earlier back analysis studies by Spencer³⁵, who estimated a value as low as 4.6 MPa. It should nevertheless be noted that a power law strength formula might not be applicable to these pillars owing to the presence of the clay layer. Although the mechanism of pillar failure needs further investigation, the low strength of the pillars can probably be attributed to the low friction angle of the clay layer, which allowed lateral deformation of the pillar and a reduction of confinement.

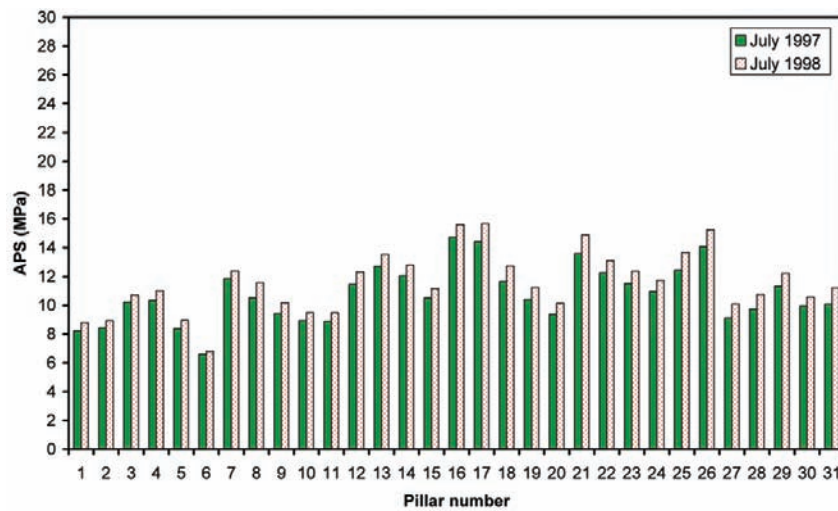
Figure 14—Simulated pillar stresses for selected pillars in the Wonderkop Mine (see Figure 12 for the positions of the pillars)

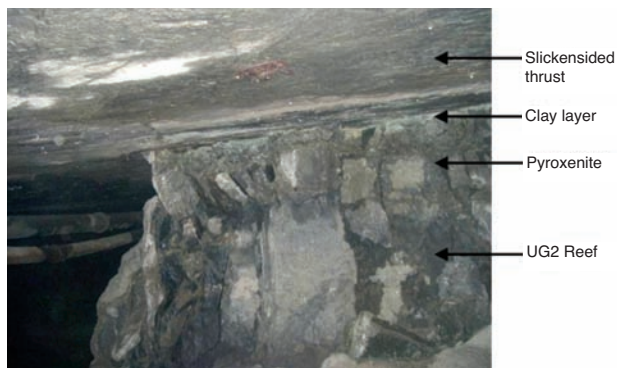
Figure 15—Typical pillar composition at Mine A (after Roberts and Clark-Mostert³⁷)

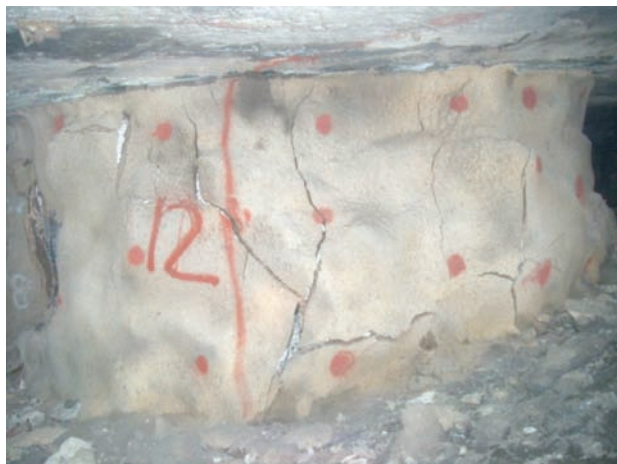
Figure 16—Pillar failure at Mine A after attempts to strengthen the pillars with shotcrete (photograph courtesy Dr Mike Roberts)

From these studies, the drawbacks of using empirical pillar strength formulae are obvious. The failure in all three cases is caused by the presence of clay layers which substan-

tially weaken the pillars. The original empirical formulae were developed for different rock types and the application of these formulae outside the limits for which they were developed resulted in the large mine collapses described here.

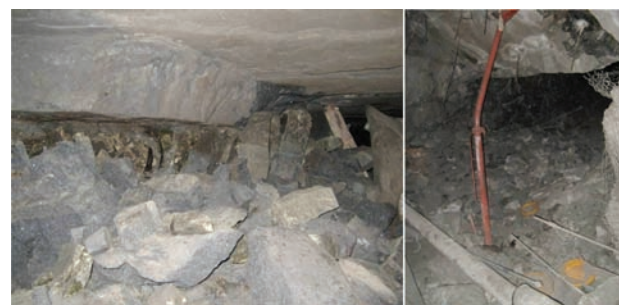
Figure 17—Interest mode of pillar failure at Mine B. For this pillar, a clay layer was found between the upper LG6A chrome and the pyroxenite below it. This slippery layer facilitates the fracturing of pyroxenite, causing it to scale out (left). The failures led to large amounts of convergence as can be seen in the photograph on the right

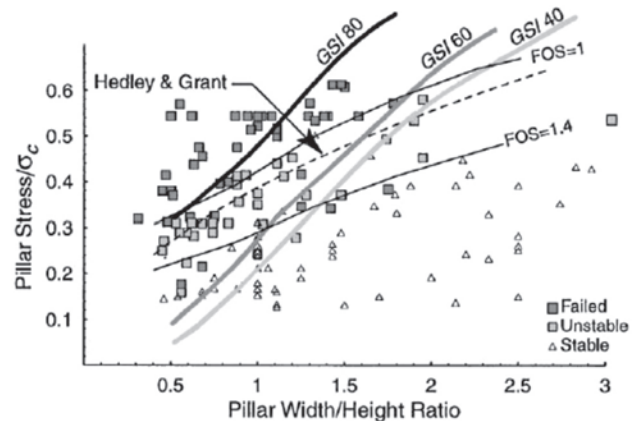
Figure 18—A comparison of the strength predicted by Hedley and Grant²³, the data and FOS lines from Lunder and Pakalnis³ and the Phase 2 modelling for various GSI values (after Martin and Maybee²²)

Martin and Maybee²² investigated the strength of hard rock pillars by using both empirical pillar strength formulae and numerical modelling using a Hoek-Brown failure envelope. Figure 18 illustrates a comparison between the pillar stability graph developed by Lunder and Pakalnis³, the Hedley and Grant equation and Phase 2 - Hoek and Brown modelling using different values of GSI. Figure 19 illustrates the same data using the Hoek and Brown brittle parameters. The conclusion reached by Martin and Maybee²² is that two-dimensional finite element analyses using conventional Hoek and Brown parameters for typical hard-rock pillars predicted rib pillar failure envelopes that did not agree with empirical pillar failure envelopes. It appears that the conventional Hoek-Brown failure envelopes over-predict the strength of hard rock pillars. This occurs because the failure process is fundamentally controlled by a cohesion loss process in which the frictional strength component is not mobilized. Their recommendation is that Hoek-Brown brittle parameters ($m_b = 0$ and $s = 0.11$) be used to simulate pillar strength.

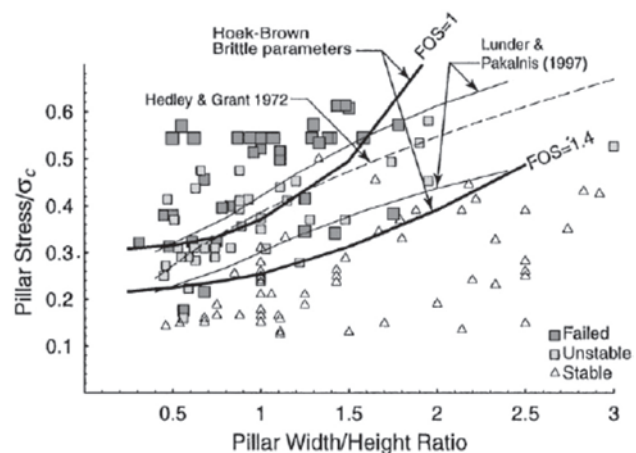
Figure 19—A comparison of the strength predicted by Hedley and Grant²³, the data and FOS lines from Lunder and Pakalnis³ and modelling results using the Hoek and Brown brittle parameters (after Martin and Maybee²²)

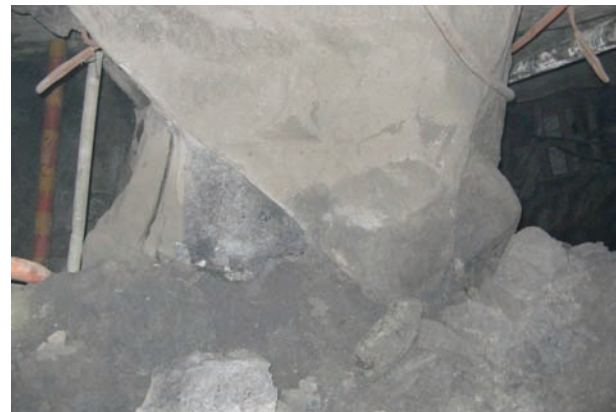
Figure 20—An example of a pillar that contains a single joint dipping at almost 45° through the pillar. This joint will have to be modelled explicitly if the behaviour of this pillar is to be correctly simulated by a numerical modelling code

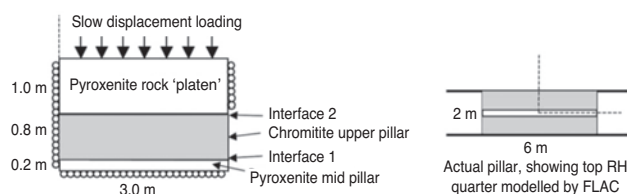
Figure 21—FLAC model to simulate the effect of weak interfaces in the pillar

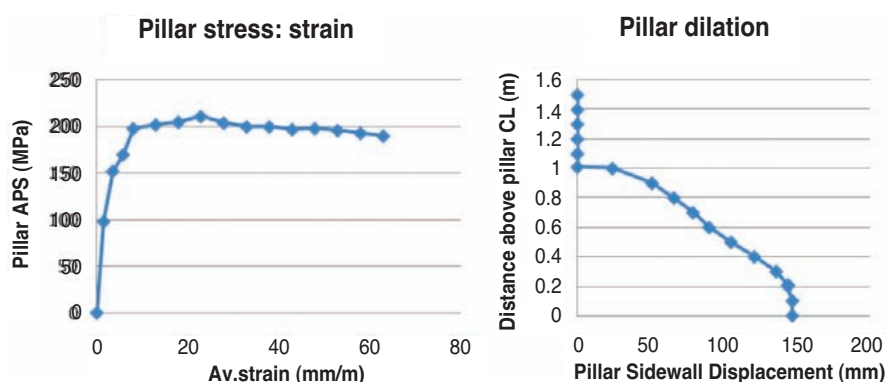
Figure 22—Pillar stress:strain and sidewall dilation (at peak strength point p), for interface friction angles of 30°

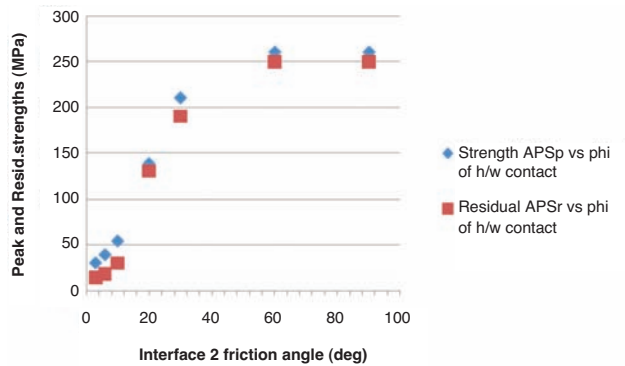
Figure 23—Peak and residual pillar strength versus hangingwall contact friction angle ϕ_2
