CHAPTER III.

# 03 context analyses

## 3.1 A Vision for the Apies River

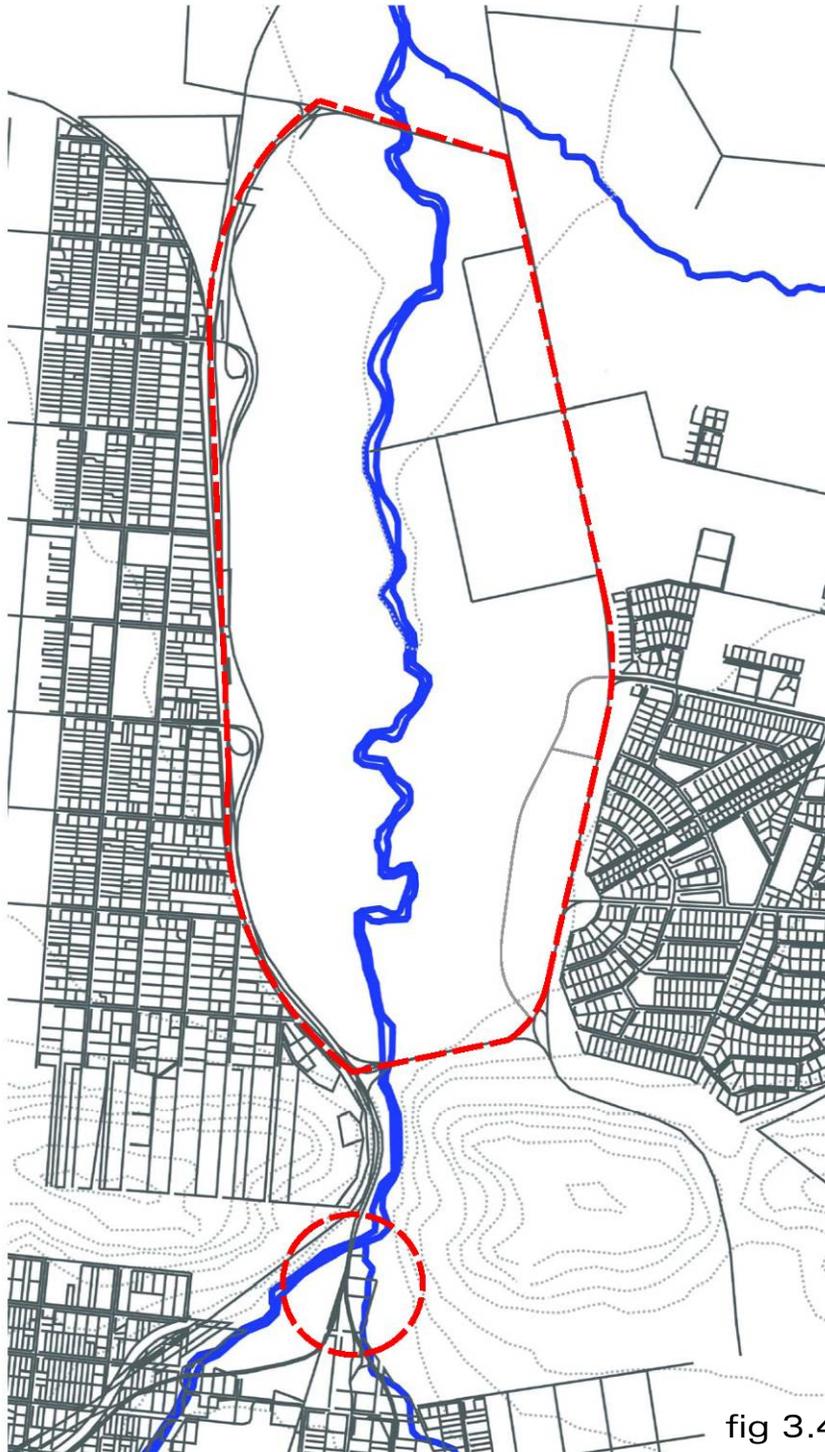
fig 3.4: the Site

The site and context analyses will be on the Wonderboom poort and the Northern Apies River edge as indicated by fig.3.4. Each aspect of the analyses will take a quick look at the greater Apies River before listing the main problems or features that can have an effect on the urban open space framework.

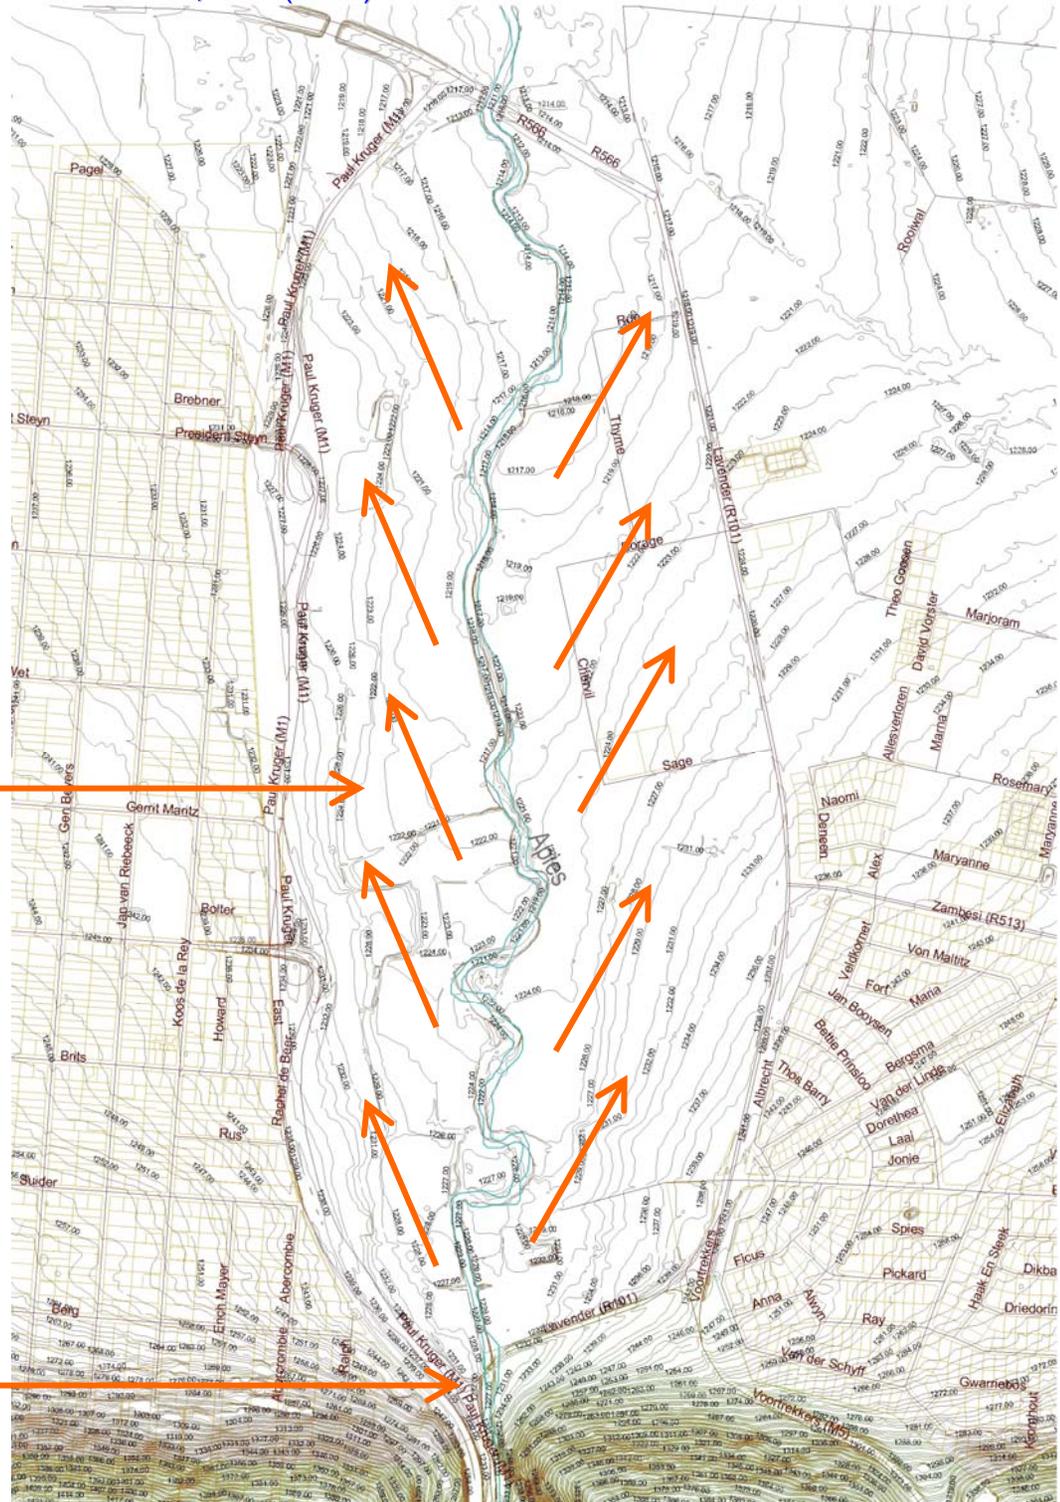
fig 3.6: site contours

In fig 3.6 it is clear how the site flattens out to the north. This part of the river can be very dangerous in storm conditions. The reason for this is the Apies River is pushed through the Wonderboom poort (fig 3.5) together with other smaller streams and storm water. The river takes up an enormous amount of storm water from the CBD and surrounding areas. This area serves as the floodplain for the river in big storms. It is thus important to protect existing and future developments from the dangers of the river.

The issue of the floodplains will be addressed in the next chapter under master plan development.

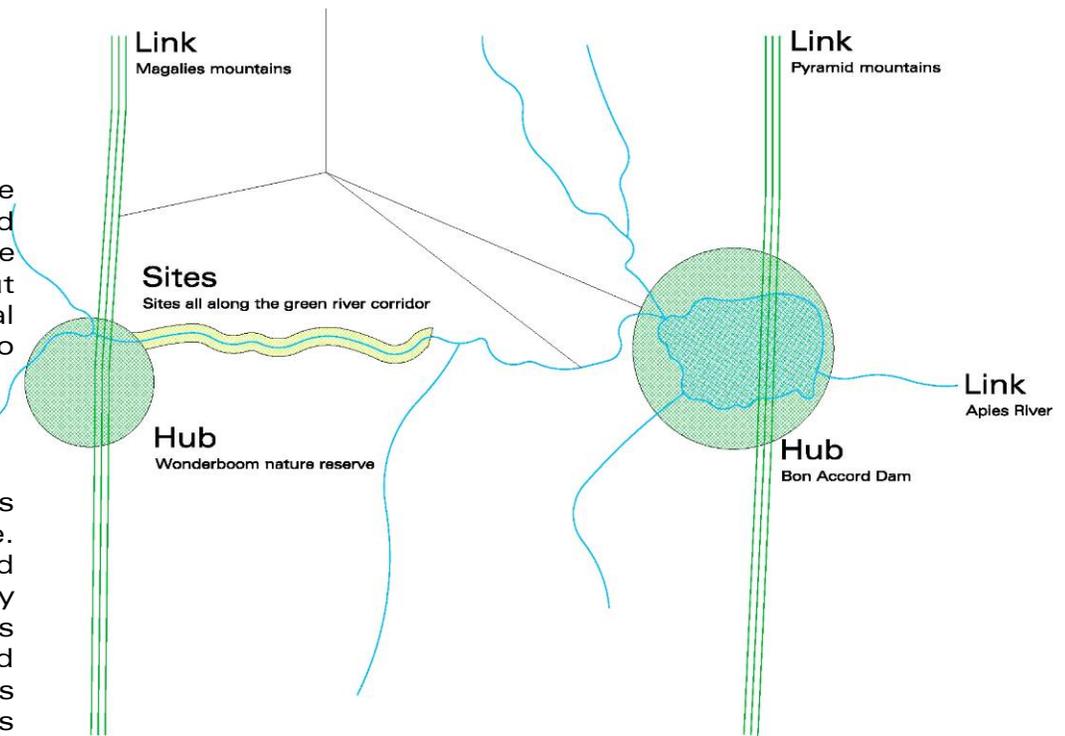
fig 3.7: Anatomy of the Greenway

**Links** are the heart of the greenway system. They are linear connections for people and nature.

**Hubs** are the anchors of the system. They provide a base or distinction for people and nature.

**Sites** are smaller features than hubs which serve as point of interest, origins or destinations.

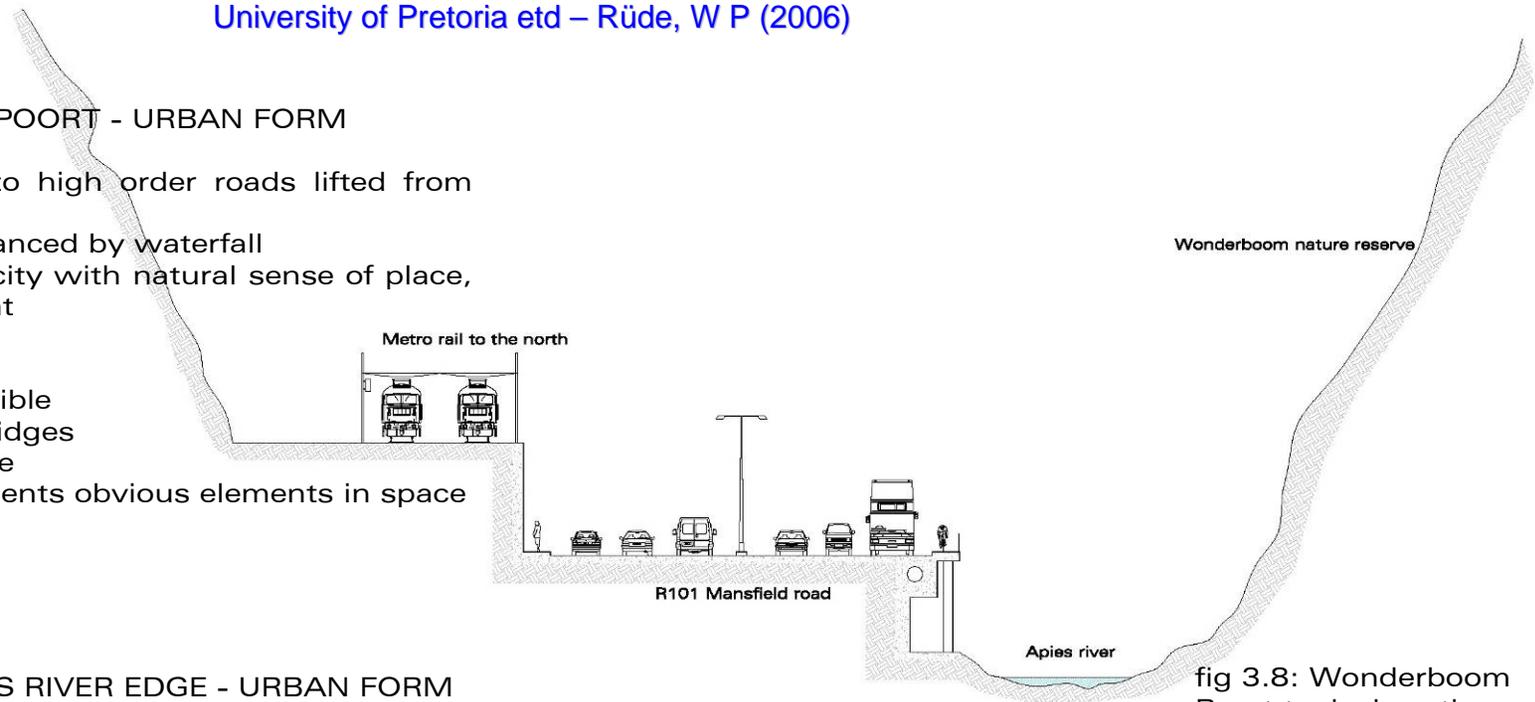
fig 3.8: Wonderboom Poort typical section

- No legibility due to high order roads lifted from level of river
- Unique image enhanced by waterfall
- Poort gateway to city with natural sense of place, waterfall focal point

- Not directly accessible
- Edges defined by ridges
- Mainly road surface
- Infrastructure elements obvious elements in space

- Roads dominate
- No river interface

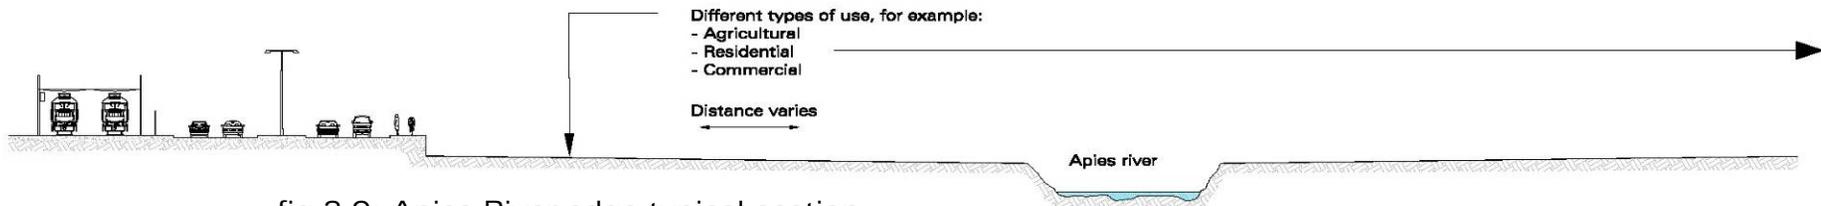
fig 3.9: Apies River edge typical section

- Legible as part of cultivated area, highly visible at bridge crossings
- Natural image supported by agricultural activities
- Cut in mountain defines gateway to city

- Not directly accessible due to private property, no direct roads
- Mountain defines southern edge of space
- Agricultural to natural surfaces
- Overhead power lines dominating elements in space
- Mainly agricultural activities, mining and illegal development to east

- Wide flood plain defined by roads on both sides
- The few residential structures along contributes to weak river interface

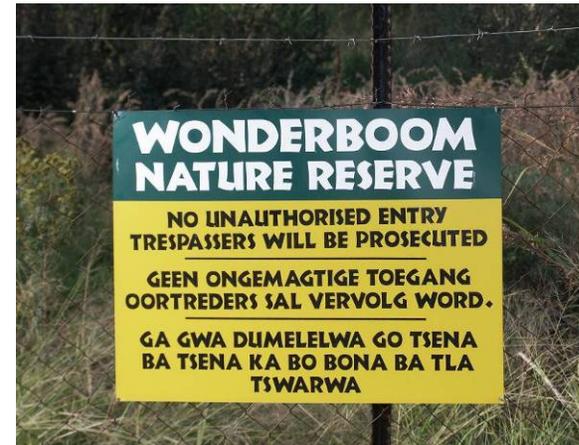
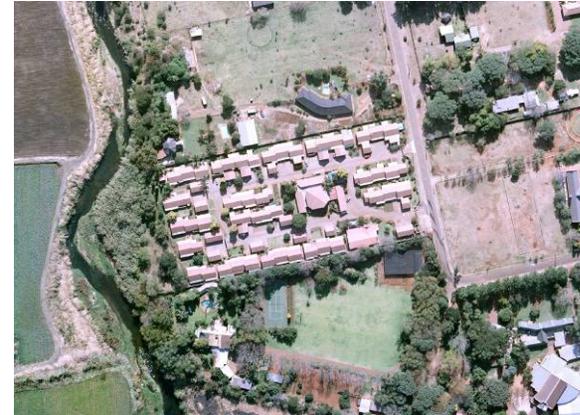
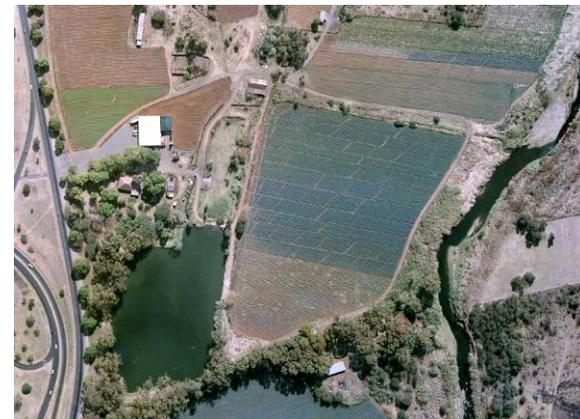
fig 3.10: Land Use along river

More than 70% of the land adjacent to the entire river (measured in distance fronting directly onto the river) consists of the following four land use categories:

- Farming activities (21%);
  - Single and low rise residential (18%);
  - Government and institutional uses (17%); and
  - Regional open space (16,5%).
- (Holm, P7)

The part north of the Magaliesberg has mainly agricultural activities along the river.

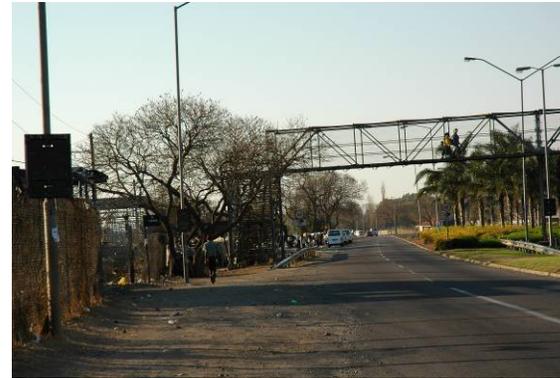
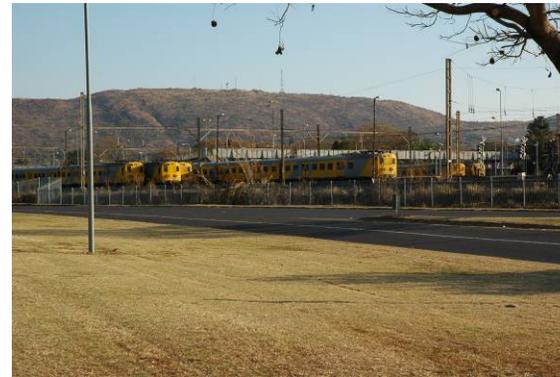
fig 3.12: Movement and transport

Road sides are used for taxi stops and informal trade. The stations do not read as part of the urban fabric. It is difficult to read how to enter and exit the stations, especially the Pretoria North station.

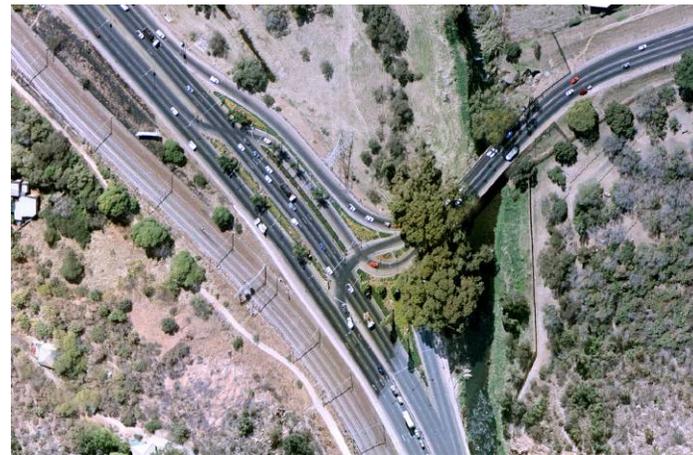
fig 3.13: Dominated by cars and trains, no safe pedestrian or cycle movement (Tshwane)

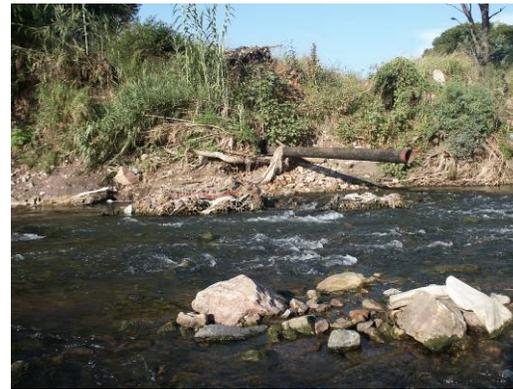
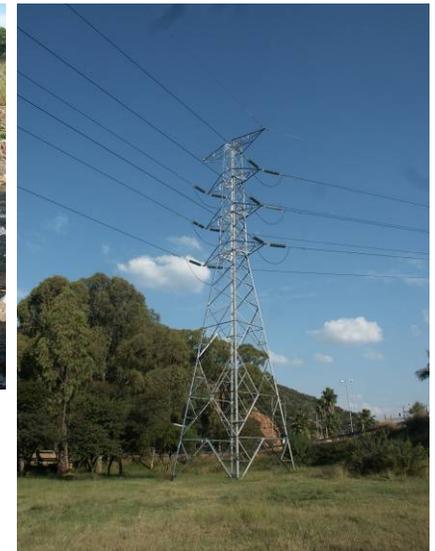
fig 3.14: Infrastructure and services in bad condition and not aesthetically pleasing

Being canalised and fixed with a concrete lining over large sections, the river bank became an urban spine along which installation of municipal services became convenient

To drain stormwater more effectively, large sections of the Apies River were canalised and lined with a concrete lining or gabion protection. This restrained the effect of flooding and reduced the possibility of loss of life and damage to property.

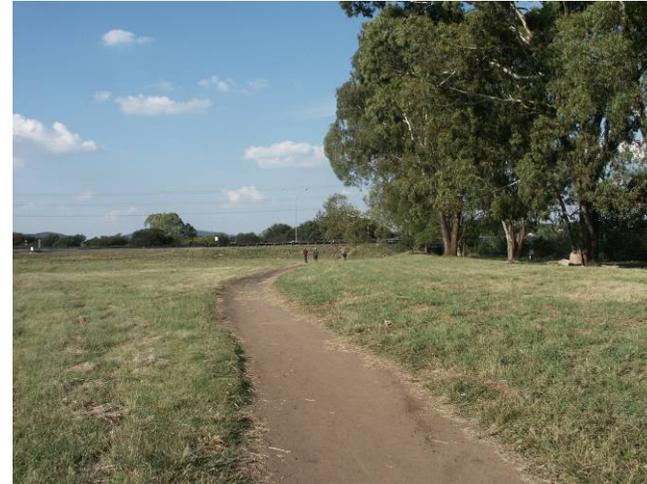
fig 3.15: No public furniture along informal pedestrian movement

A general lack of public amenities and public furniture are an obvious problem. Lighting, benches, litter bins and drinking fountains are either neglected or totally lacking. Only in the Caledonian Precinct is new street furniture provided as part of the upgrading of the road network. There is, however an unintegrated implementation and design of only one side of the river.

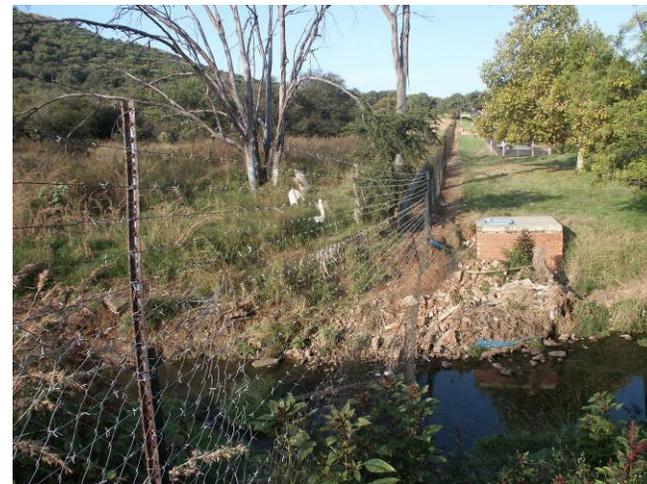
fig 3.16: No safe river crossings for pedestrians, vehicle crossings used for pedestrian movement
