**CHAPTER 4: SPATIAL CONFIGURATION OF ORIGINAL HOUSING PROVISION AND CHANGES OVER TIME**

This chapter aims to provide details of the case study areas prior to and during initial housing provision. It is meant to be demonstrative of the considerations made toward providing housing by government, the processes followed, the date of establishment and completion, the type of subsidies implemented, and the end results (erf configuration and size, and house configuration and size). This chapter addresses sub-problem 1.

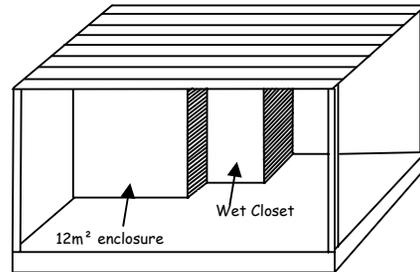
FIGURE 21: TYPE OF HOUSING PROVIDED IN EXTENSION 10

The project was initiated in 1994 and the majority of housing was completed in the year 2000. In total, there are six hundred and fifty five stands. It was decided by the present South African government that Extension Ten be provided with 24m<sup>2</sup> houses with 12m<sup>2</sup> enclosed with a toilet, windows and doors (refer to figure 21).

A compromise was reached, after many discussions, where an enclosure of 12m<sup>2</sup> was made (refer to diagram above). Beneficiaries requested that the wet closets be provided outside the roof structure for economic reasons (if they decide to build another extension at the back of the erf and rent out one of them, both the tenants and the owners have easy access to the wet closet without having to encroach on anyone's privacy). The following was provided with the wet closet at the corner of the erf:

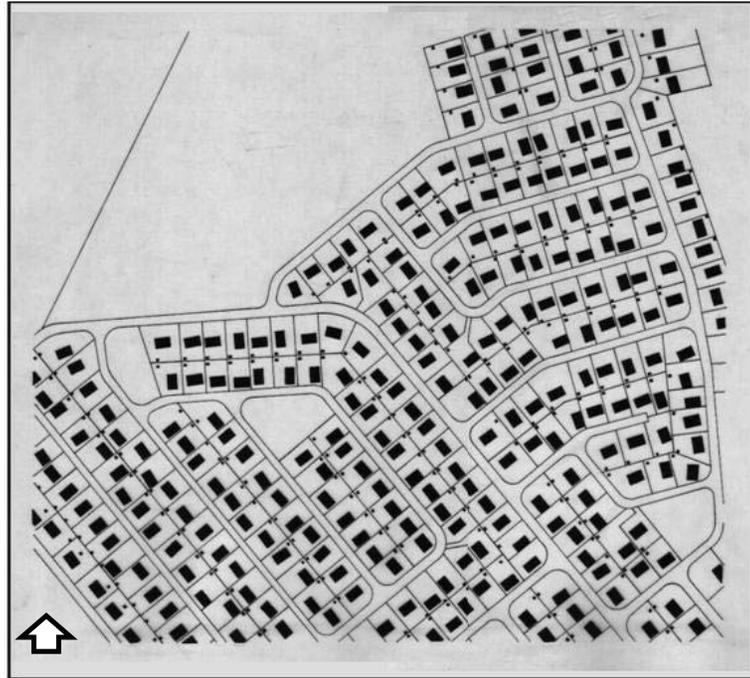
MAP 7: INITIAL PROVISION OF HOUSING IN EXTENSION 10

The representation of the initial provision of housing in this diagram has not taken into consideration the shacks already constructed by the residents prior to the provision of housing by government. Therefore, what appears in this diagram is merely a representation of the type of housing provided by government, i.e. roof structures with services.

GROSS DENSITY: 163p/ha  
NETT DENSITY: 266p/ha

The placing of the wet cores seems to take place at the back of the erven in either the left or right corners (influenced by the engineers). The wet closets have been placed in such a manner to save on service costs. The roof structures, on the other hand, seem to follow a different pattern. Although the wet closets seemed not to be influenced, in terms of positioning, by the presence of shacks, the roof structures were. The roof structures were placed in various positions on the erven depending on the position of residents' shacks. The majority appear to be placed away from the back boundary because of the presence of shacks. Most erven have the roof structures placed with the long side parallel to the road frontage. There is no clear consistent pattern as to the placing of these structures.

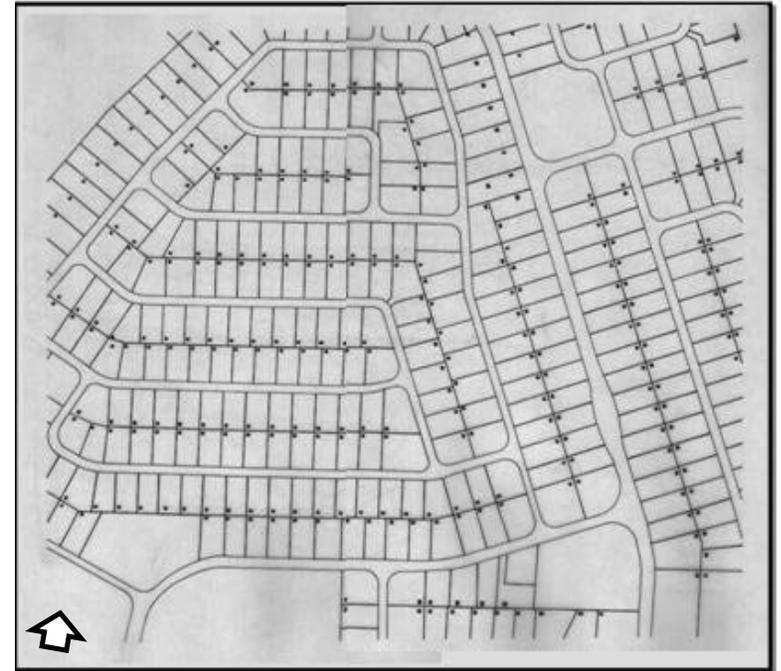
MAP 8: INITIAL PROVISION OF HOUSING IN EXTENSION 6

The representation of the initial provision of housing in this diagram has not taken into consideration the shacks already constructed by the residents prior to the provision of housing by government. Therefore, what appears in this diagram is merely a representation of the type of housing provided by government, i.e. site and service.

GROSS DENSITY: 219p/ha  
NETT DENSITY: 364p/ha

The placing of the wet closets in this extension also appear to be placed at the back of the erven in either the left or right corners to save on service costs. The placing of the wet closets has therefore been influenced by the engineers.

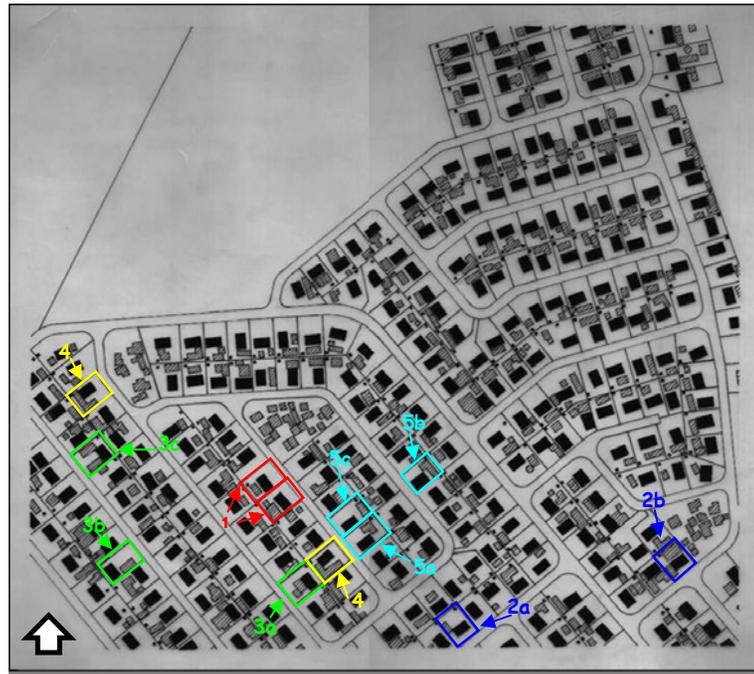
MAP 9: CHANGES OVER TIME IN EXTENSION 10

With the observation of changes taken place on the erven, four typical patterns can be extracted and are numbered correspondingly to the map above:

1. Roof structures placed **centrally** on the erven with the **long side parallel to the street**:
  - a. Temporary structures have been built at the back behind these structures. This creates minimal living space at the back of the erven with more space at the front.

2. Roof structures placed toward the **front** of the erven with the **long side parallel to the street**:
  - a. Structures have been built at the back or along the side of the erven. Privacy is created within the larger living space in comparison to 1 with enough space for a garden at the front.

3. Roof structures placed toward the **back** of the erven with the **long side parallel to the street**:
  - a. In some cases, roof structures have been placed at the back. With the initial placing of temporary structures on the erven, the placing of the roof structures appeared to be a difficult task, i.e. the size of the roof structure made it impossible to fit anywhere else. Two households appear to be fine in terms of living space, i.e. 3b and 3c. All structures have been arranged along the erven boundaries (back and sides). This creates maximum space for living and space in front for a garden. Privacy levels might be a bit lower. In the case of 3a, odd space has been created.

4. Roof structures placed in either **side** of the erven toward the **centre** (in relation to the front and back boundaries) with the **shorter side parallel to the street**:

- a. Temporary structures have been built along the back and sides of the erven to create space between the structures. The arrangement appears somewhat cramped and creates more space at the front of the erven than between the structures.

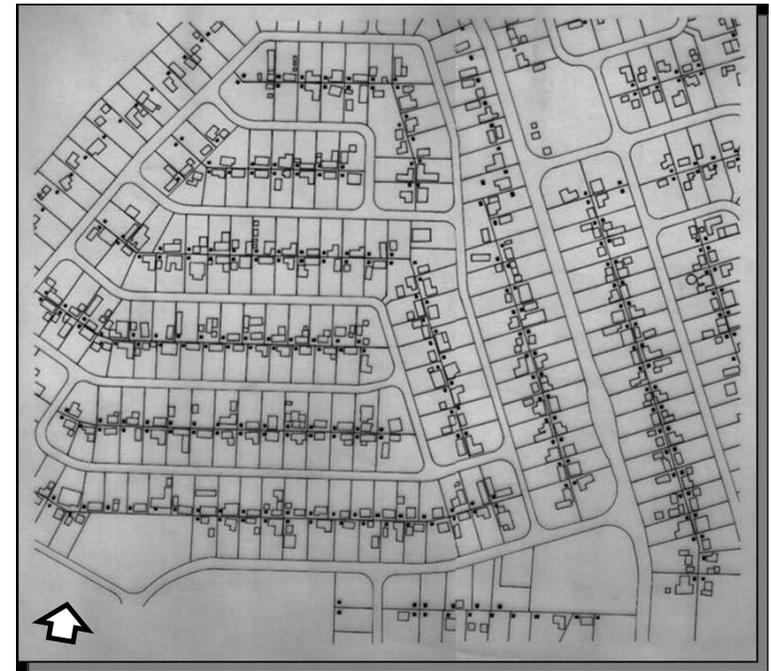
MAP 10: CHANGES OVER TIME IN EXTENSION 6

The typical pattern presented here is that of structures built at the back of the erven. This allows the use of space has been optimised for the future houses to be built. In this way, temporary structures would not have to be demolished or disturbed during the process of construction of the future houses.
